# Storm Damage – Floating Culverts & Other Inlet Issues

Mark Bailey, PE - Hydraulic Manager, INDOT  
Dale Sedler, PE - Sr. Hydraulic Engineer, INDOT

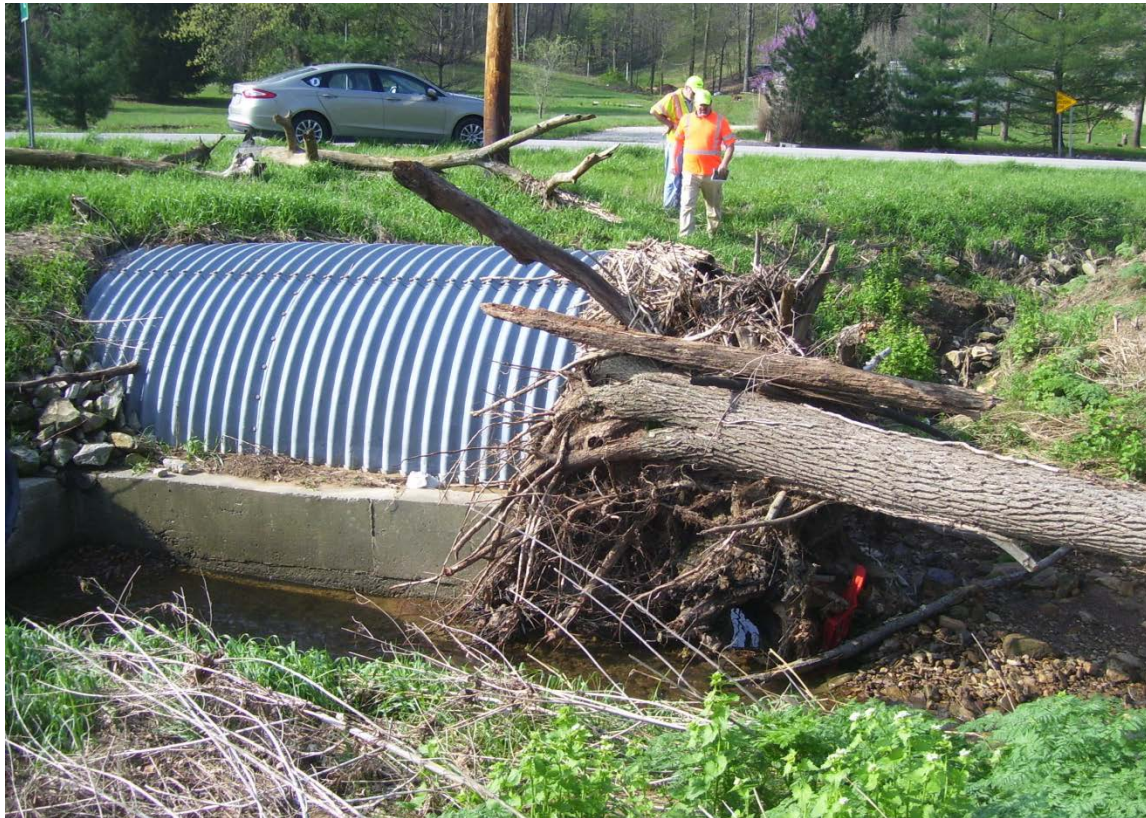
**SR 56 Dubois @ RP 54.2**  
**April 2015**

Debris at inlet.

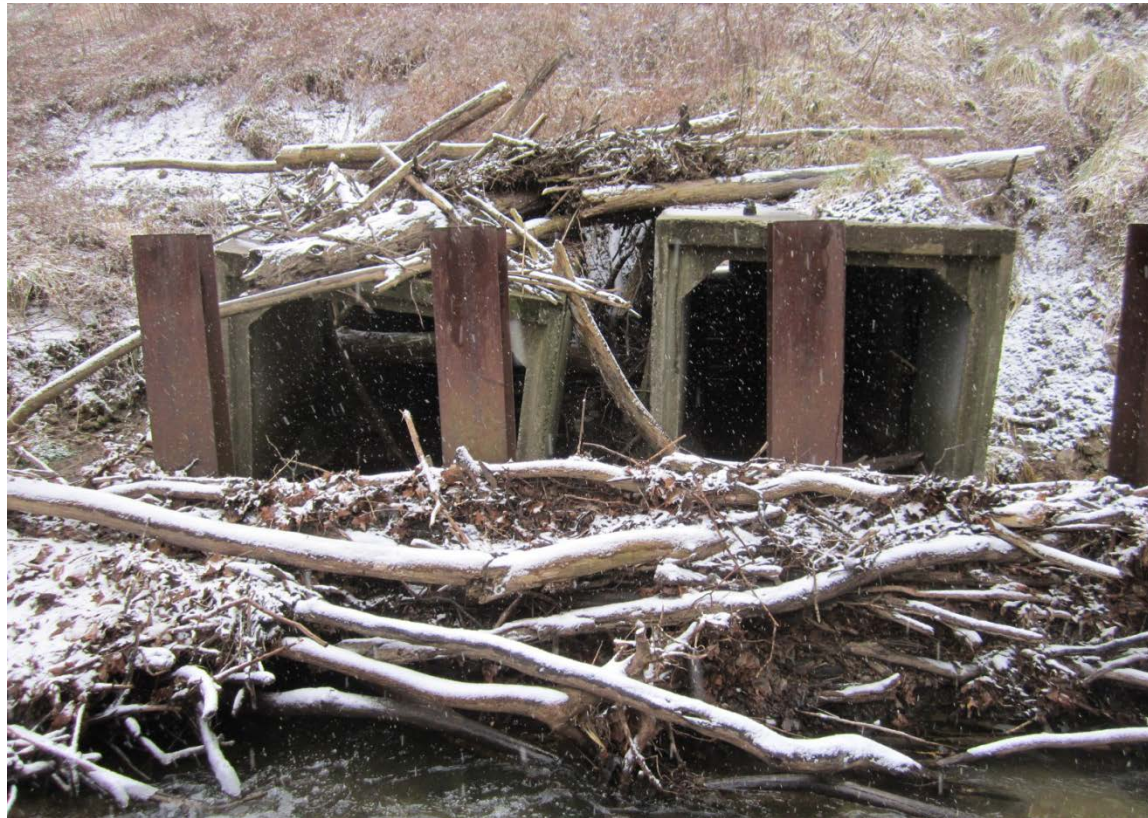
## SR 26 Tippecanoe Co. @ RP 28.10

Debris accumulation on collector and on top of structures.

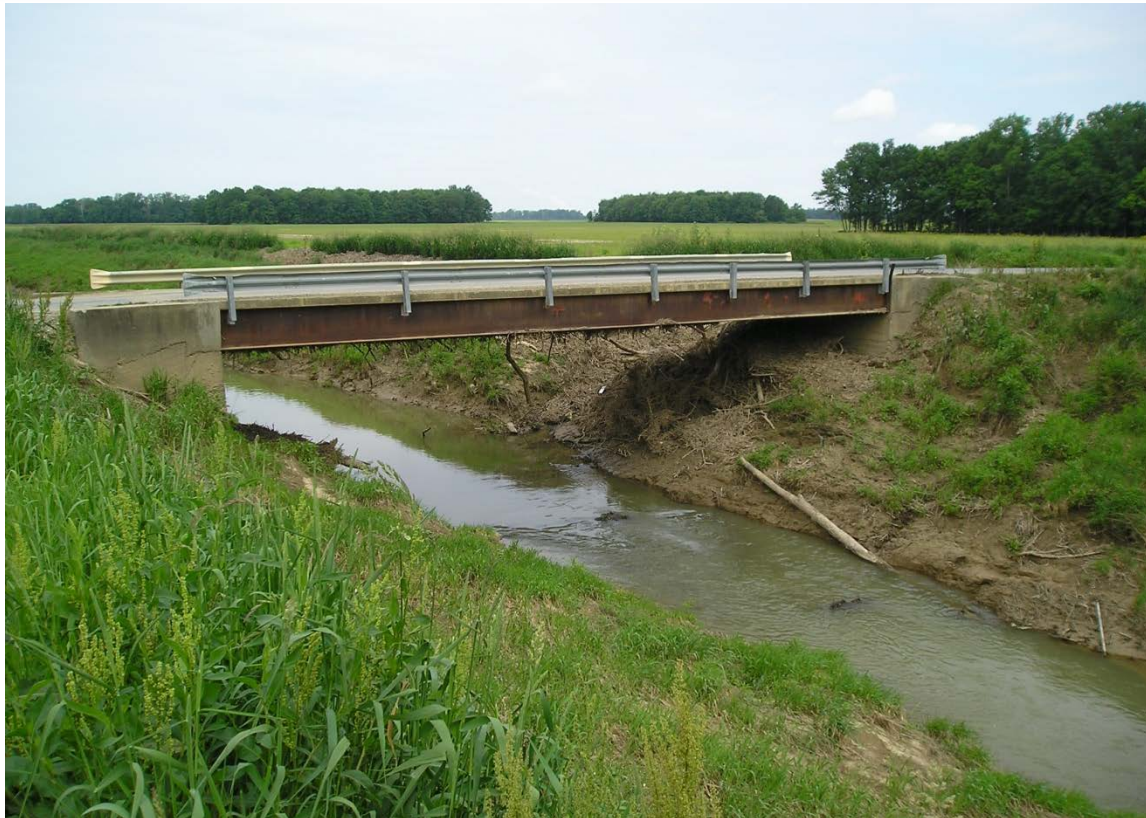
## CO Rd 550 E Gibson Co @ Pigeon Creek May 2011

This 60 ft. bridge is immediately upstream of I-69 Bridge and was plugged by debris, mainly branches and corn stalks. A local farmer unplugged it using a tractor with a backhoe attachment.

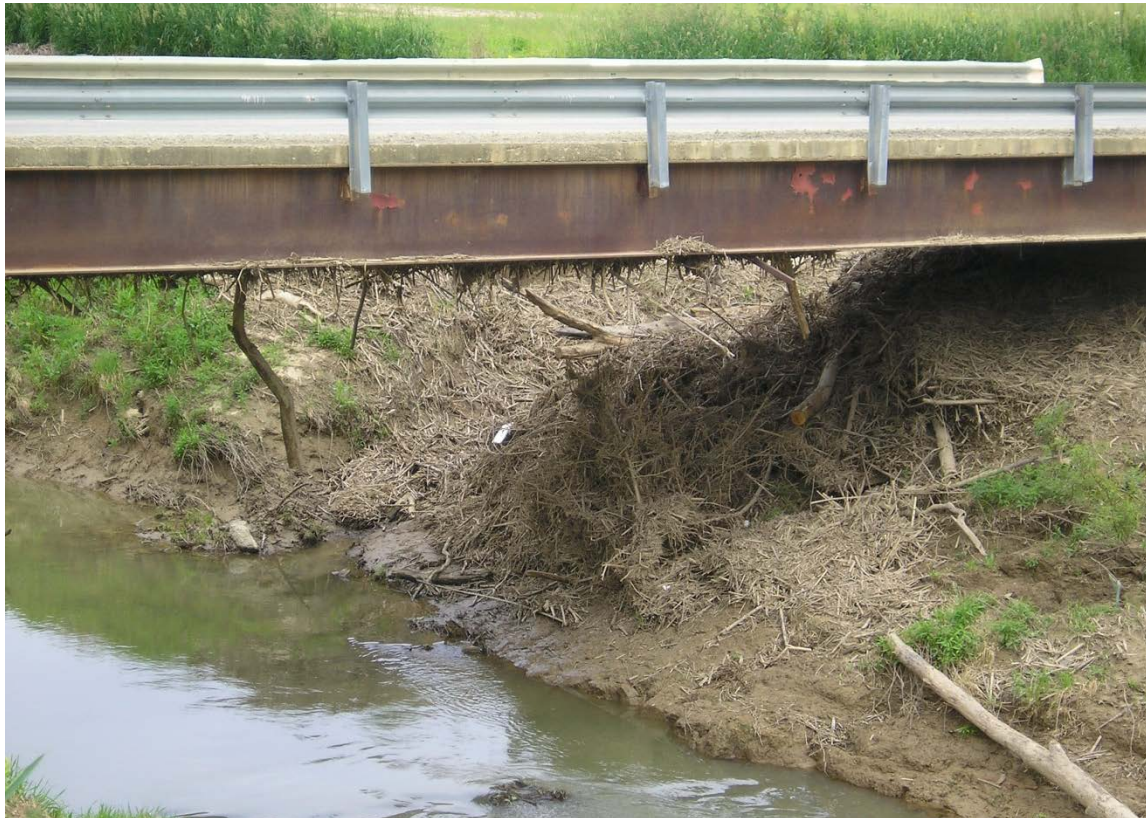
**CO Rd 550 E Gibson Co @ Pigeon Creek**  
**May 2011**

Note the branches and corn stalks.

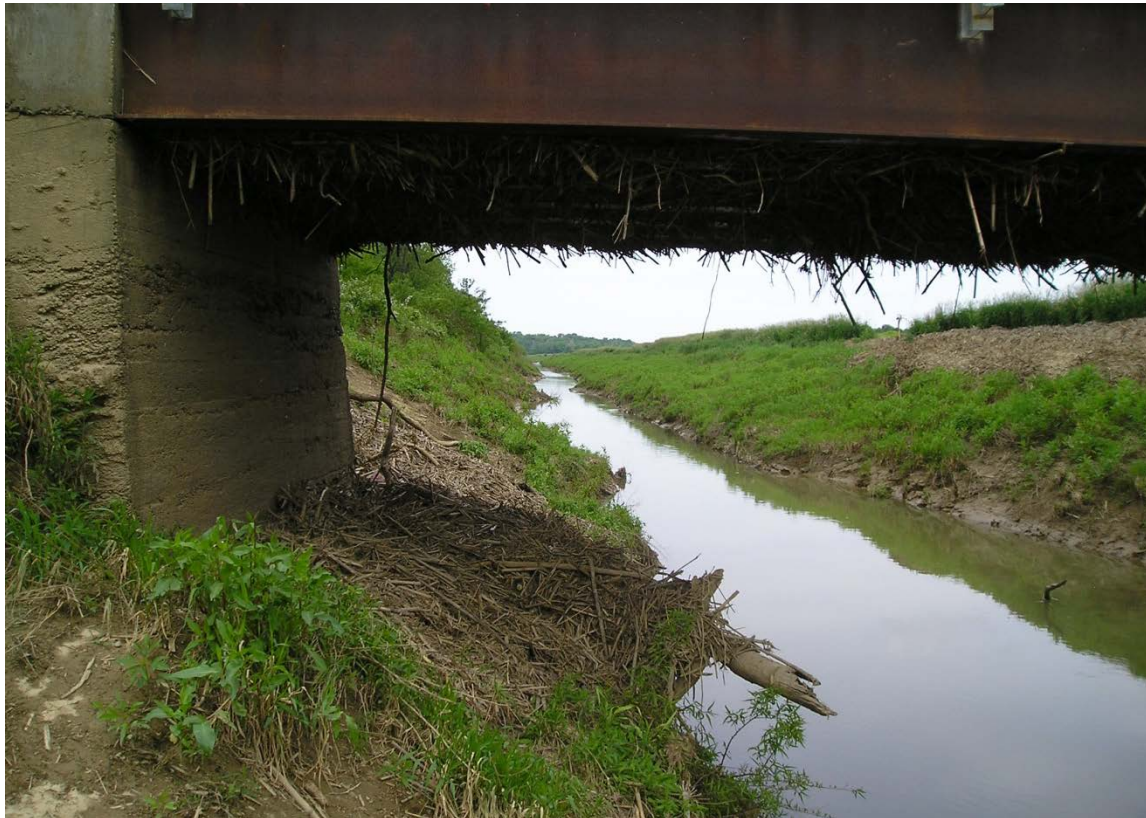
**CO Rd 550 E Gibson Co @ Pigeon Creek**  
**May 2011**

Note the corn stalks jammed in between the beams.

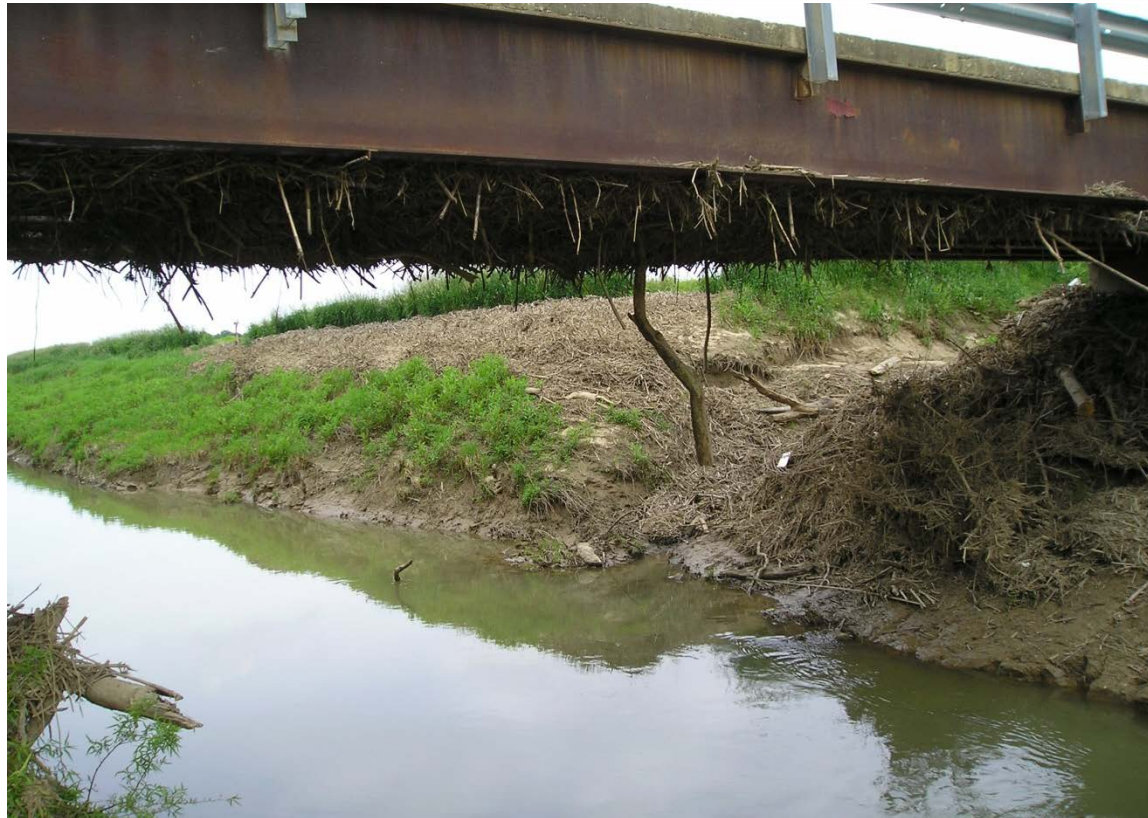
## CO Rd 550 E Gibson Co @ Pigeon Creek May 2011

More of the corn stalks and branches in the beams. Note the corn stalks on the bank upstream of the bridge.

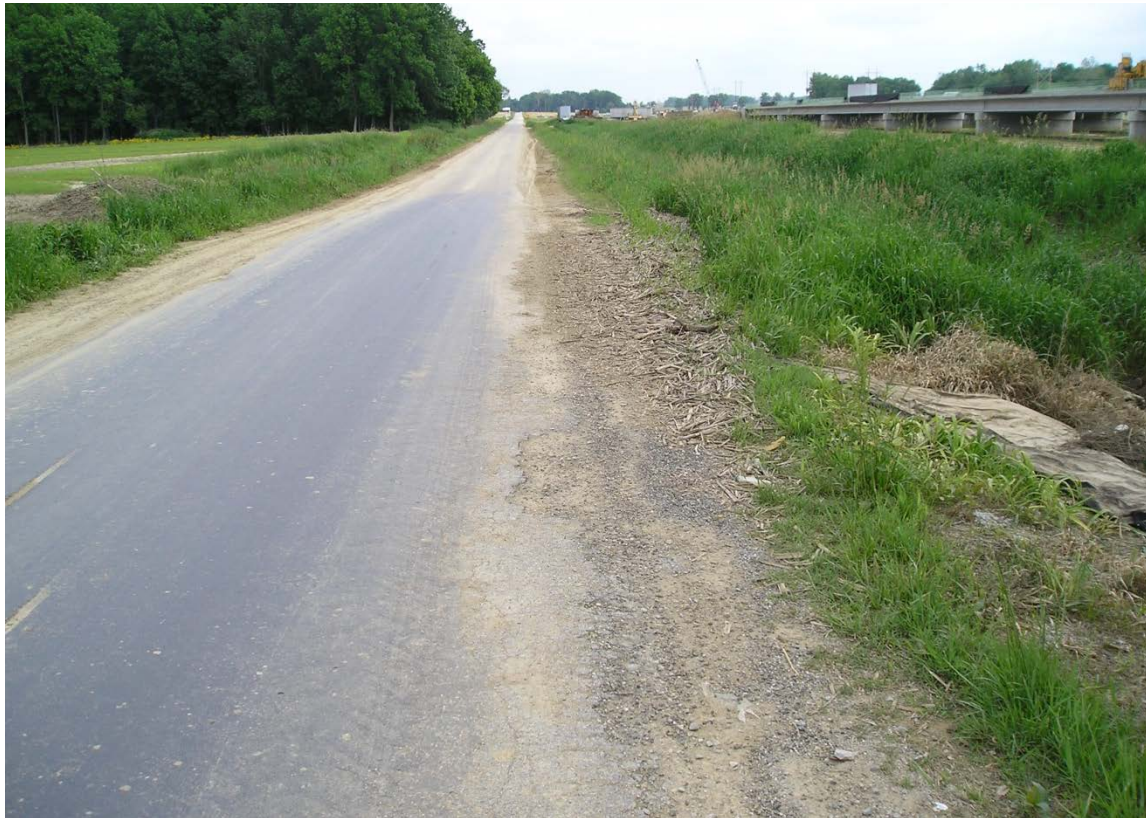
## CO Rd 550 E Gibson Co @ Pigeon Creek May 2011

Looking N from bridge. Note the stains on the County Road due to overtopping, as well as the corn stalks. Also, note how the I-69 bridge extends far onto the flood plain. Br is > 1,300 ft long.

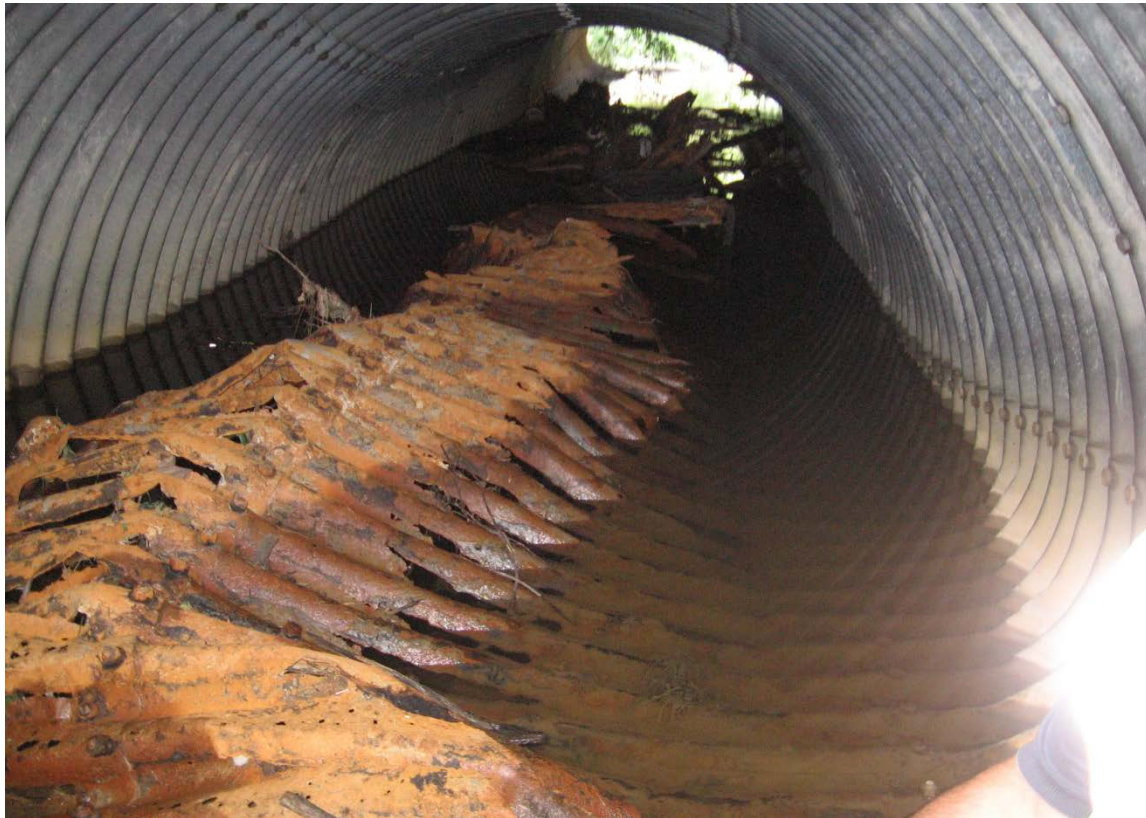
**SR-60, Clark Co., July 2006, 11.40 x 7.24 SPPA**  
**7-16-2006**

Items to observe: 1. Culvert bottom was in poor shape prior to event. 2. Note upwards bending of culvert (looking in inlet direction).

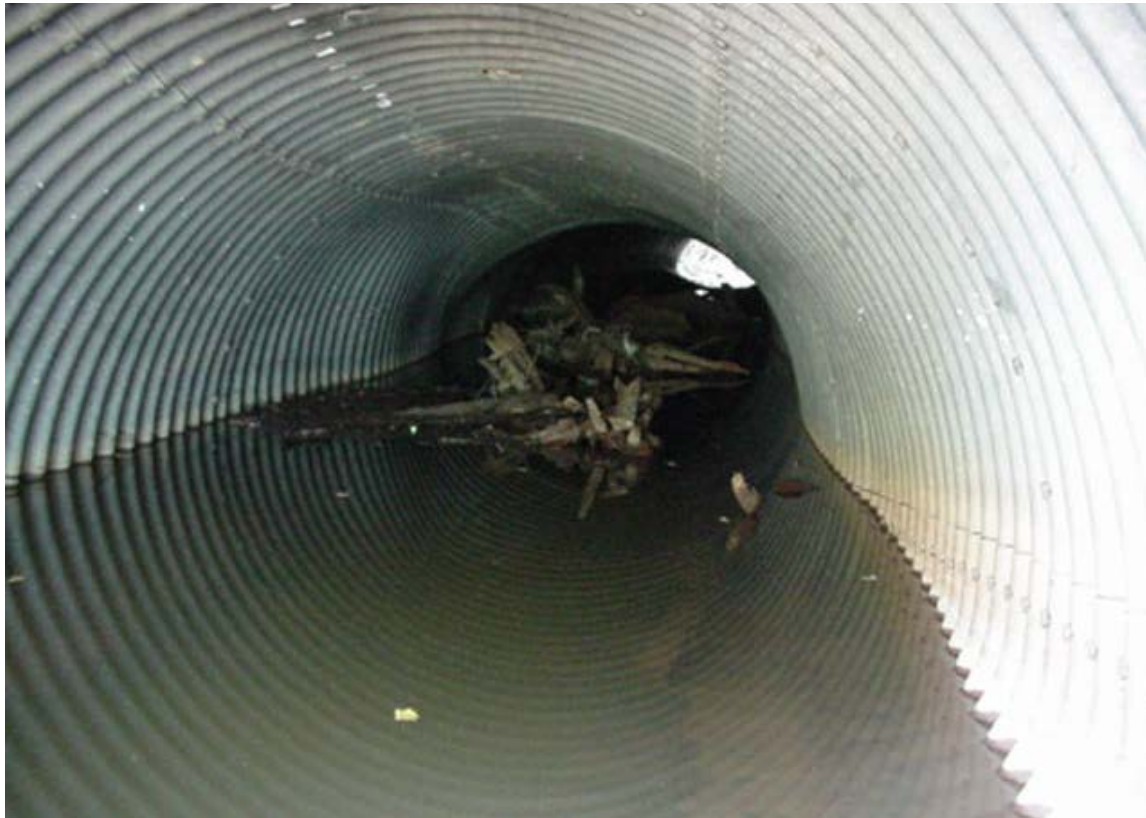
**SR-60, Clark Co., July 2006, 11.40 x 7.24 SPPA**

Residual debris in culvert (looking towards inlet)

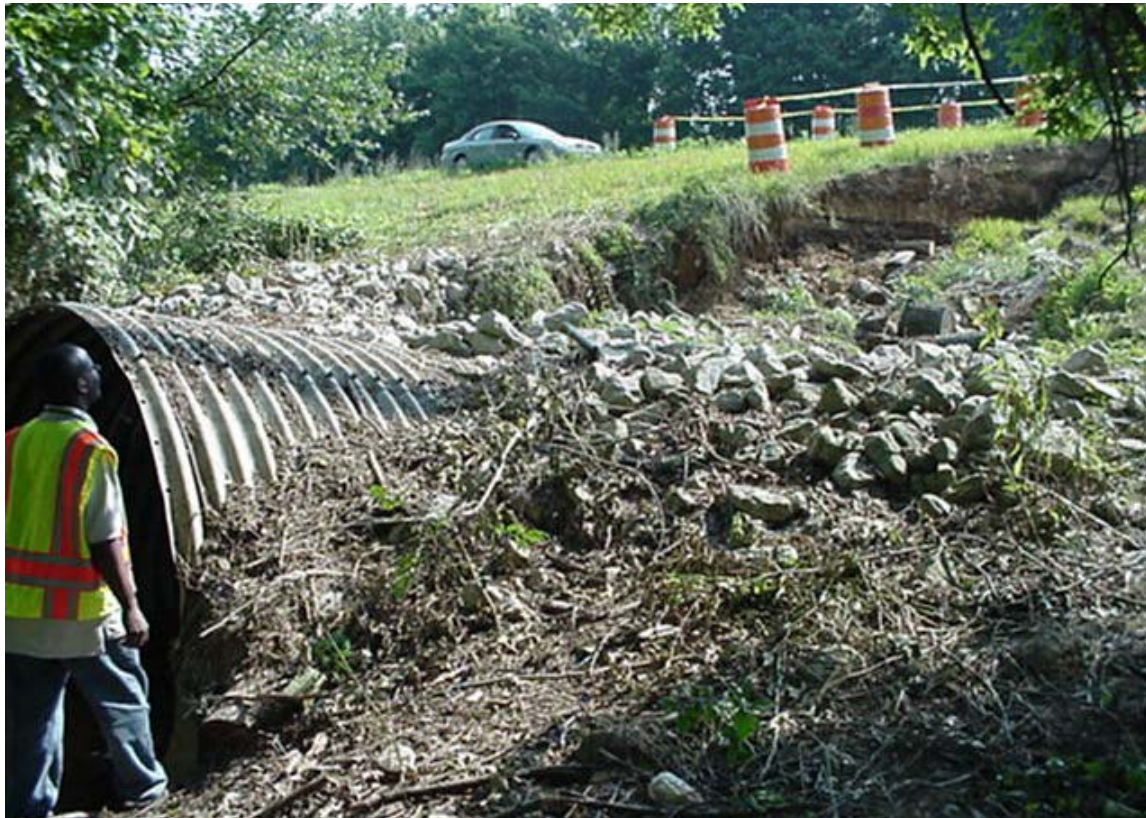
**SR-60, Clark Co., July 2006, 11.40 x 7.24 SPPA**  
**7-26-2006**

Disturbed embankment at inlet. Again note the upwards bend of the culvert.

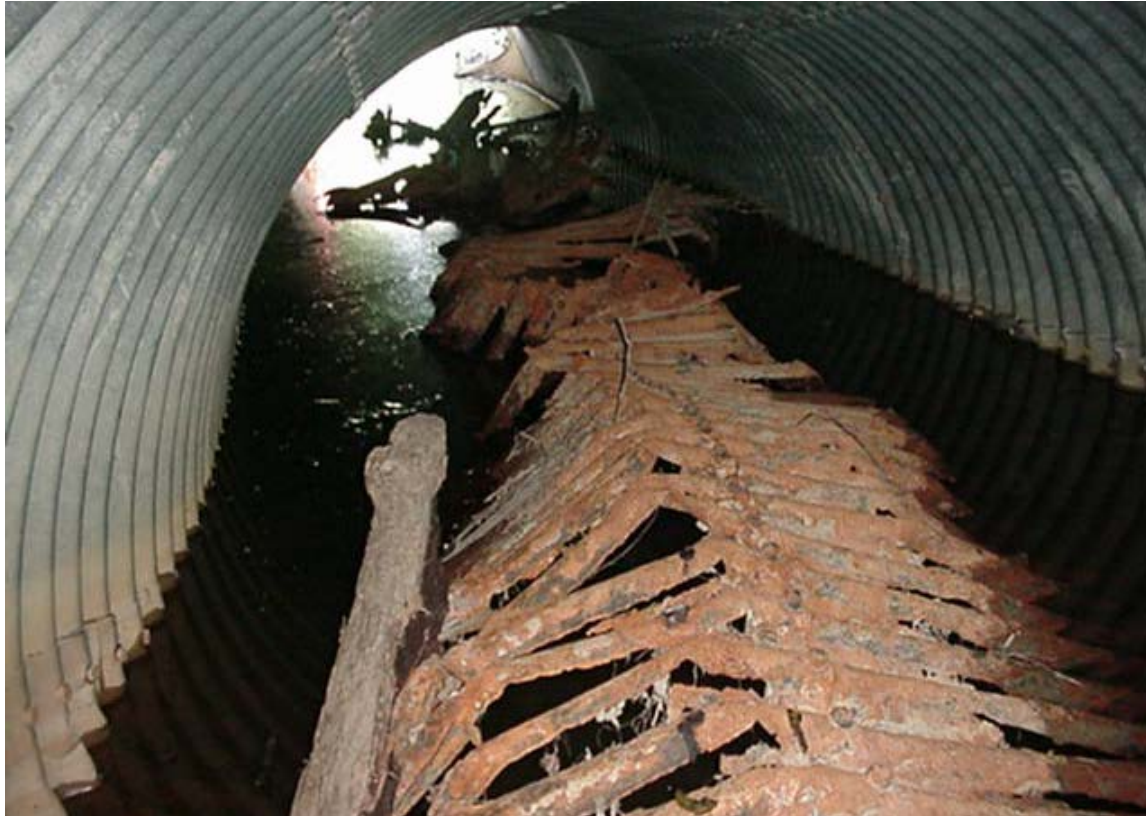
**SR-60, Clark Co., July 2006, 11.40 x 7.24 SPPA**  
**8-4-2006**

Interior bottom damage to culvert near inlet. Again, note the bending of the culvert and debris.

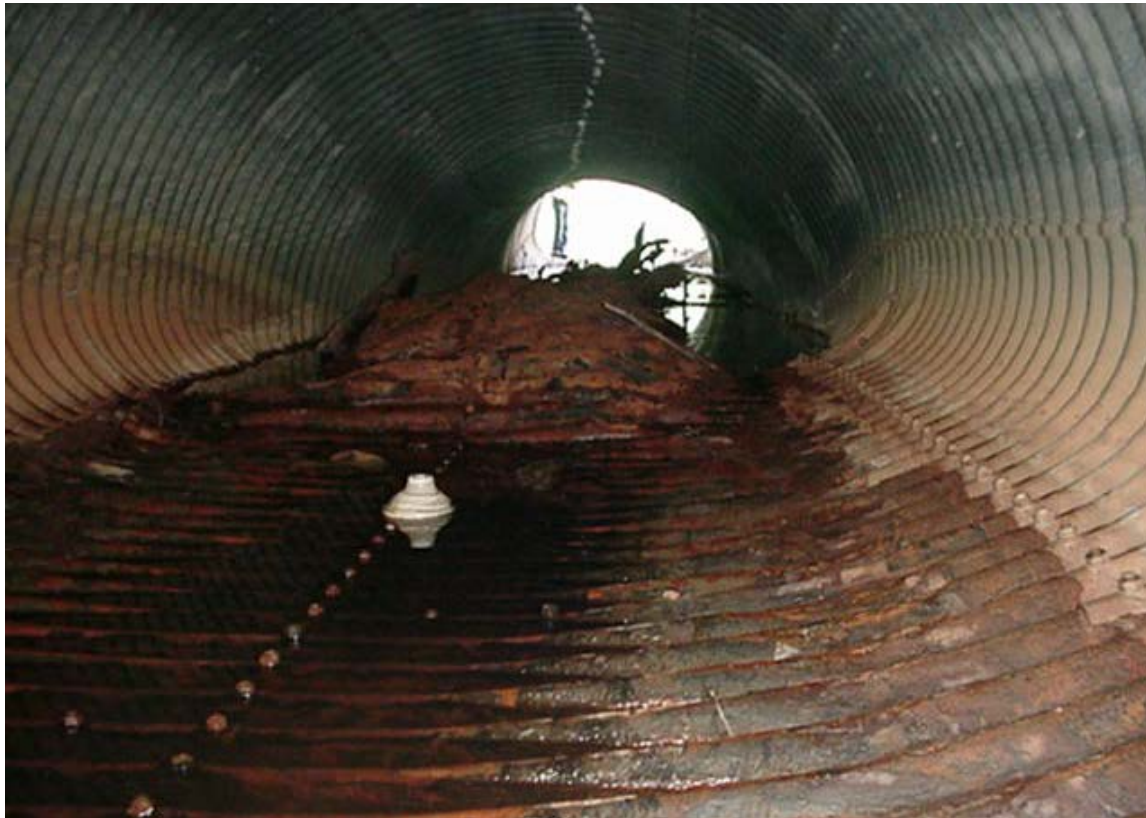
**SR-60, Clark Co., July 2006, 11.40 x 7.24 SPPA**

Culvert bottom damage.

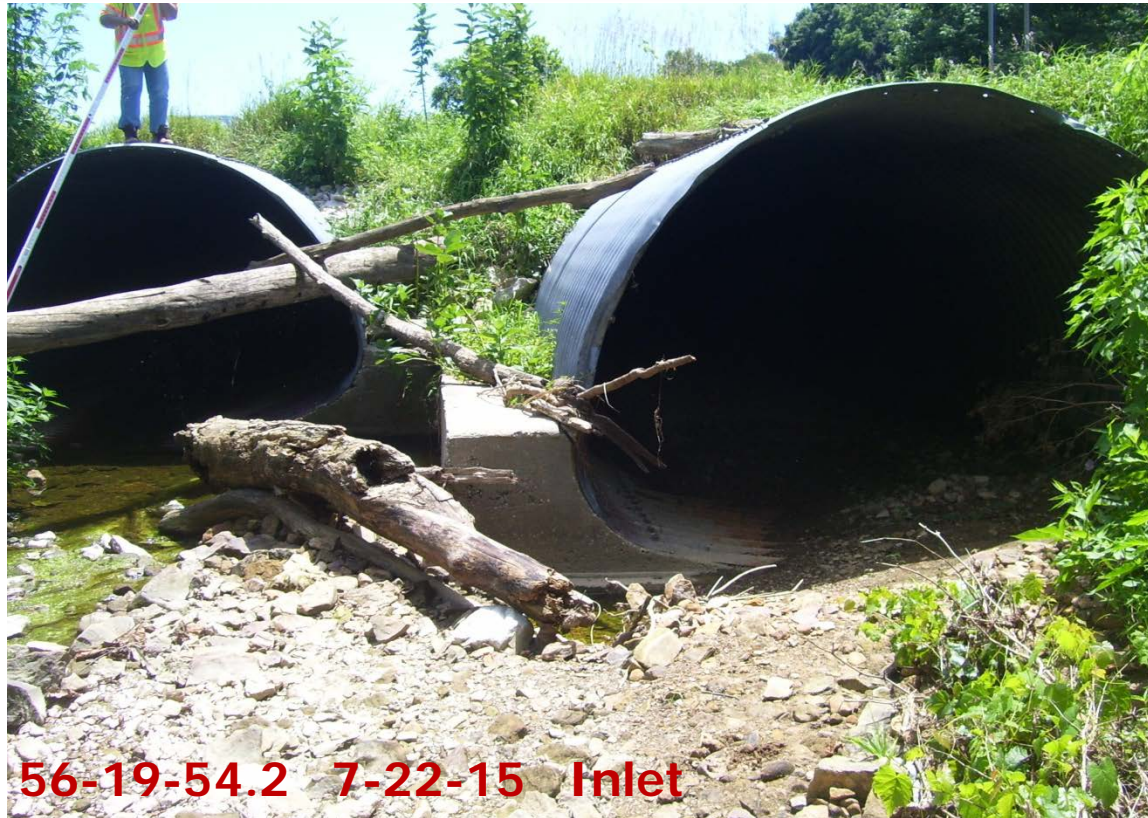
## Multiple culvert problems

Note that one culvert tends to become the streams choice, and the other may experience sediment accumulation. And, the one the stream chooses to use, also collects floating debris.

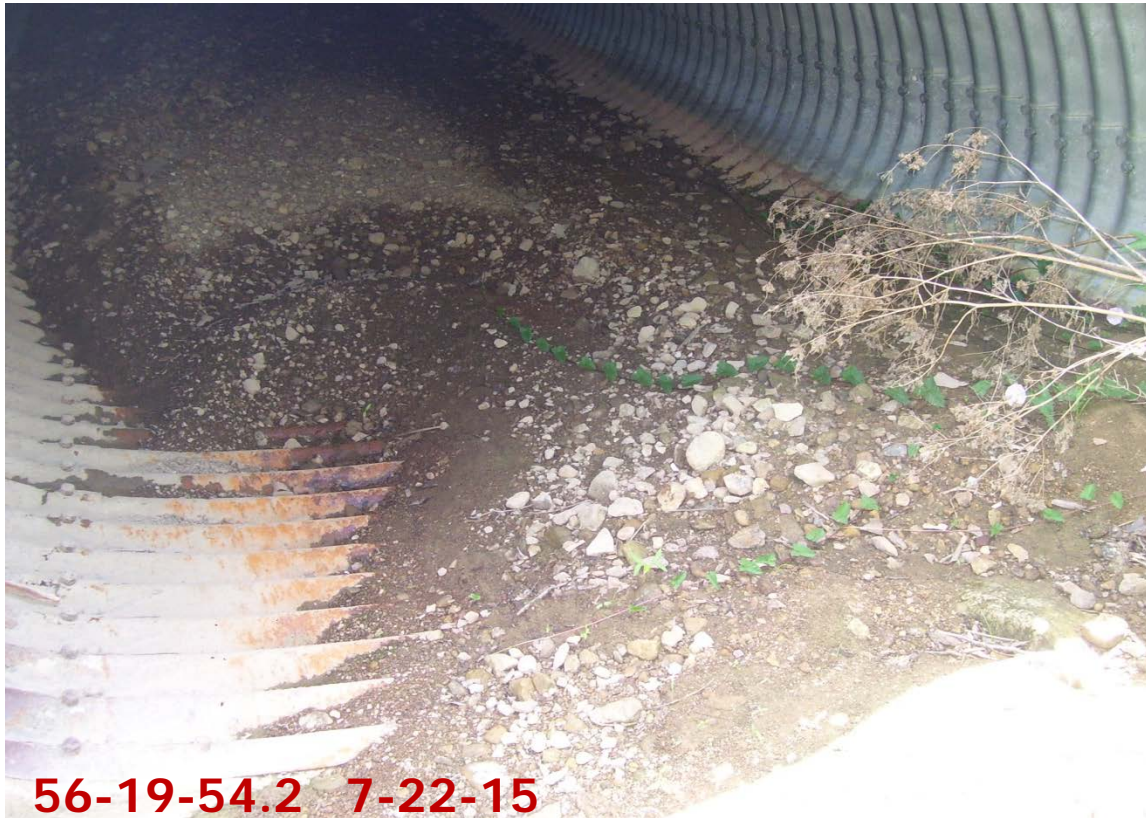
56-19-54.2 7-22-15

Accumulating sediment

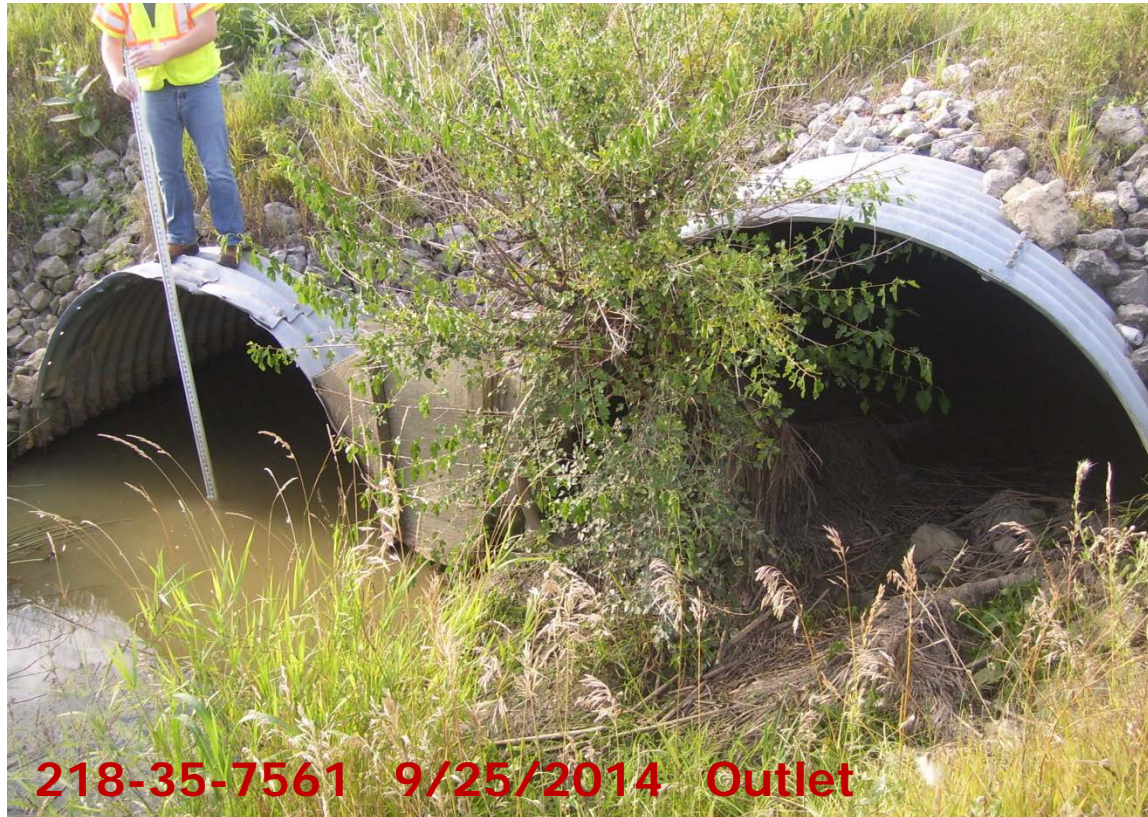
At the higher culvert outlet sediment and debris accumulation is visible, as well as a tree starting to grow.

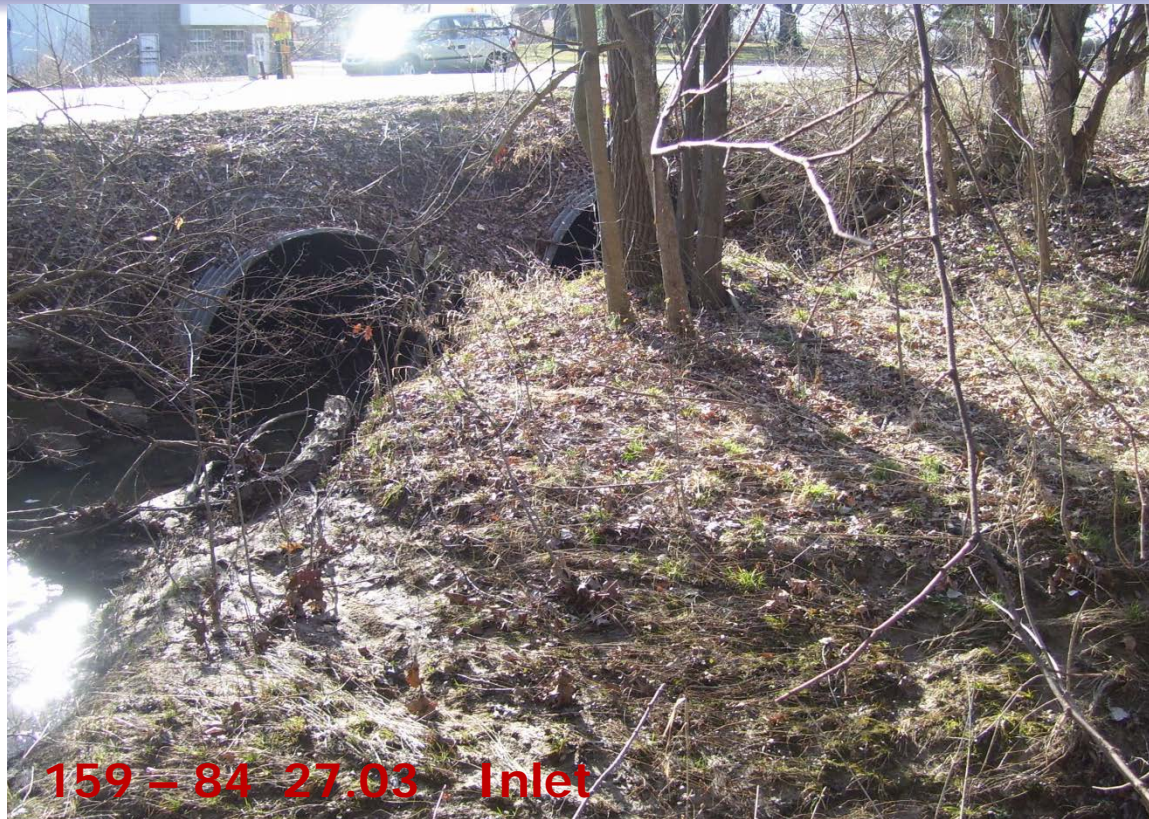
Double culvert where the stream has shifted and abandoned the other culvert, which now has a ridge of soil with trees growing immediately upstream of the inlet.

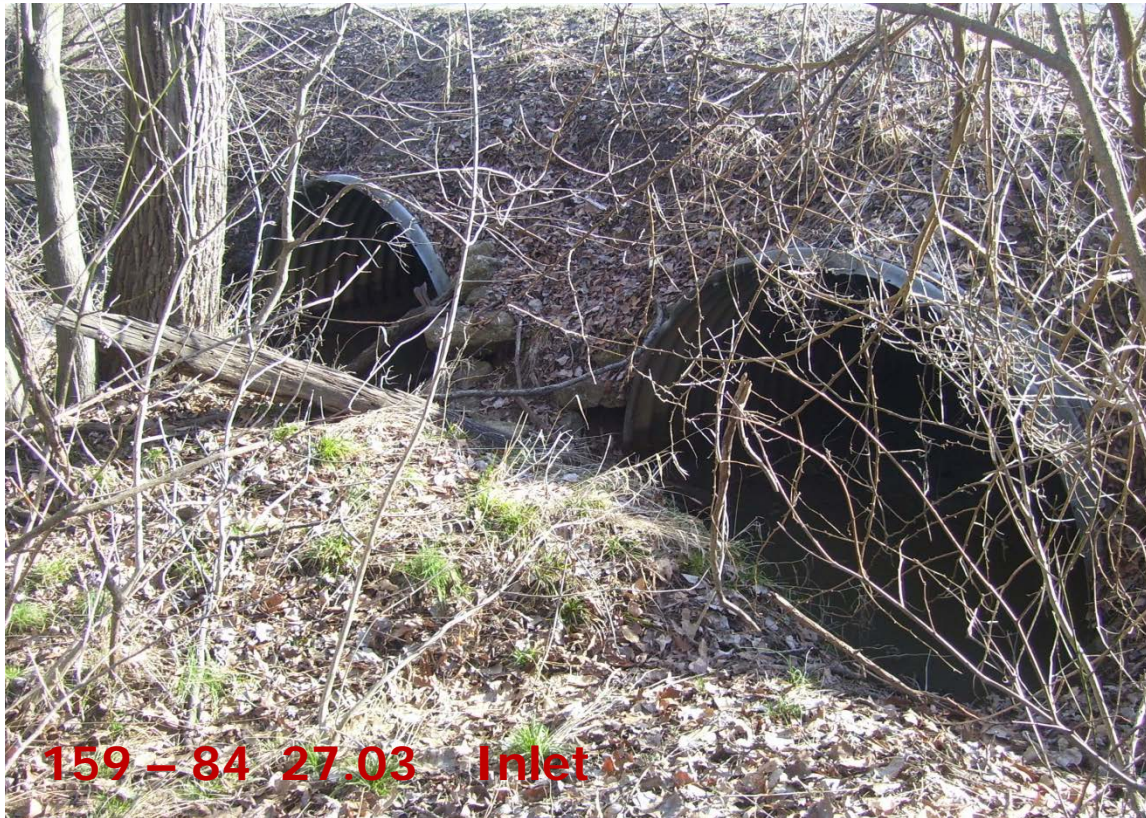
159 - 84 27.03 Inlet

Close-up of the same culverts showing how water has to be very deep to get into the second culvert.

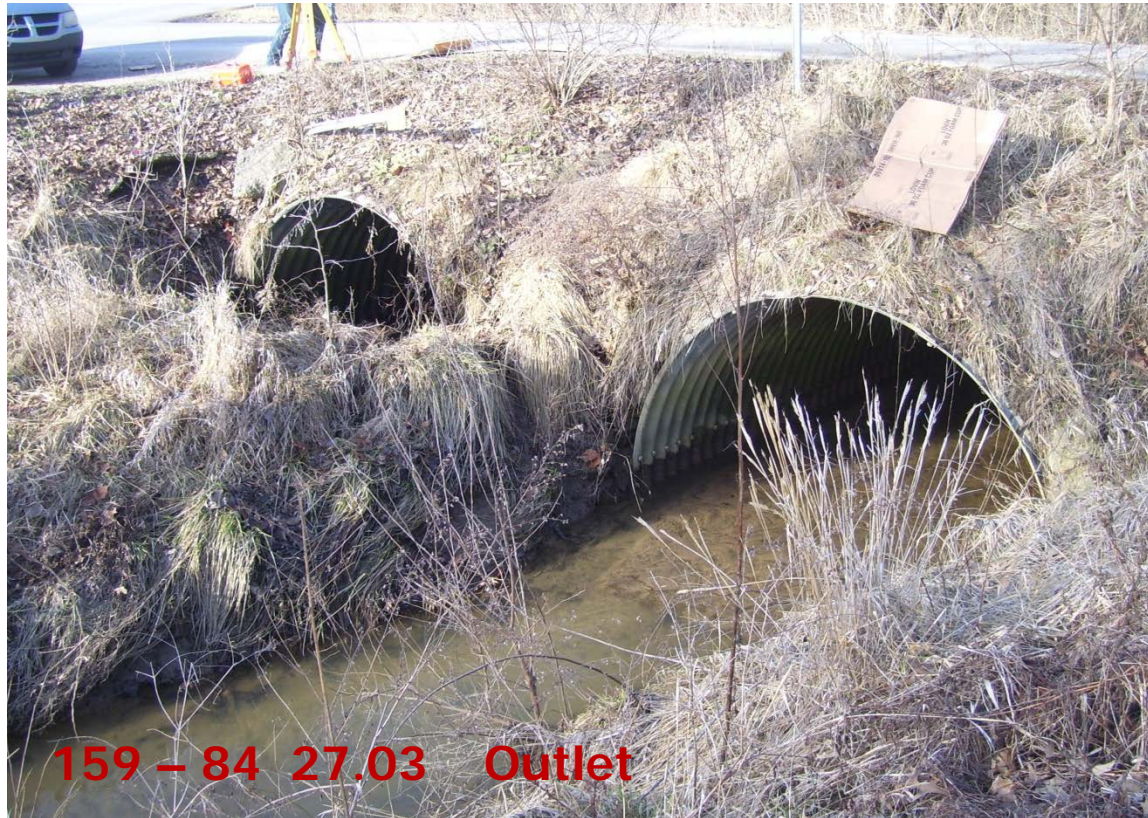
159 - 84 27.03 Outlet

At the outlets it is apparent that the other culvert has been abandoned by the stream.

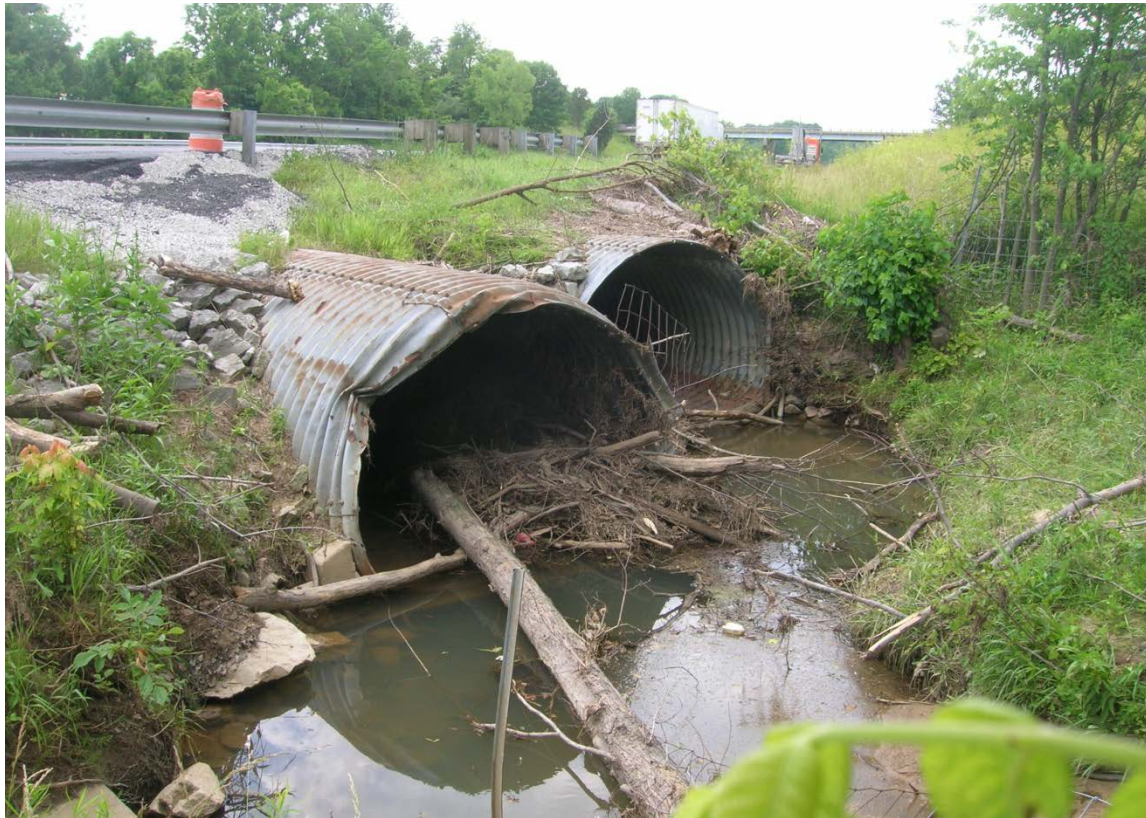
## I-70, Putnam Co., June 2008, Twin 9.5 x 6.0 SPPA

Culvert inlets. Closest one was blocked and floated, popping up through the pavement of westbound I-70.

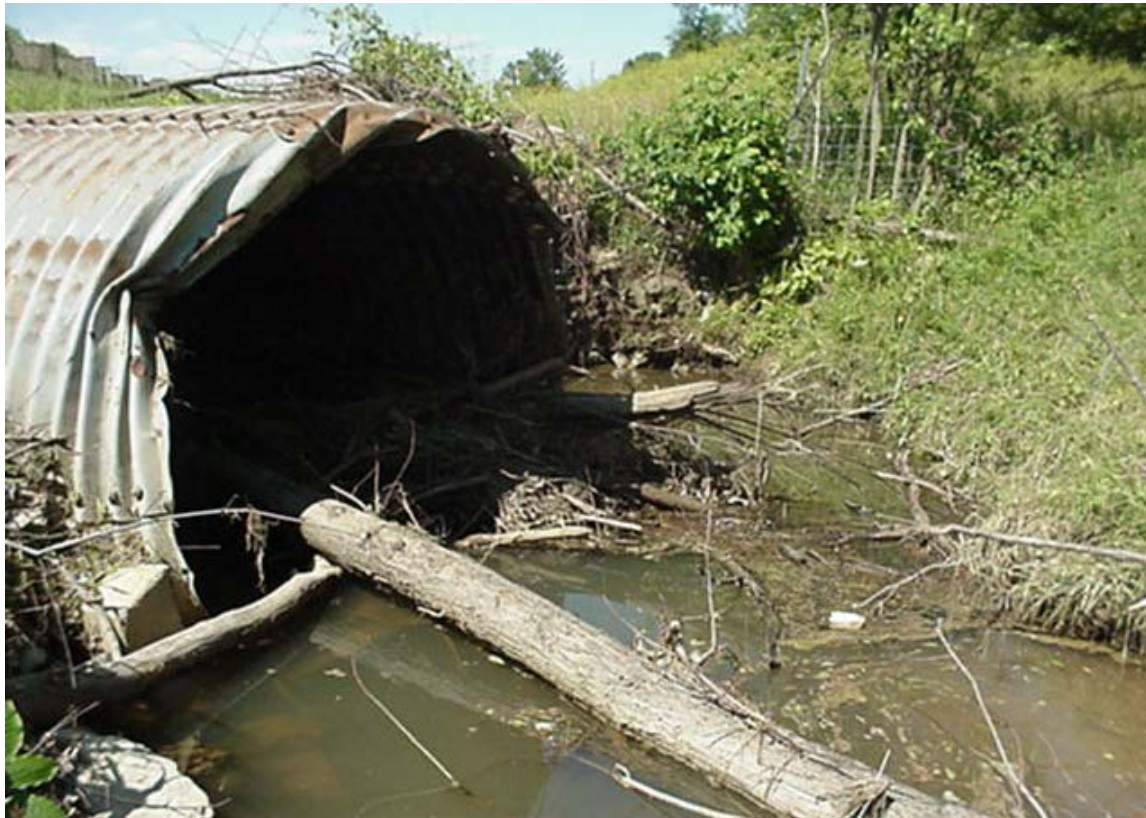
## I-70, Putnam Co., June 2008, Twin 9.5 x 6.0 SPPA

East pipe inlet. Note large dent and debris, including a tree.

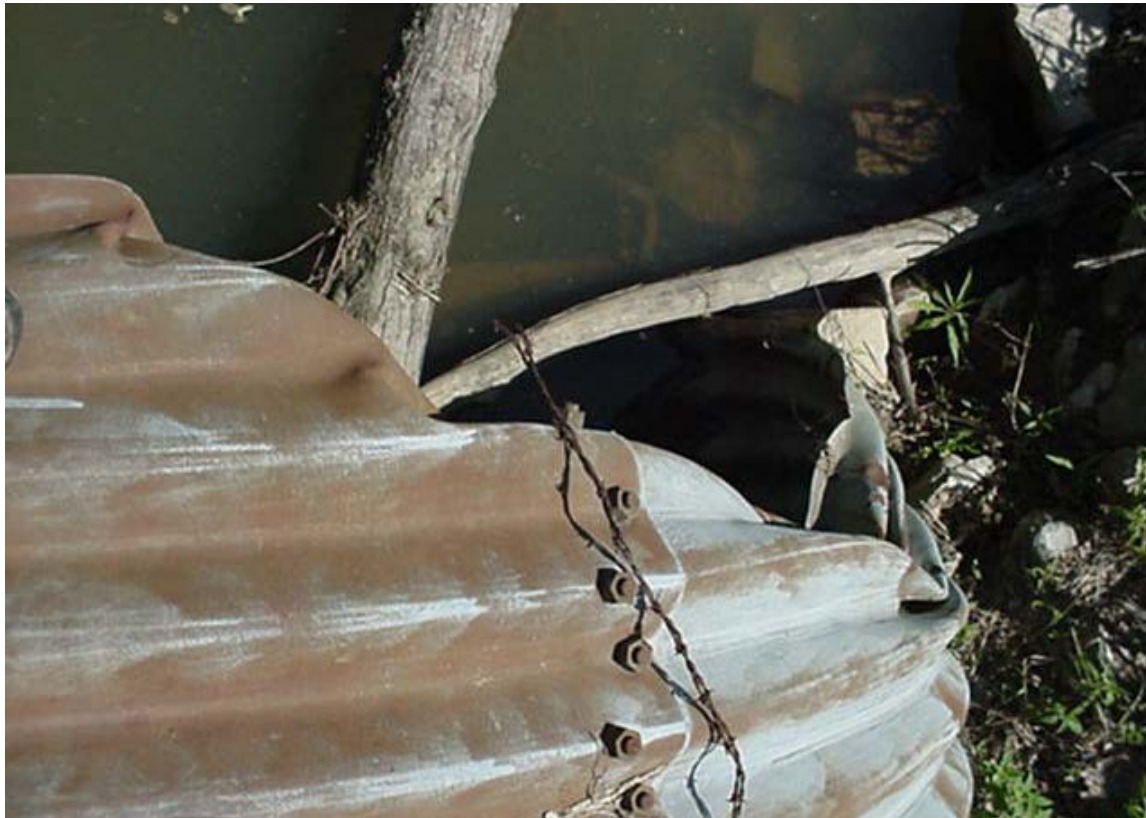
**I-70, Putnam Co., June 2008, Twin 9.5 x 6.0 SPPA**

Dent on eastern side of east culvert inlet.

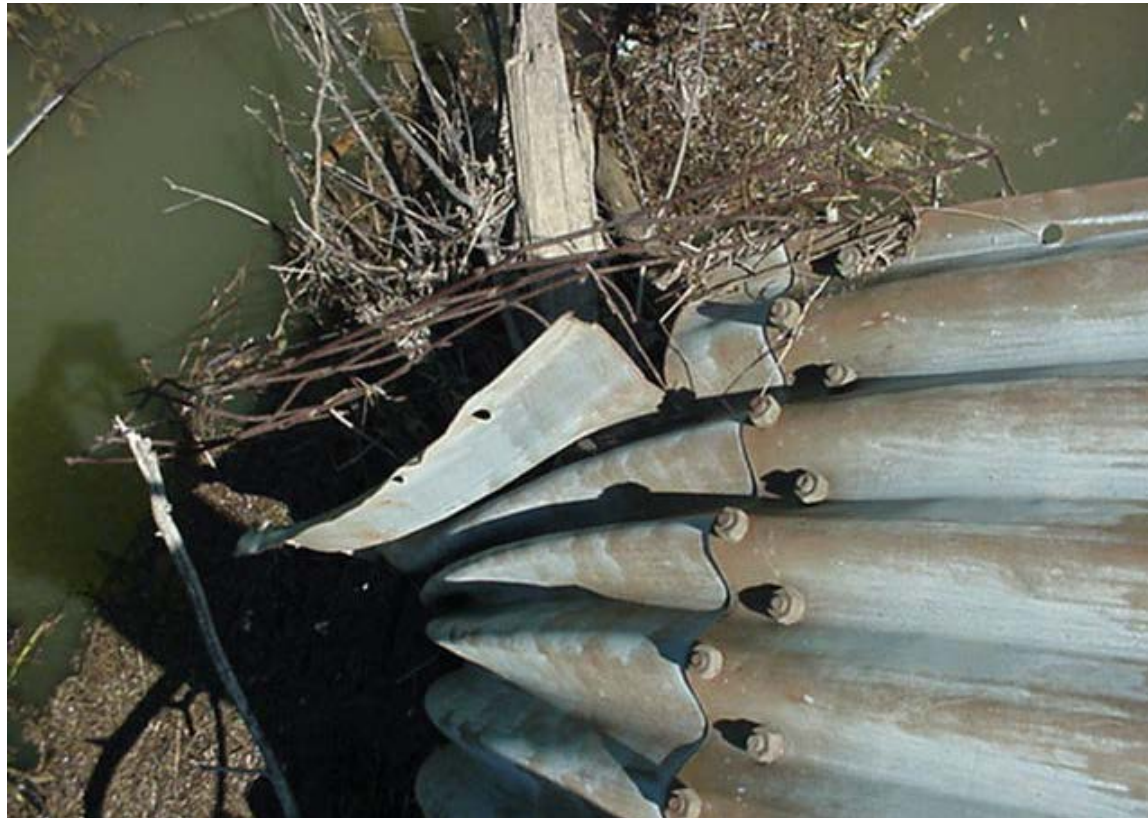
**I-70, Putnam Co., June 2008, Twin 9.5 x 6.0 SPPA**

Dent on western side of east culvert inlet.

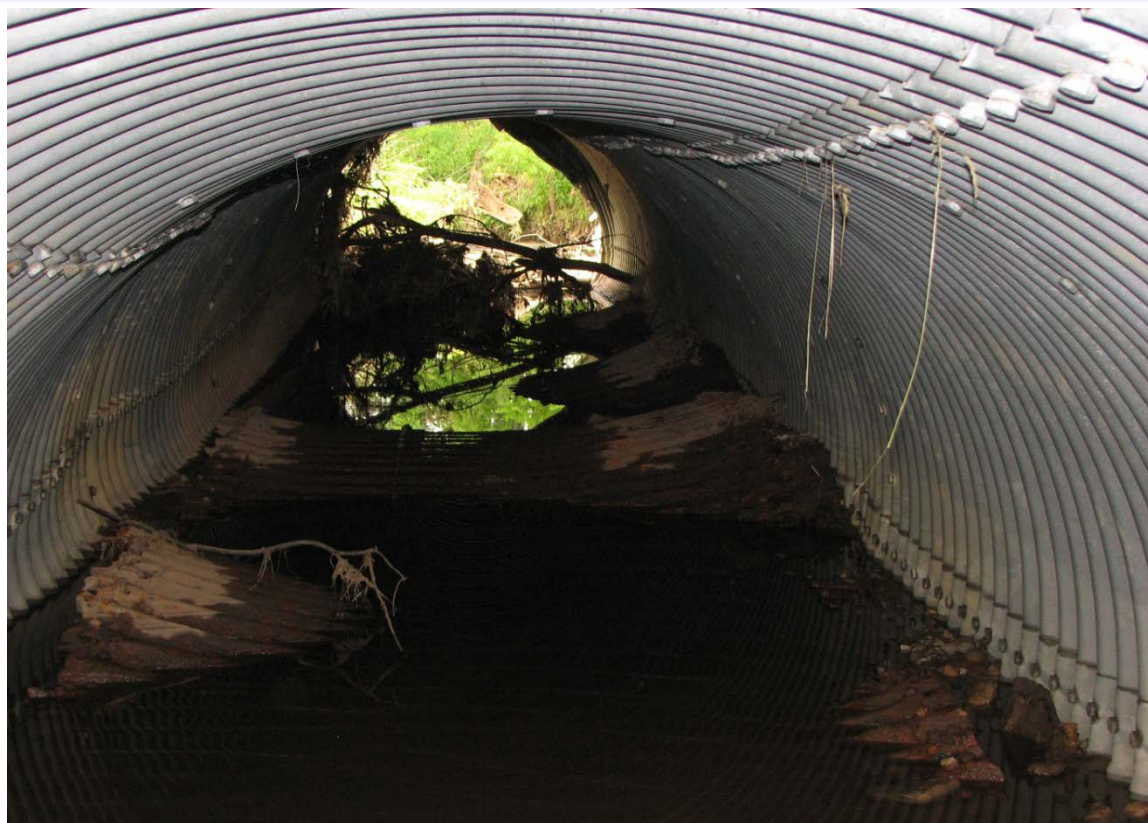
## I-70, Putnam Co., June 2008, Twin 9.5 x 6.0 SPPA

East pipe, bottom damage, looking towards inlet. Note upwards bend in culvert top.
