# Storm Damage – Floating Culverts & Other Inlet Issues

Mark Bailey, PE - Hydraulic Manager, INDOT  
Dale Sedler, PE - Sr. Hydraulic Engineer, INDOT

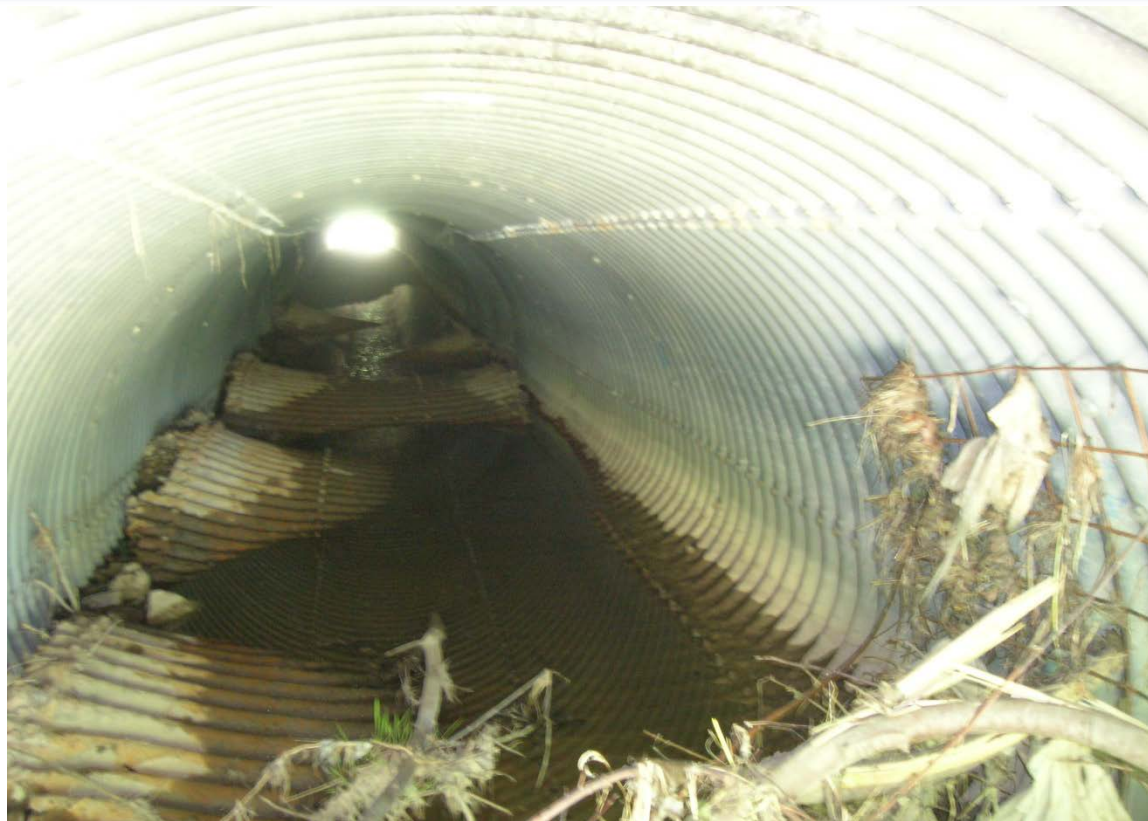
## I-70, Putnam Co., June 2008, Twin 9.5 x 6.0 SPPA

East pipe, bottom damage, looking towards inlet

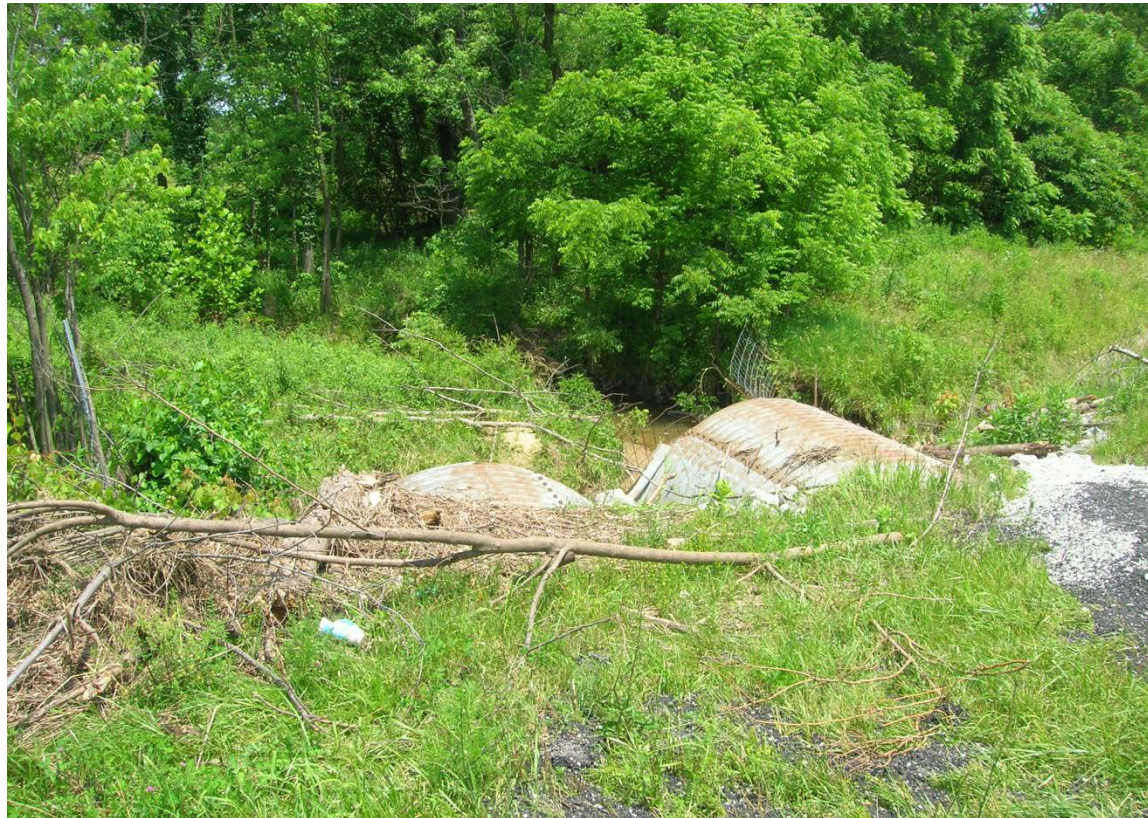
## I-70, Putnam Co., June 2008, Twin 9.5 x 6.0 SPPA

Looking upstream at inlets. Note debris deposits above culverts. And stream has chosen one culvert and abandoned the other resulting in sediment is collecting in the abandoned one.

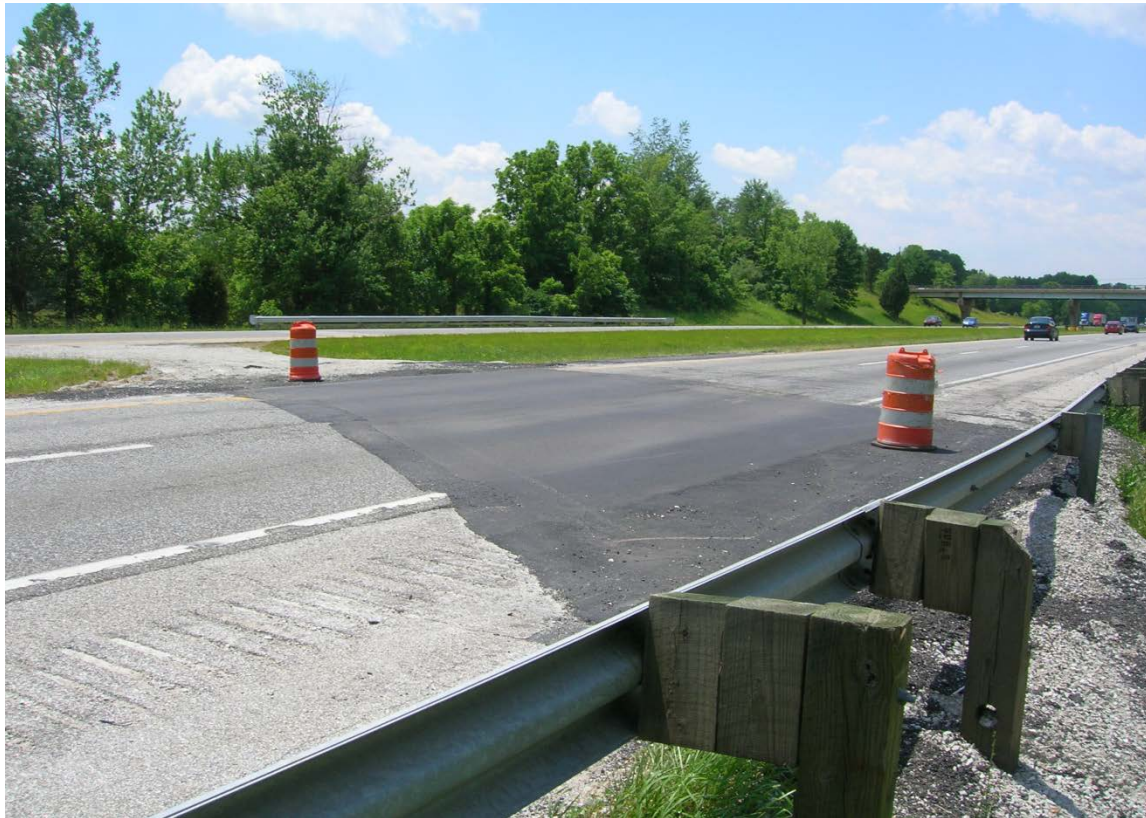
## I-70, Putnam Co., June 2008, Twin 9.5 x 6.0 SPPA

Temporary patching where culvert popped up through the westbound lane of I-70.

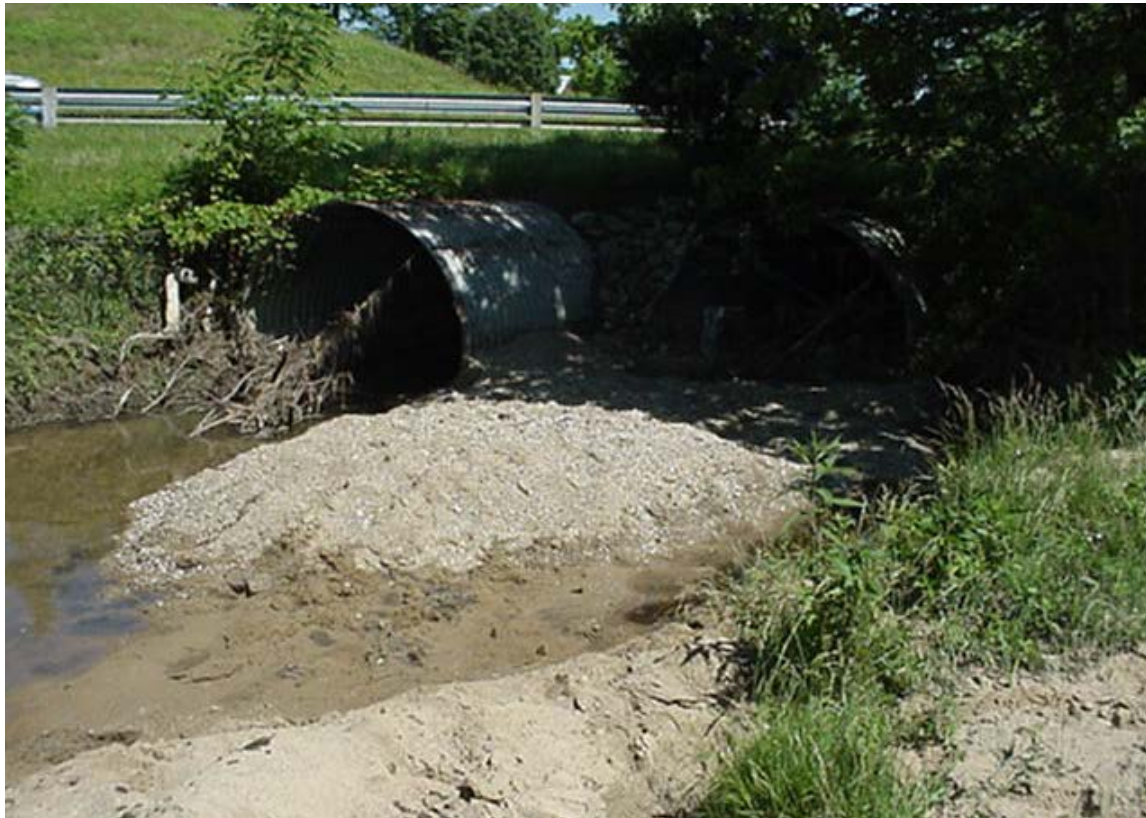
## I-70, Putnam Co., June 2008, Twin 9.5 x 6.0 SPPA

Culvert Outlets, east culvert (one that floated) barely visible in the shade. Note the embankment material that was transported through the culvert when it was floated.

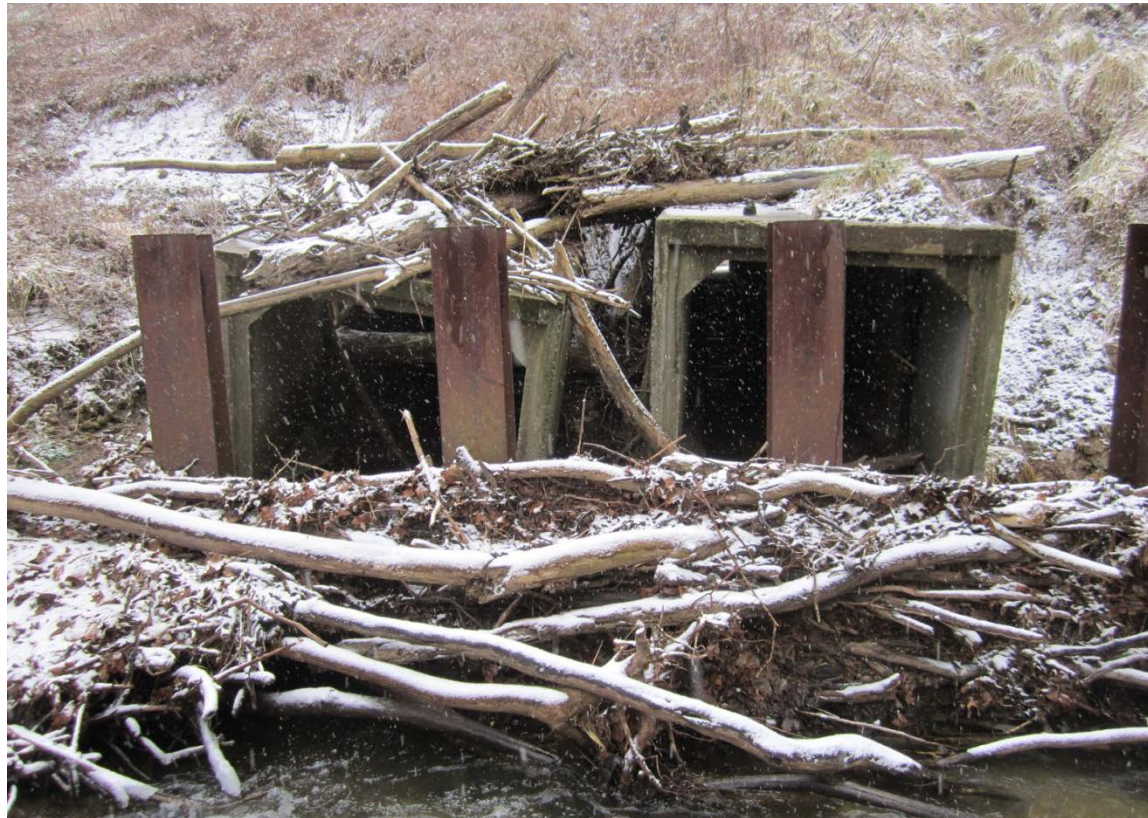
## SR-26 RP 28.10 Twin 7 ft x 7 ft Precast RCBs

Culvert inlets with debris collected at deflector and tree lodged between separated sections visible on left. Embankment issues.

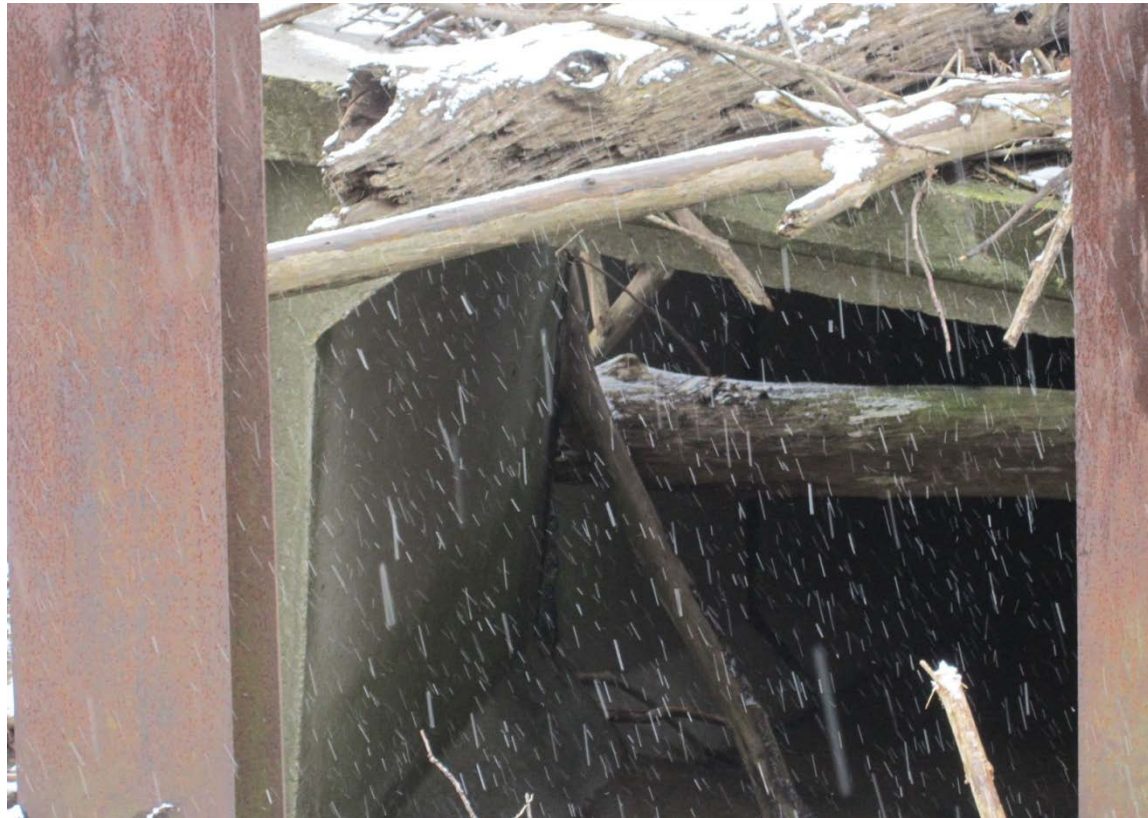
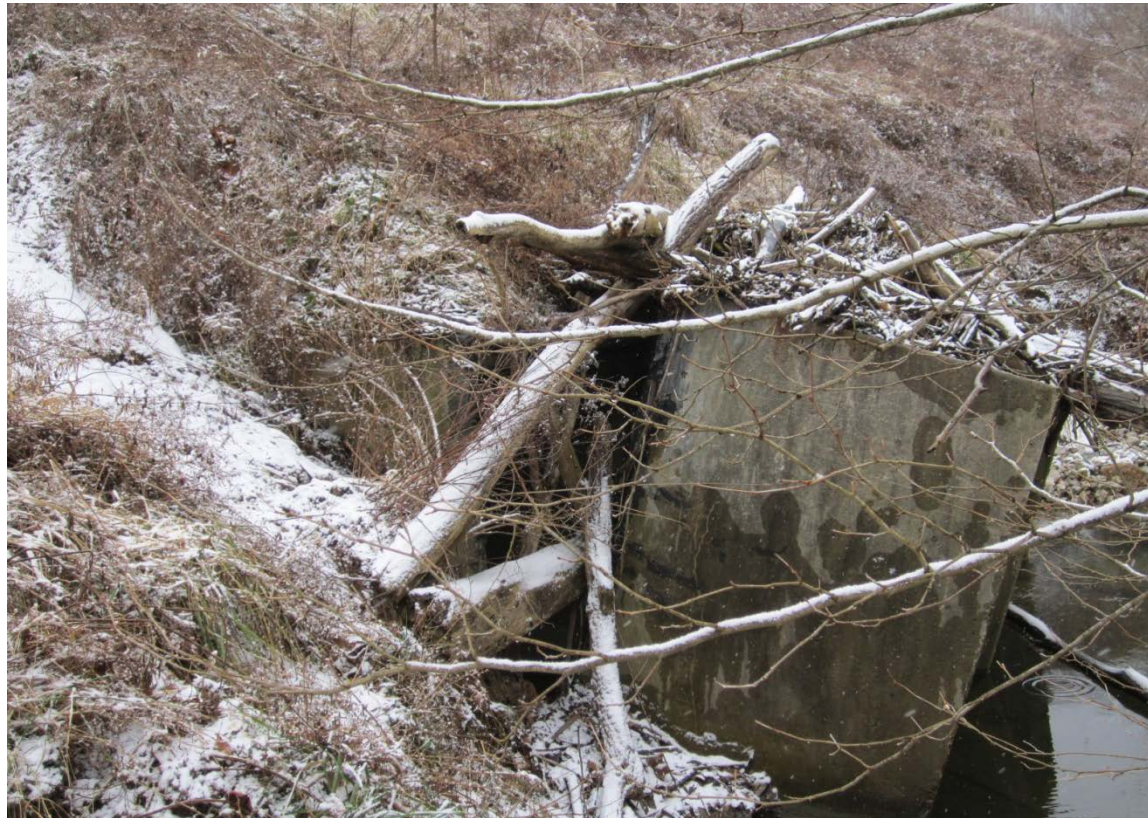
Culvert inlets with separated section and timber lodged in gap.

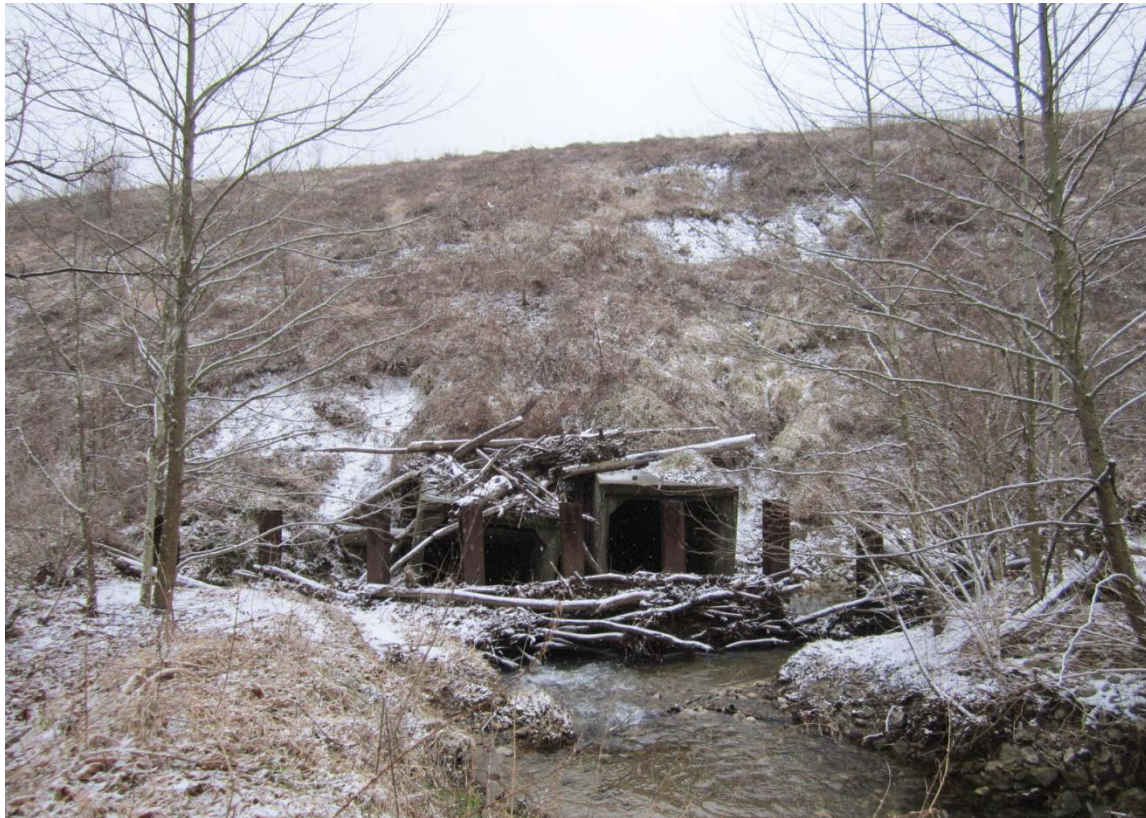
## SR-26 RP 28.10 Twin 7 ft x 7 ft Precast RCBs

Slope sloughing on inlet side. Possibly due to embankment disturbance.

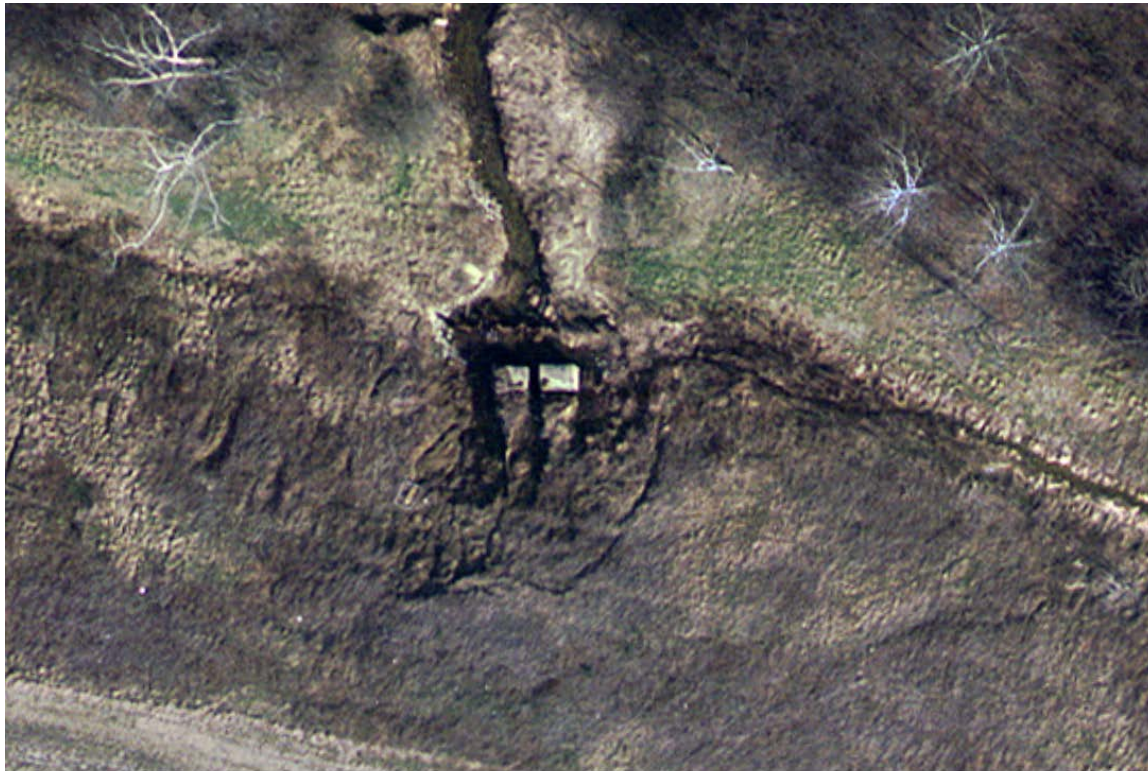
## SR-26 RP 28.10 Twin 7 ft x 7 ft Precast RCBs Embankment Damage 2005 Aerial Photo

With ponding at inlet due to blockage, rapid drawdown can result.

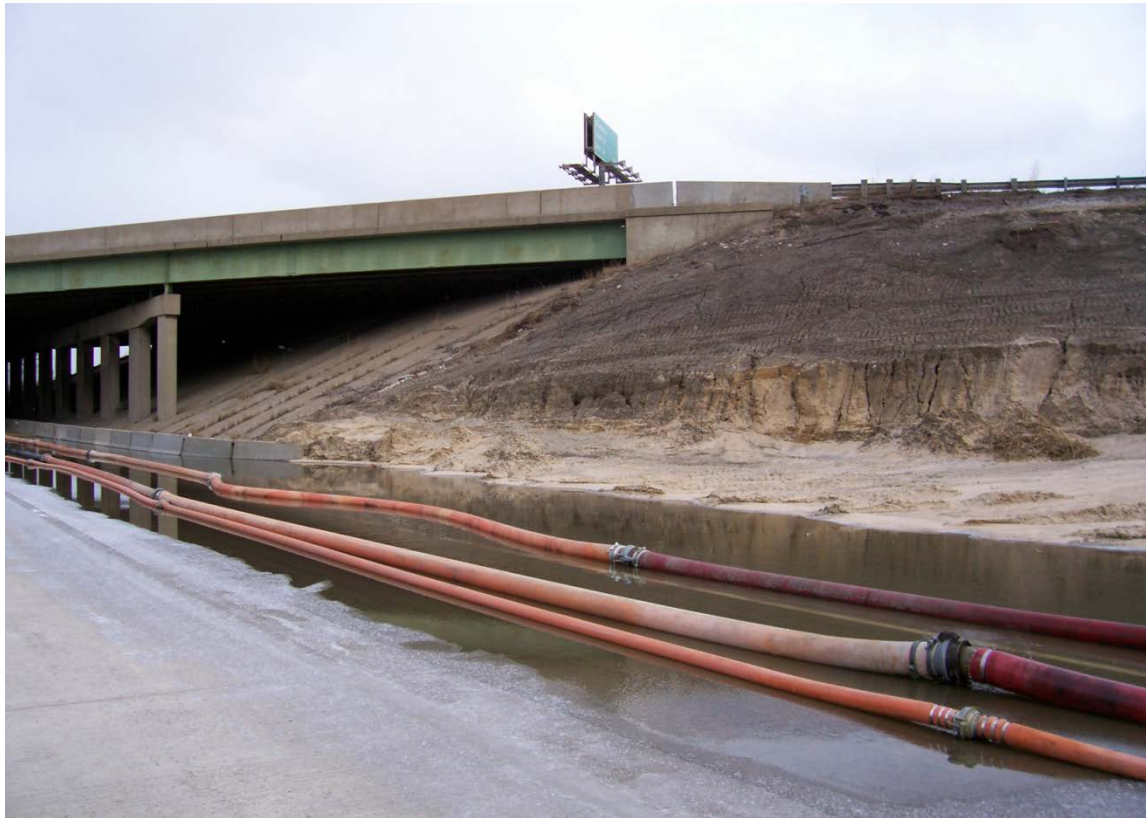
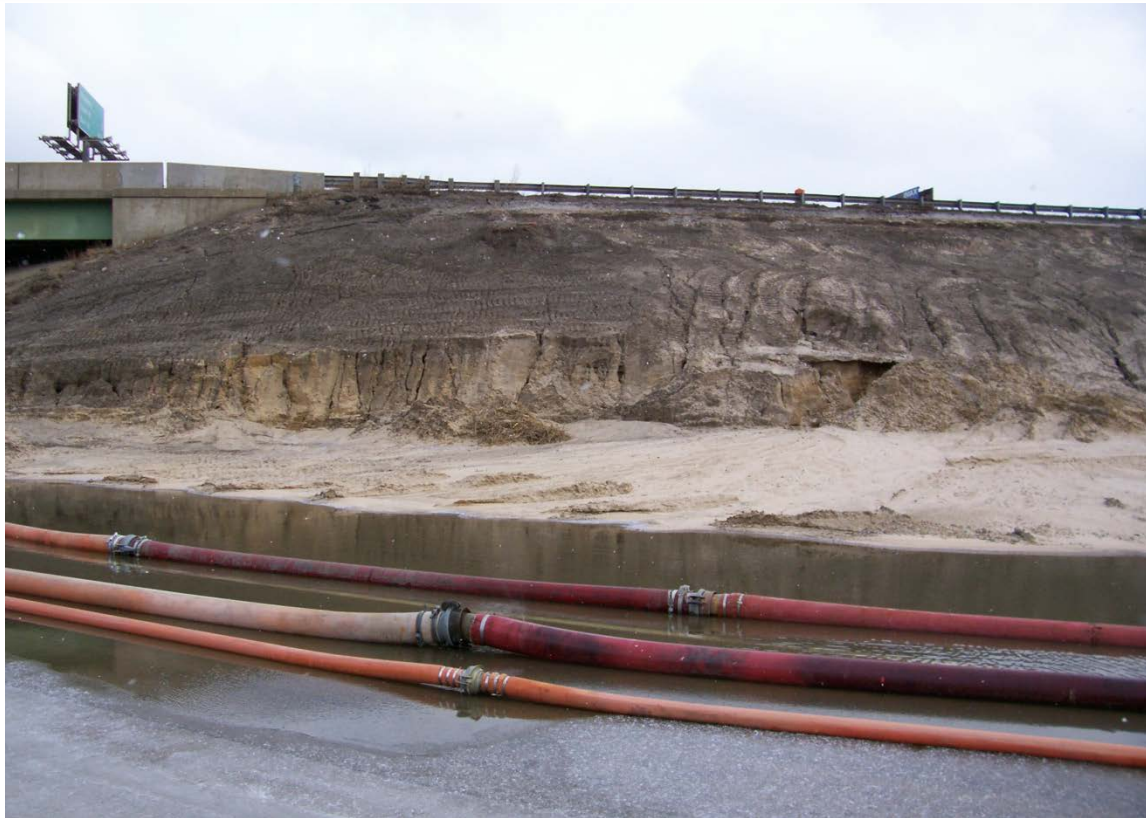
## **Embankment damage due to rapid drawdown Borman Expressway, 2008**

Ponding in interchange due to clogged levee flapgate.

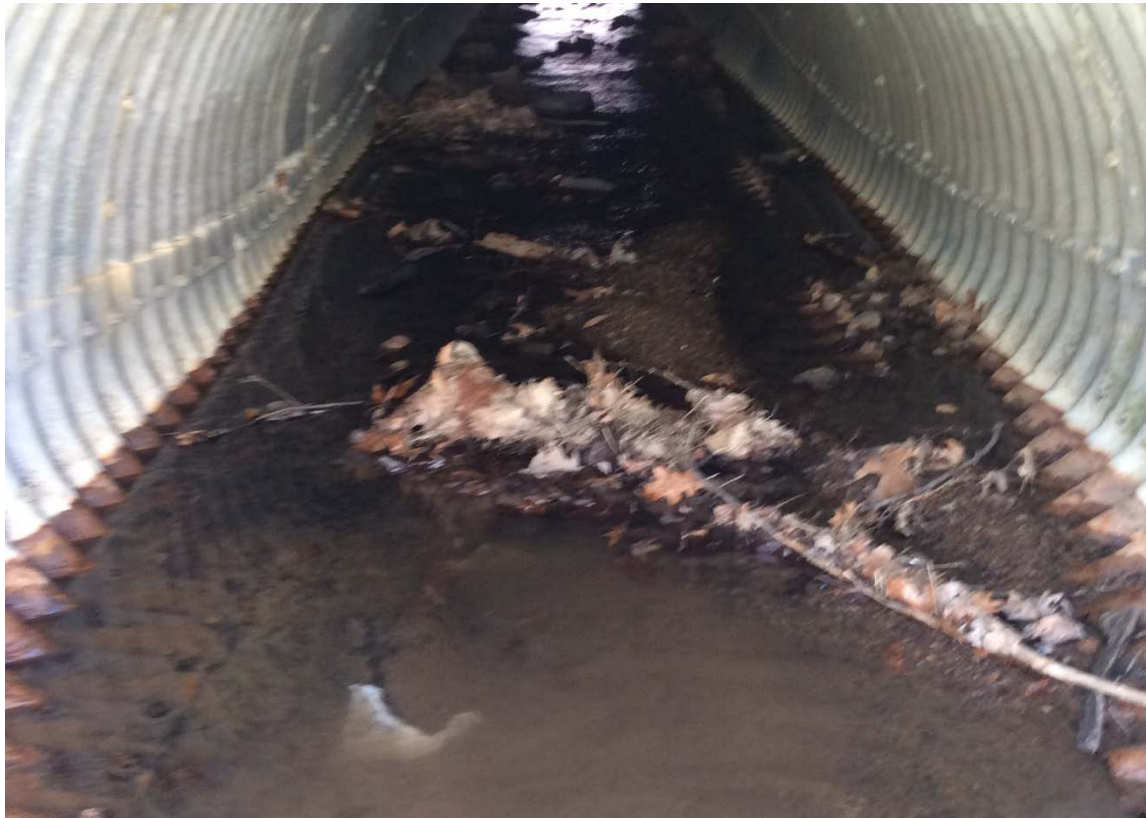
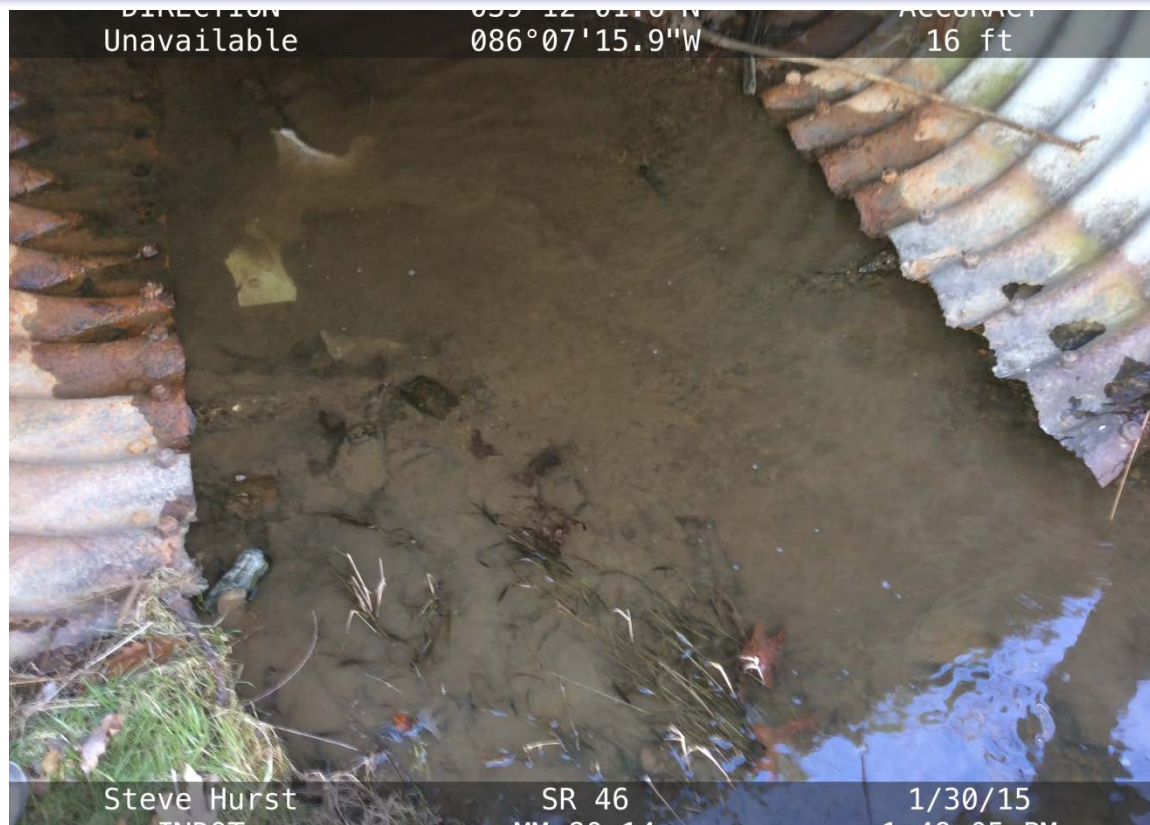
**SR-46 RP 80.14 8'-2" x 5'-9"**

**Reported to Hydraulics as possibly  
in failure mode due to pipe  
deformation and bottom of culvert  
gone. Anchor was also gone.**

Culvert inlet, invert gone.

Sharp edge on missing floor of culvert suggests that it was manually removed.

The bottom at the inlet was likely tilted upwards when the culvert was new, the bottom was cut out to allow the creek to flow through.

**Recommendation: pave the invert,  
construct a headwall with wingwalls,  
and protect the outlet from scour  
with riprap.**

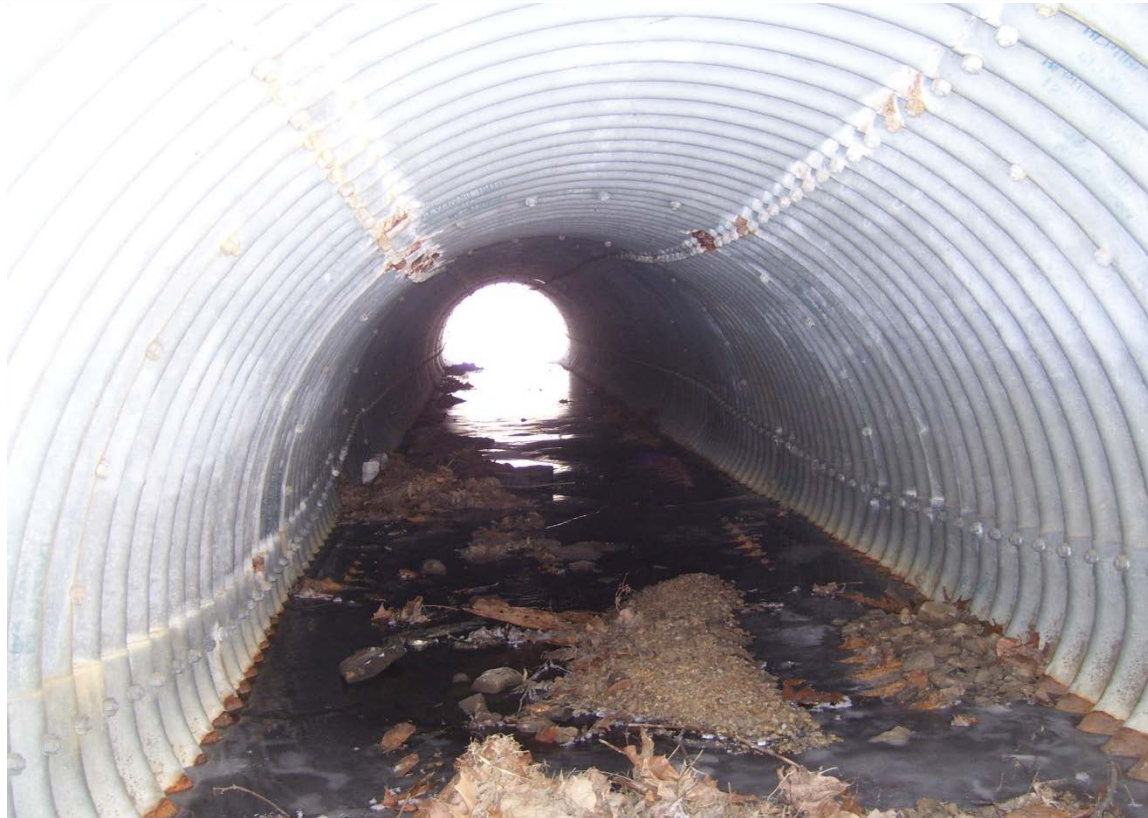
**SR-46 RP 80.14 8'-2" x 5'-9"**

Culvert inlet.

Note that pipe is in good shape, but is bent upwards at the inlet.

Upwards bend at culvert inlet suggests blockage and buoyancy force occurred in the past.

Both factors suggest event occurred when culvert was new and was structurally sound, especially the bottom which didn't deform as seen in older pipes.

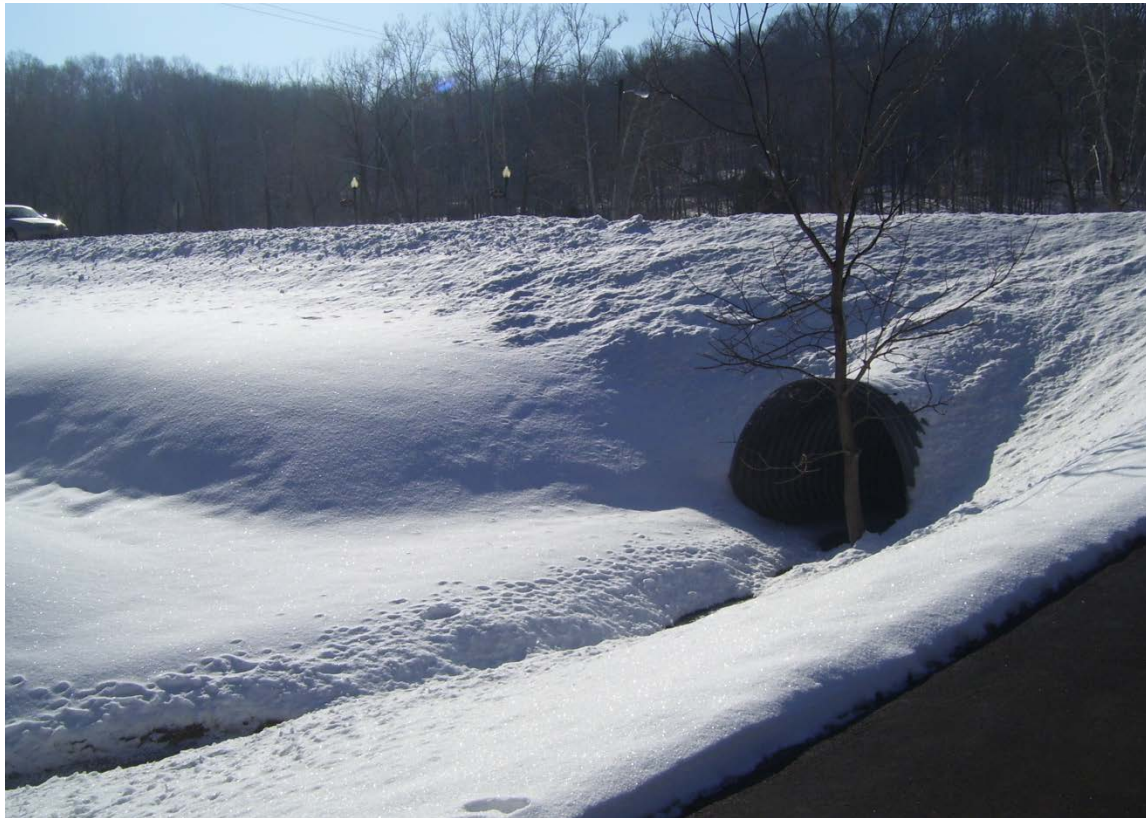
**SR-46 RP 80.14 8'-2" x 5'-9"**

Culvert inlet. Note driveway adjacent. Resident said it is difficult to mow around the inlet. A headwall with wingwalls will satisfy backwater requirements, plus make it easier to mow the grass.

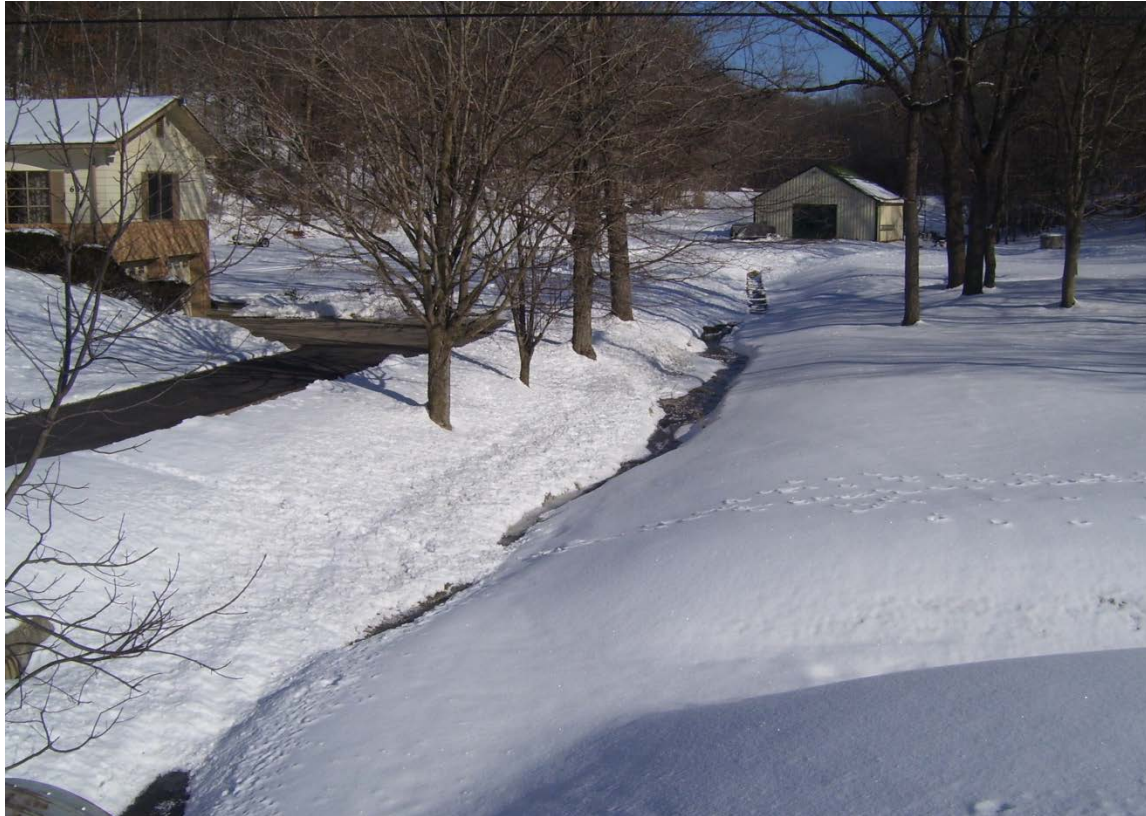
**SR-46 RP 80.14 8'-2" x 5'-9"**

Upstream. Garage and basement require no increase in backwater necessitating both a paved invert and headwall.

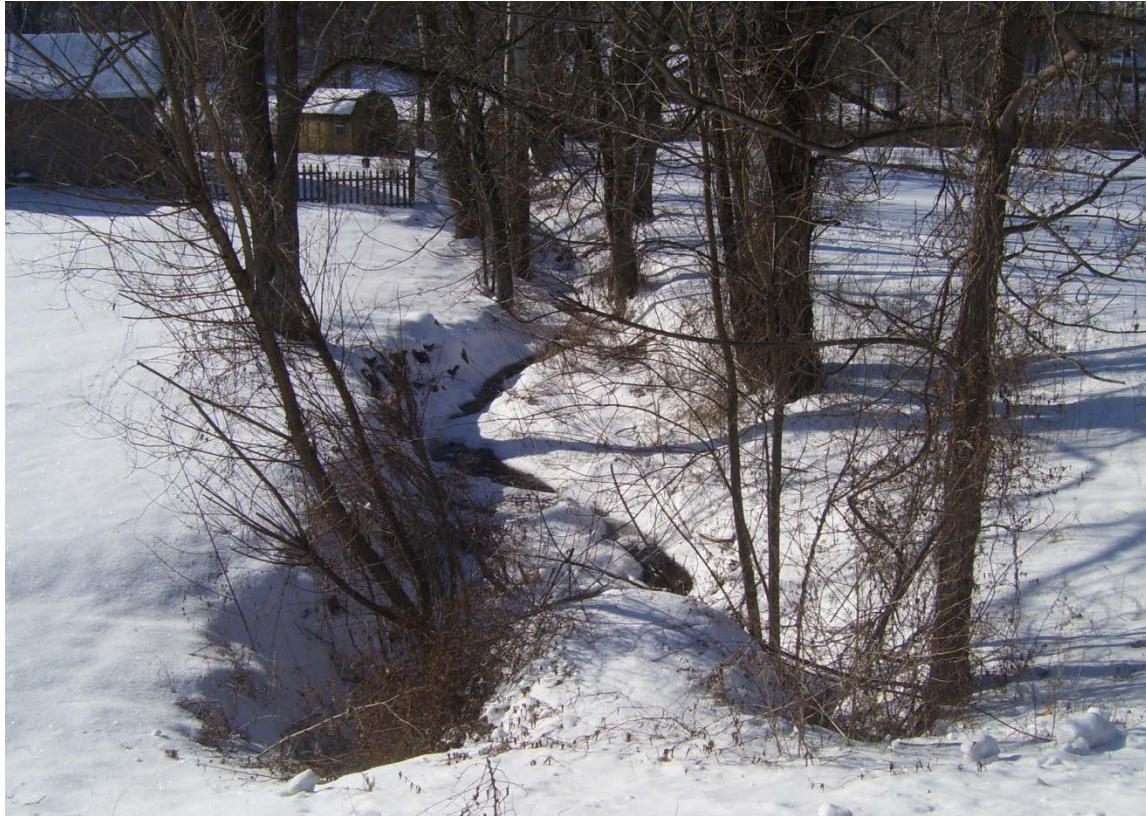
**SR-46 RP 80.14 8'-2" x 5'-9"**

Downstream. Paved invert will increase outlet velocity requiring riprap to protect channel from scour at the outlet.

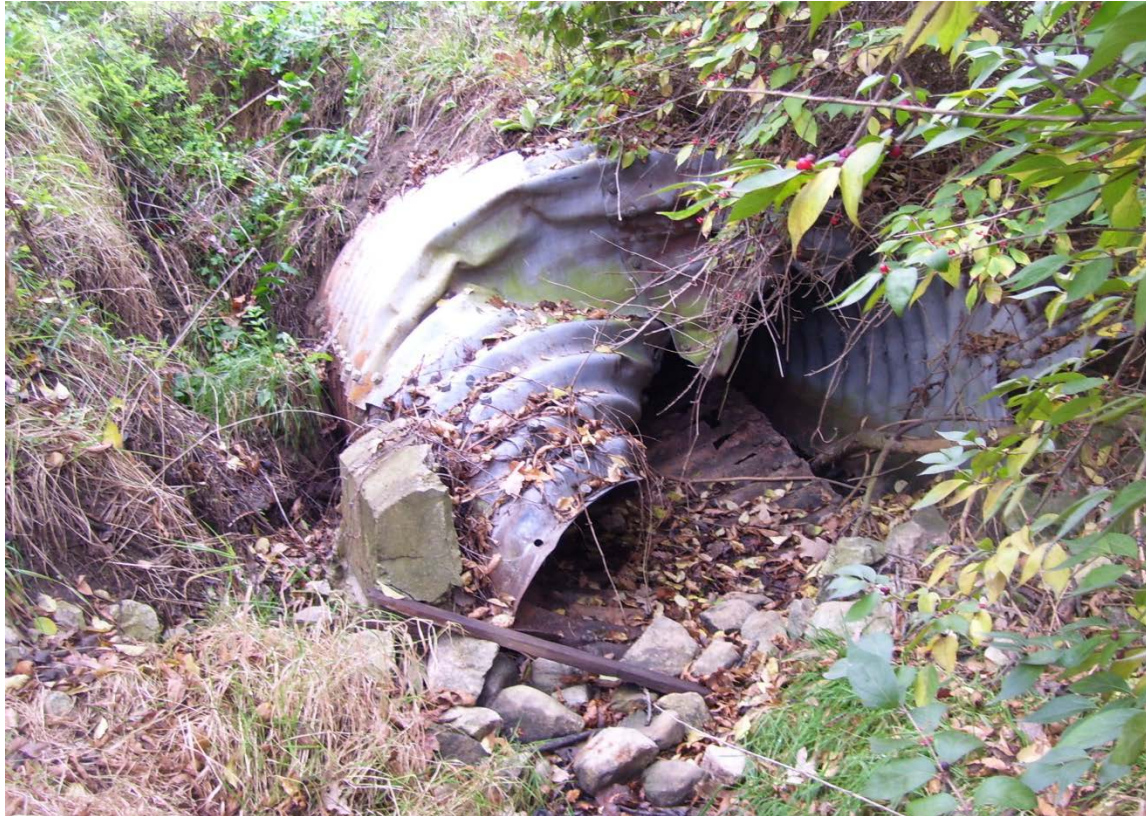
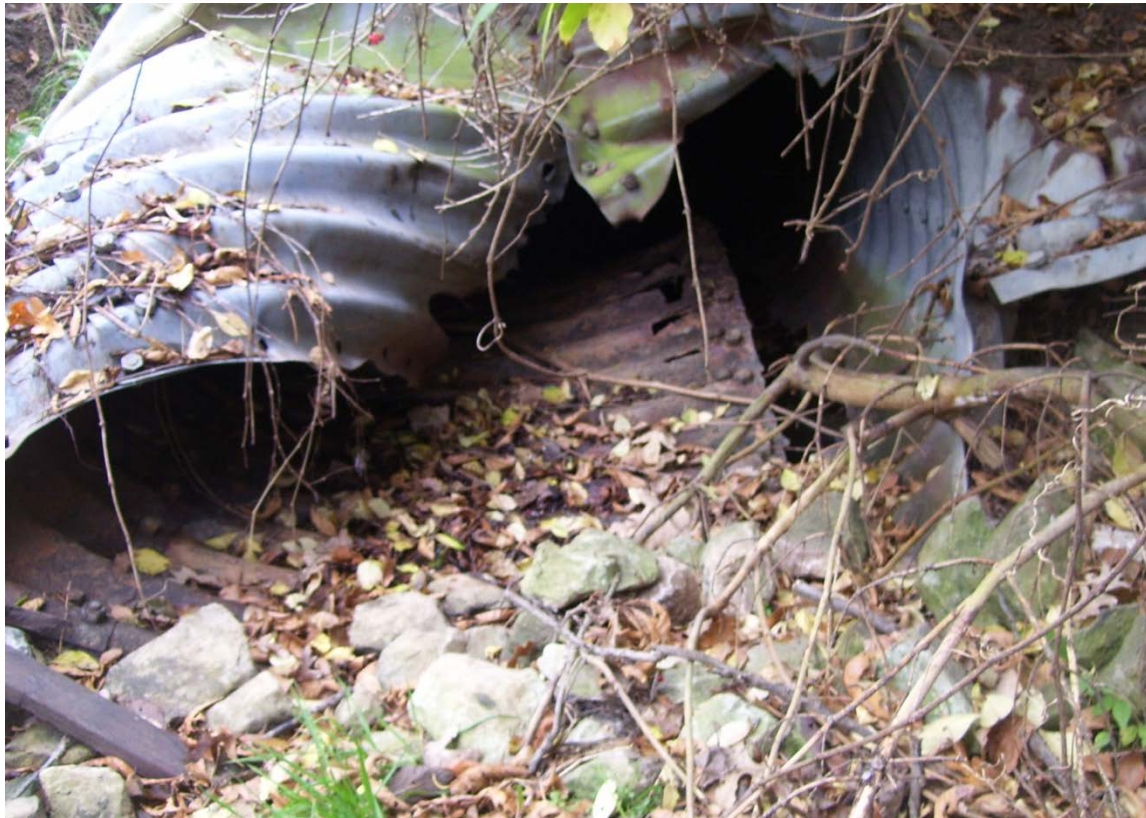
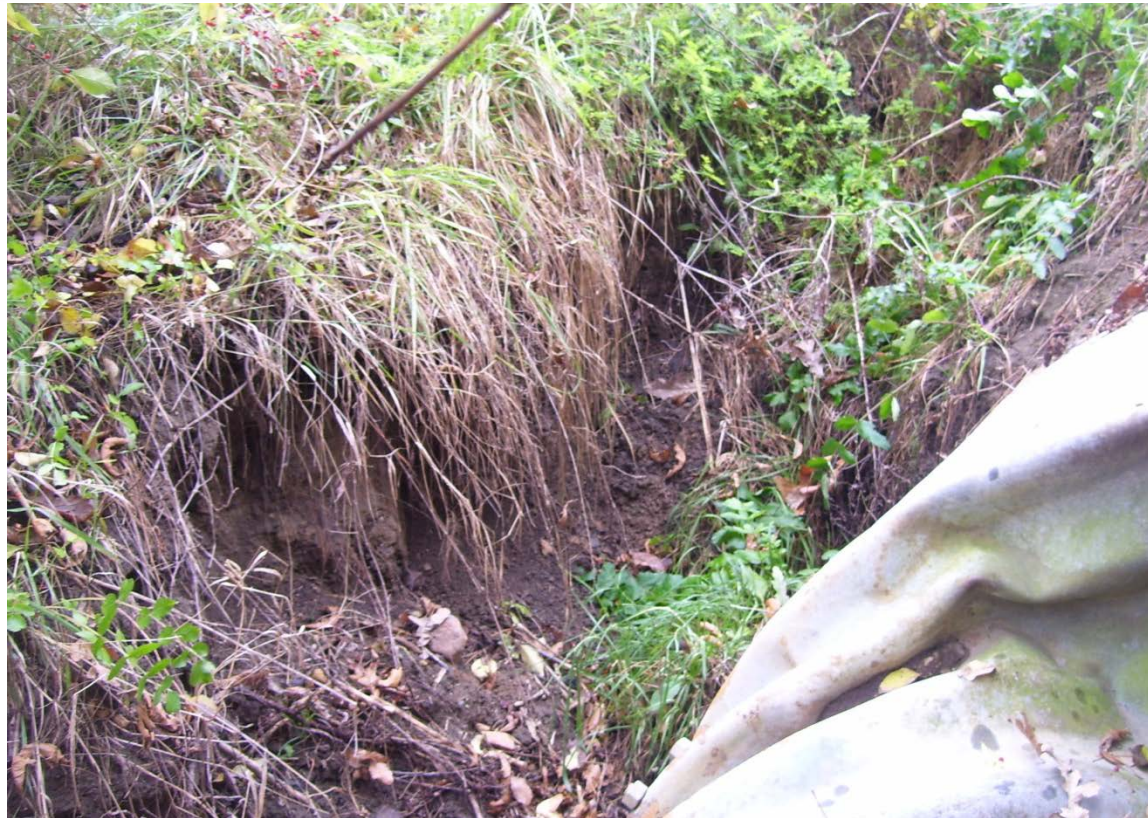
## I-70 Morgan Co. RP 55.02 6'-6" x 4'-6" SPPA

Damaged inlet. Bottom distorted. Anchor damaged. Embankment disturbed.

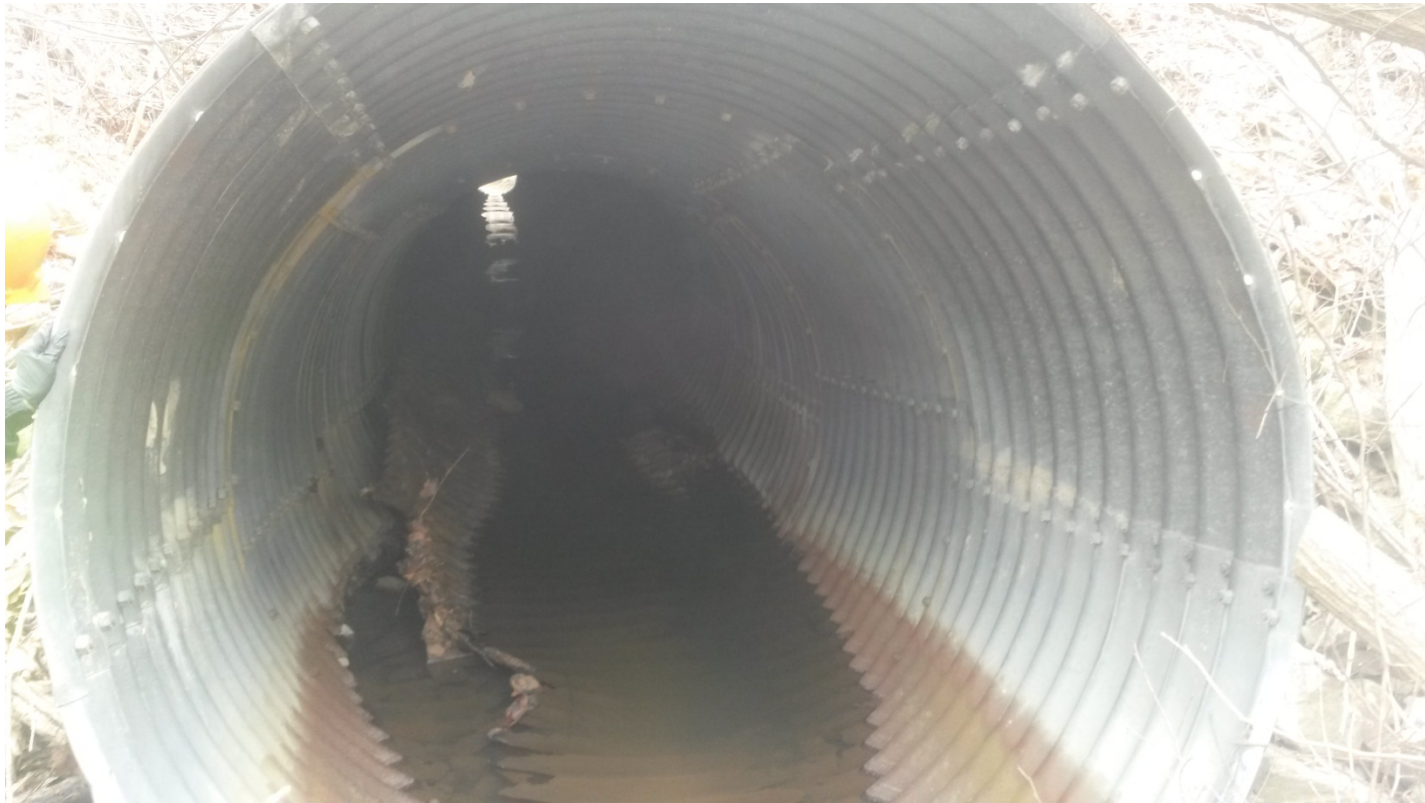
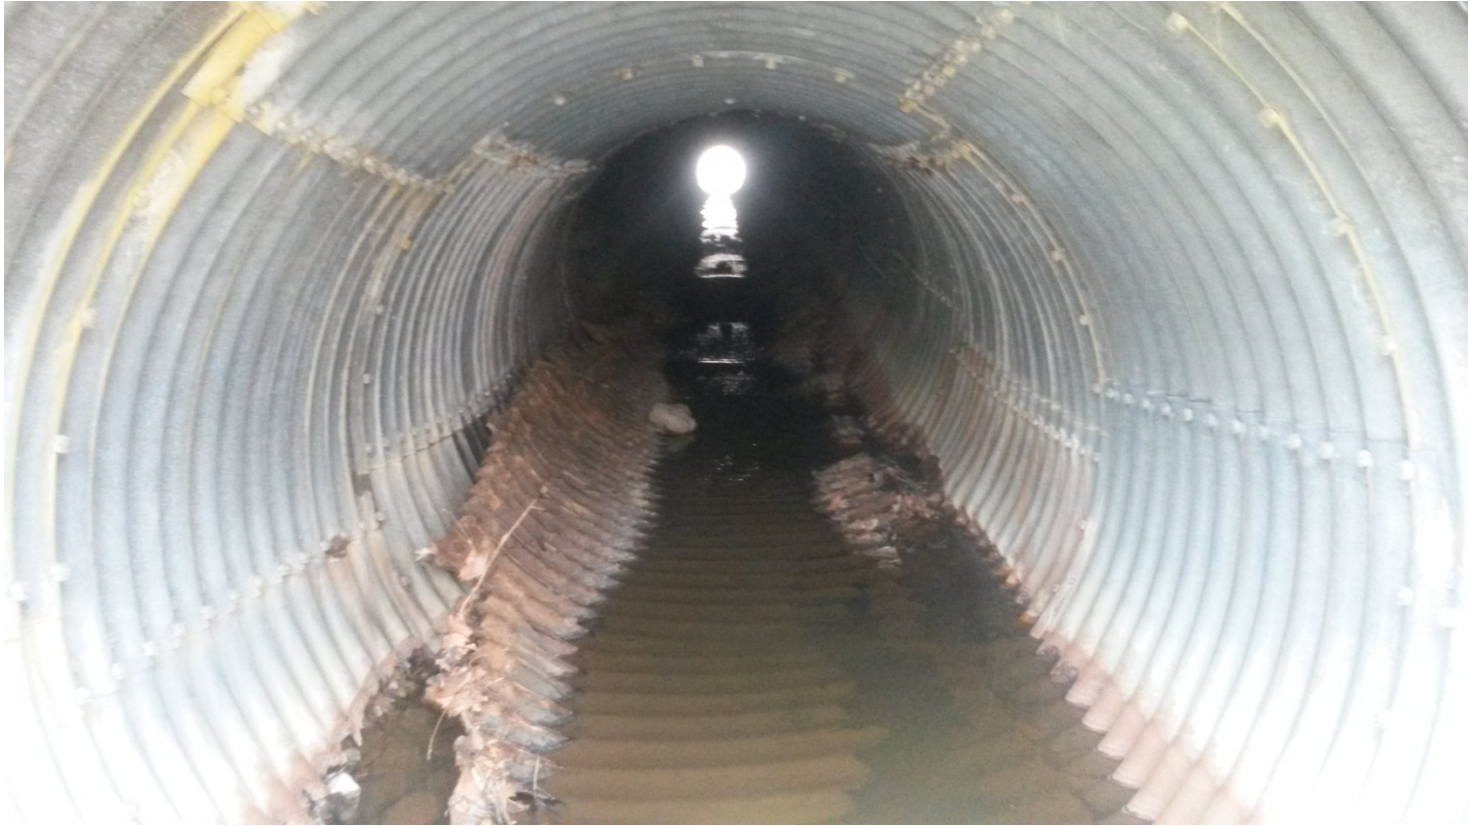
## **I-65 RP 27+15**

Bottom distorted. Pipe has upwards bend.
