**Indiana Classified Forest & Wildlands
Forestry Best Management Practices
Monitoring Results
1996-2017**

By: Jennifer Sobecki & Duane McCoy

Indiana Classified Forest and Wildlands BMP Report

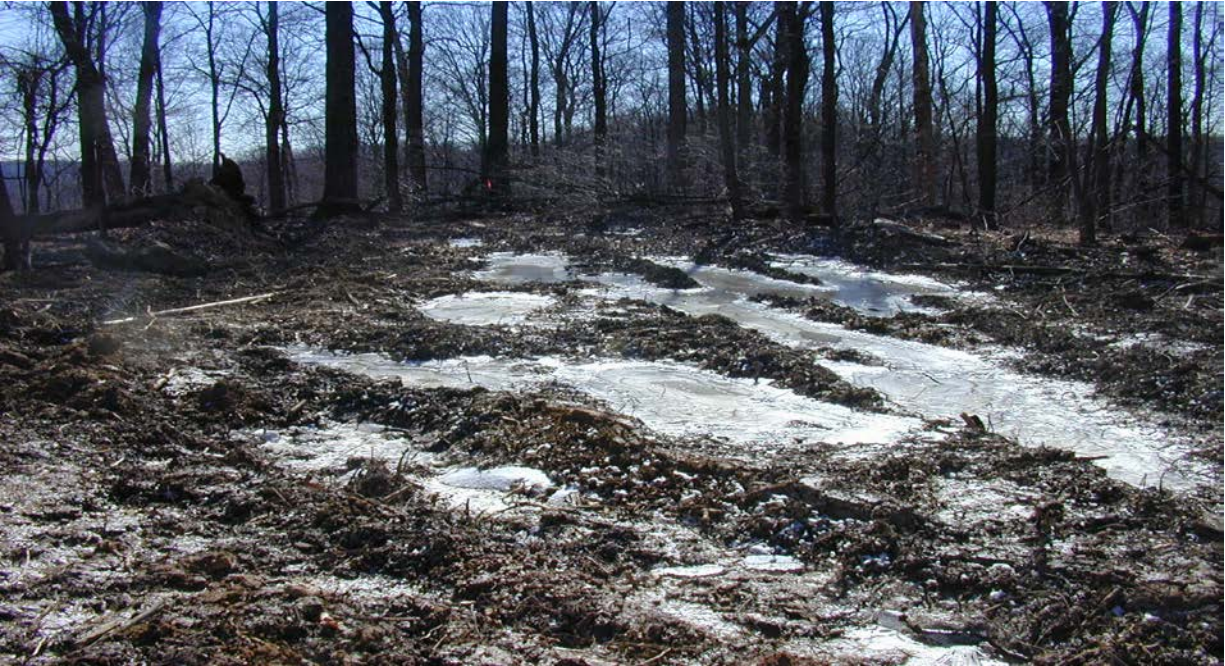
Log landing that was used during a wet period, causing rutting and the collection of runoff at the site.

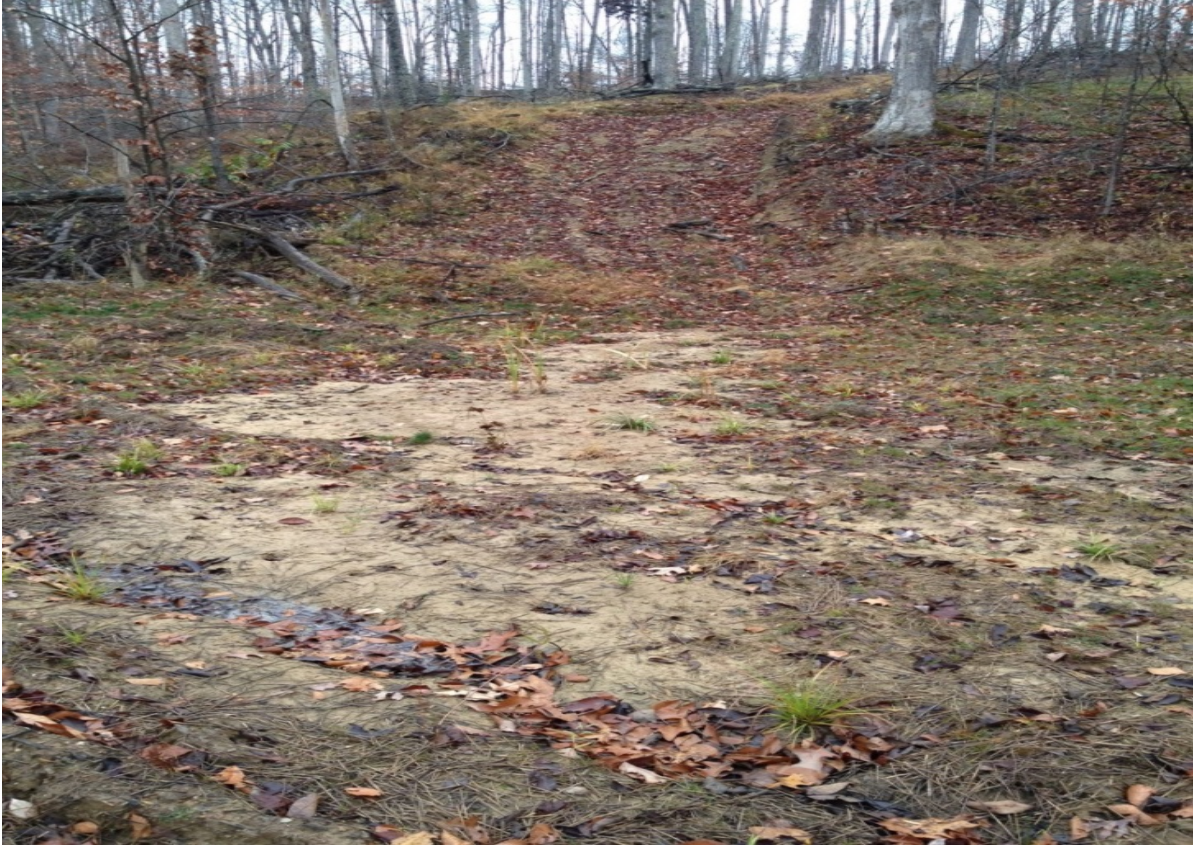
Skid trail not closed out, causing erosion and sediment plume to build up on log yard.

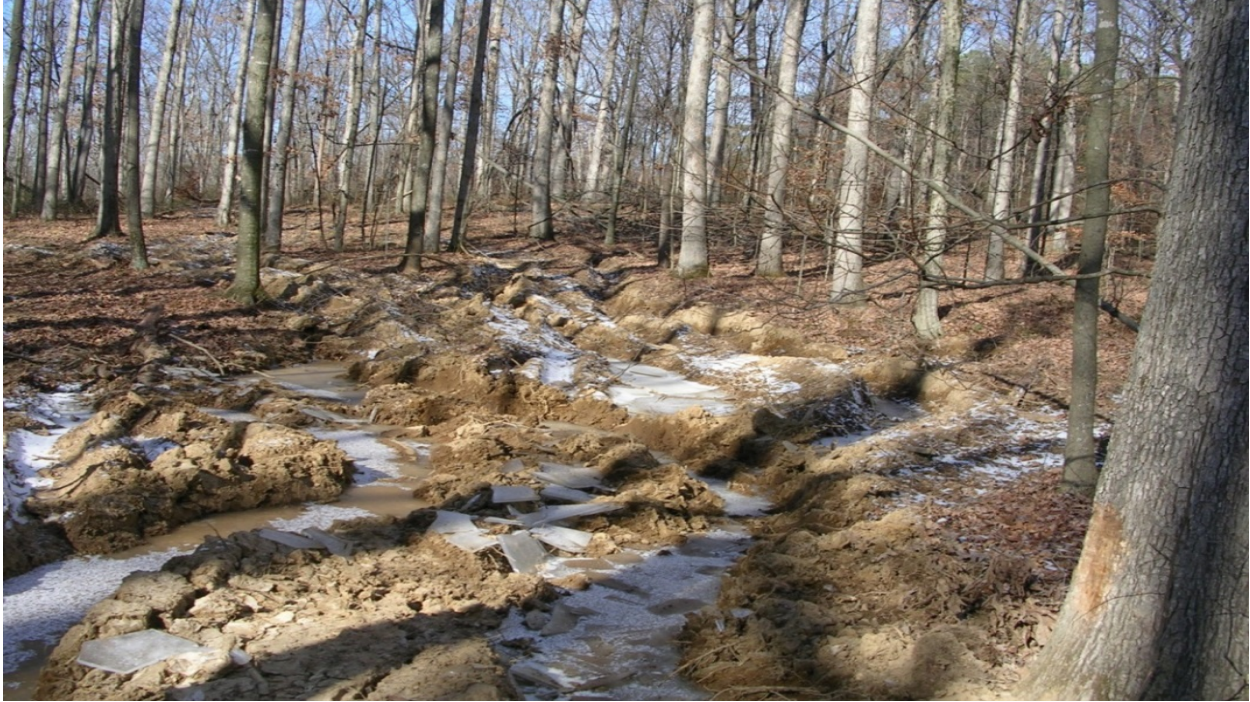
Extreme skid trail rutting due to operations taking place during wet winter conditions.

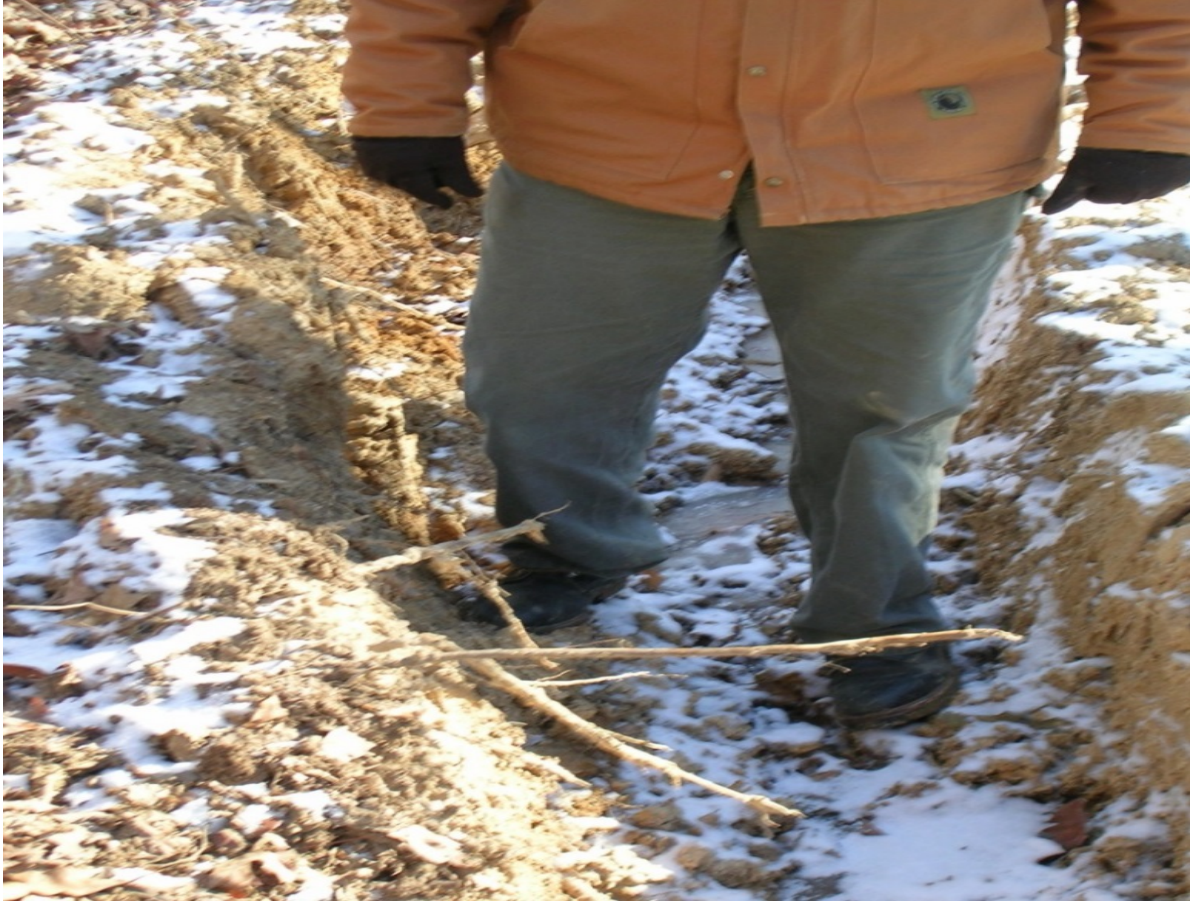
Deep skid-trail ruts, causing tree-root damage.

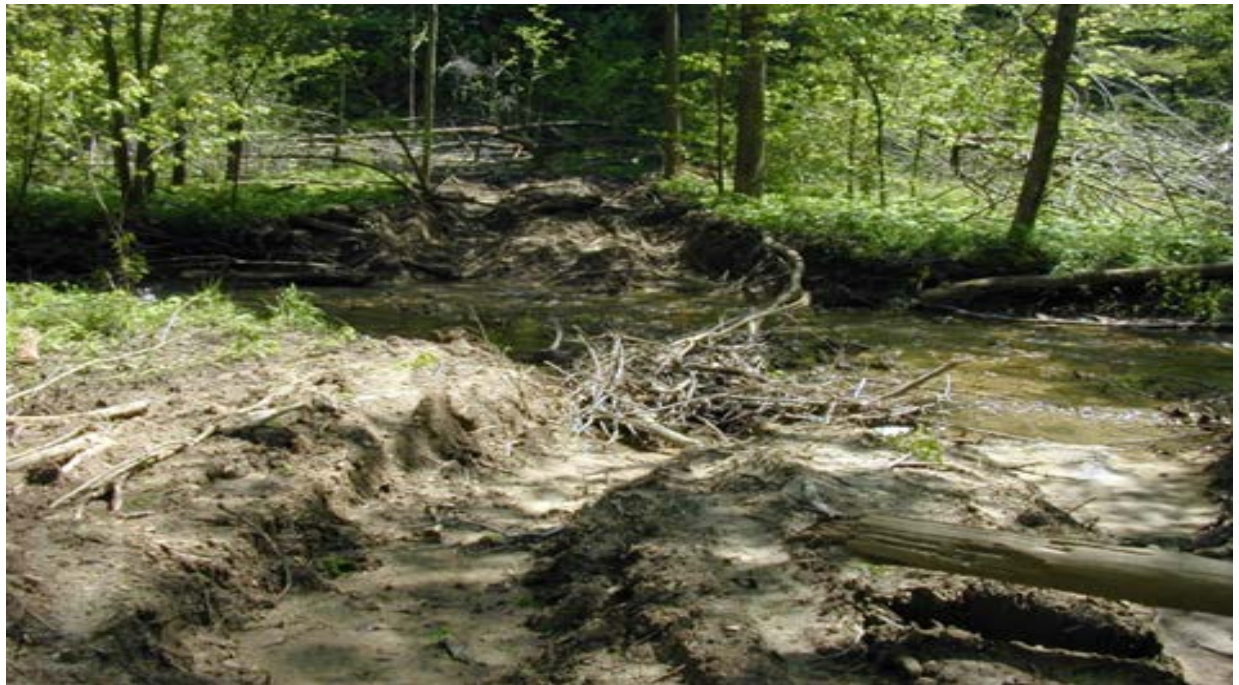
A poorly applied and implemented stream crossing with no attempt to repair. There are no water diversions before stream crossing, no stream bank stabilization/revegetation.

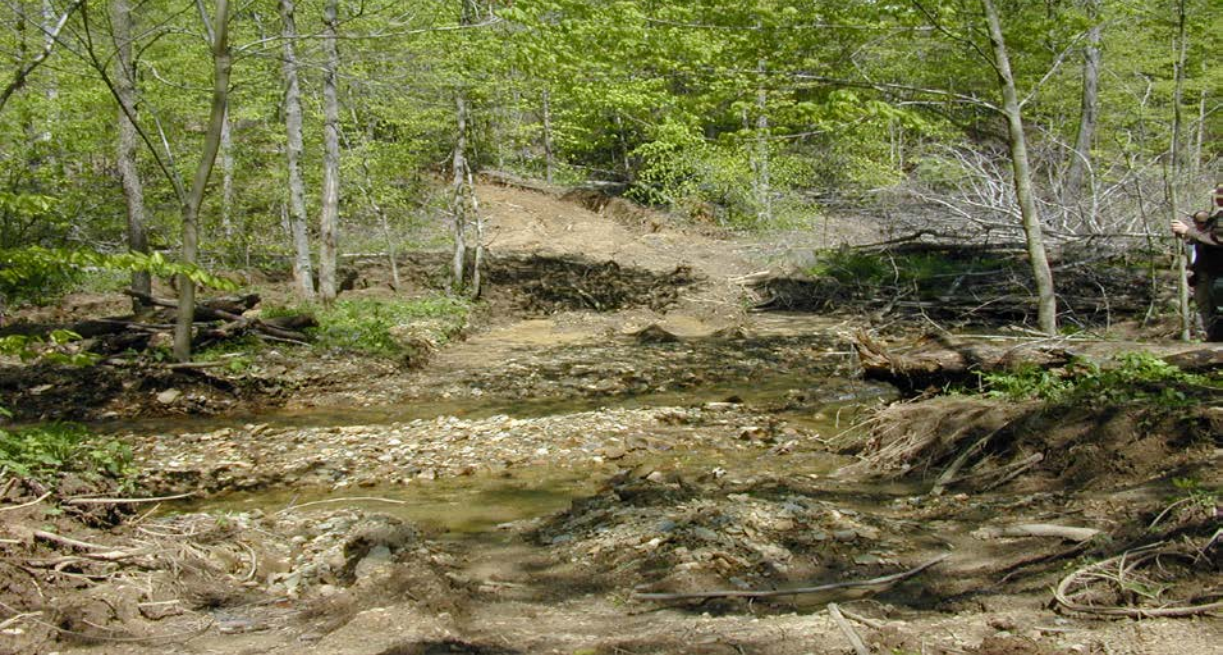
A stream crossing that was poorly executed and not closed after the harvest was completed.

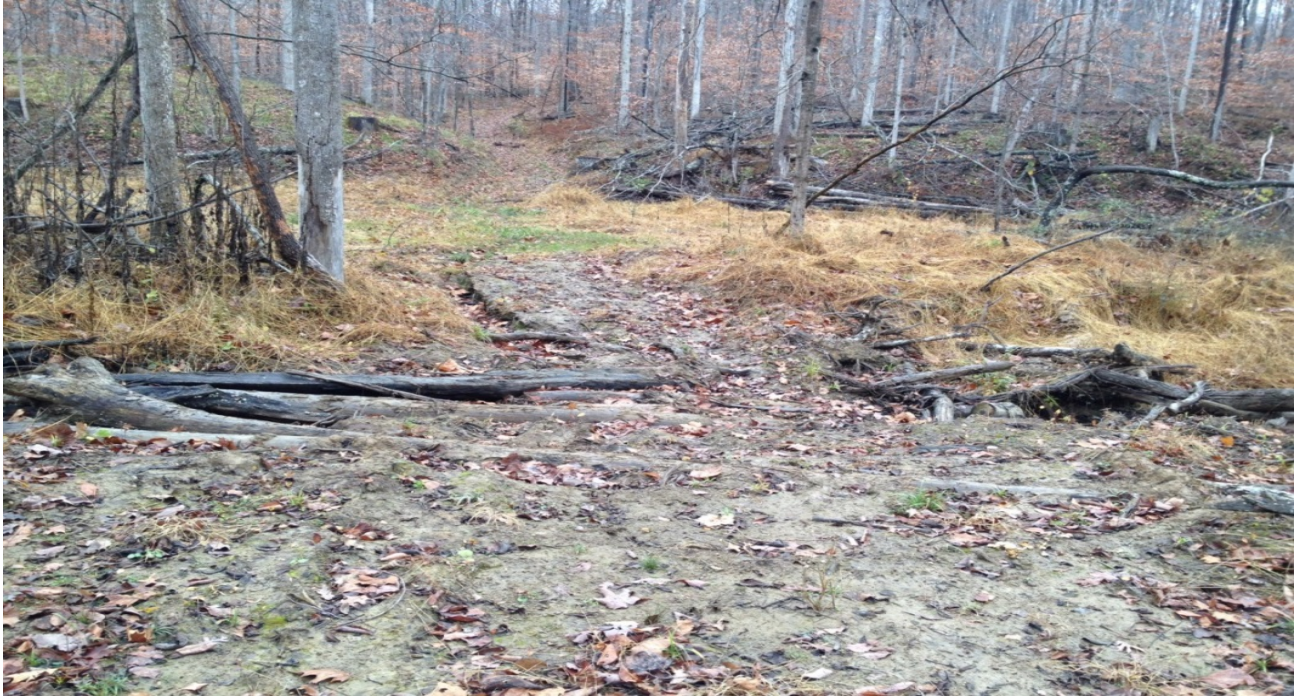
Corduroy logs and soil left in intermittent stream crossing cause obstruction of flow. Impacts from this kind of forestry BMP departure can lead to sometimes extreme erosion and sedimentation. The stream will reroute itself around the obstruction. This results in destabilization of the stream banks and streambed both up and downstream of the obstruction.

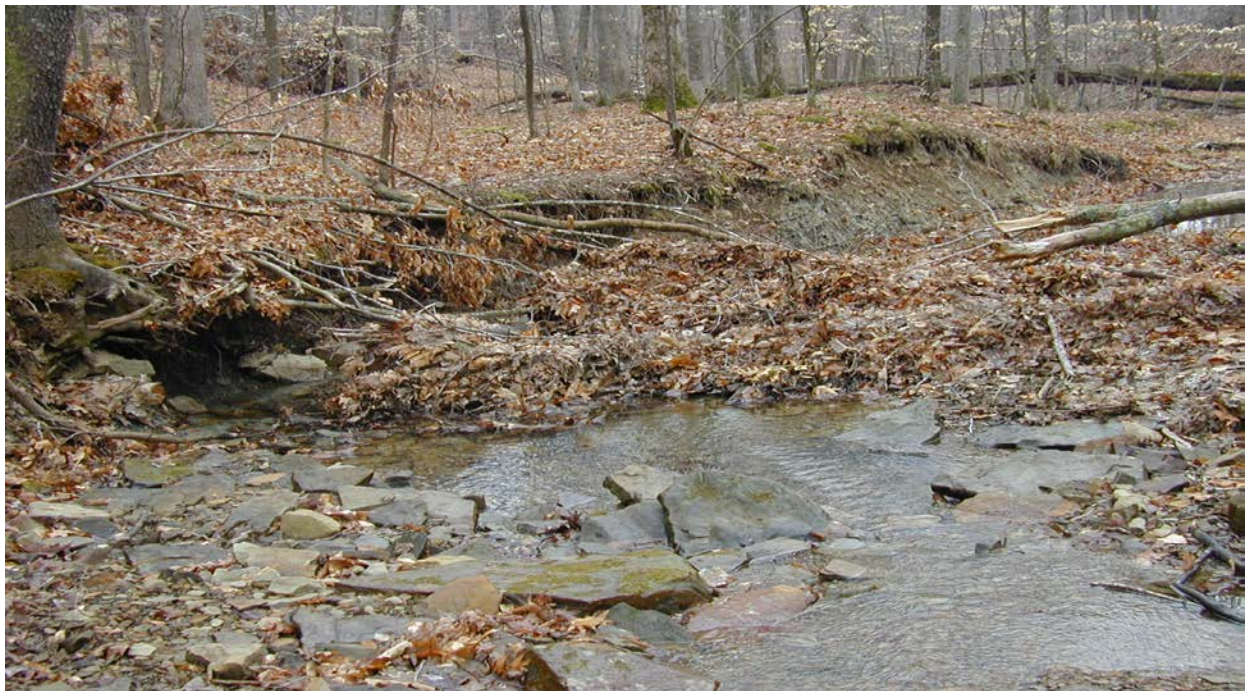
Logging debris in stream can obstruct stream flow, leading to the stream carving out a new bank, which results in erosion and sedimentation directly into the stream.
