Indiana Classified Forest & Wildlands Forestry Best Management Practices Monitoring Results 1996-2018

By: Jennifer Sobecki & Duane McCoy

Indiana Classified Forest and Wildlands BMP Report

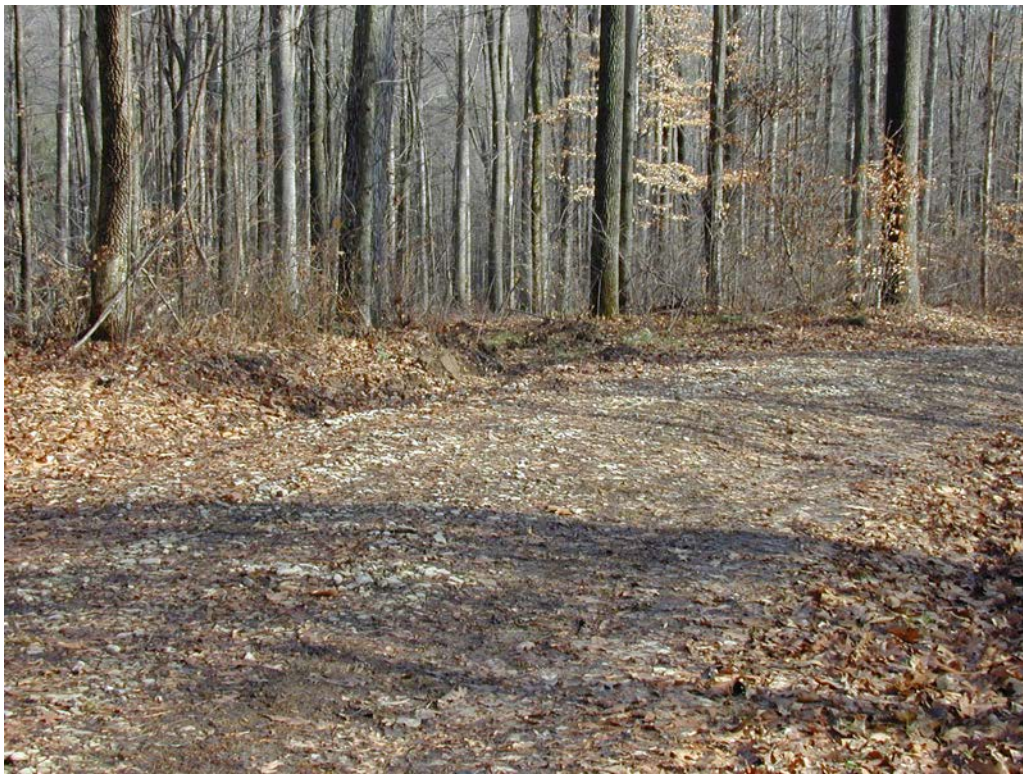
Access road and cutout water diversion on State Forest property.

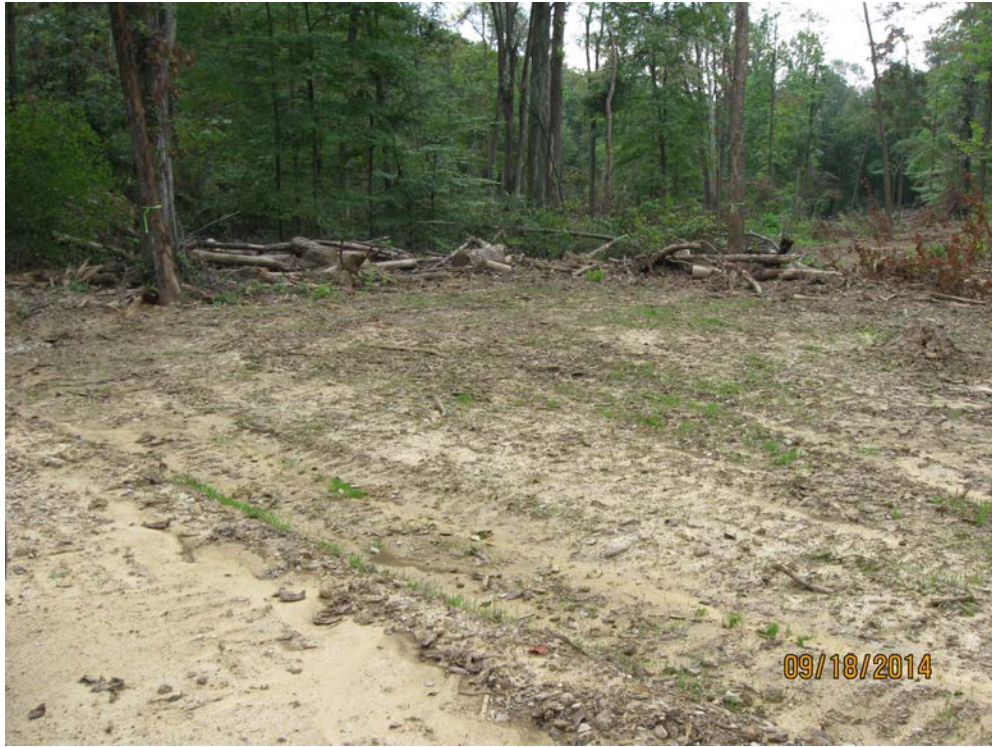
Log landing recently closed out with grass sprouting from seeding.

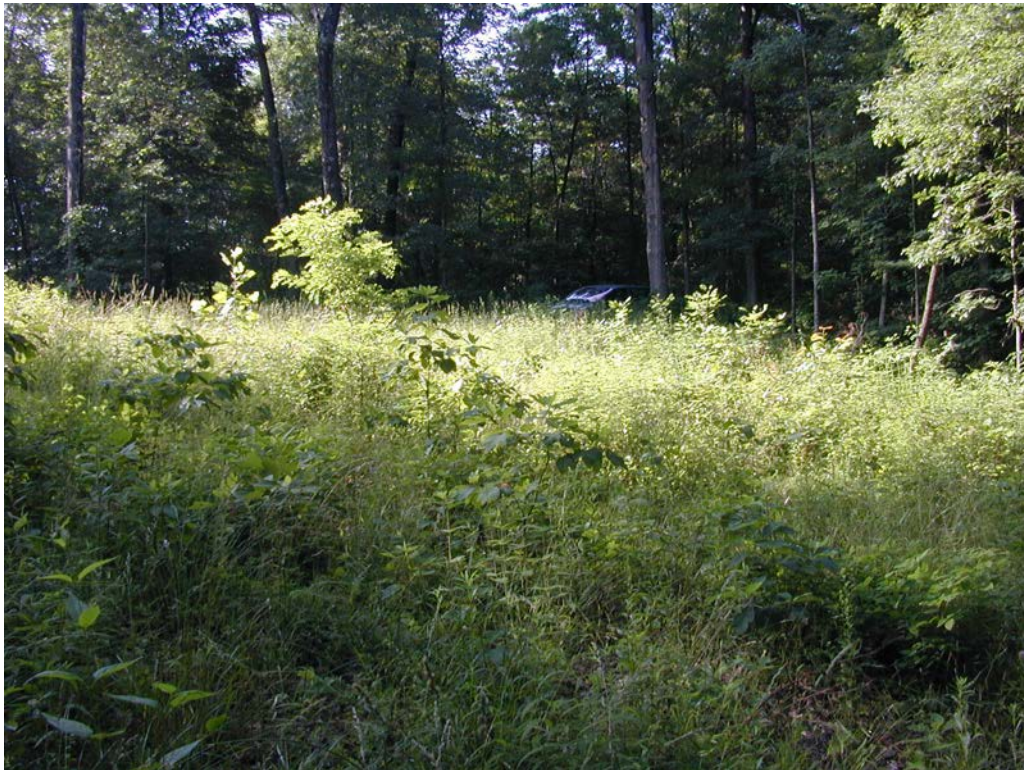
Log landing several years after closeout.

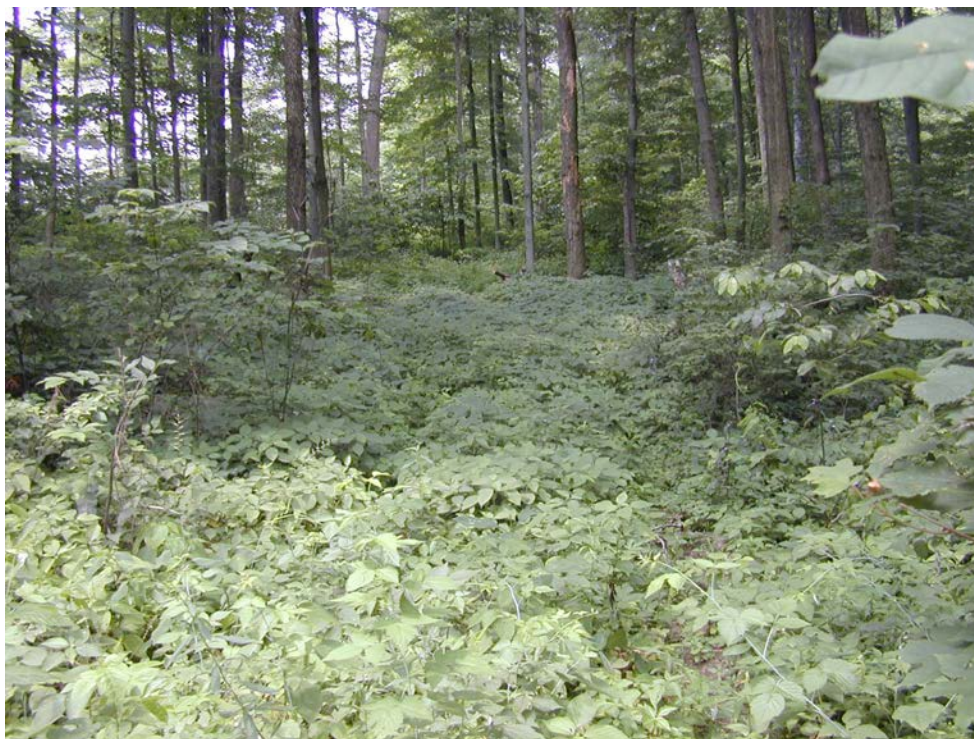
A steep skid trail that has well established vegetative cover.

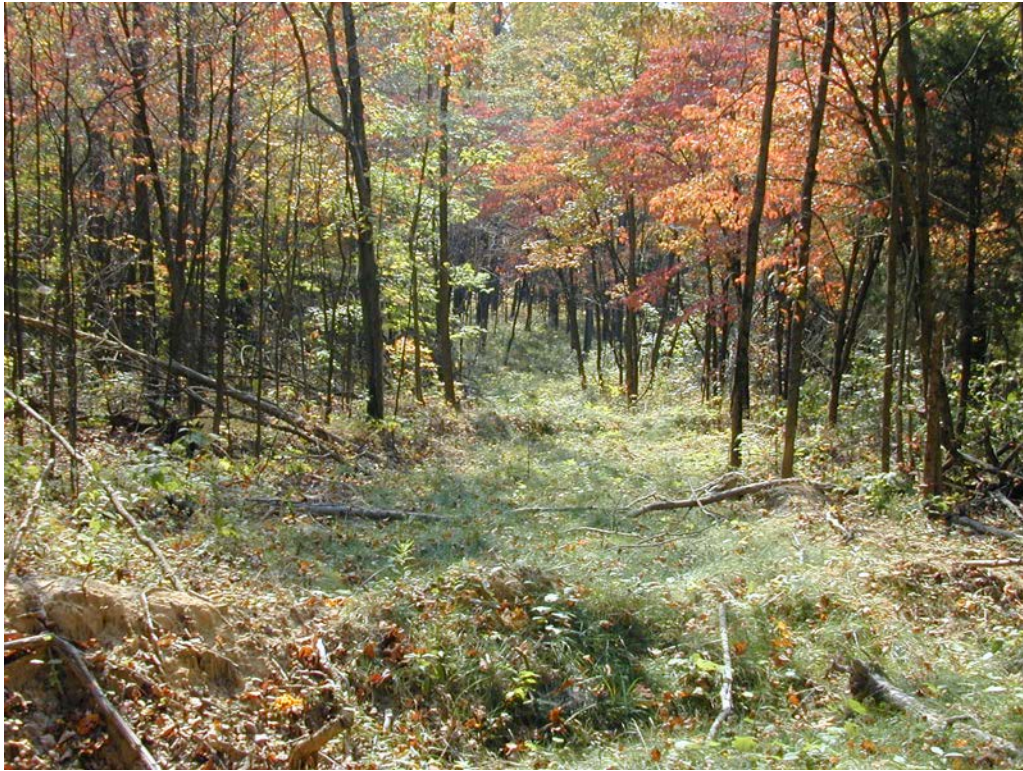
Waterbars have been installed on skid trail. Revegetation and diversions have stabilized the trail.

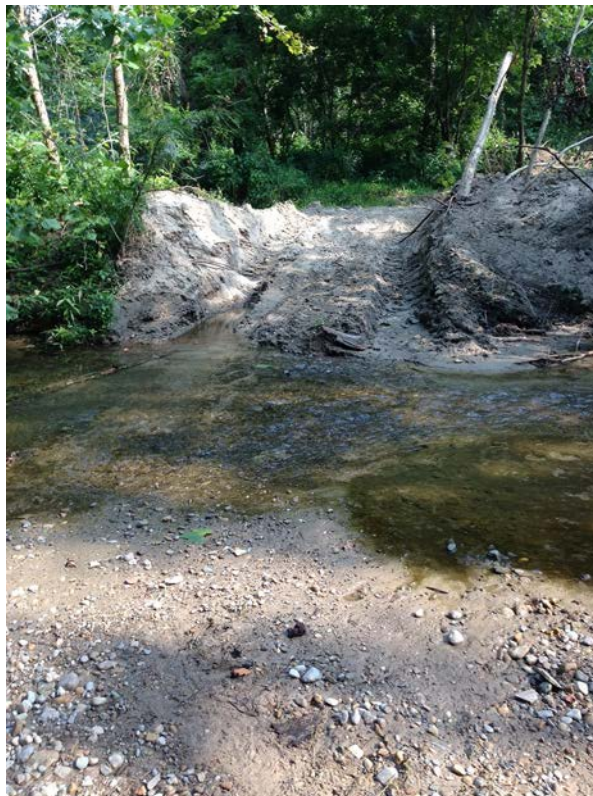
A poorly applied and implemented stream crossing with no attempt to repair. There are no water diversions before stream crossing, no stream bank stabilization/revegetation.

Stream crossings on CLFW sites had four main areas of concern, X2, X3, X4, and X13. Because X2 through X4 are not done properly, it directly impacts the score of X9. X2 application was 56.7% with 58.1% effectiveness. The proper design and stabilization of stream-bank approaches (X3) were low, at 48.7% for application and 50.9% effectiveness. The crossing BMP with the lowest implementation and performance rates was X4, water runoff diverted from road prior to crossing, with an implementation rate of 45.2%, for an effectiveness rate of 50%. Because these practices are low in implementation, the ford's banks and streambeds needed more stable banks and streambeds (X9), with similar application and effectiveness rates of 53.7%. X13 had concerns with the removal of temporary crossing structures and resulting obstructions, and reported application and effectiveness rates were 60.9% and 60.8%.

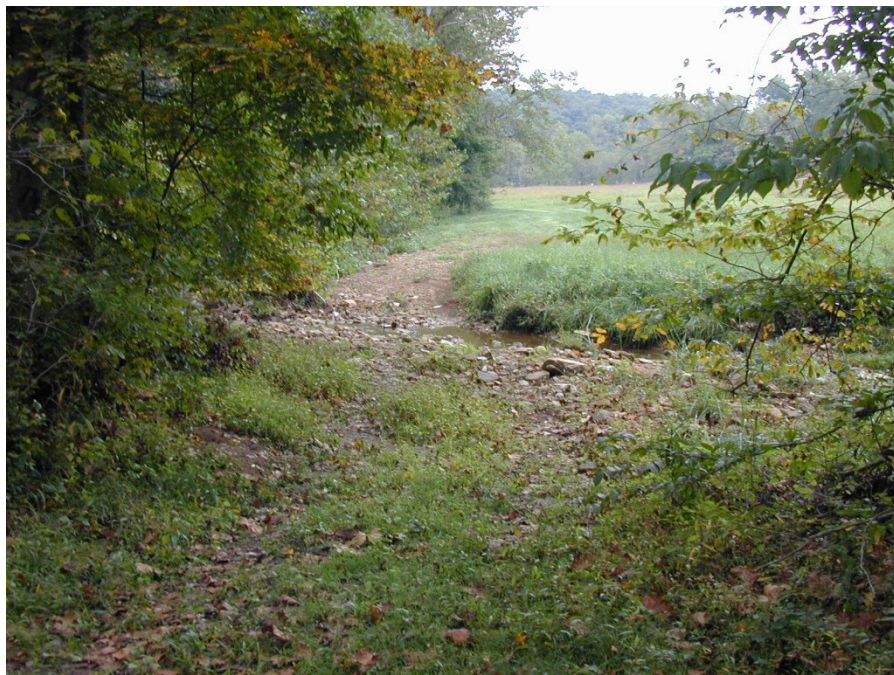
A low and stable ford crossing. Photo by: Duane McCoy

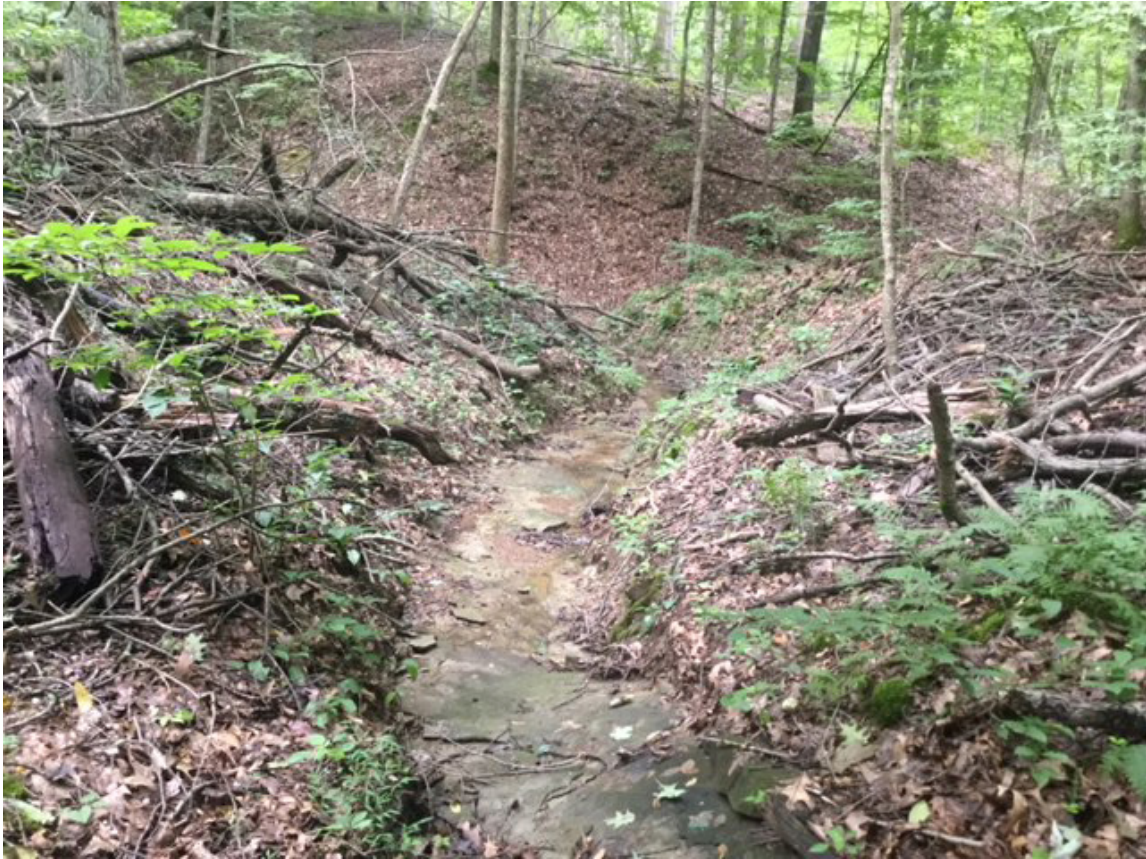
Logging debris removed from a mapped intermittent stream after a harvest.

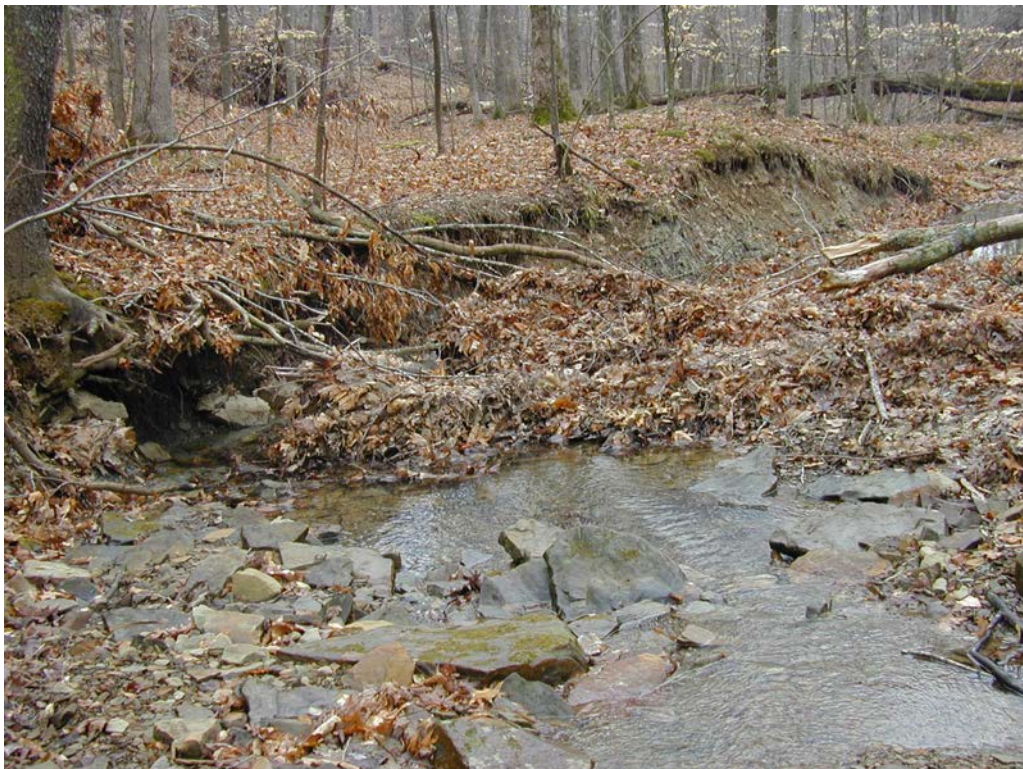
Obstructing debris in streams (Z2) is an issue with a 59.1% application and 61.2% effectiveness. RMZs “free of roads and landings” (Z7) with a 60.8% implementation rate, effectiveness was 80.1%. Water was not commonly diverted before entering RMZ (Z8) with application of 61.4% and effectiveness of 70.7%. When water was diverted, it was not always diverted onto stable areas of the forest floor (Z9); this process had 70% application and 75.2% effectiveness. Roads and trails were not always stabilized as needed within the RMZ (Z10), with an application rate of 76.3% and effectiveness rate of 79.5%. Ephemeral channels were not always free of excavated materials (Z11) with a 70.5% application rate and 71.2% effectiveness rate.

Logging debris in stream can obstruct stream flow, leading to the stream carving out a new bank, which results in erosion and sedimentation directly into the stream.
