January 2020 to December 2020

ANNUAL STATE OF THE ITR REPORT

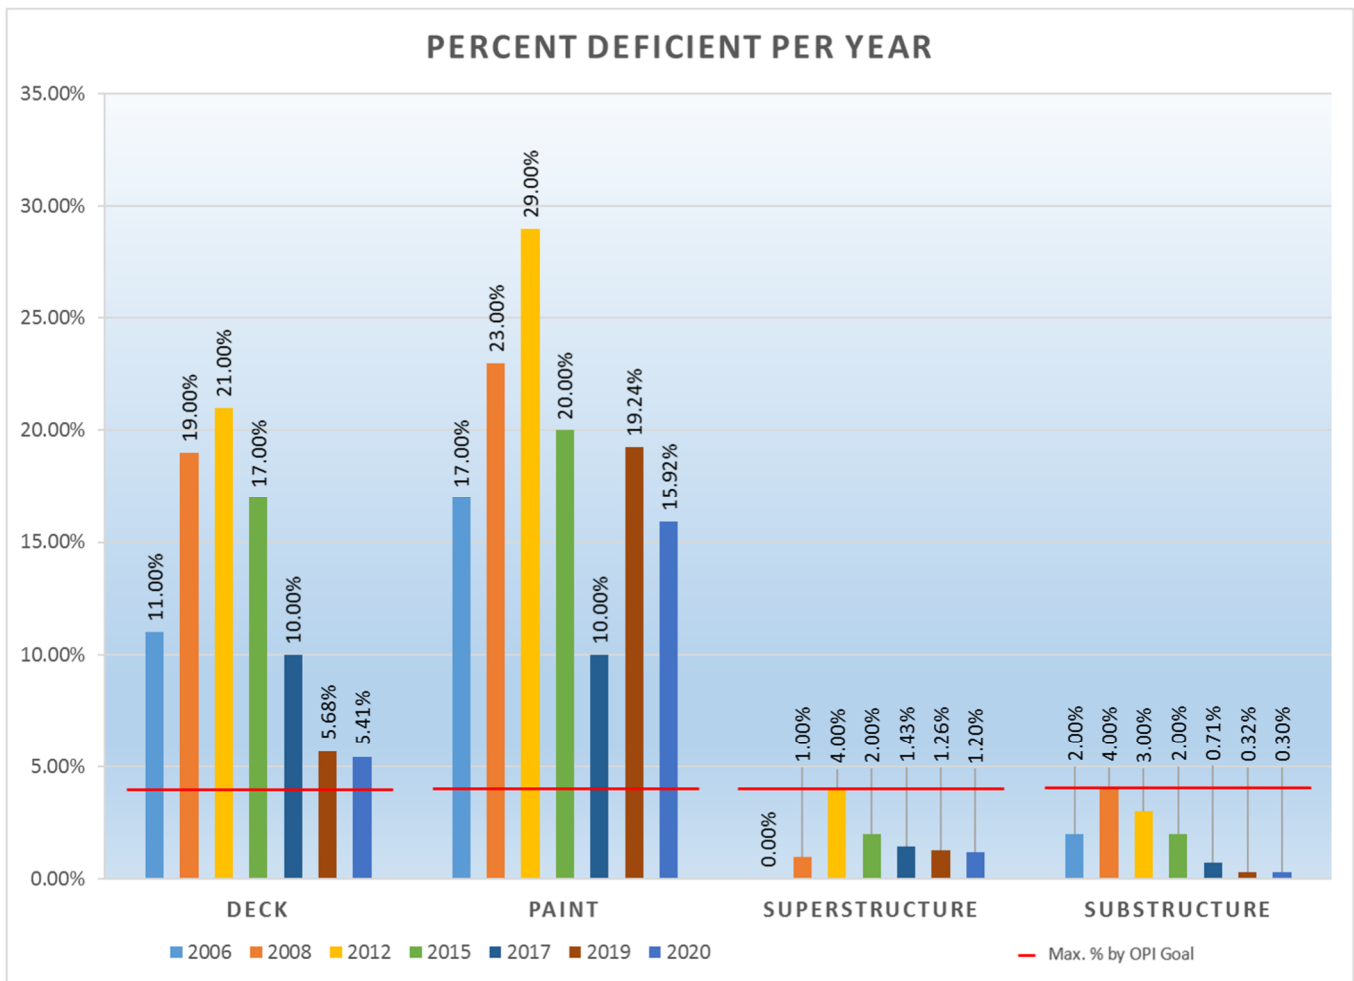
Figure 1.1: Bridge Condition Ratings

The state of the ITR structures have increased in their overall percentages of satisfactory and greater condition ratings, which is the result of lower deficiencies discovered during inspections. Wearing surface and deck deficiencies have improved as well, due to minor rehabilitation projects and the major rehabilitation projects of PUSH 1.0 and PUSH 2.0. The rehabilitations and new construction applied to many structures have increased the Deck, Superstructure, and Substructure ratings.

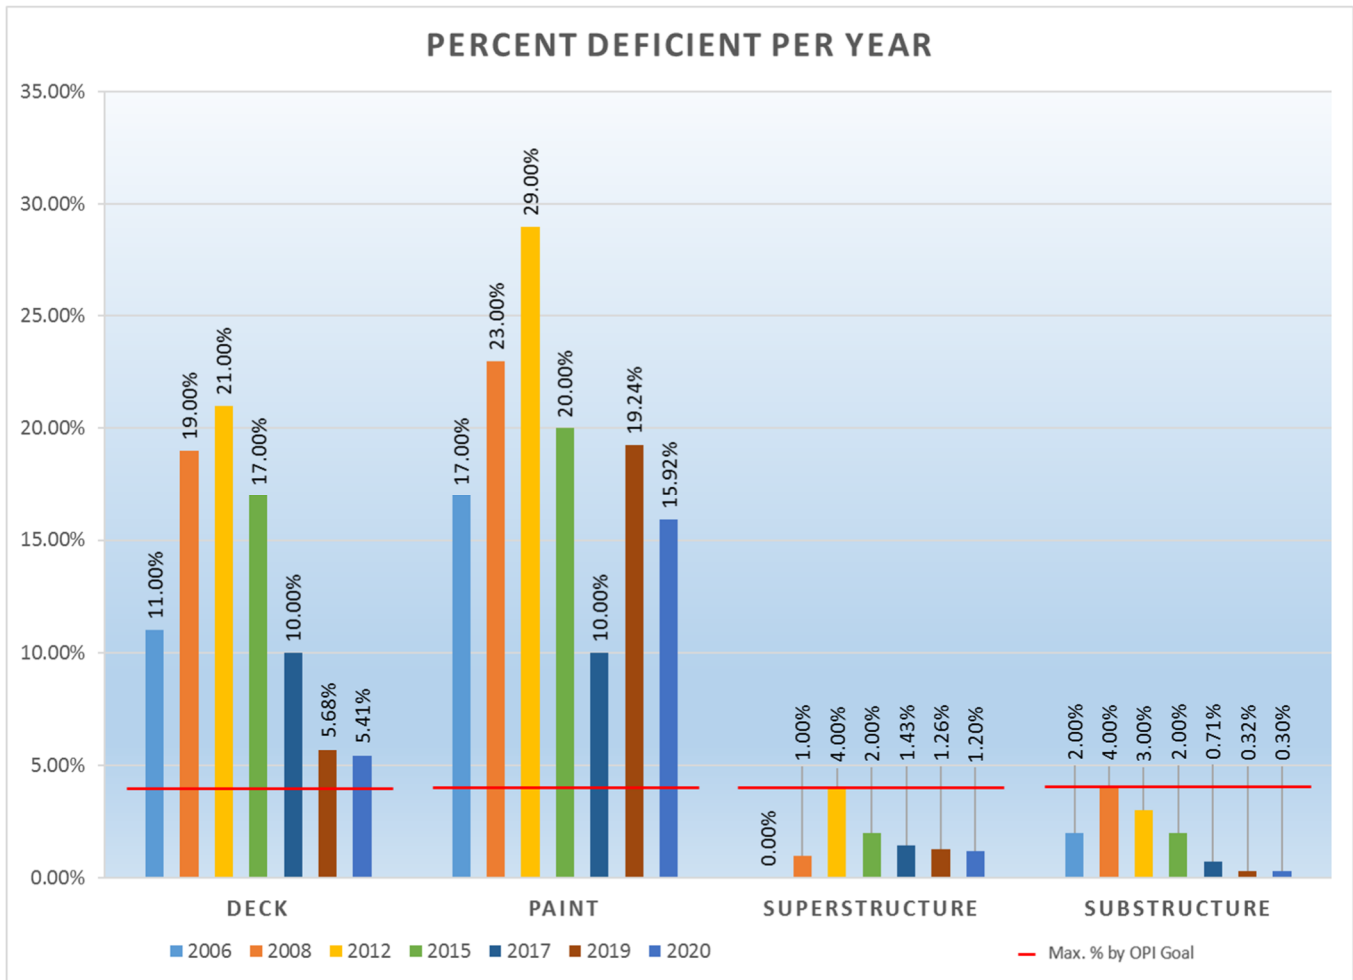
Figure 3.1: Bridge Condition Ratings illustrates that there has been a decrease in the percent deficiencies of the individual items compared to the previous years. This decrease is due to the implementation of the PUSH 1.0 and PUSH 2.0 projects as well as other structure specific contracts the ITR has procured since 2015. The PUSH projects have addressed over 25% of the structures within the ITR corridor.

It should be noted that the ITR is the closest it has ever been, since the initial lease in 2006, to achieving OPI compliance ratings greater than 0 in the Wearing Surface and Deck categories. Per the CLA and the OPI charts, the ITR will be in compliance once the Wearing Surface and Deck ratings reach a percentage of 4% or less of structures being deficient (ratings less than or equal to 5).

The ITRCC has implemented a preventive maintenance plan to address additional annual cleanings and maintenance across all 333 structures, including a budget of \$1.5M to continue paint improvements in line with their programmatic approach to bring down the ratings. The plan includes annual bridge washing of the deck, superstructure, and substructures from travel debris and winter maintenance residuals, along with correcting minor drainage, joint, and patching needs. ITRCC continues to maintain an aggressive preventative maintenance program to inspect and clean bridge structures on an annual basis, building on the foundation of professional training received in 2017. This crew and plan will help to lower and maintain low deficiencies throughout the bridge structures' surface life.
