Engineering Documents

SR 912 Michigan Avenue Bridges Project - Des. No. 1703011

912-45-02543 B MICHIGAN AVENUE over SR 912 EB/WB, RAMPS, RR

Bridge Inspection Report

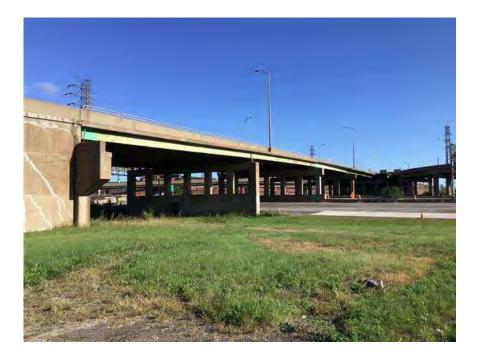
Minor deck pan rusting throughout. The wearing surface of the deck has numerous longitudinal and transverse cracks, some have been sealed.

Comments: Corrosion throughout steel beams.

(2018 Special Inspection Notes) There are multiple cracks in welds on the cover plates and minor section loss in multiple beams. There is some corrosion at

the end of the cover plates in the bottom flanges that is initiating section loss. Also it was determined that there are cracked welds possibly due to pack

rust at the west end of Span D.

The abutments and pier walls have extensive wide cracks. There has been attempts to seal the cracks however they have cracked through the seal.

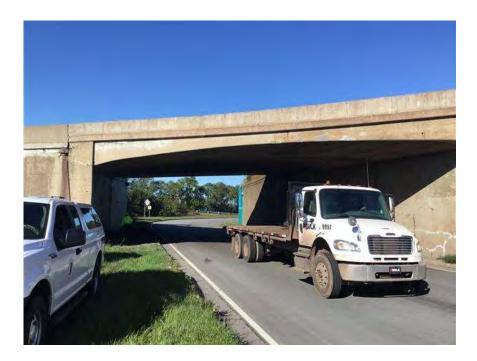
912-45-06596 B RAMP B over RAMP B

Wide centerline crack. Widespread map cracking.

Underside slab cracking. Spalling along center joint and coping spalls and cracking.

(60) SUBSTRUCTURE:	5 - Fair Condition (minor section loss)				
Comments: Wide vertical and horizontal cracking in abutments					
(61) CHANNEL/CHANNEL PROTECTION Comments:	N - Not Applicable

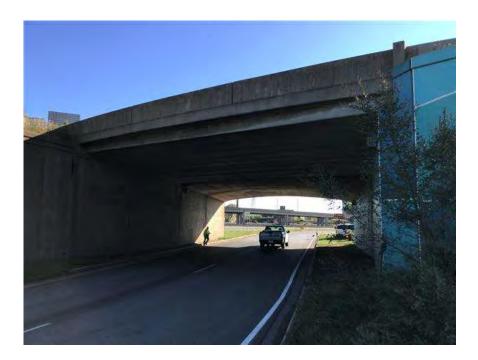
912-45-06596 JA RAMP H over RAMP B

Longitudinal cracking throughout deck length, some transverse cracking.

(59) SUPERSTRUCTURE:	5 - Fair Condition (minor	section loss)			
Comments:					
There are large scrapes and minor sp 1. PCBB #5 from W, E. Edge Spall:

2. PCBB #8 from W, W. Edge Spall	: 6"x3"x2' w/ exposed strand	over C/L of Ramp B.			
3. PCBB #9 from W. W. Edge & Ce	enter Spall: 6"x2"x2'.				
(60) SUBSTRUCTURE:	6 - Satisfactory Condition	(minor deterioration)			
Comments: Vertical cracks throughout abutment	ts, some horizontal cracking.

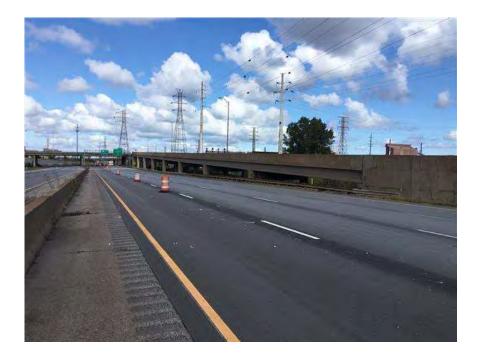
912-45-02543 A RI SR 912 RAMP (INLAND) over ELEVATION CHANGE-UP RAMP

59) SUPERSTRUCTURE:	6 - Satisfactory Condition (minor deterioration)	(62) CULVERTS:	N - Not Applicable
CONDITION COMMENTS			
(58) DECK:	6 - Satisfactory Condition	(minor deterioration)	
Comments: Delamination on under side of deck at	span G, several cracks with	minor efflorescent starting to form

Several small spalls near North end of bridge on wearing surface. Many transverse cracks and map cracking

Several beam ends are spalled with some exposed steel

C Satisfastana C	7 diti	(
(60) SUBSTRUCTURE: Comments:	6 - Satisfactory Condition (minor deterioration)						
Some cracking on the bottom of Pier 5 cap and spalling on Pier 3 far East column with tension strands exposed

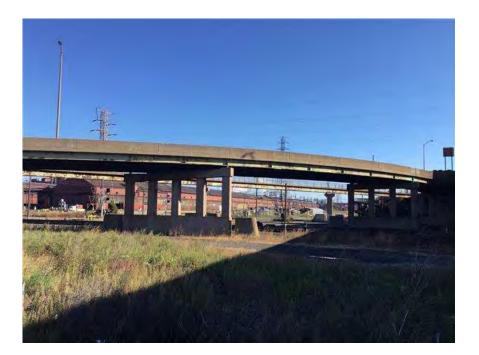
P912-45-02543 A NEC SR 912 RAMP NEC over RR YARD, RAMP NER, RD

(59) SUPERSTRUCTURE:	6 - Satisfactory Condition (minor deterioration)	(62) CULVERTS:	N - Not Applicable
CONDITION COMMENTS			
(58) DECK:	6 - Satisfactory Condition	(minor deterioration)	
Comments: Cracking in the deck and wearing surf that are bolted to the deck behind the j		jersey barriers set on the bridge deck. Ther	e are two steel angle

Comments: Significant surface rust.

(60) SUBSTRUCTURE:	7 - Good Condition (some minor problems)			
Comments:				
Minor cracking.				
(61) CHANNEL/CHANNEL PROTECTION	N - Not Appli	cable		
Comments:

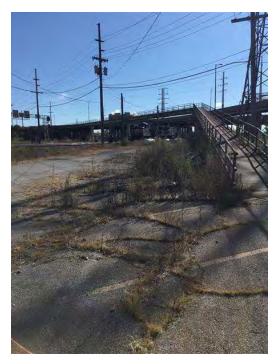
P912-45-02545 ADJ PEDESTRIAN TRAIL over RR YARD, SERVICE RD

Good condition walkway.

Poor condition, advanced deterioration, spiral ramp. JDB 7-12-2018

(58.01) WEARING SURFACE:	N - Not Applicable		
Comments: Good condition walkway Poor condition, advanced deterioratio	n spiral romn		
Pedestrian Bridge is rarely used by ste	eel employees, only	viral Ramp needs Rehabilitation by Arcelor	Mittal Steel Company.
