Des. No. 2002197
SR 159 at UNT to Splunge Creek
 Small Structure Project
 4.15 Miles North of SR 246
 Vigo County

Photo Orientation Map - North

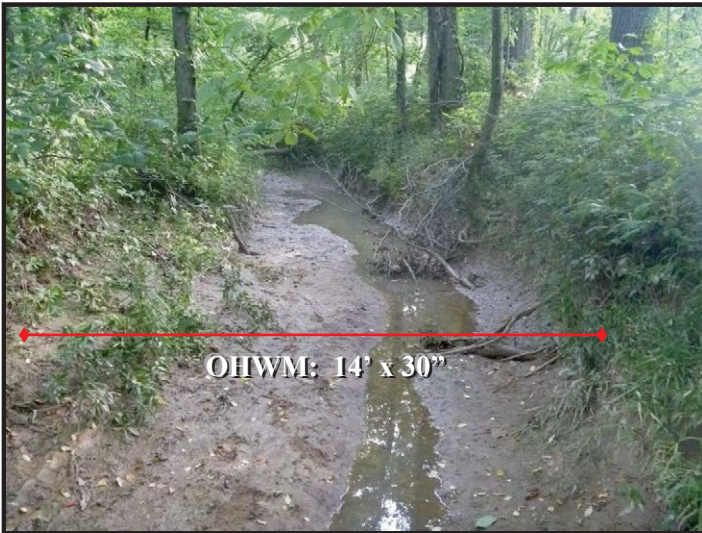
Photo 1 – UNT to Splunge Creek, Upstream from SR 159: Facing upstream to the southwest along UNT to Splunge Creek at the western limits of the AOI. The OHWM in this area measured 14 ft. wide by 30 in. deep.

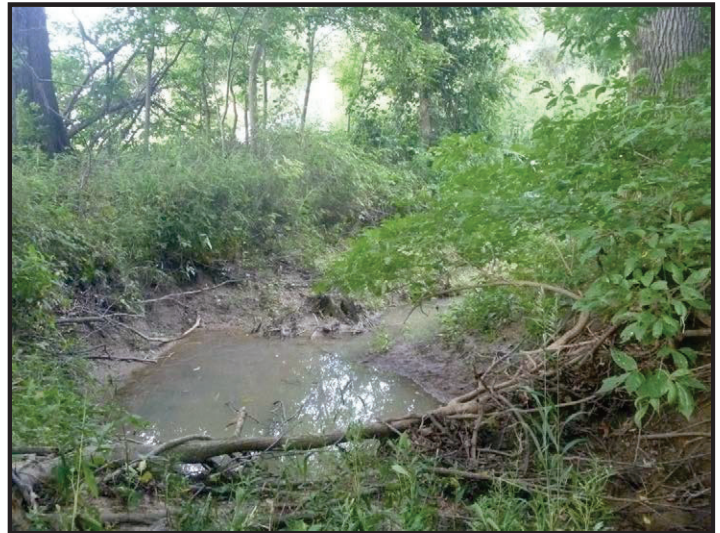
Photo 2 – UNT to Splunge Creek, Upstream from SR 159: Facing downstream to the northeast toward a scour hole at a small drop in the streambed.

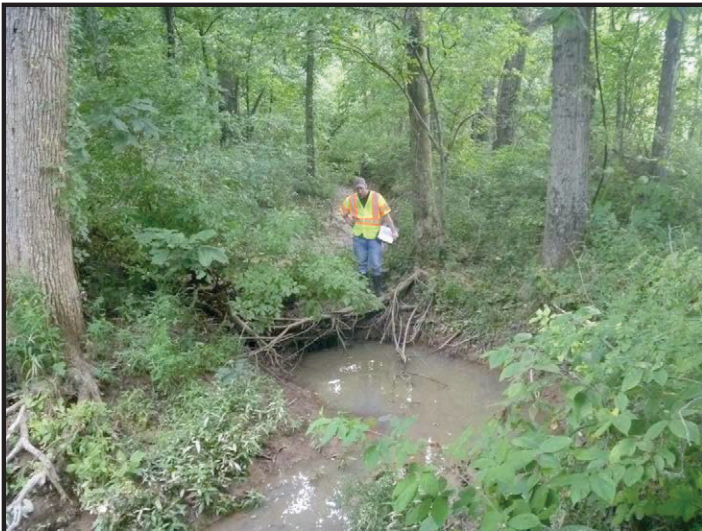
Photo 3 – UNT to Splunge Creek, Upstream from SR 159t: Facing upstream to the southwest along UNT to Splunge Creek toward the scour hole shown in Photo 2.

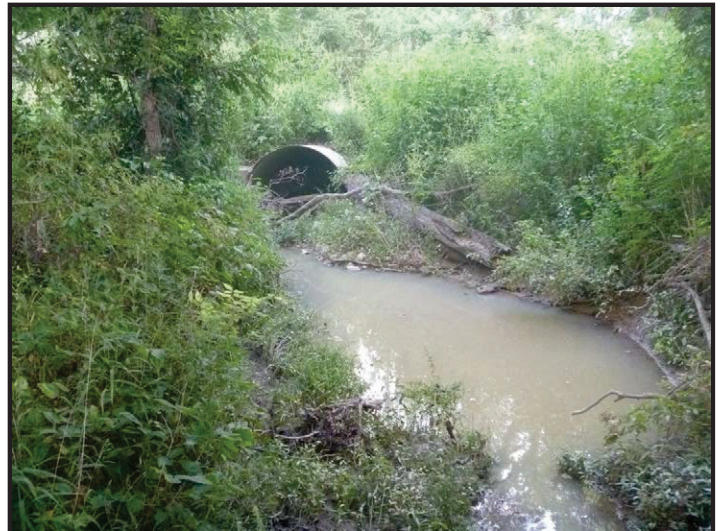
Photo 4 – UNT to Splunge Creek, Upstream from SR 159: Facing downstream to the northeast toward the scoured area at the inlet of the SR 159 small structure.

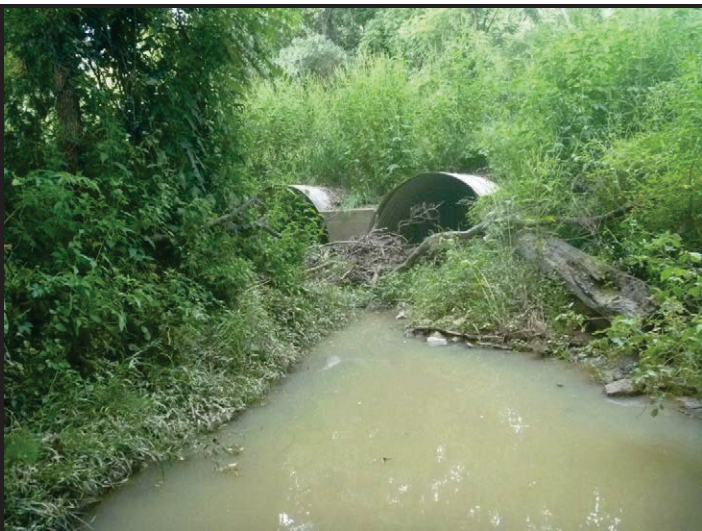
Photo 5 – SR 159 Culverts at UNT to Splunge Creek: Facing northeast toward inlet of SR 159 small structure, Str. No. CV 159-084-23.30, a set of twin, elliptical 47-foot-long steel pipes, each 8.5 feet wide and 6 feet high. The structure is proposed for replacement.

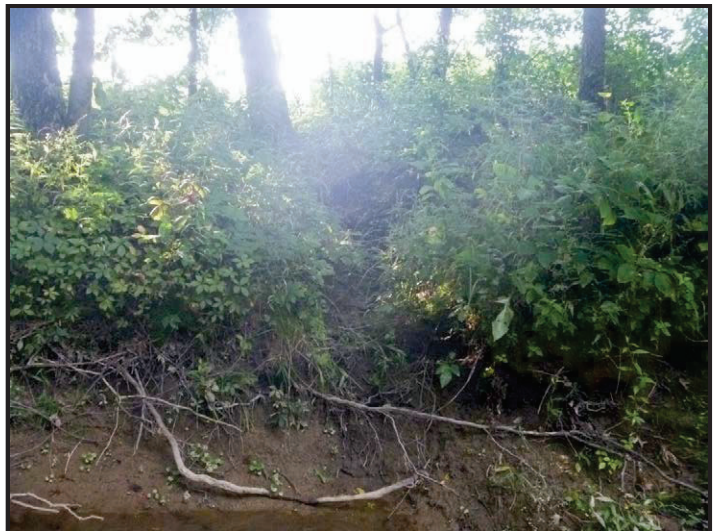
Photo 6 – Erosional Feature at UNT to Splunge Creek: Facing northwest toward the outfall of an erosional feature (EF-1) that carries field drainage into UNT to Splunge Creek.

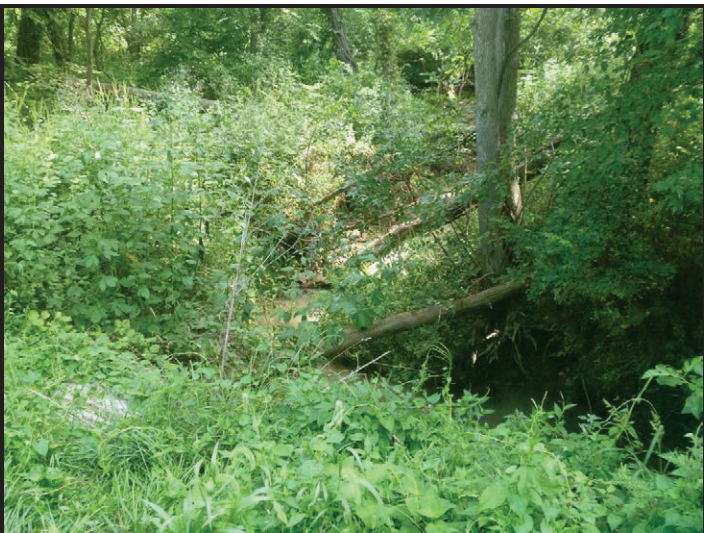
Photo 11 – SR 159 Crossing of UNT to Splunge Creek: Facing downstream to the east along UNT to Splunge Creek from the top of the SR 159 small structure. The left pipe flows freely, but the right pipe outfalls into a scour hole.

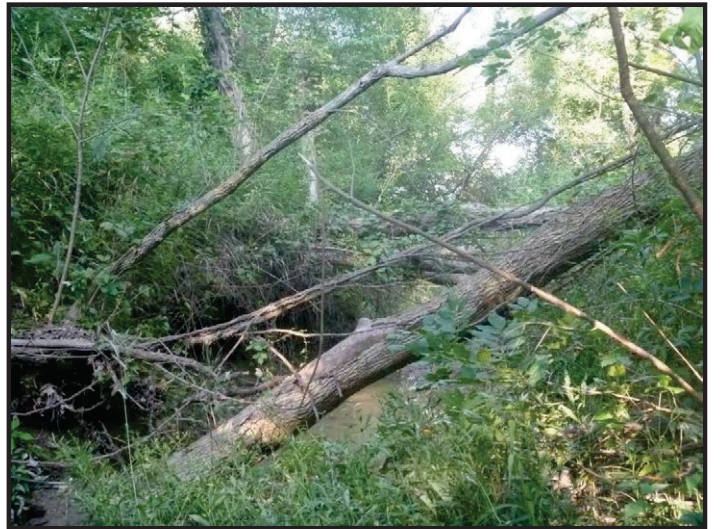
Photo 16 – UNT to Splunge Creek, Downstream from SR 159: Facing downstream to the east along UNT to Splunge Creek. The creek is heavily obstructed by fallen trees.

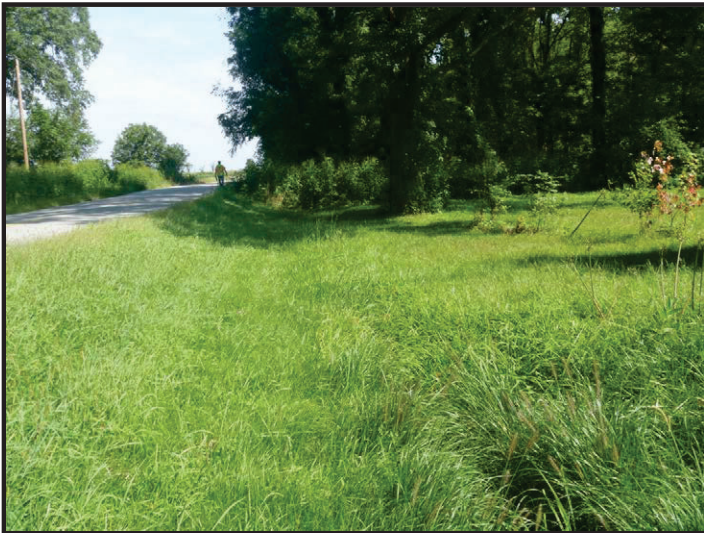
Photo 31 – Southeast Quadrant, RSD-1: Facing downgrade to the north along RSD-1. The ditch becomes poorly defined along the remaining segment toward its outfall into UNT to Splunge Creek.

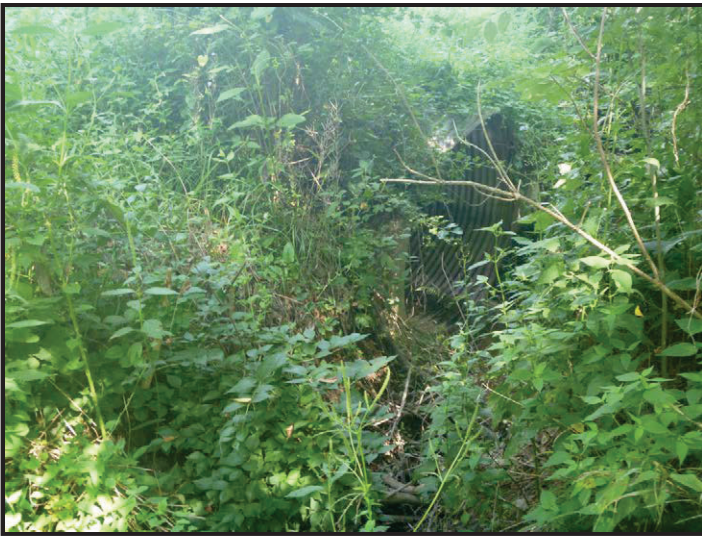
Photo 37 – Southeast Quadrant, RSD-1: Facing north toward the outfall of RSD-1 into UNT to Splunge Creek. Beyond the access into the wooded clearing, RSD-1 becomes deeply eroded (obscured by vegetation and roots).
