Inspector: Joshua Biller
Inspection Date: 03/08/2021

Asset Name: 009-57-02086 C
Facility Carried: NORTHPORT ROAD

Bridge Inspection Report

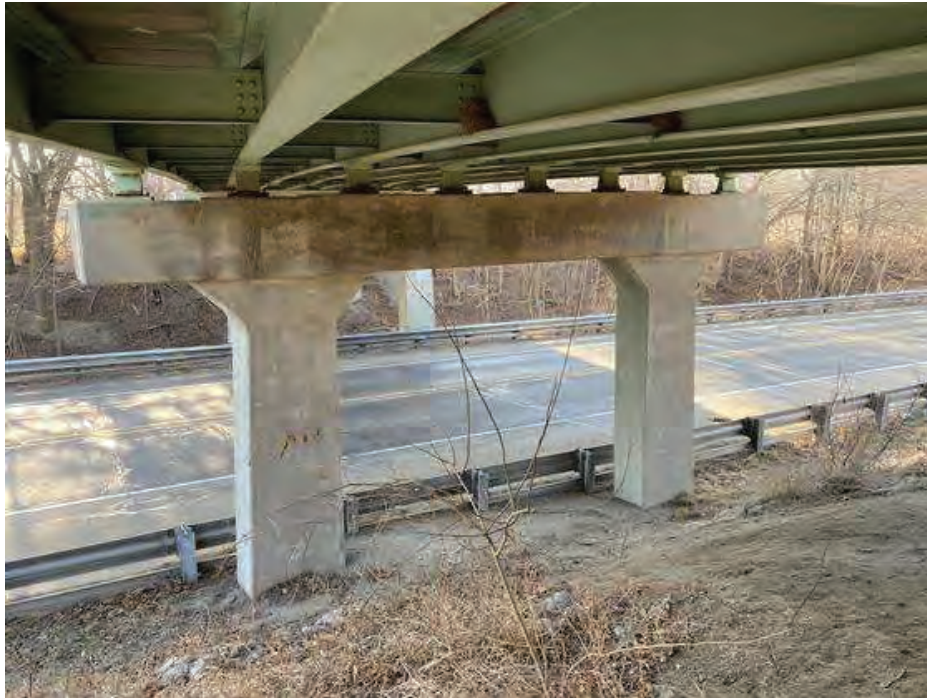
PHOTO 17

Description Span A Underside and Bent 2

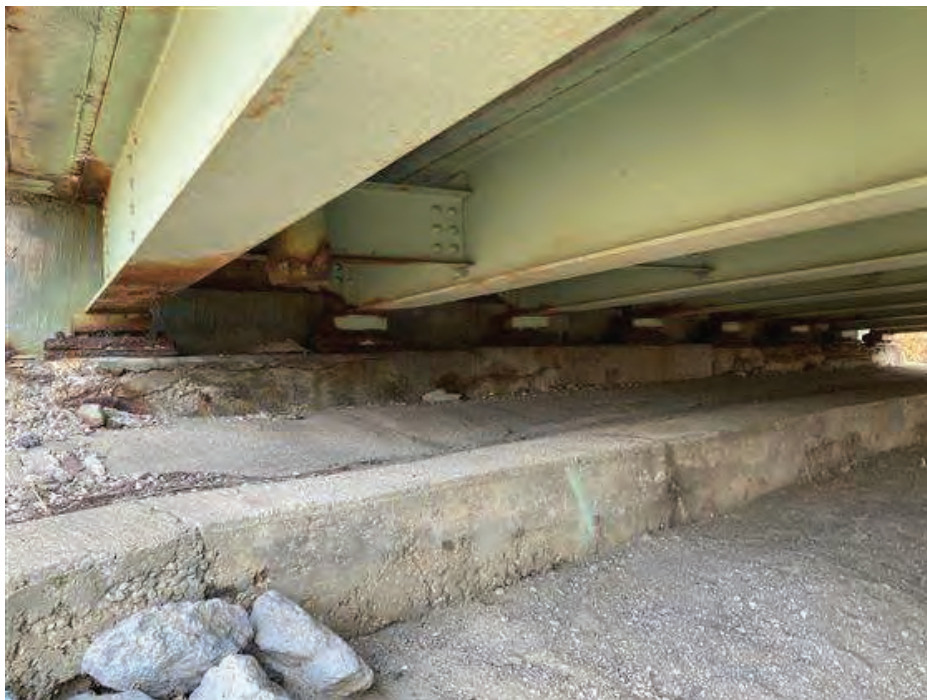
PHOTO 18

Description Span A Underside and Abutment 1

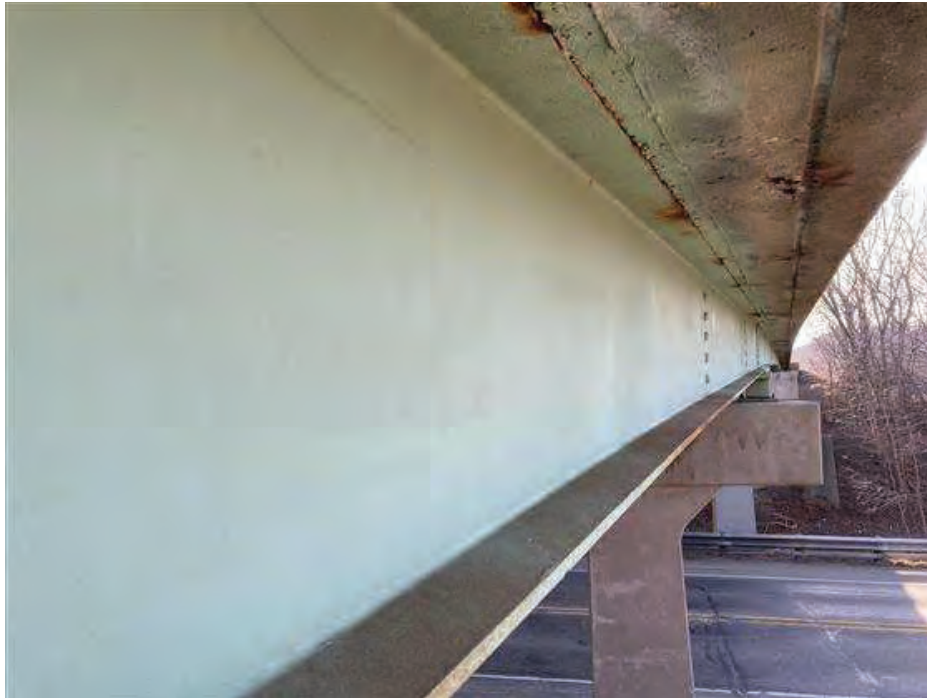
PHOTO 19
Description Along South Fascia (SW corner)

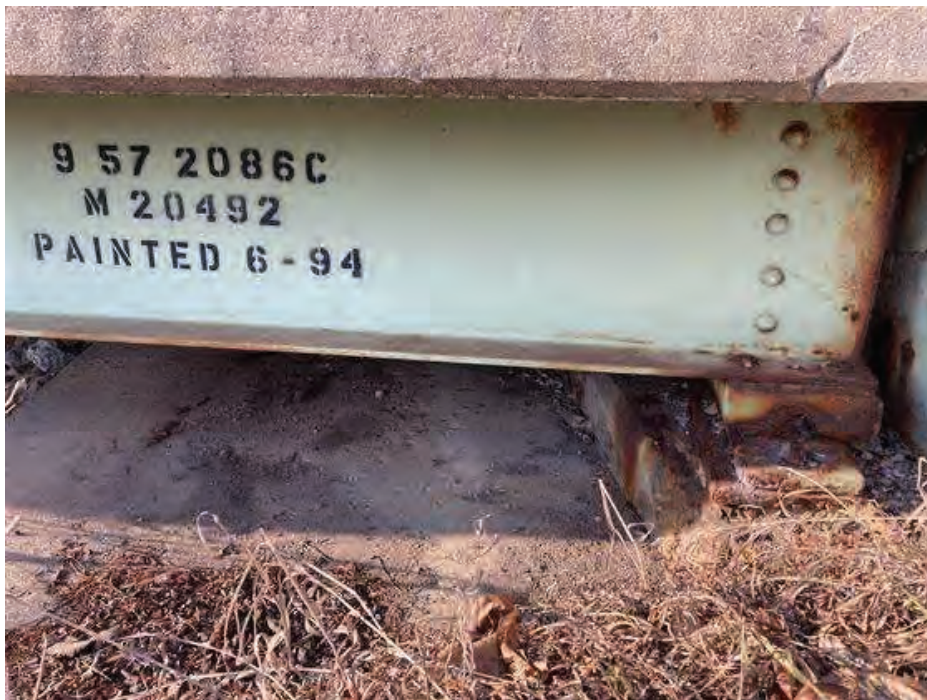
PHOTO 20
Description Abutment 1 (NW Corner)
