The project is located on State Road (SR) 225 over Wabash River, 0.60 mile north of SR 25 in Tippecanoe County, Indiana. The Federal Highway Administration (FHWA) and the Indiana Department of Transportation (INDOT), Crawfordsville District, are planning to proceed with a bridge rehabilitation project on SR 225 over Wabash River. The proposed project includes full replacement and partial replacement of original truss members, including the floor system. The deck will be replaced, a new railing will be constructed, and patching of substructure units will occur to repair damaged piers and abutments.

Asset Name: 225-79-04016 G
Facility Carried: SR 225

Bridge Inspection Report

Inspector: Matthew Ference
Inspection Date: 05/23/2022

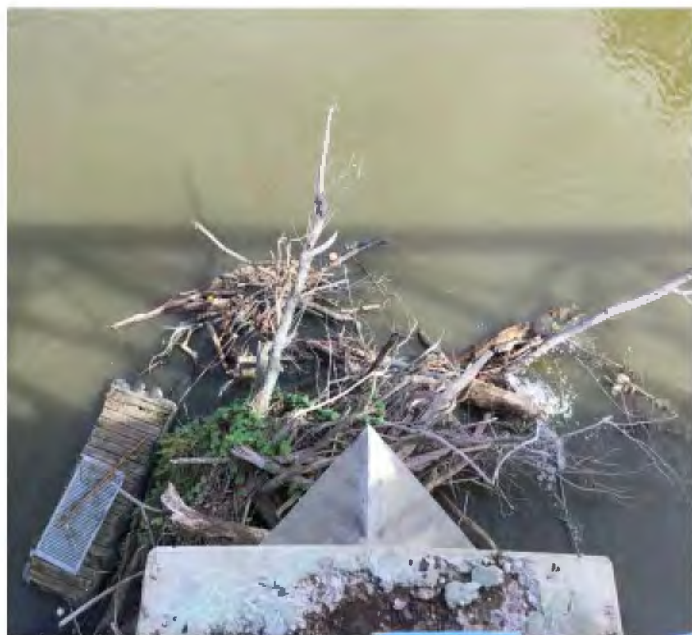
PHOTO 1 Description Log jam on east side of pier 2

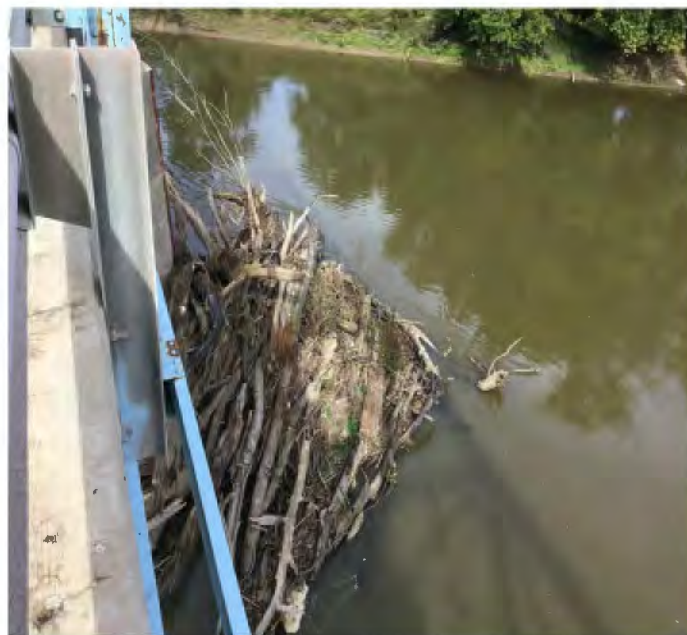
PHOTO 2 Description Look north at east side of Pier 2 log jam

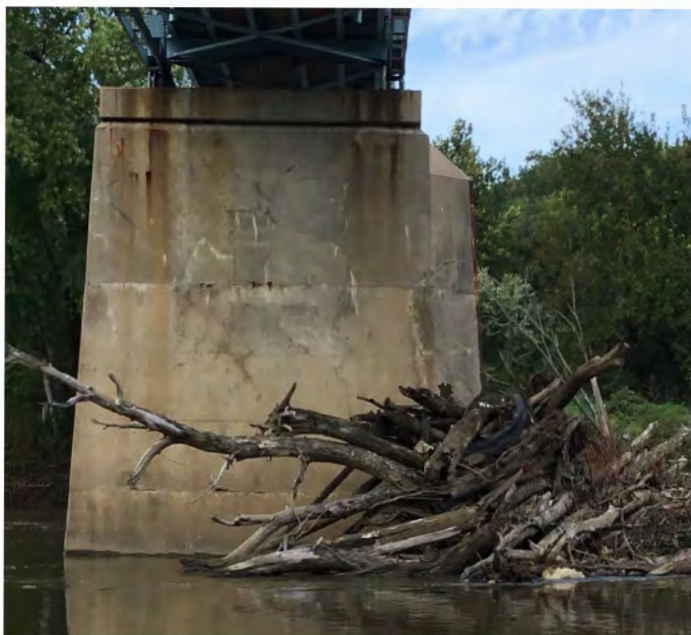
PHOTO 3 Description Looking north at Pier 4

Deficiencies: Abutment No. 1 has a large vertical crack at the southwest corner but is in otherwise satisfactory condition. Abutment No. 5 has a large crack at the northwest corner and varying levels of weathering of the original portion of the abutments. The piers have map cracking with some leaching. There is a large amount of debris against Pier No. 4.

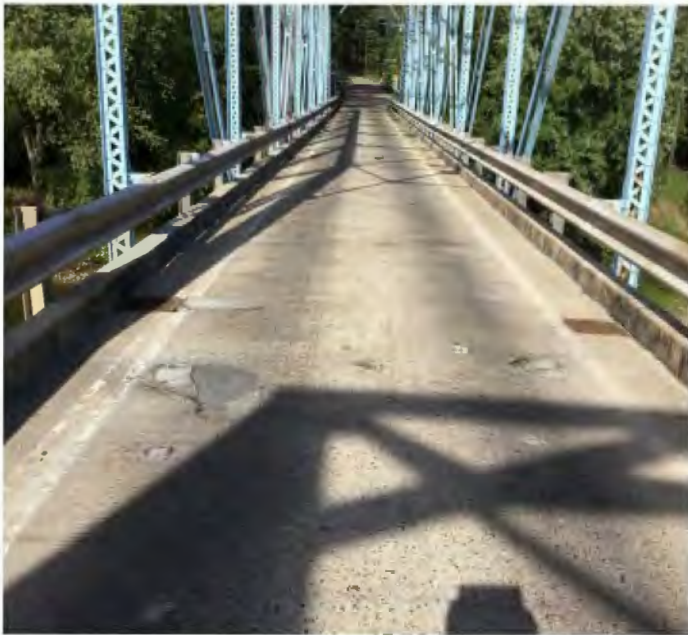
There are cracks and spalling in deck at all spans. This issue was reported in 2019.

PHOTO 1 Description Span A with patching and spalling

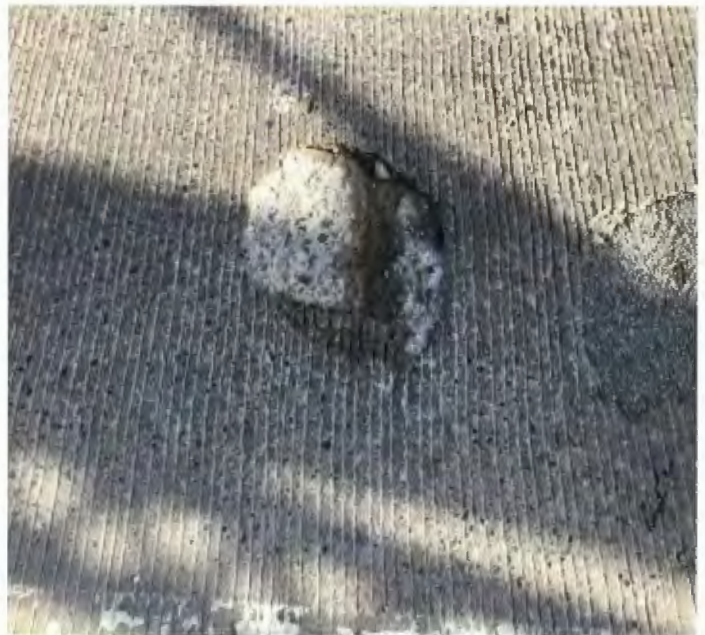
PHOTO 2 Description Span A with delamination and exposed rebar

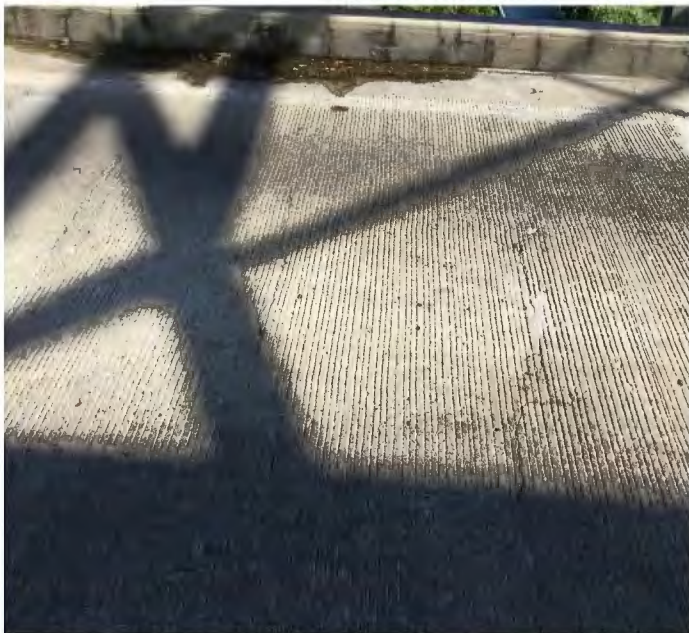
PHOTO 3 Description West end of Span B with more patching and cracks

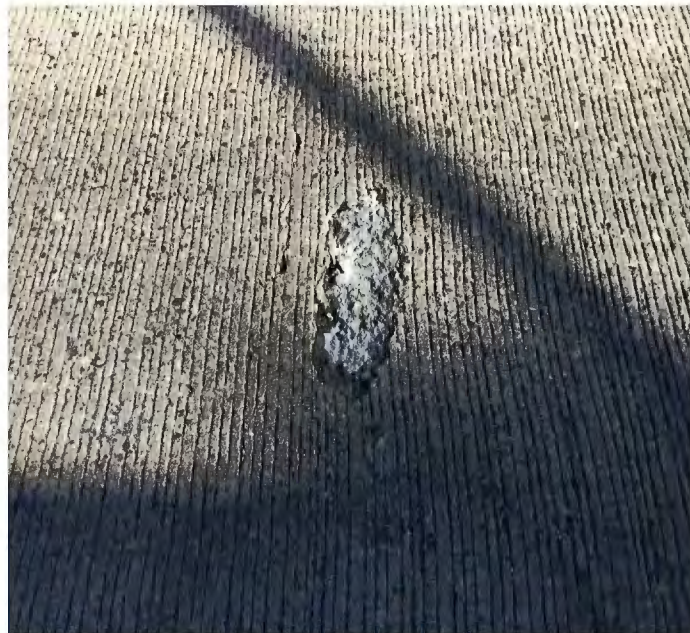
PHOTO 5 Description Spalling at mid span D

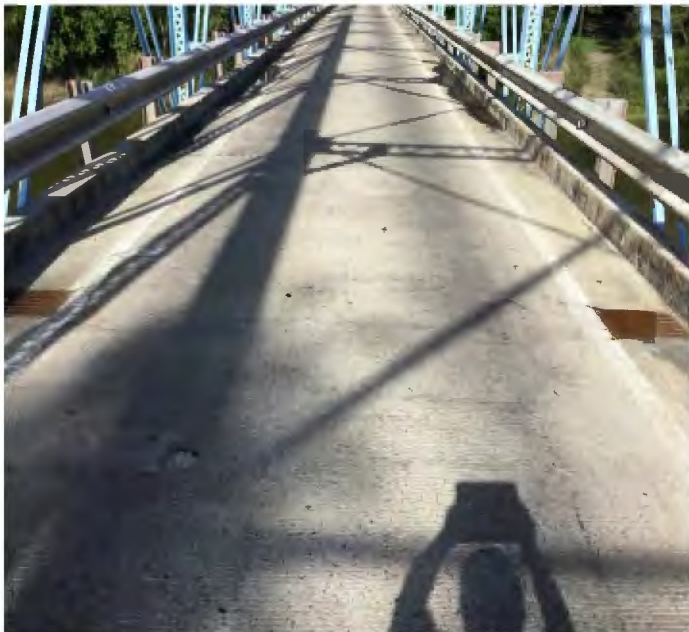
PHOTO 4 Description Span C with many spallings

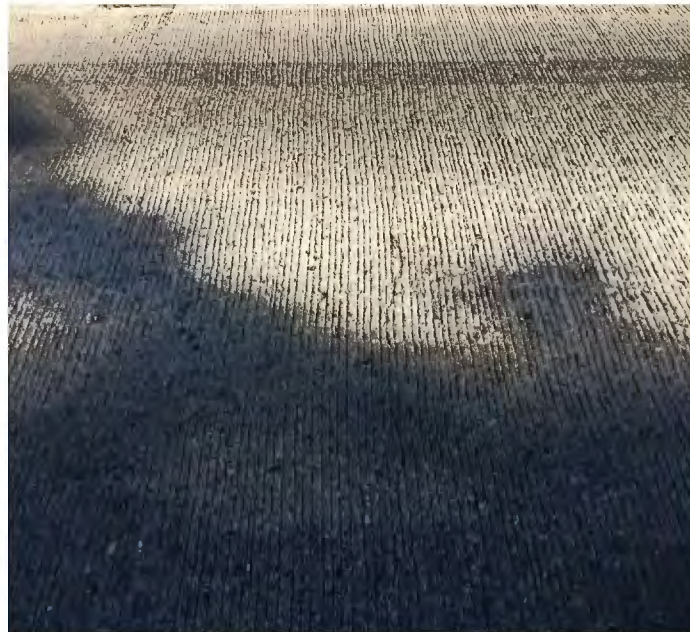
(58) DECK: 4 - Poor Condition (advanced deterioration)
 Comments:
 There are many transverse cracks in all spans at approximately 5' apart. Most of cracks of previously reported cracks have been patched.

PHOTO 6 Description Span D wide width transverse cracks at 5 feet apart

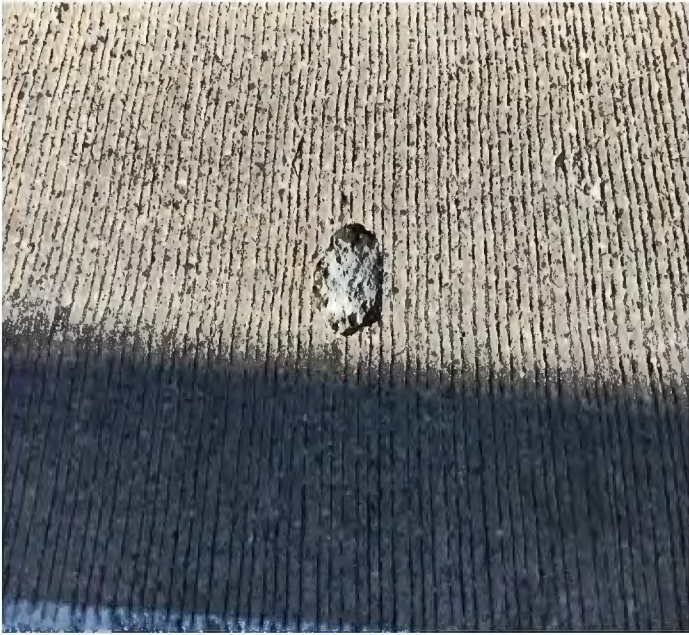
PHOTO 7 Description Spalling at north end of span D

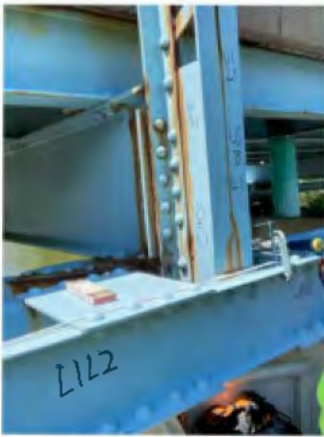
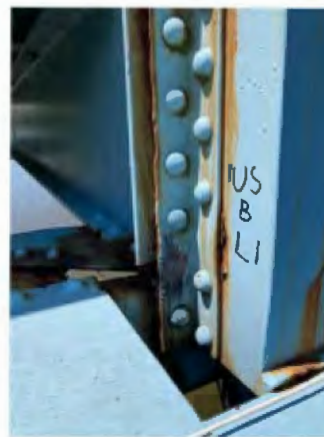
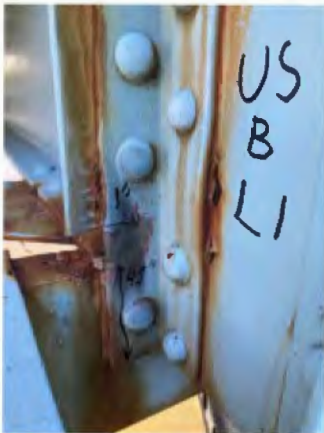
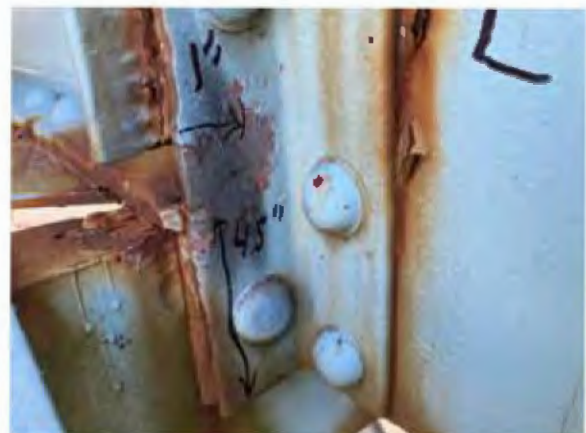
- 1.) Fracture Critical Member U1L1 (Upstream Truss, Span B): 1" long crack located on the east interior angle flange, 4.5" from the bottom of the vertical
- 2.) Fracture Critical Member U7L7 (Upstream Truss, Span B): 0.25" long crack located on the east interior angle flange, 20" from the bottom of the vertical

File Description US Span B,
U1L1, 1" crack
in interior
flange, 4.5"
from bottom of
vertical pic 1

The recommendation is to close the bridge until the truss members are repaired.

Safety Action Taken Lafayette Unit Foreman Scott Krintz and staff have closed the bridge to traffic with road closure barriers. Once the Fracture Critical Inspection is complete (next 2 days) more permanent barriers will be placed at both ends of the bridge.
 (By Whom/When)

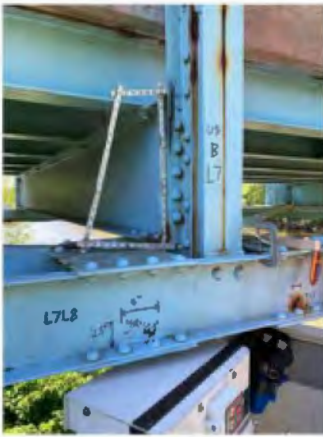
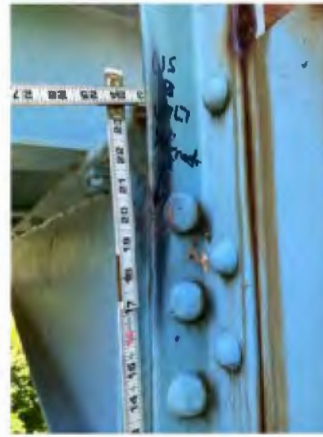
File Description US Span B, U7L7, 0.25" crack in interior angle flange, 20" from the bottom of the vertical pic 1
