## Appendix F – Traffic Data

## TRAFFIC DATA

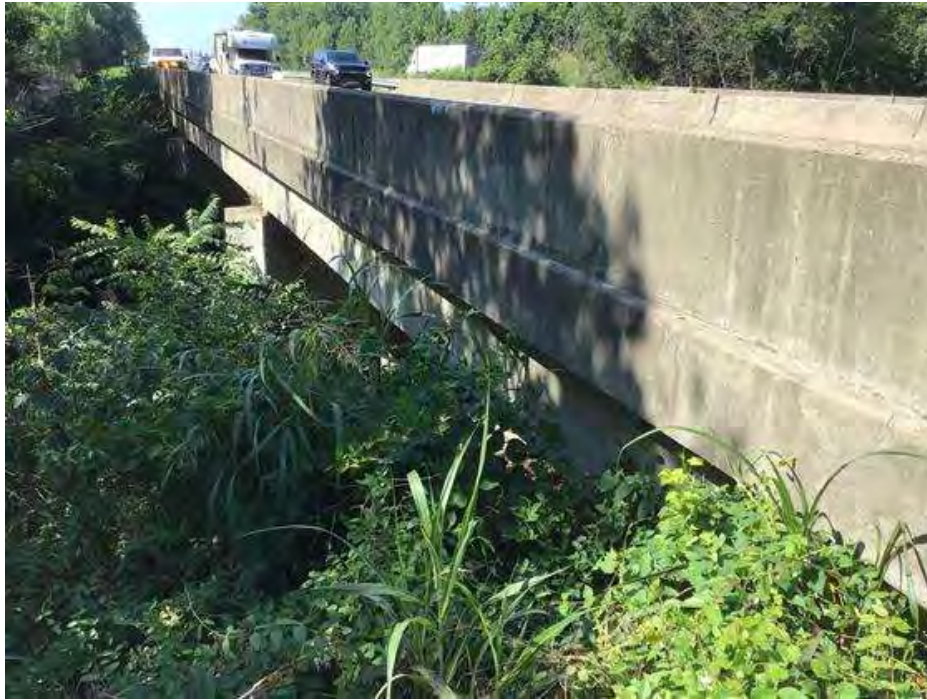
PHOTO 1 Elevation, Condition  
Description East side.

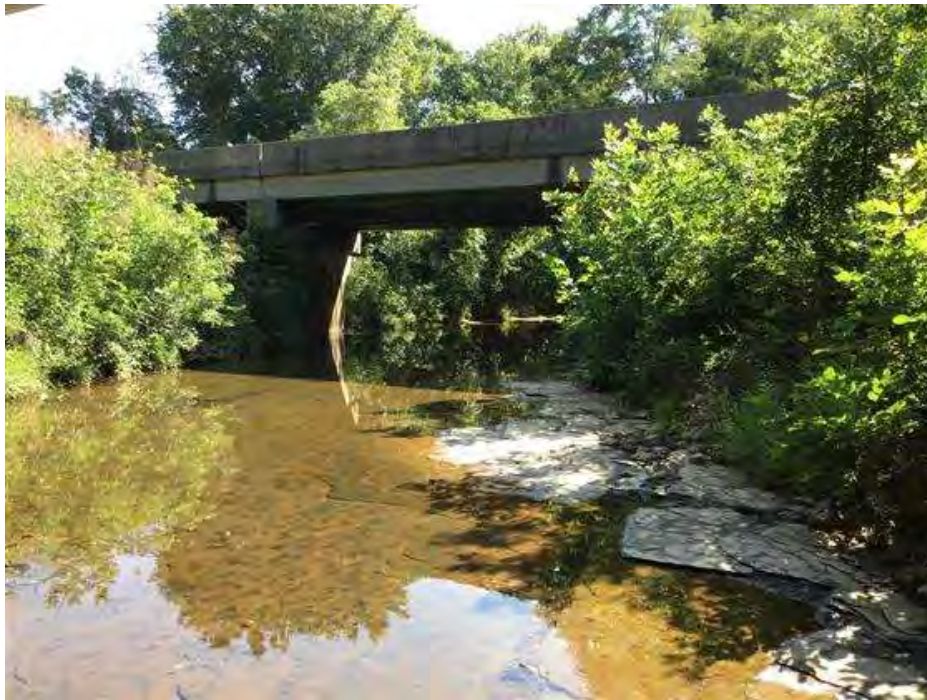
PHOTO 2 Elevation, Condition  
Description West side.

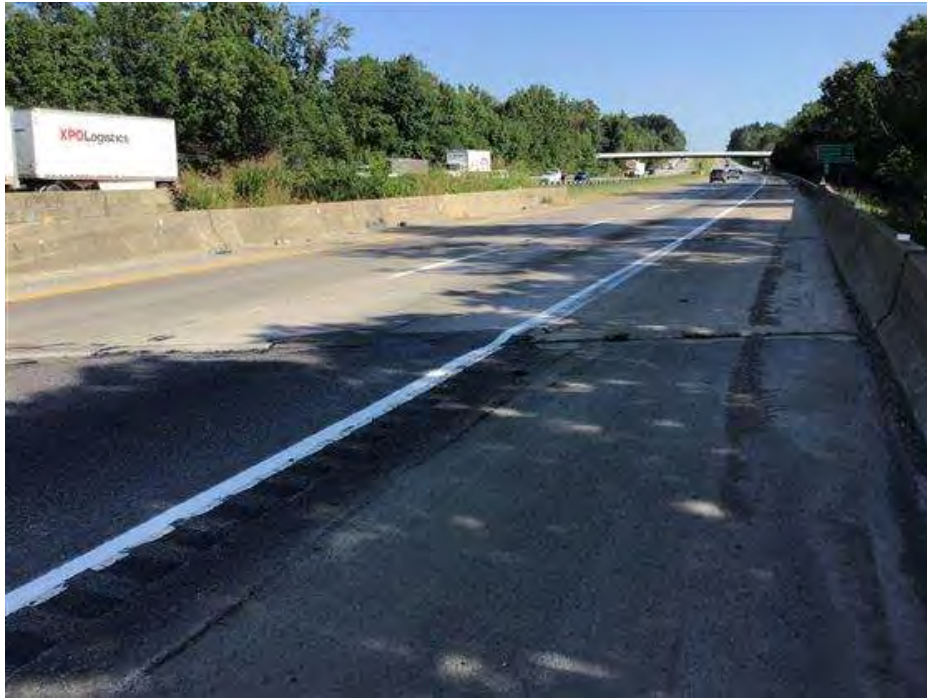
PHOTO 3 Condition  
Description Roadway north.

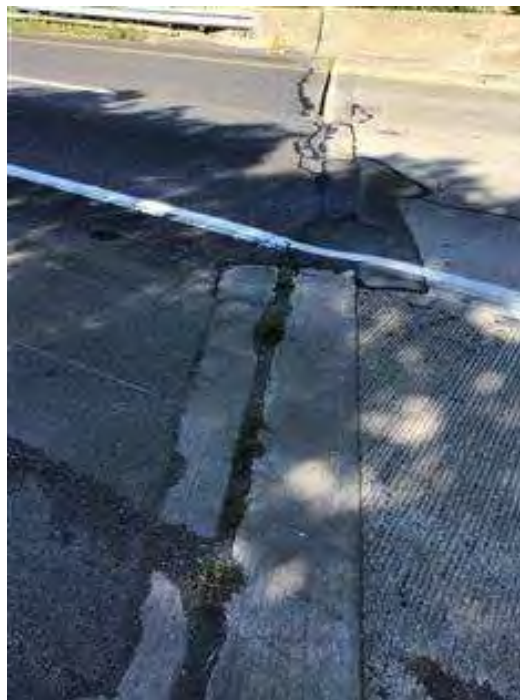
PHOTO 4 Condition  
Description South joint.

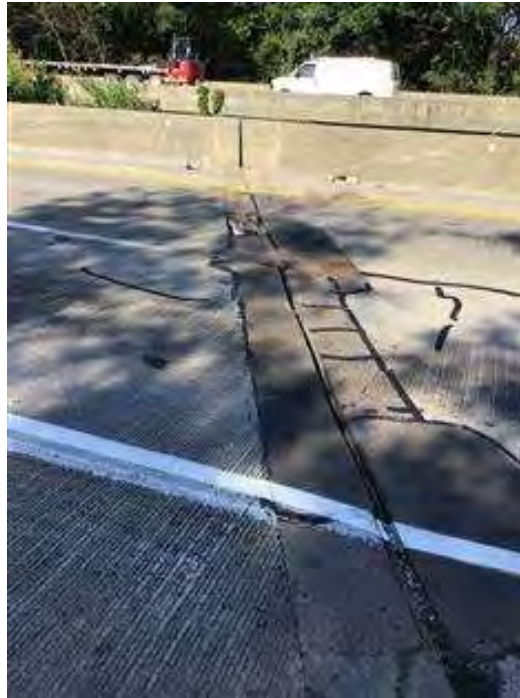
PHOTO 5 Condition, Other, Maintenance - Bridge

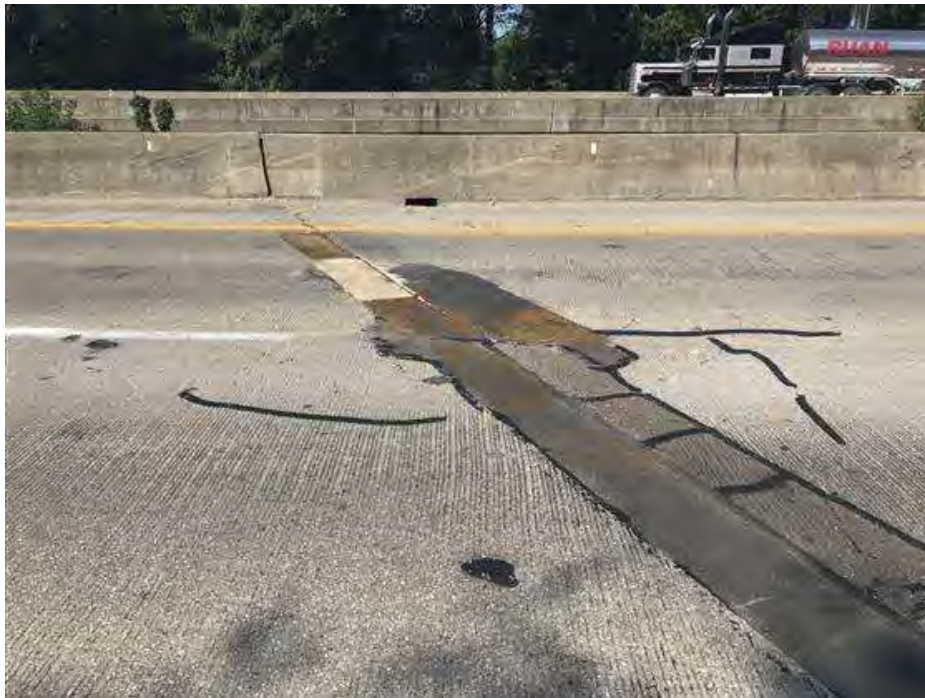
Description Joint 2 facing west.

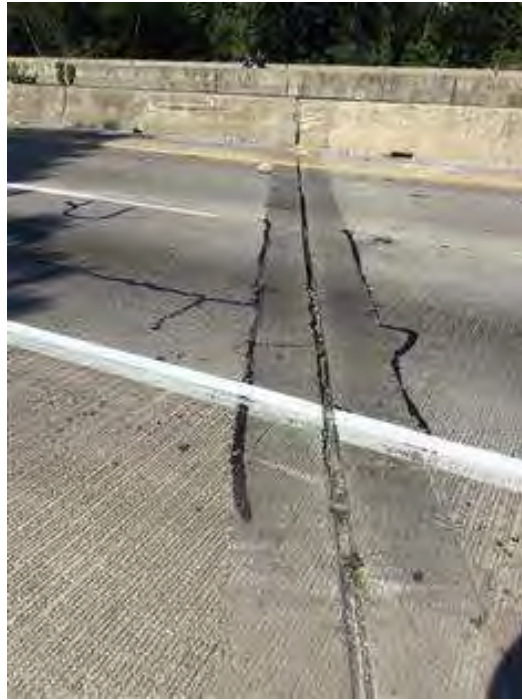
PHOTO 7 Condition  
Description Joint 3 facing west.

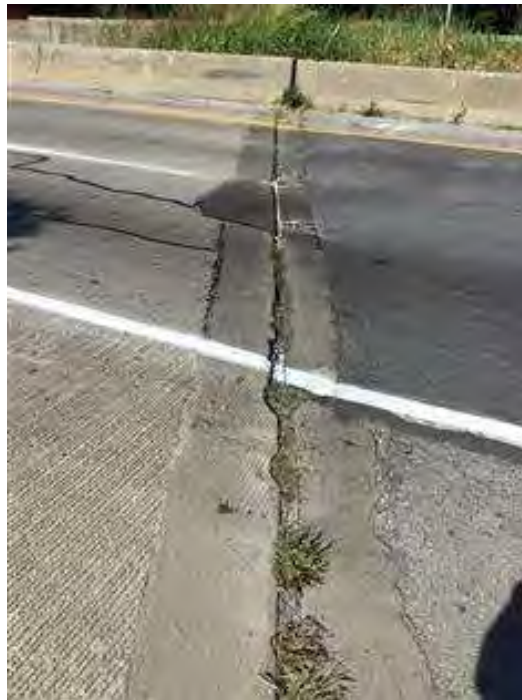
PHOTO 8 Condition  
Description North joint.

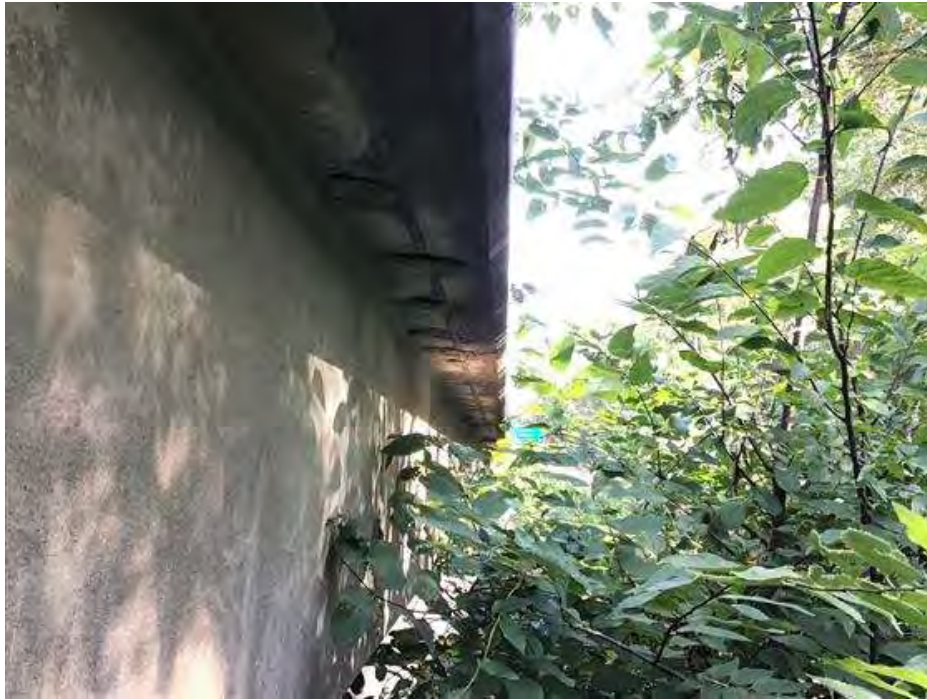
PHOTO 9 Condition  
Description West coping.

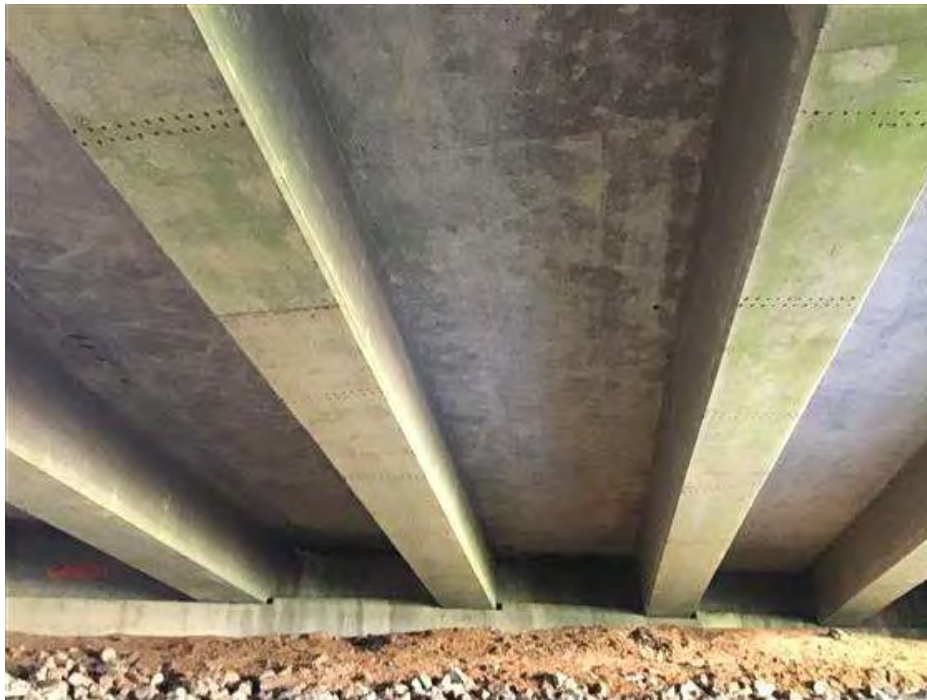
PHOTO 10 Condition  
Description Span A facing south.

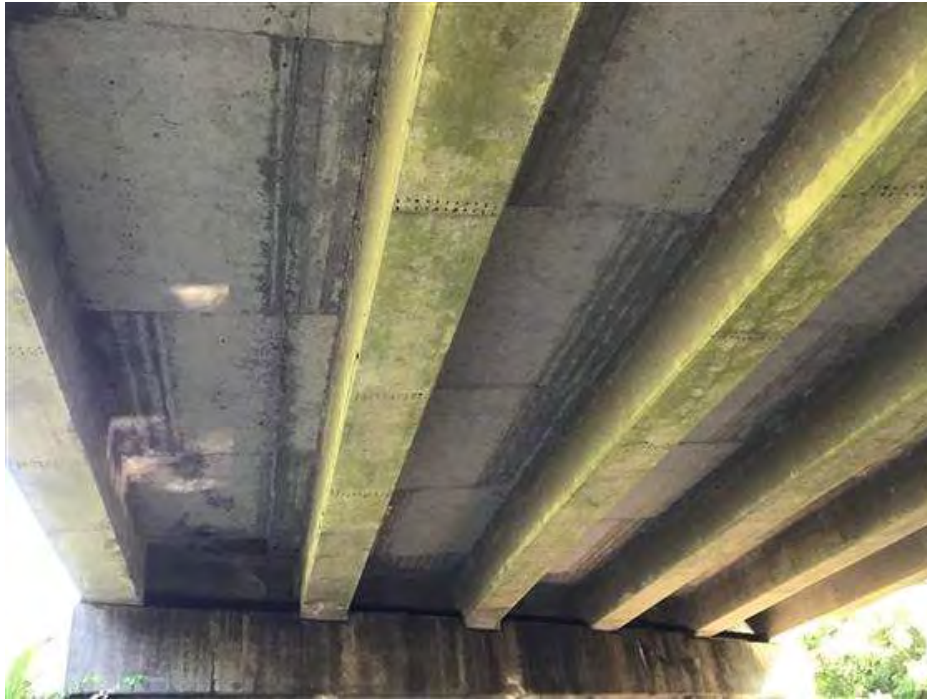
PHOTO 11 Condition  
Description Span B facing north.

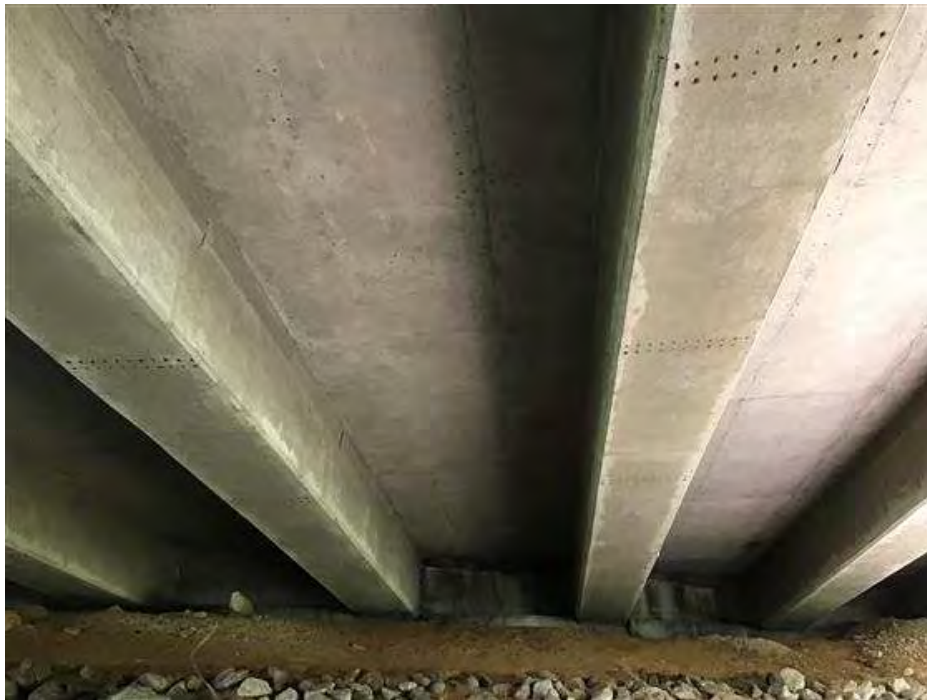
PHOTO 12 Condition  
Description Span C facing north.

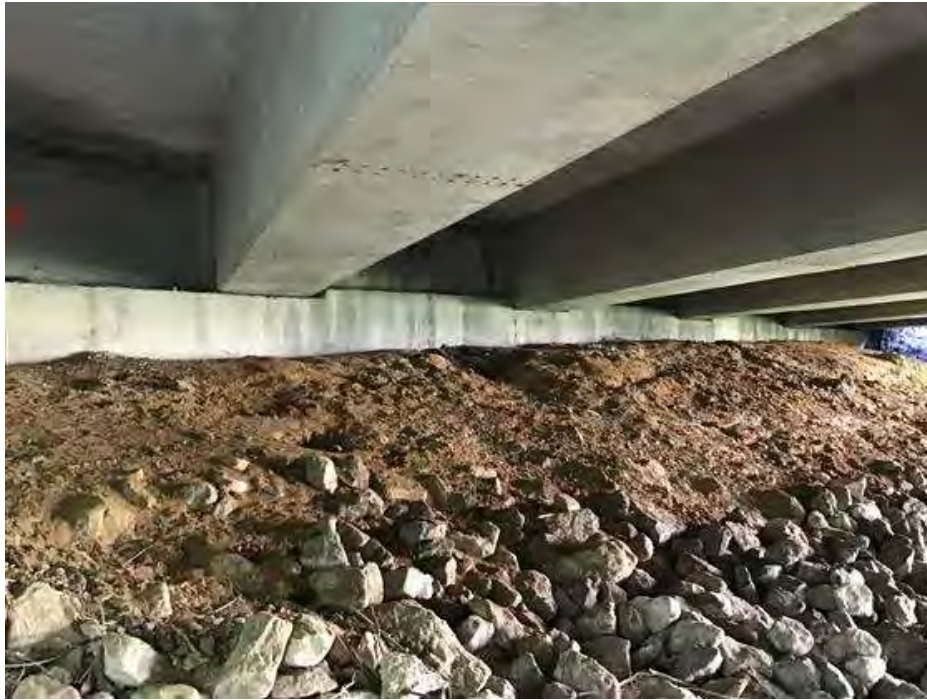
PHOTO 13 Condition  
Description South abutment.

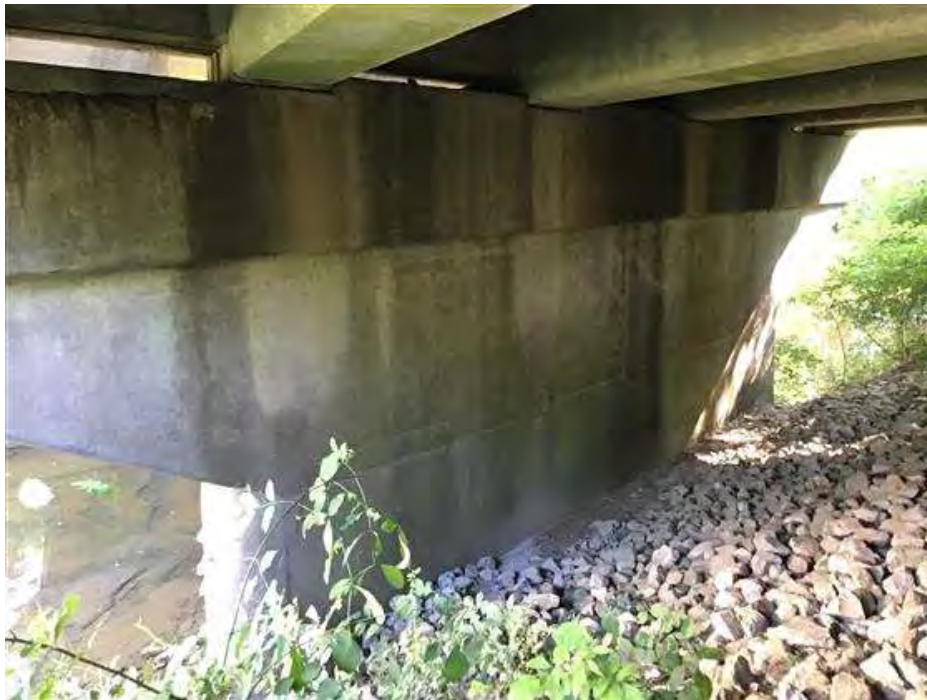
PHOTO 14 Condition  
Description Pier 2 south side.

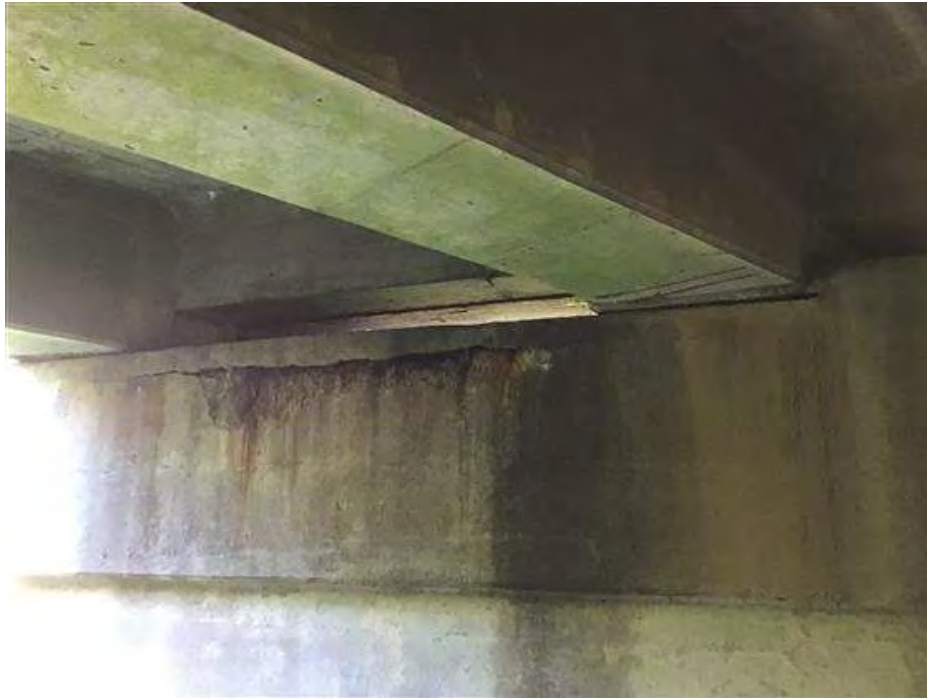
PHOTO 15 Condition  
Description Pier 2 south side, west nose.

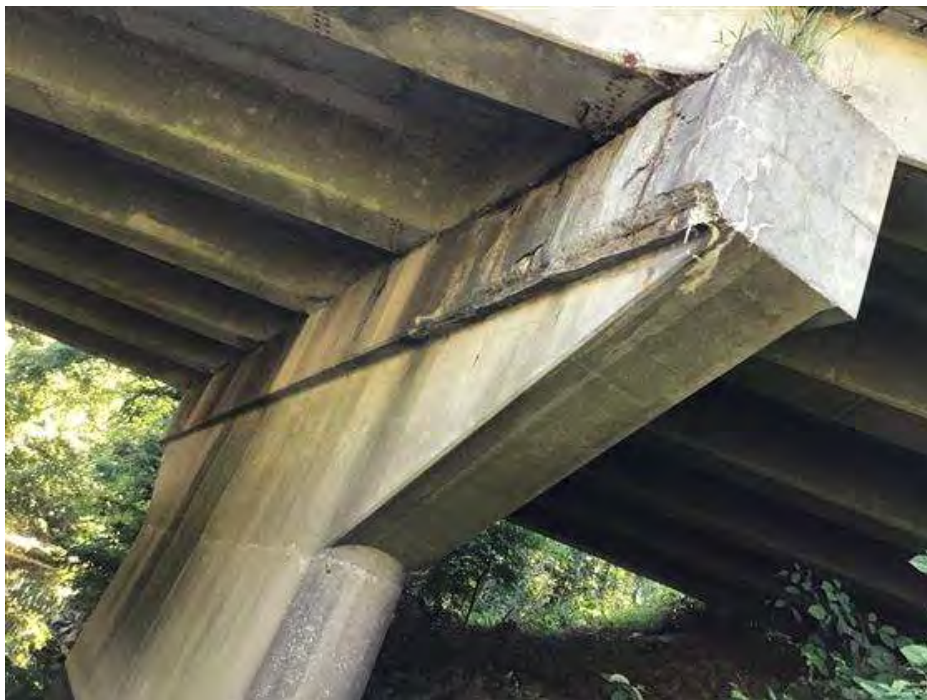
PHOTO 16 Condition  
Description Pier 2 north side, west nose.

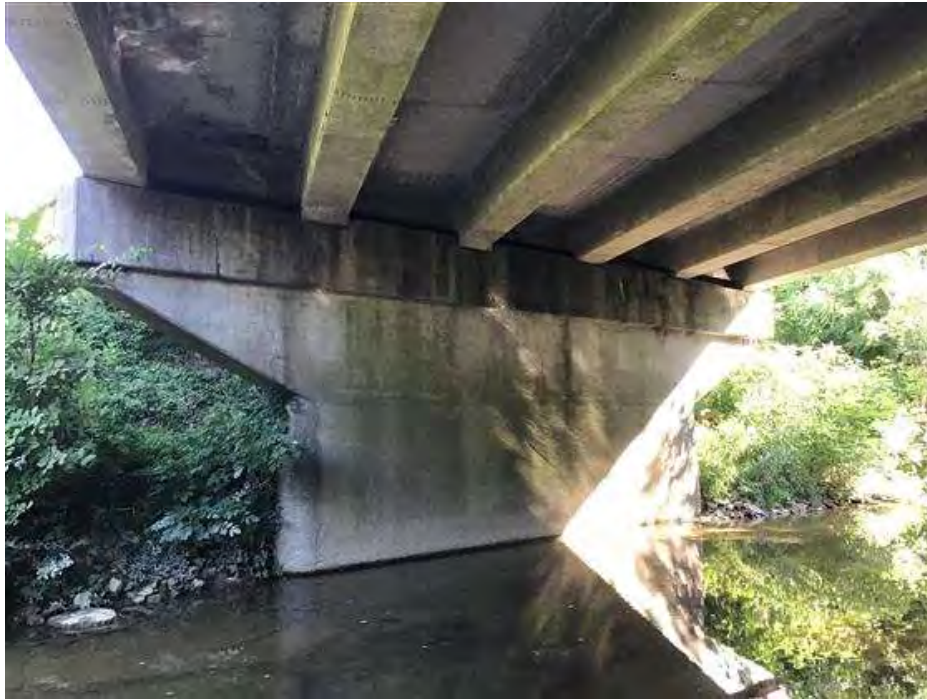
PHOTO 17 Condition  
Description Pier 3 south side.

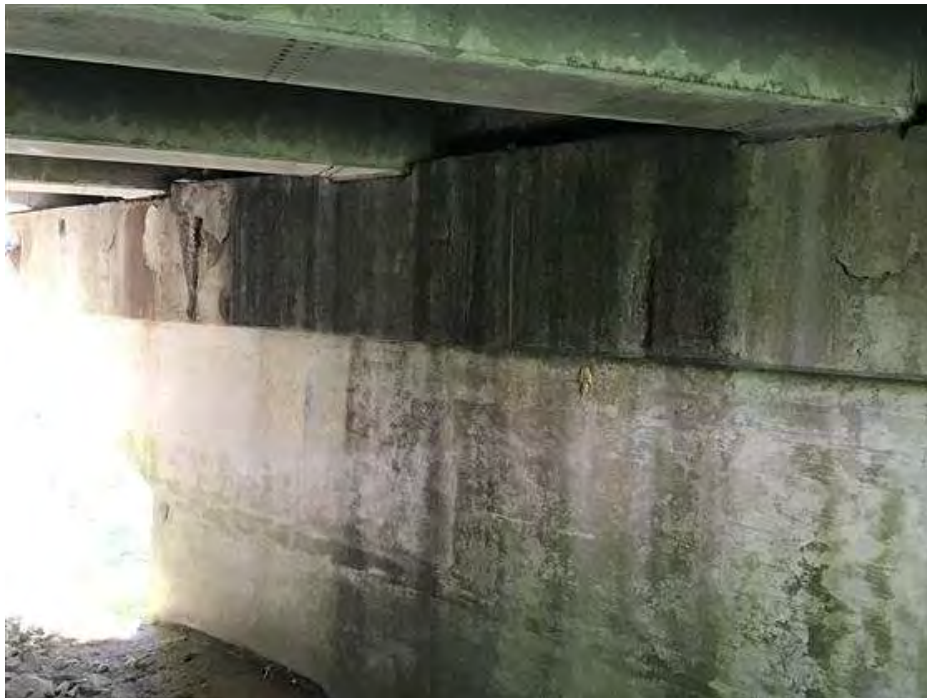
PHOTO 18 Condition  
Description Pier 3 north side.

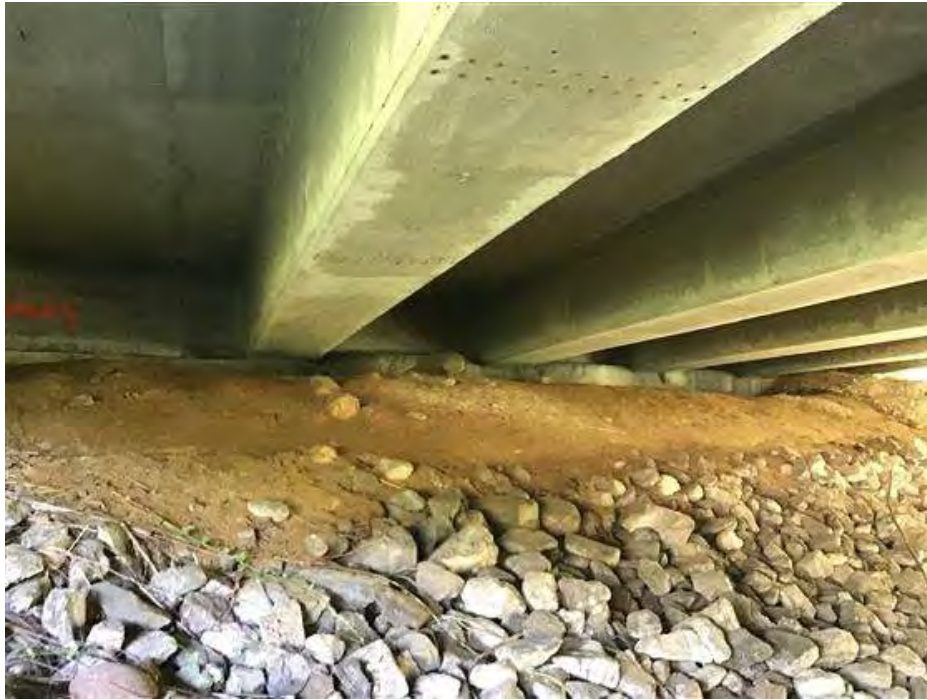
PHOTO 19 Condition  
Description North abutment.

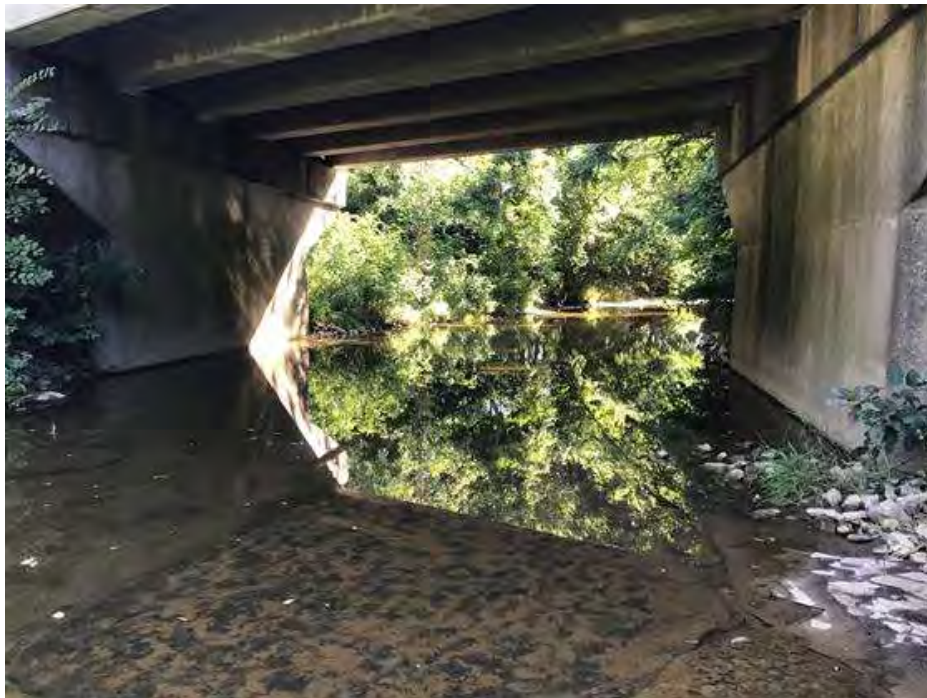
PHOTO 20 Condition  
Description Channel facing east.

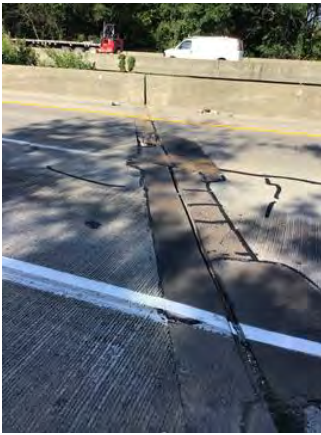
File Description Joint 2 facing west.  
File Type Category Condition, Maintenance - Bridge, Other

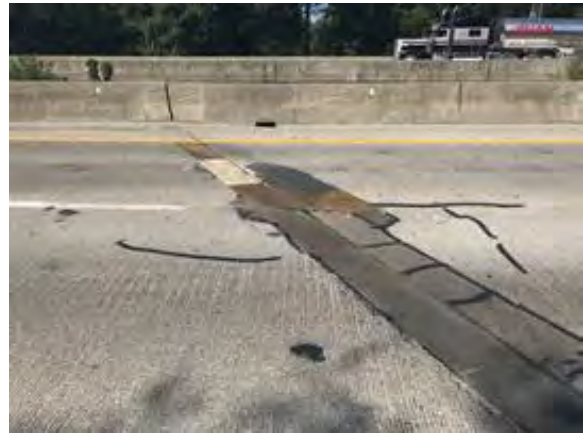
File Description Joint 2 over Pier 2. CF close out.  
File Type Category Condition

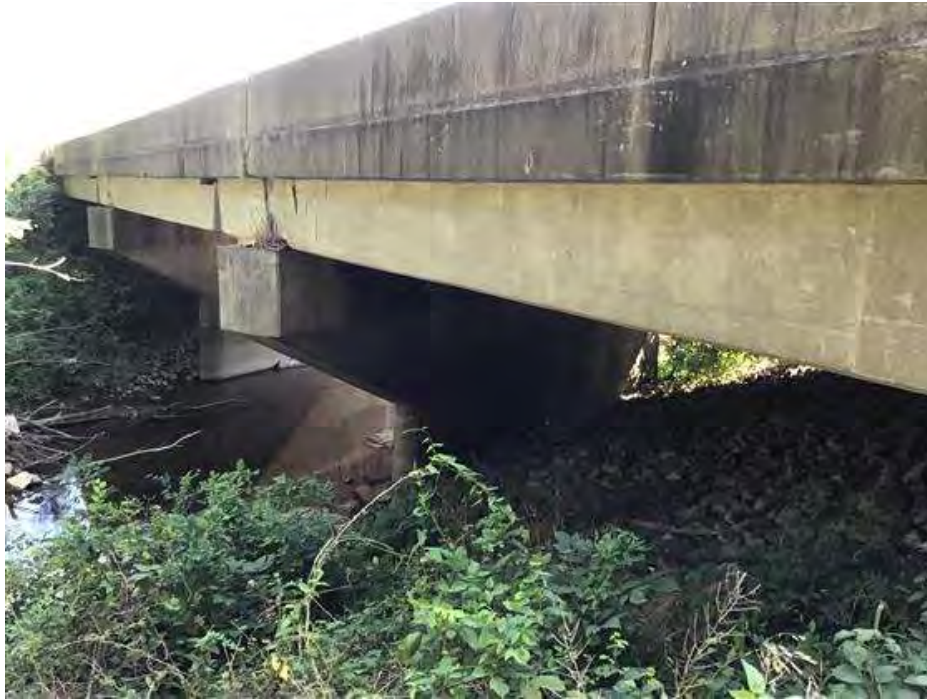
PHOTO 1 Elevation, Condition  
Description West side.

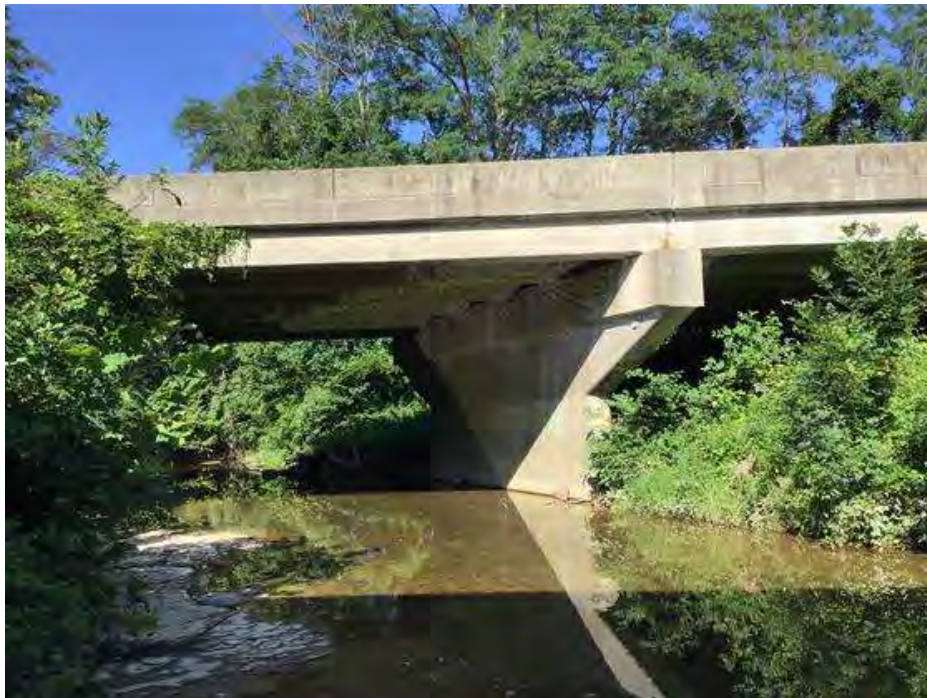
PHOTO 2 Elevation, Condition  
Description East side.

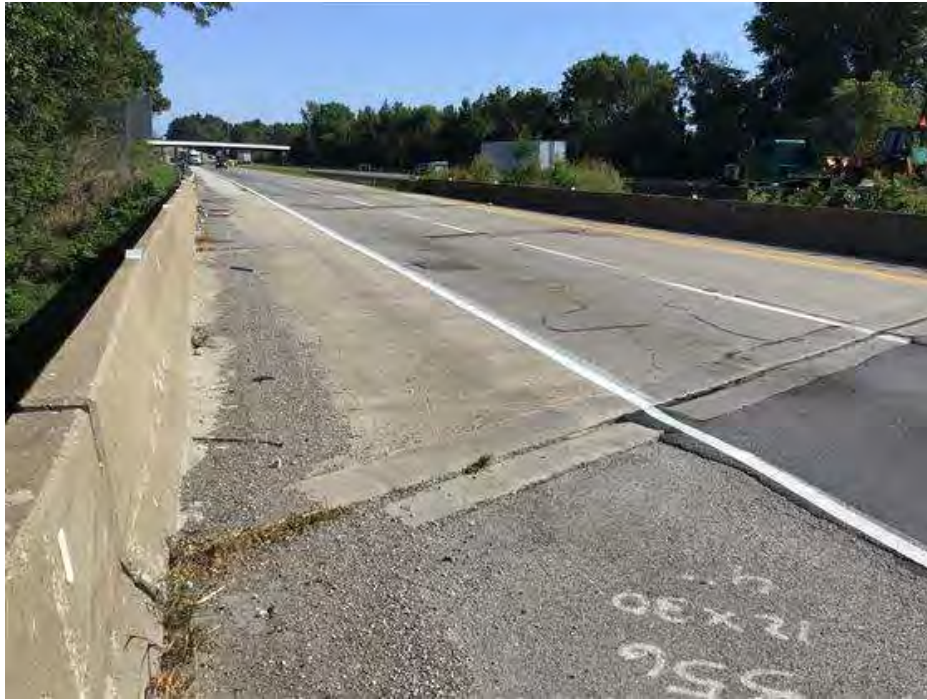
PHOTO 3 Condition  
Description Roadway north.

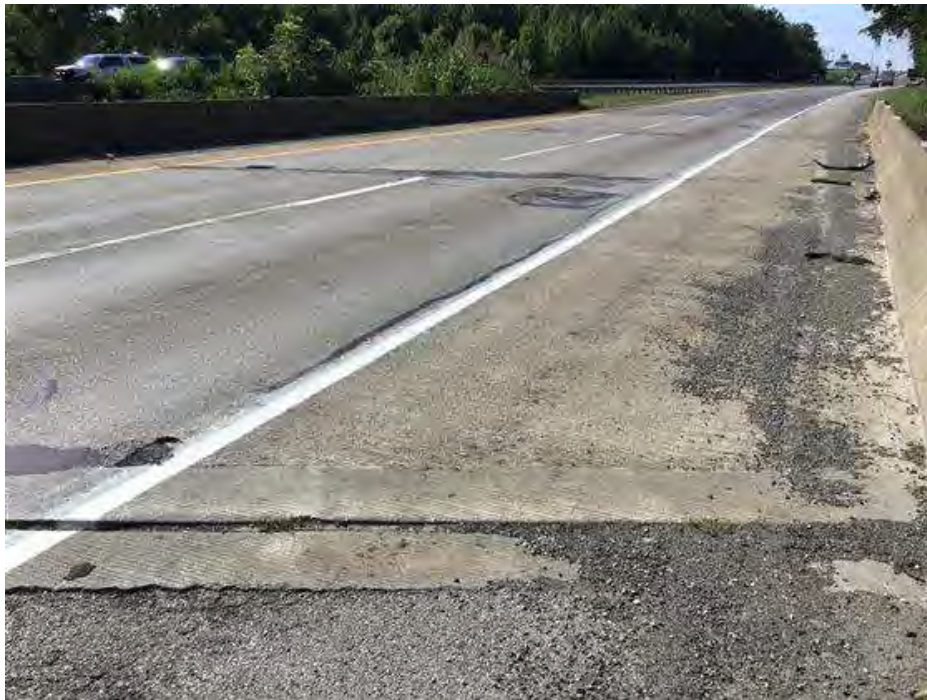
PHOTO 4 Condition  
Description Roadway south.

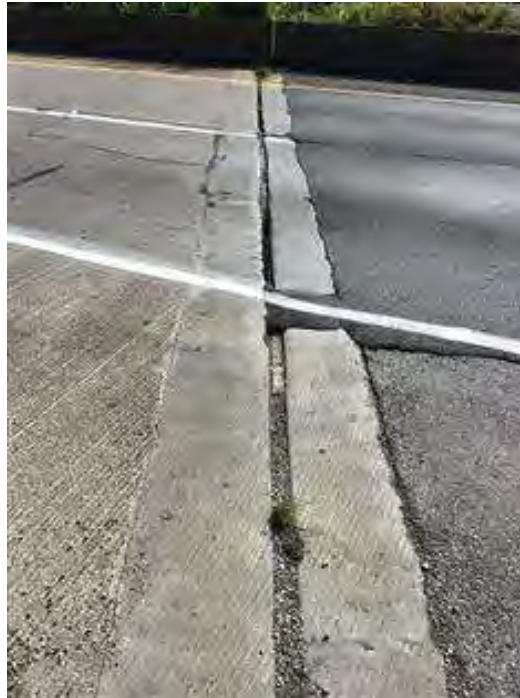
PHOTO 5 Condition  
Description South joint.

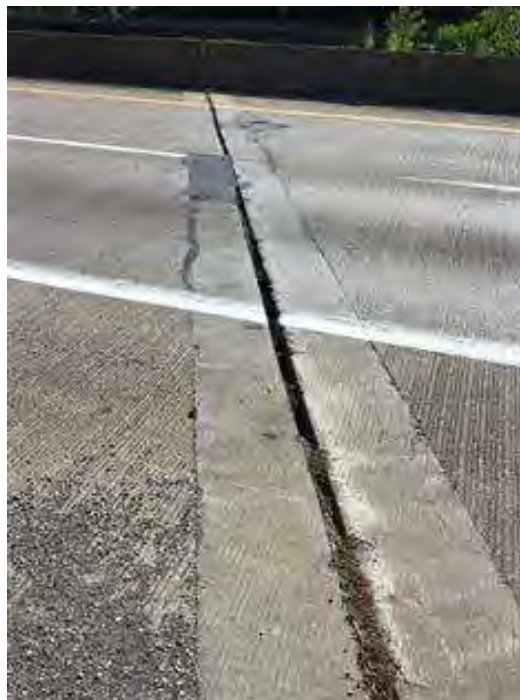
PHOTO 6 Condition  
Description Joint 2 facing east.

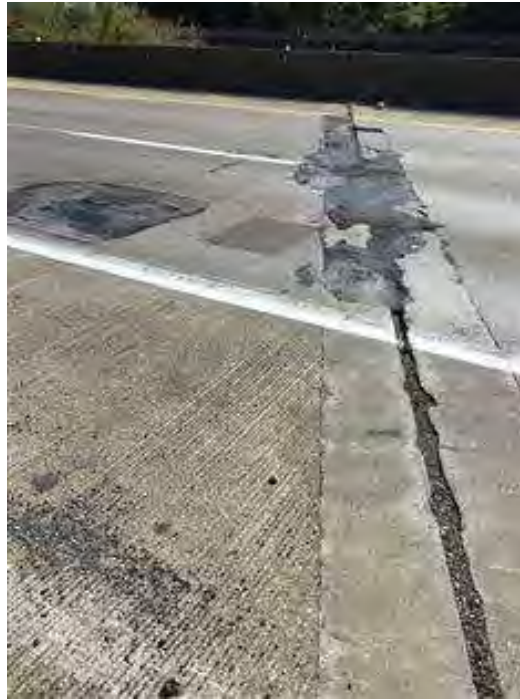
PHOTO 7 Condition  
Description Joint 3 facing east.

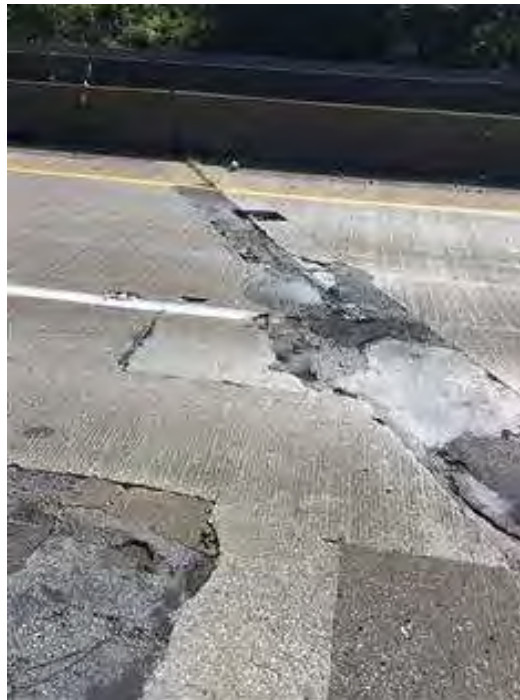
PHOTO 8 Condition, Other, Maintenance - Bridge  
Description Joint 3 facing east.

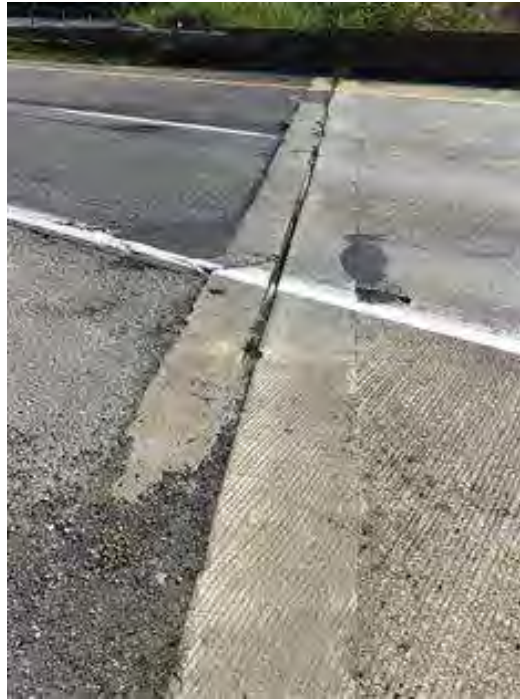
PHOTO 9    Condition  
Description    North joint.

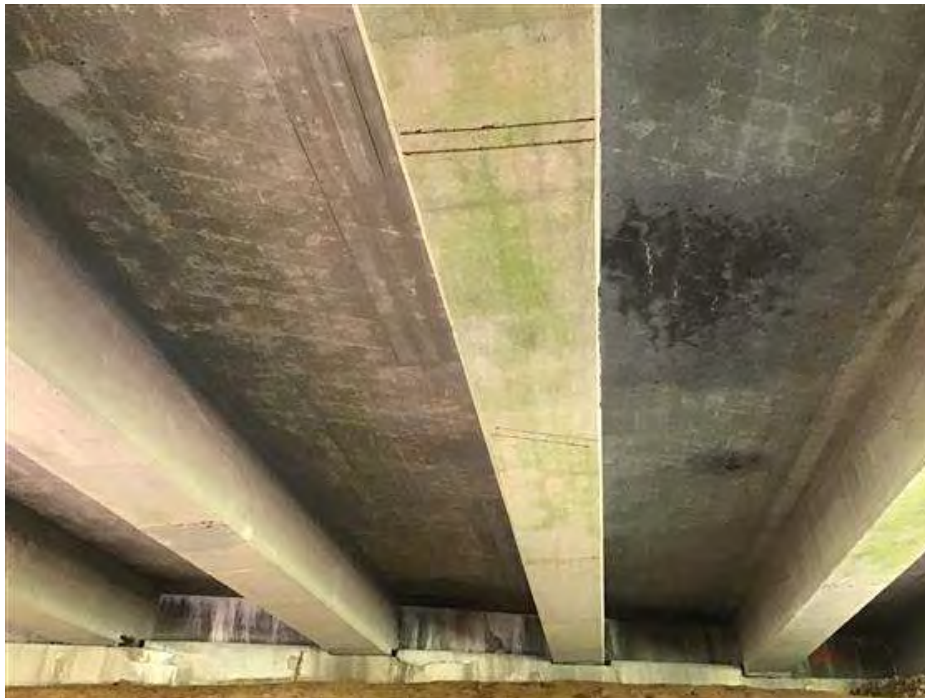
PHOTO 10    Condition  
Description    Span A facing south.

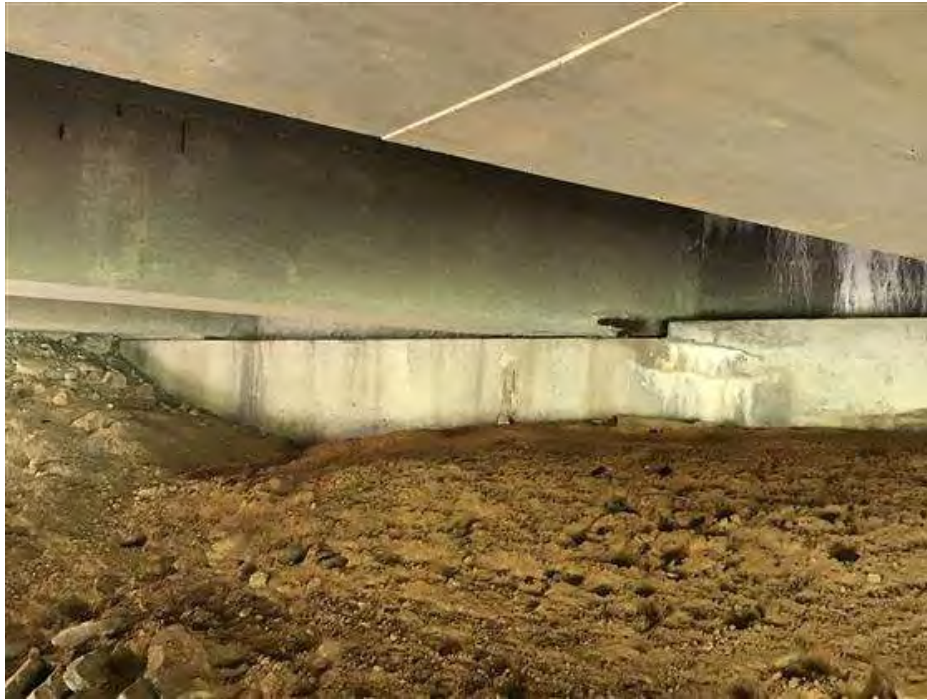
PHOTO 11 Condition  
Description Beam 5 in Span A at south abutment.

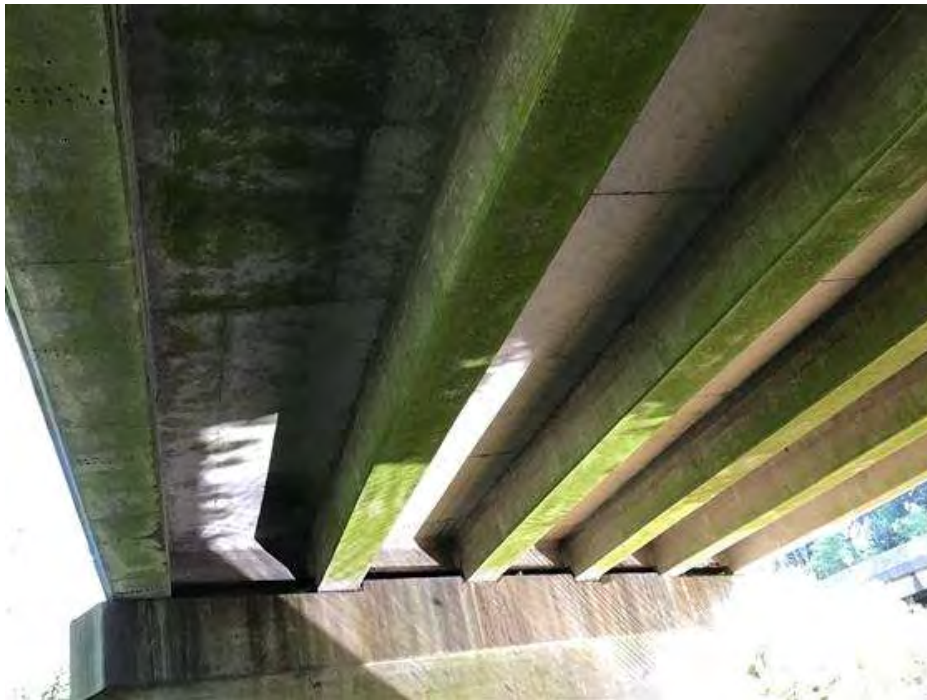
PHOTO 12 Condition  
Description Span B facing north.

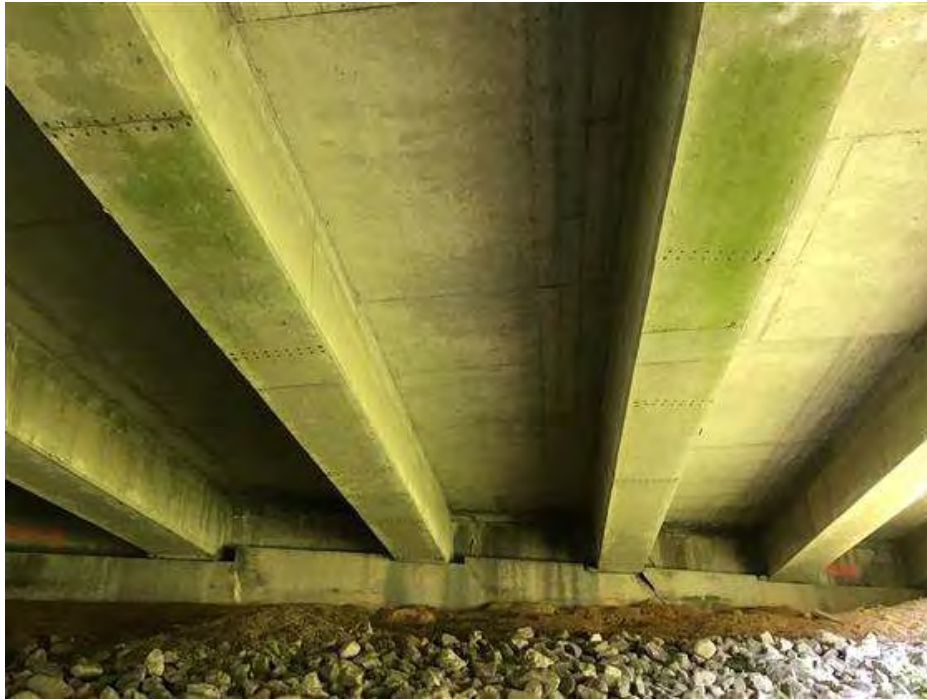
PHOTO 13 Condition  
Description Span C facing north.

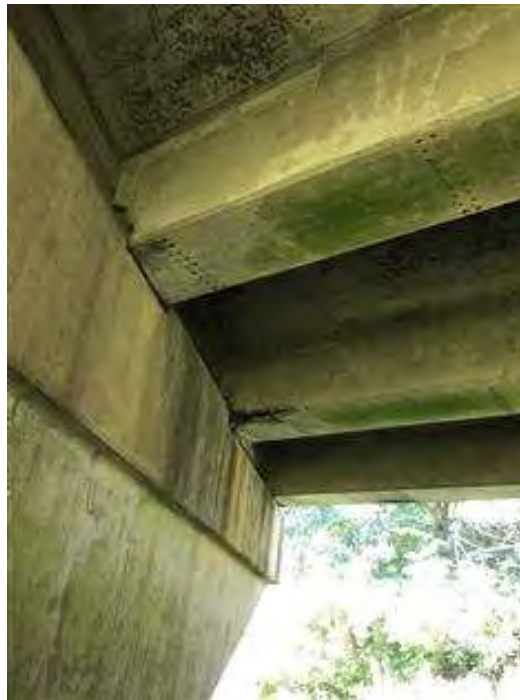
PHOTO 14 Condition, Other  
Description Beam 2 in Span C at Pier 3.

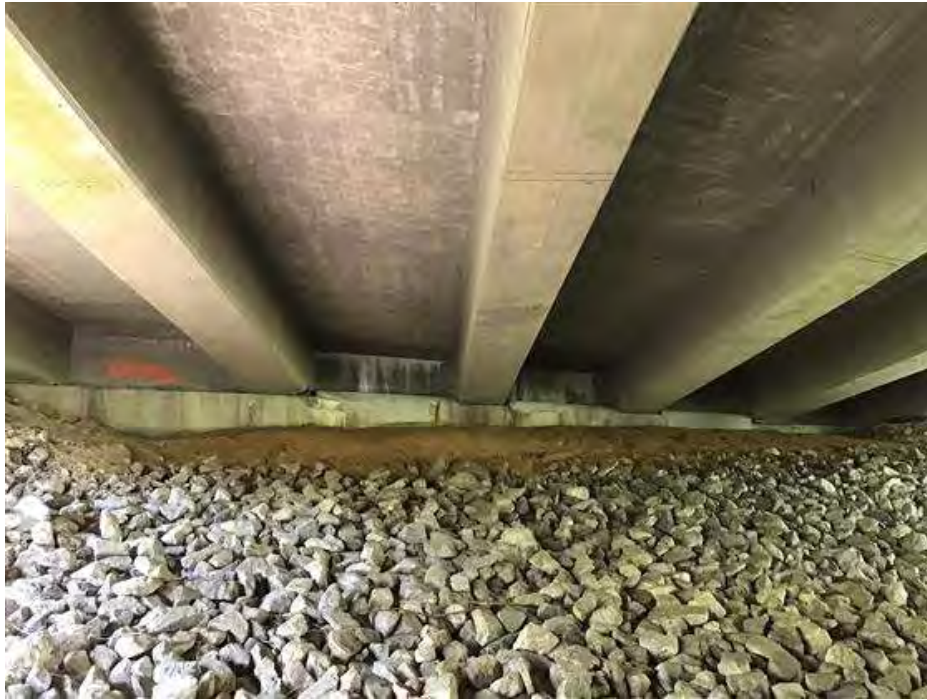
PHOTO 15 Condition  
Description South abutment.

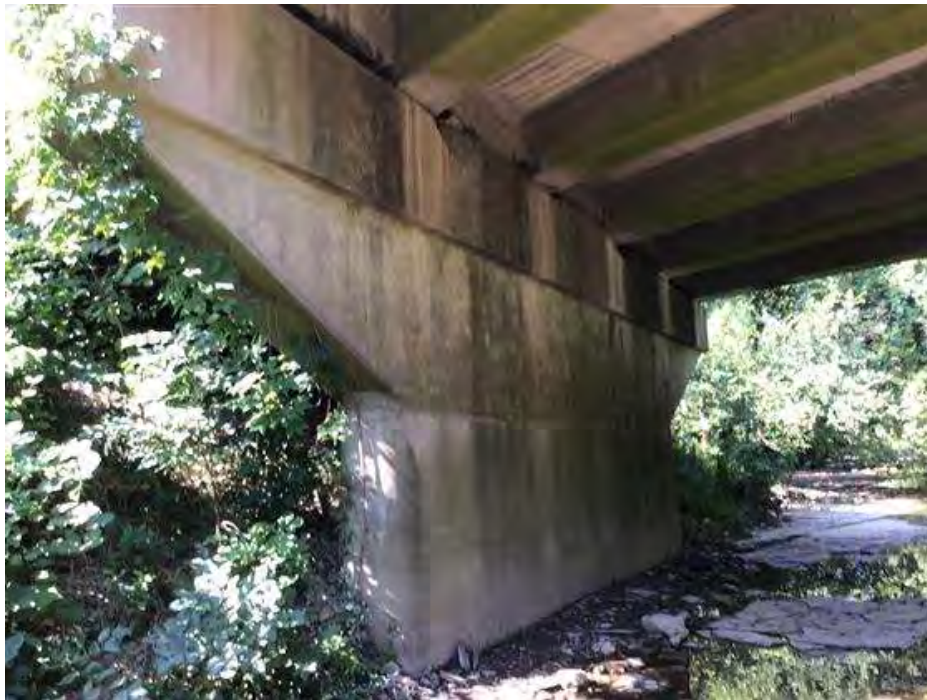
PHOTO 16 Condition  
Description Pier 2 north side.

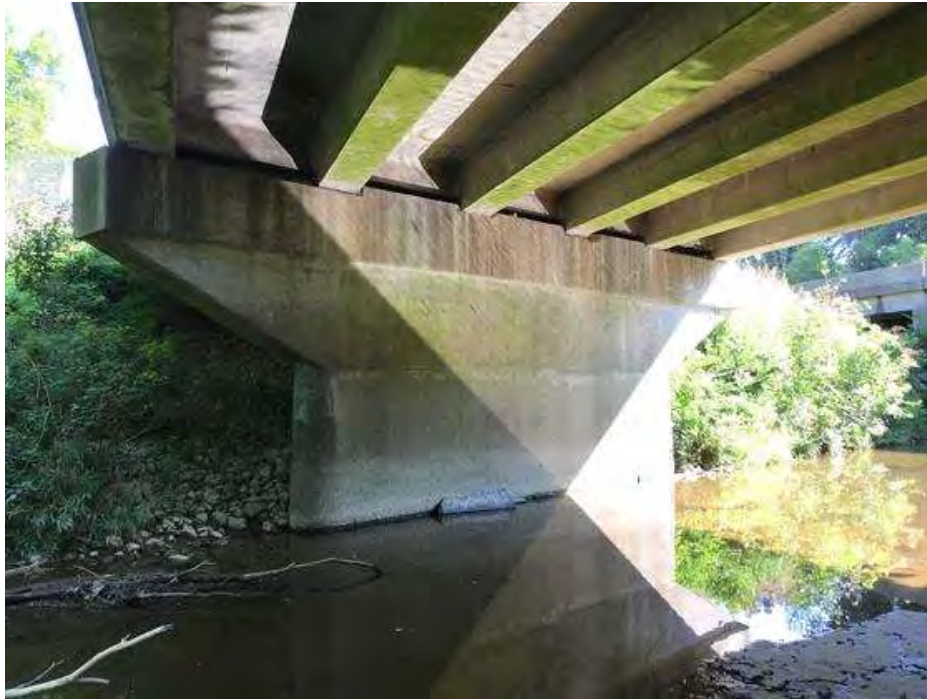
PHOTO 17 Condition  
Description Pier 3 south side.

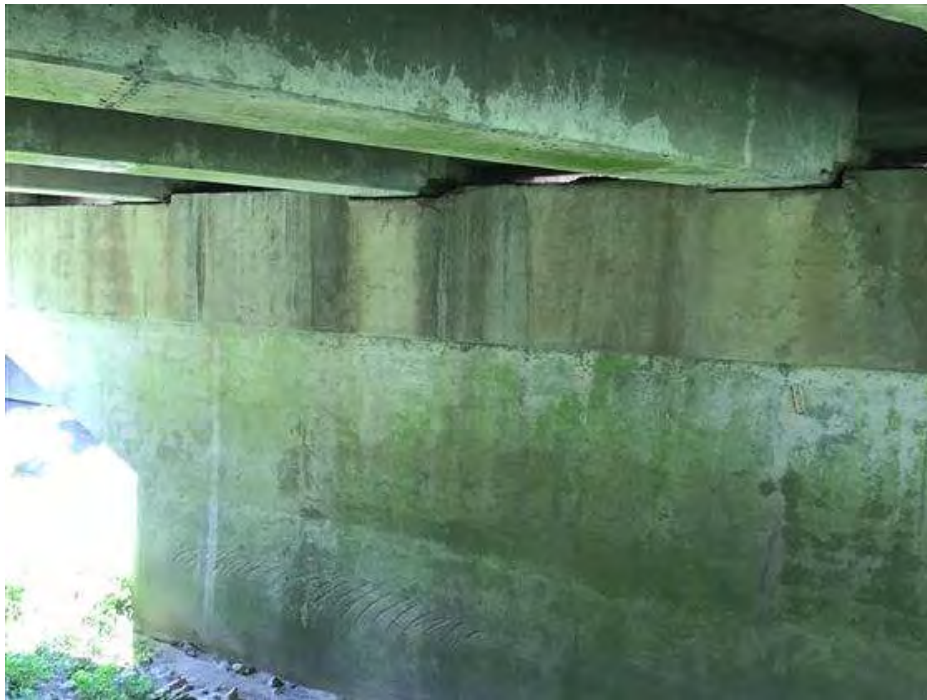
PHOTO 18 Condition  
Description Pier 3 north side.
