## Appendix F – Traffic Data

## TRAFFIC DATA

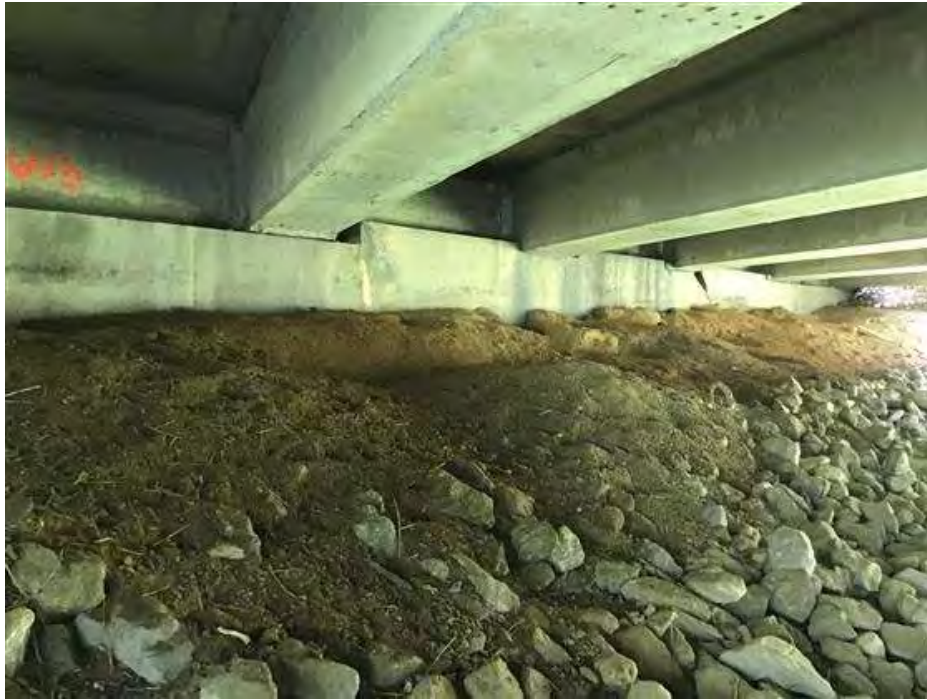
PHOTO 19 Condition  
Description North abutment.

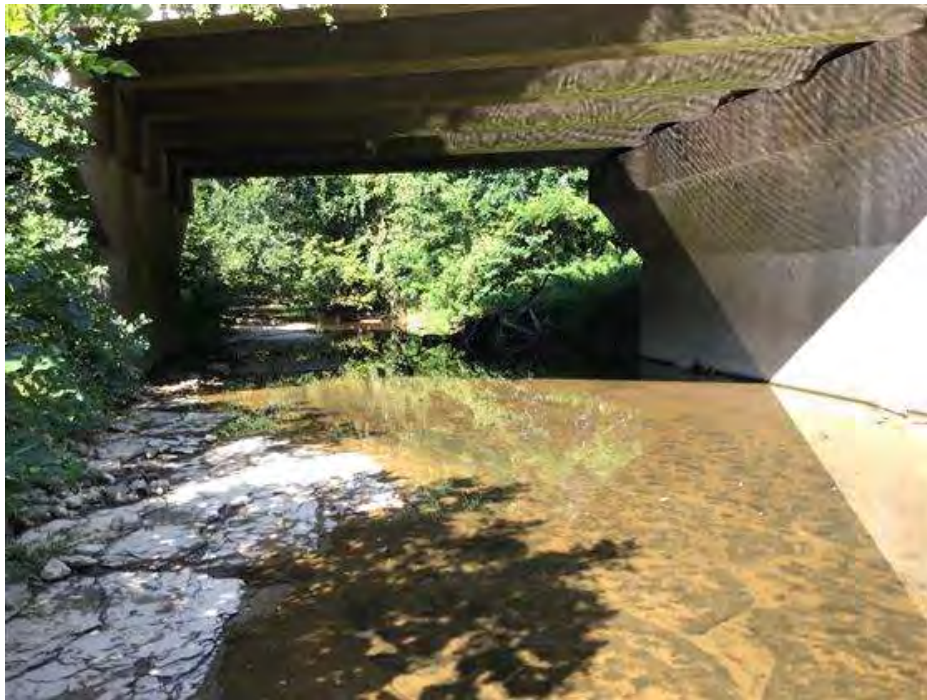
PHOTO 20 Condition  
Description Channel facing west.

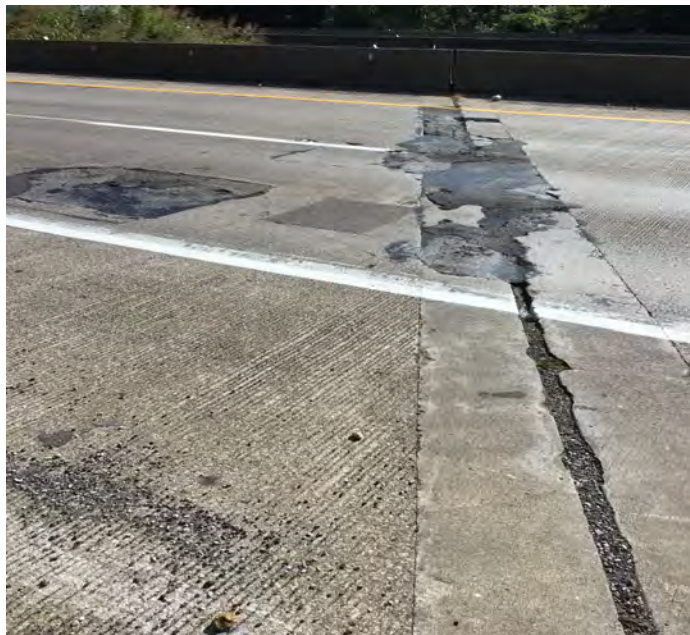
PHOTO 1 Description Joint 3 facing east.

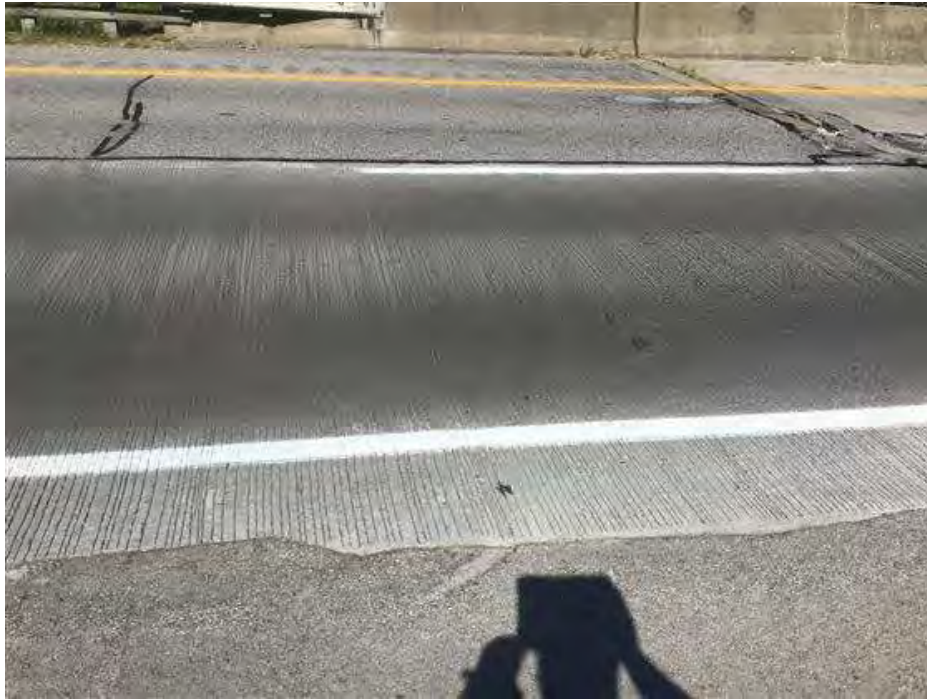
PHOTO 1 Condition  
Description South Approach facing West

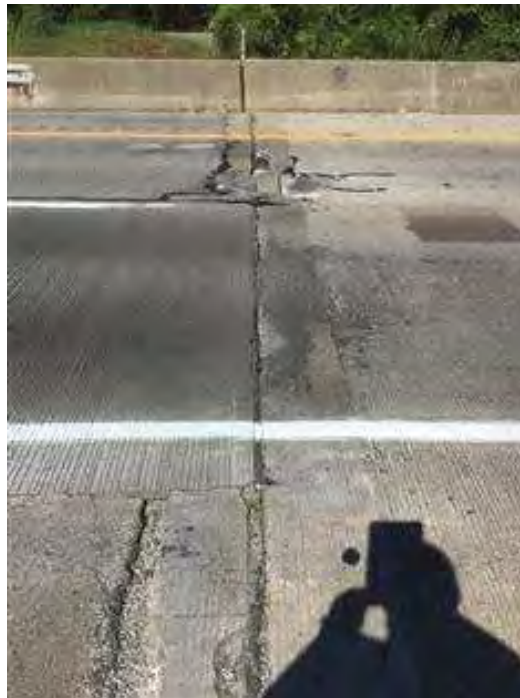
PHOTO 2 Condition, Maintenance - Bridge  
Description South Joint facing West  
2' X 2' and 3' X 1' Spall

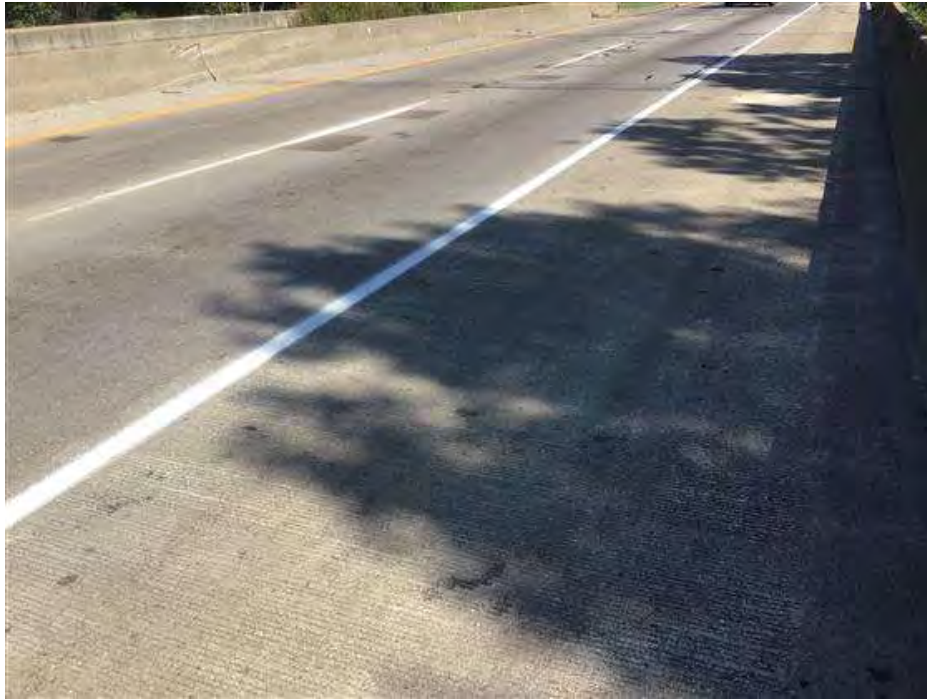
PHOTO 3 Condition  
Description Deck facing North

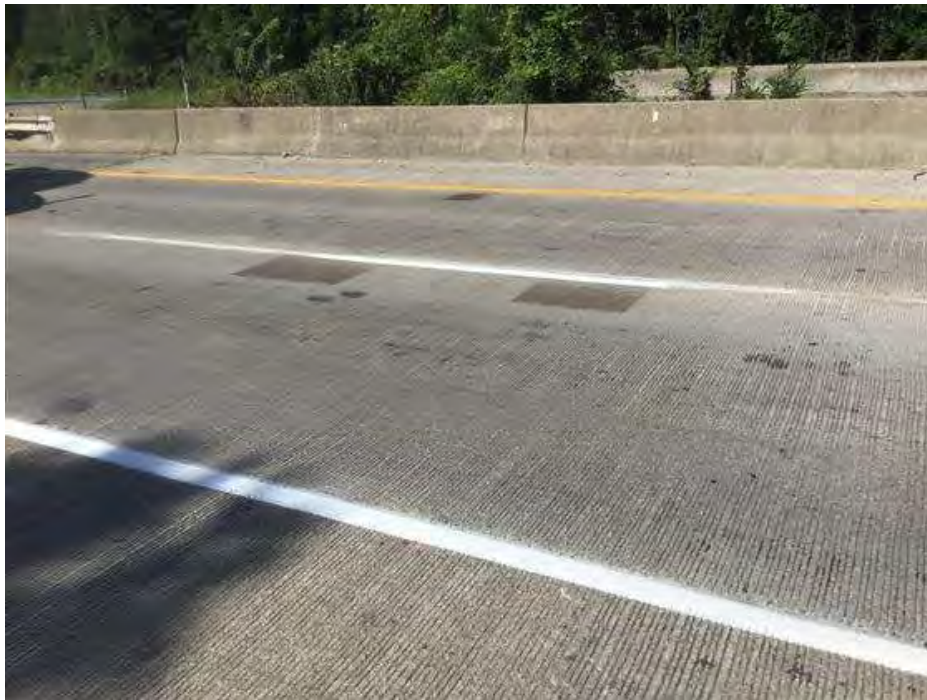
PHOTO 4 Condition  
Description Patches over Span A

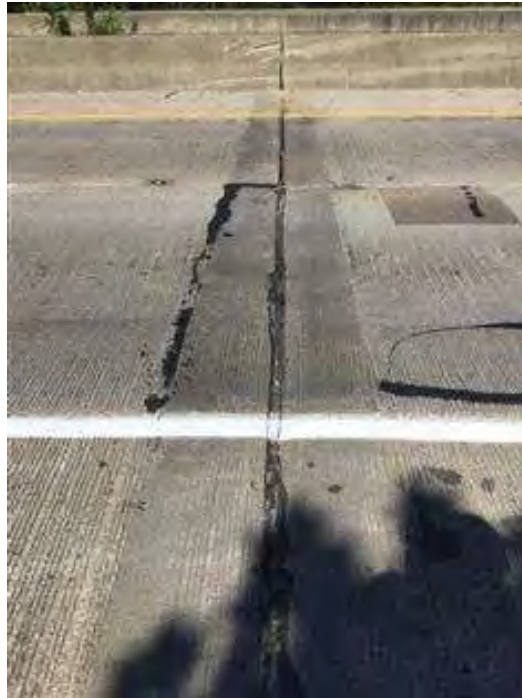
PHOTO 5 Condition  
Description Joint over Pier #2 facing West

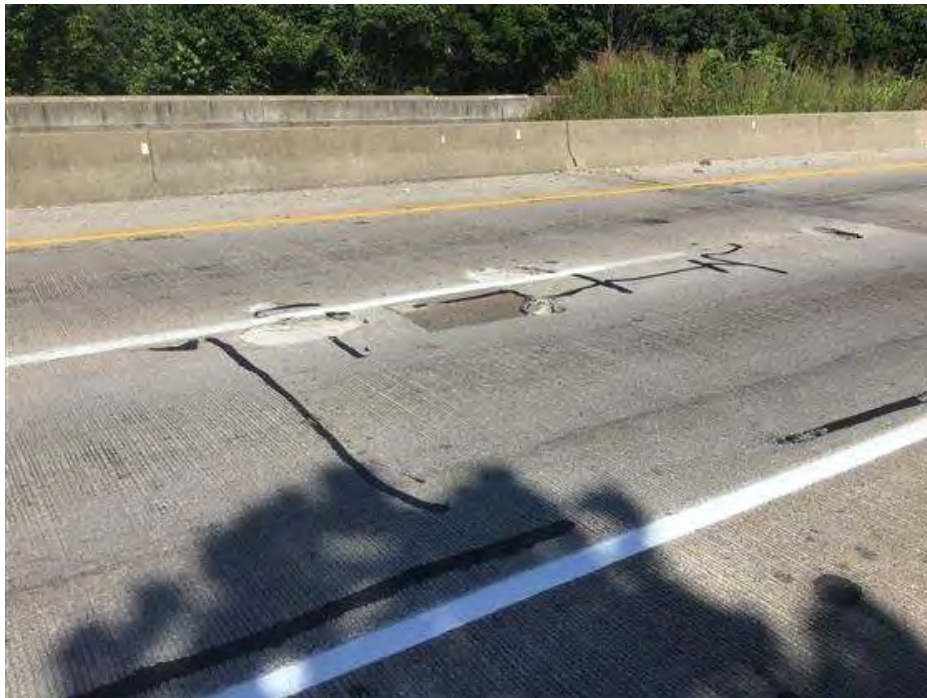
PHOTO 6 Condition, Maintenance - Bridge  
Description 4 Spalls (two 2' X 2' and two 1' X 1') over Span B

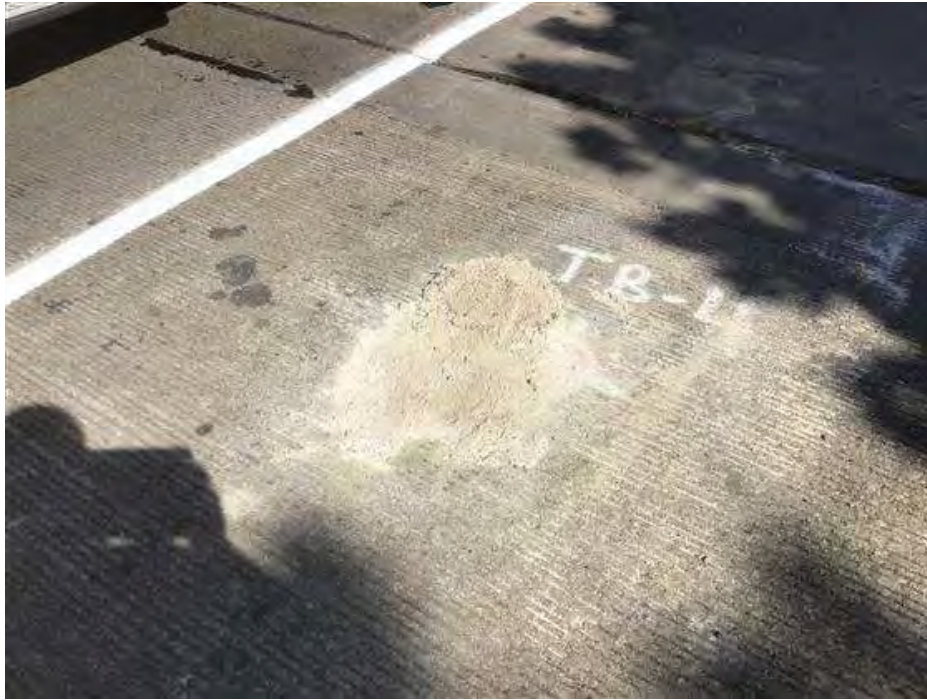
PHOTO 7 Condition  
Description Excess Concrete on the East Shoulder near Joint #2

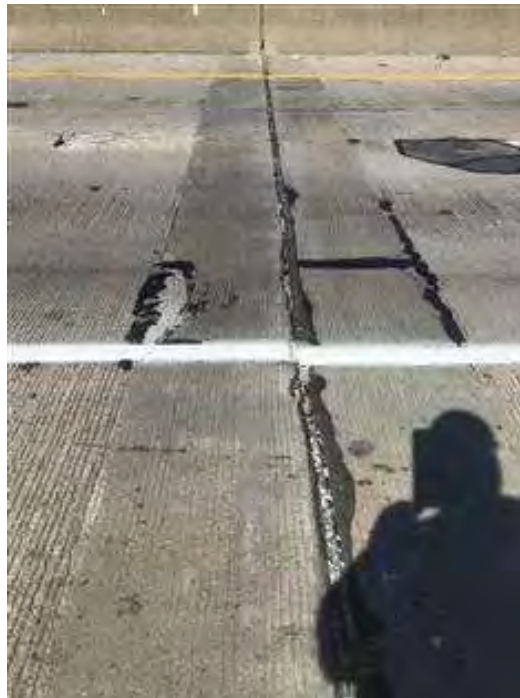
PHOTO 8 Condition  
Description Joint over Pier #3 facing West

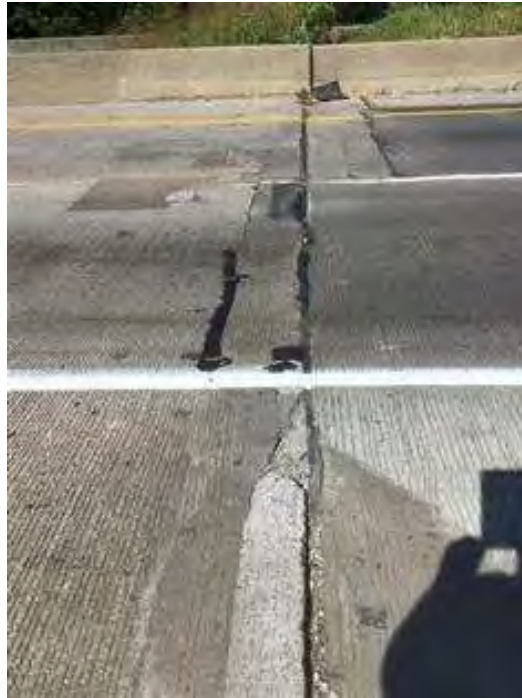
PHOTO 9 Condition  
Description North Joint facing West

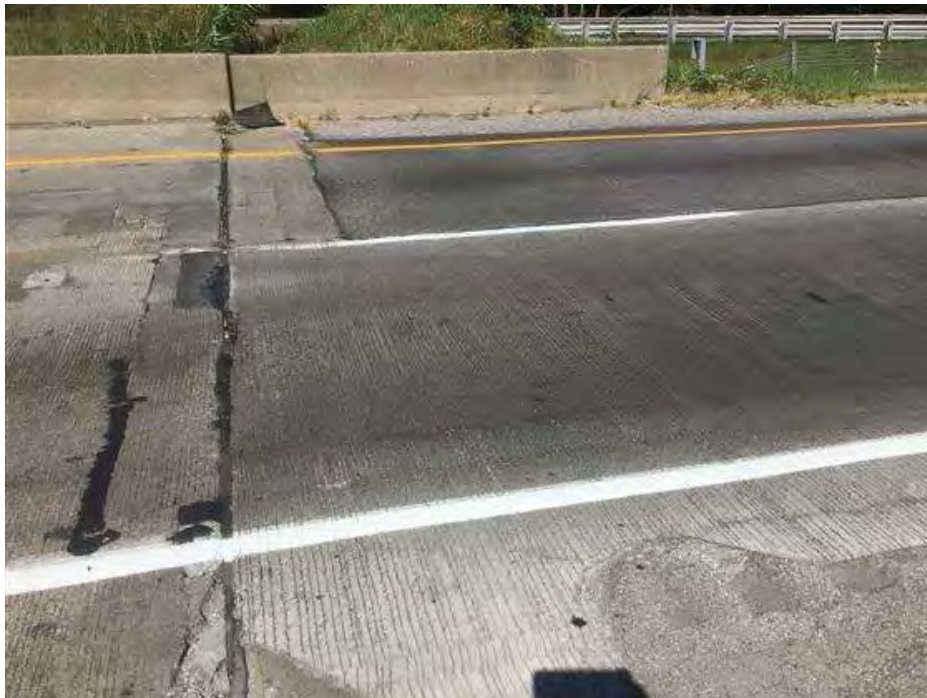
PHOTO 10 Condition  
Description North Approach facing West

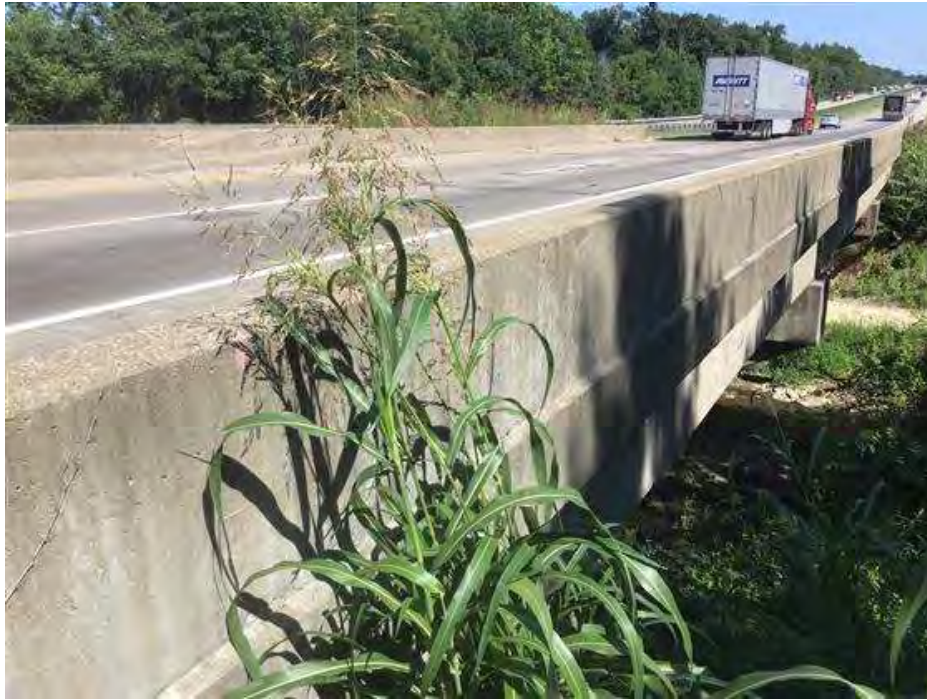
PHOTO 11 Elevation, Condition  
Description Side facing Northwest

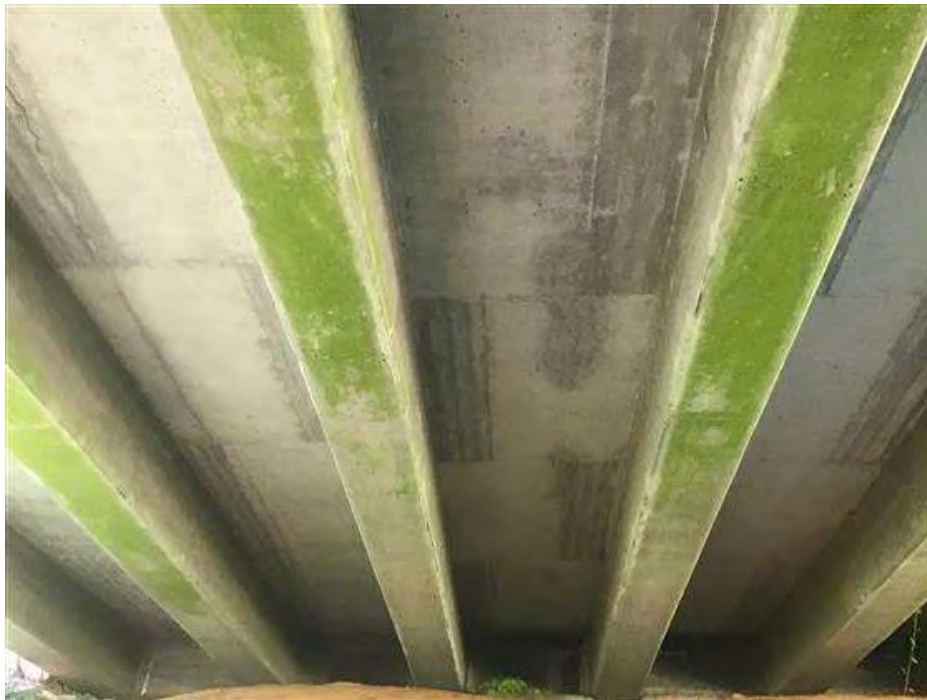
PHOTO 12 Condition  
Description Underside Span A and Abutment #1 facing South

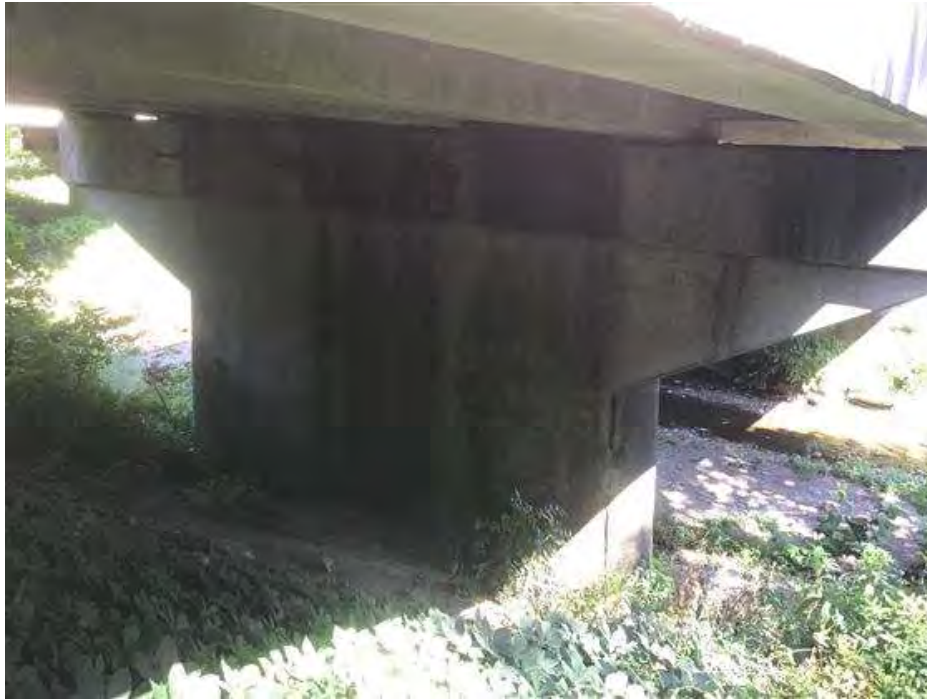
PHOTO 13 Condition  
Description Pier #2 facing North

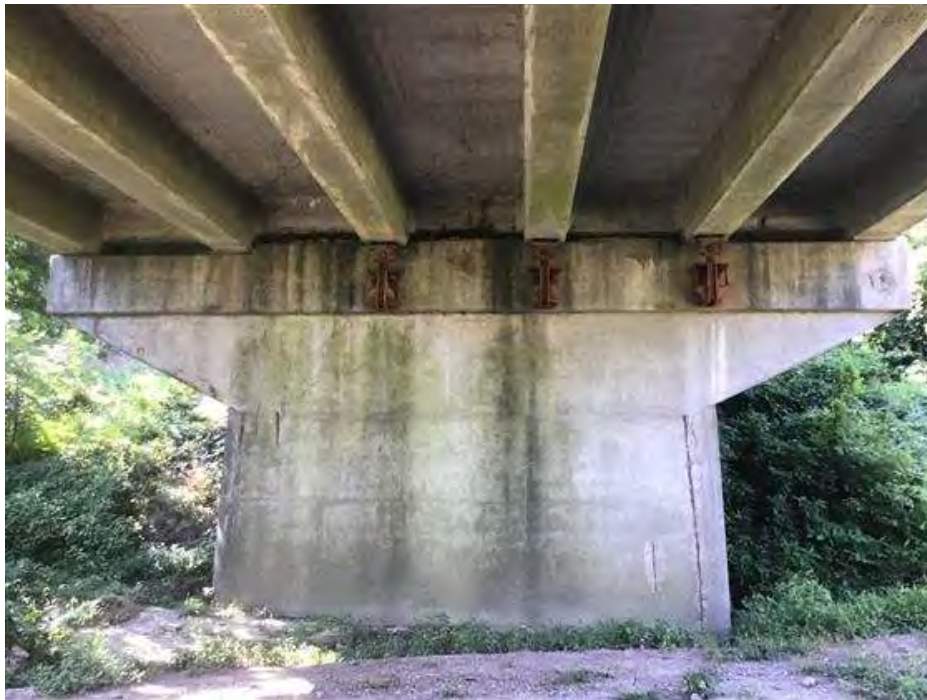
PHOTO 14 Condition  
Description Pier #2 facing South

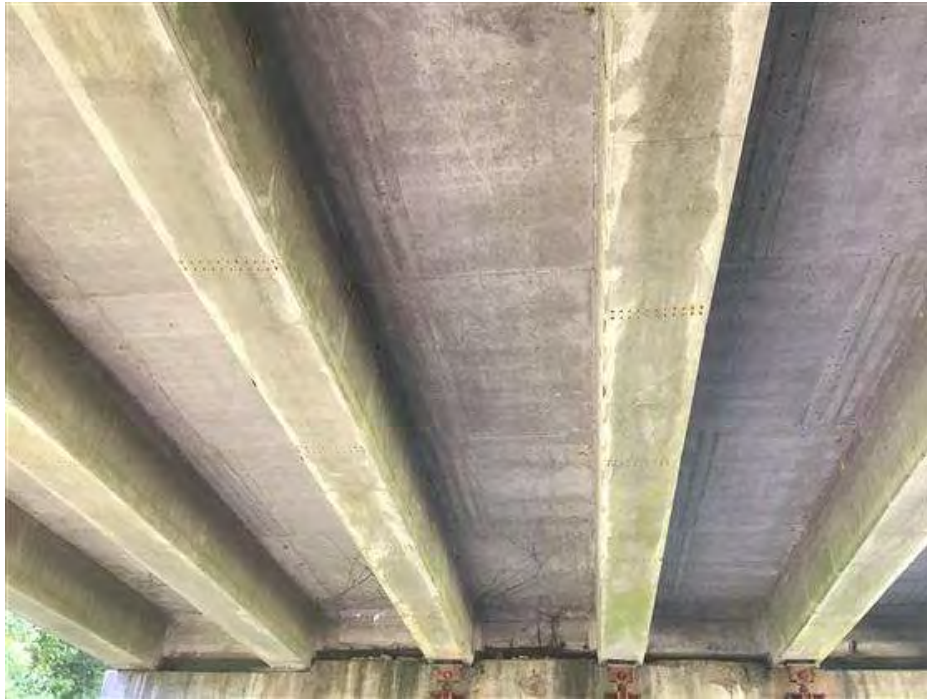
PHOTO 15 Condition  
Description Underside Span B facing South

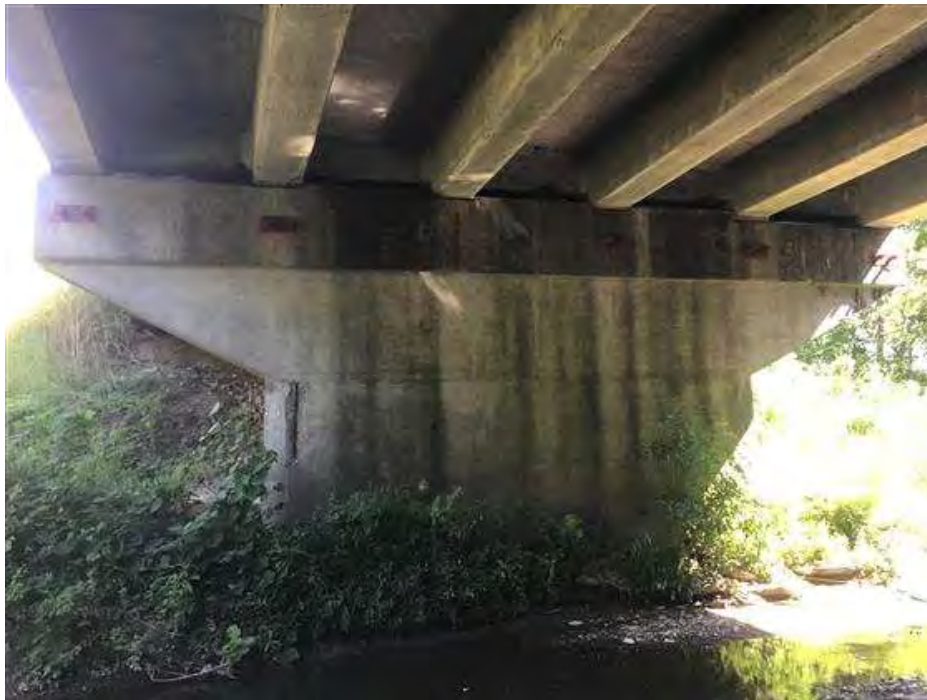
PHOTO 16 Condition  
Description Pier #3 facing North

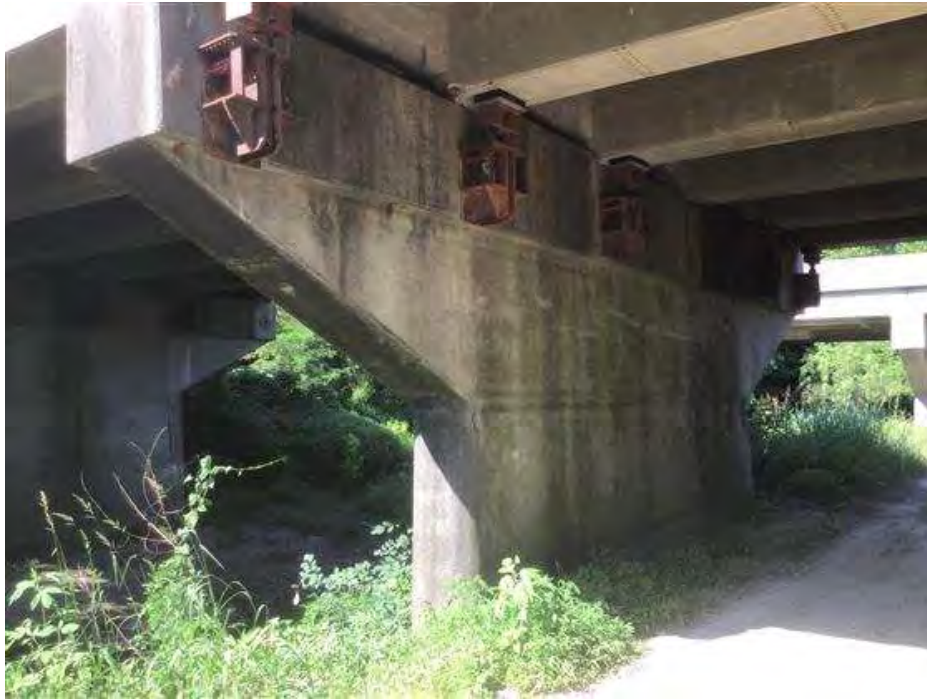
PHOTO 17 Condition  
Description Pier #3 facing Southwest

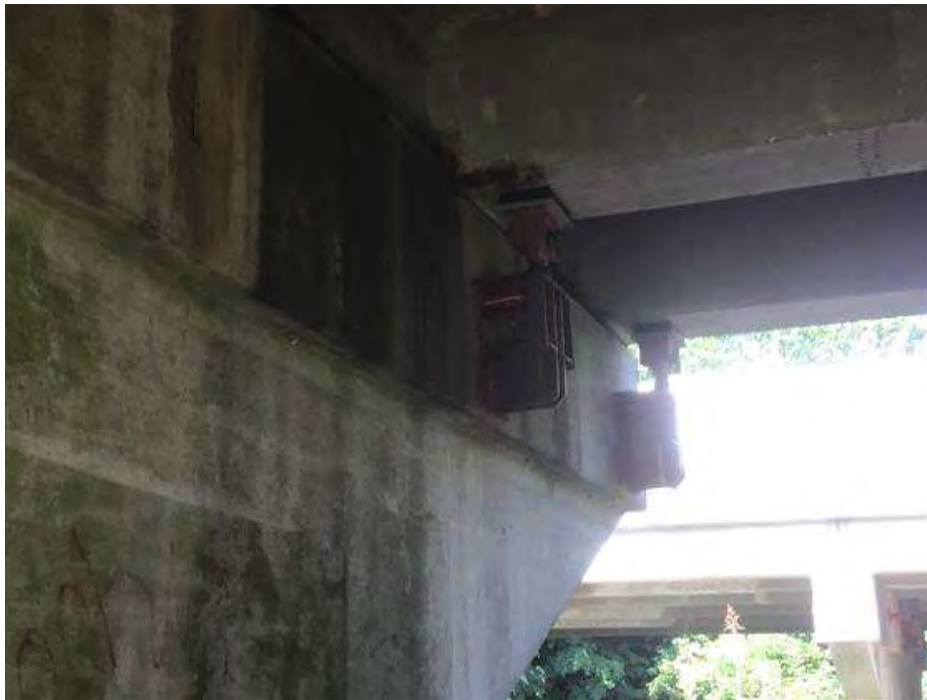
PHOTO 18 Condition  
Description Temporary Bearings on Pier #3

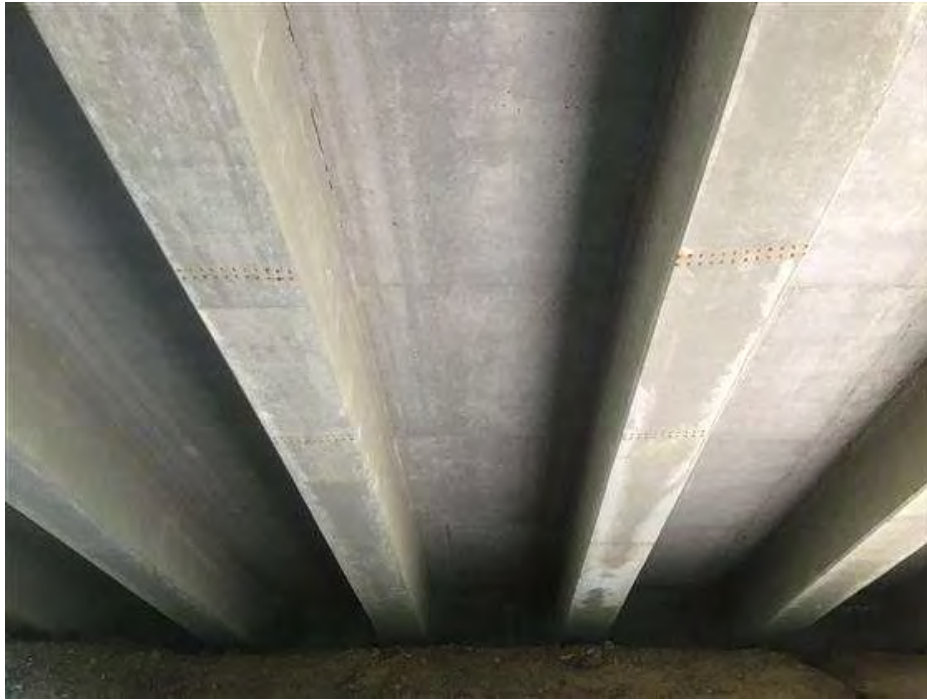
PHOTO 19 Condition  
Description Underside Span C facing North

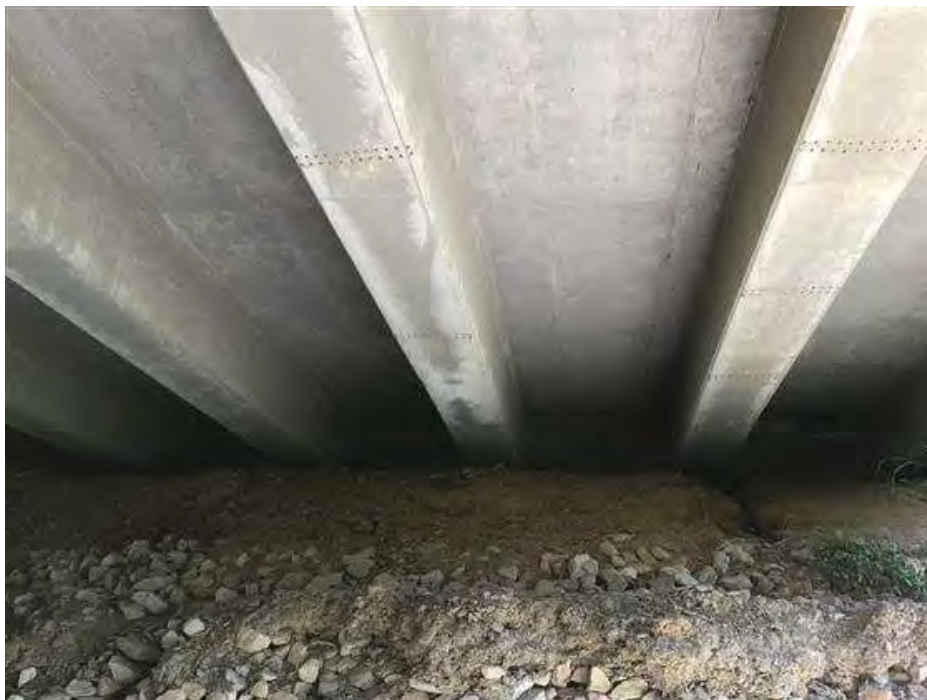
PHOTO 20 Condition  
Description Abutment #4 facing North

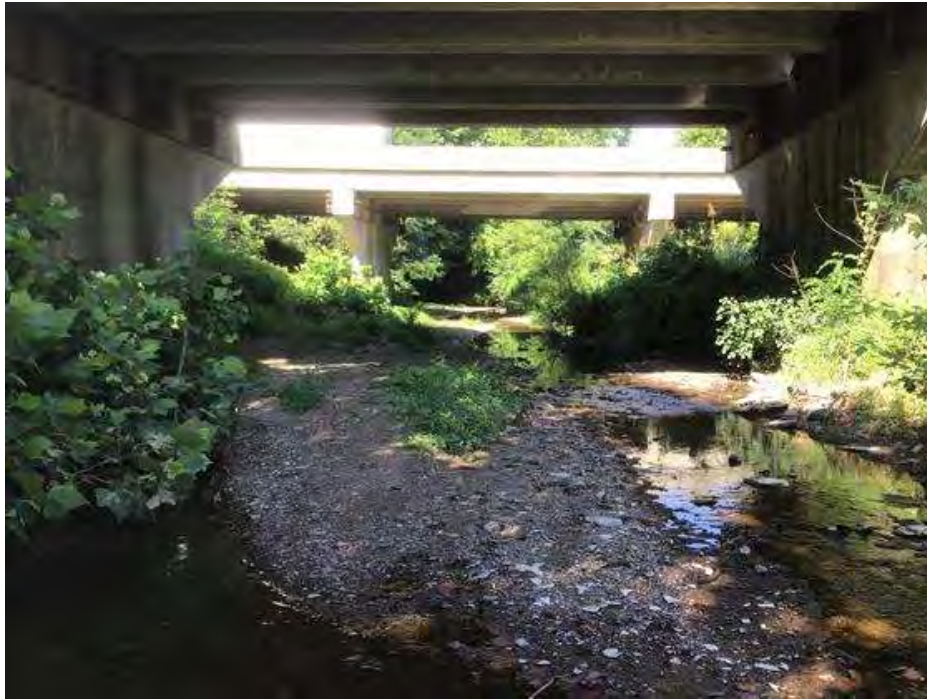
PHOTO 21 Condition  
Description Channel facing West

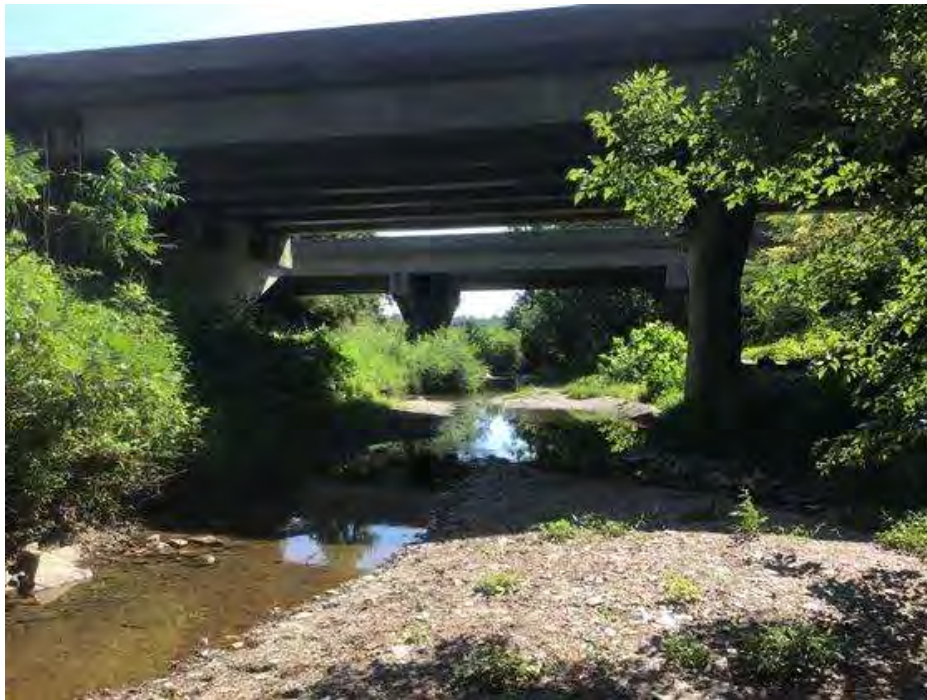
PHOTO 22 Condition  
Description Channel facing East

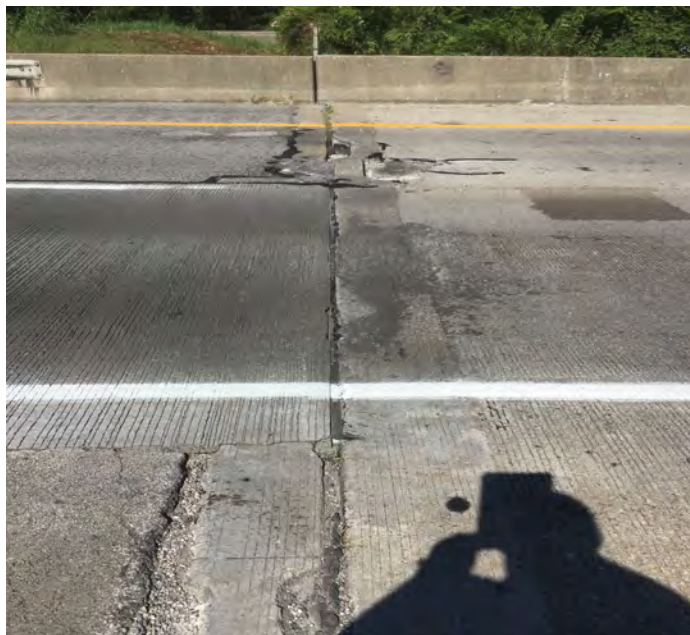
PHOTO 1 Description South Joint facing West  
2' X 2' and 3' X 1' Spall

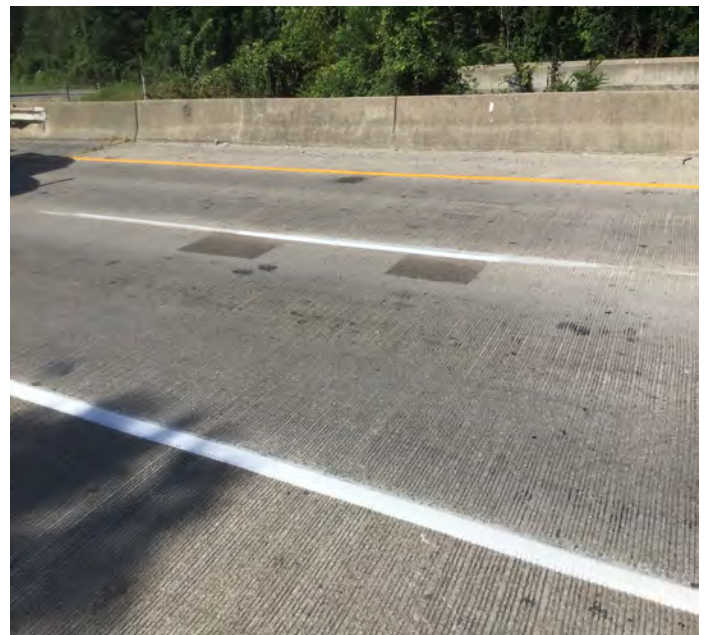
PHOTO 2 Description Patches over Span A

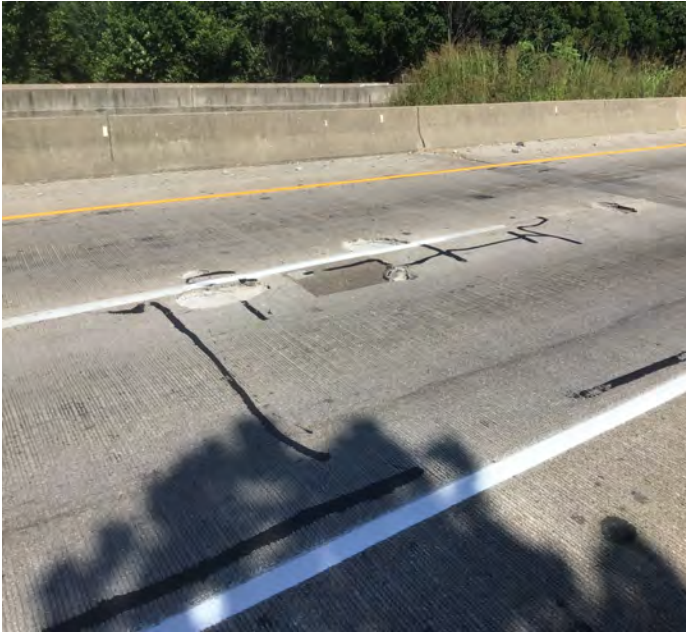
PHOTO 3 Description 4 Spalls (two 2' X 2' and two 1' X 1')  
over Span B

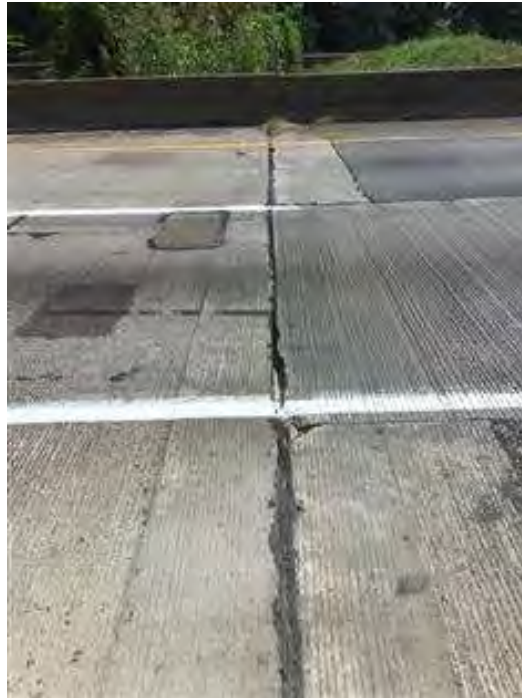
PHOTO 1 Condition  
Description South Joint facing East

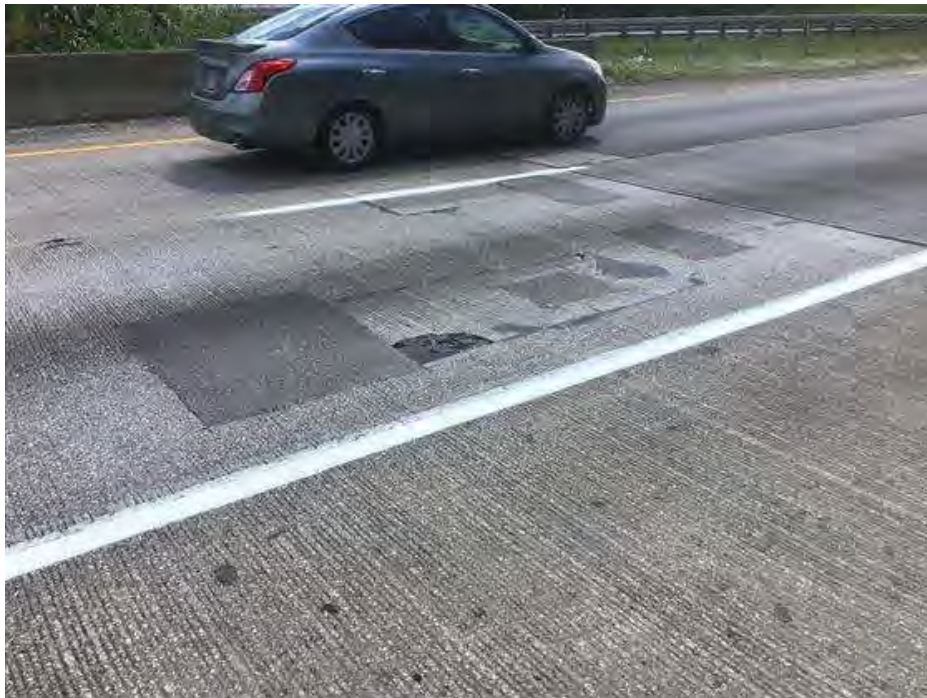
PHOTO 2 Condition  
Description Patches on South end of the Deck

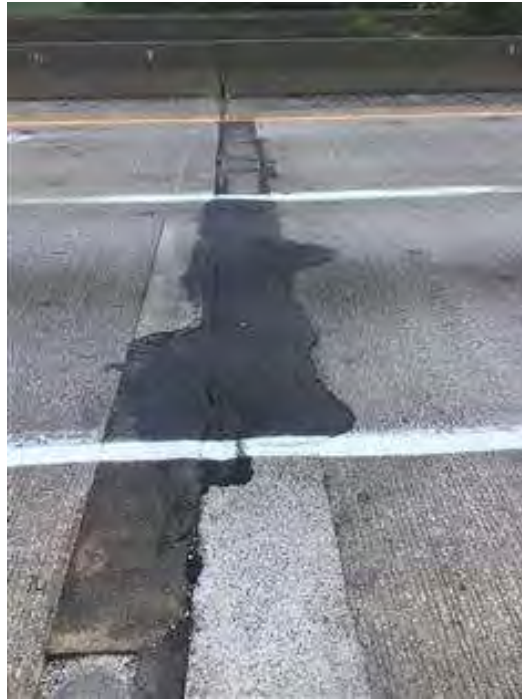
PHOTO 3 Condition  
Description Joint over Pier #2 facing East

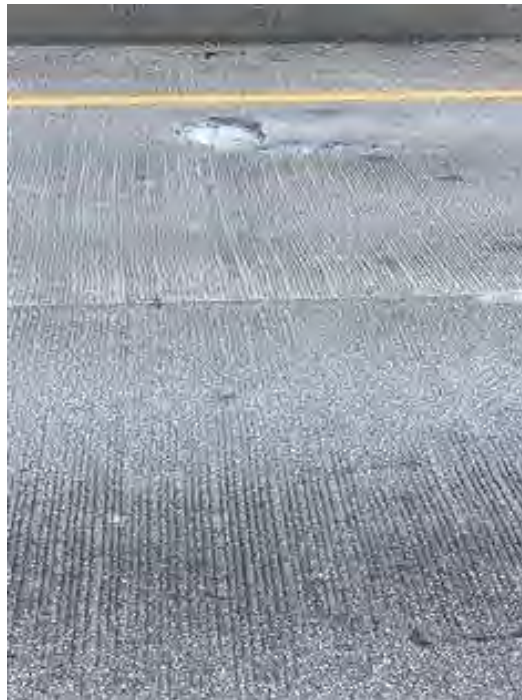
PHOTO 4 Condition, Maintenance - Bridge  
Description 3' X 3' Spall in the Passing Lane over Span B

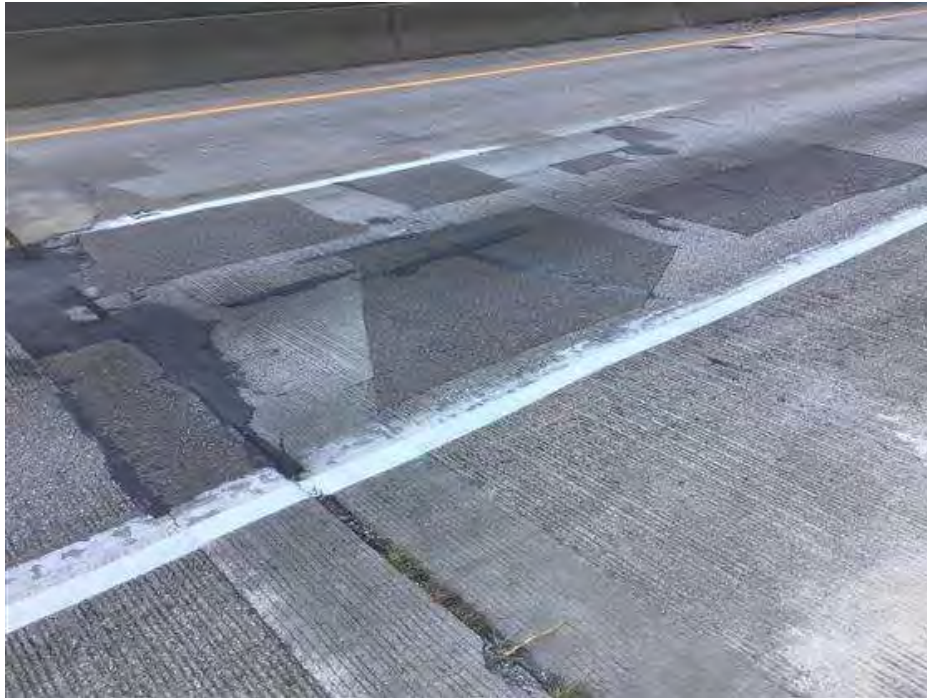
PHOTO 5 Condition  
Description Patches over Span B

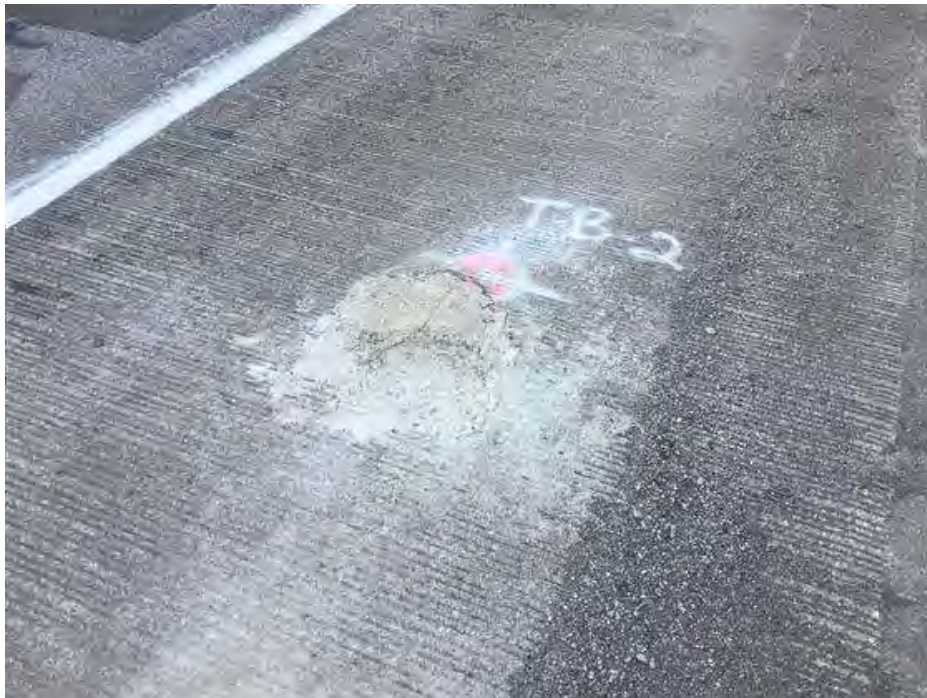
PHOTO 6 Condition  
Description Excess Concrete in the West Shoulder

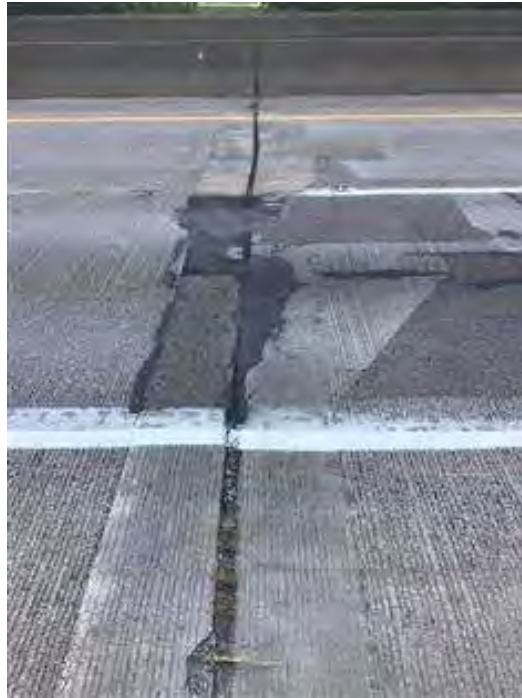
PHOTO 7 Condition  
Description Joint over Pier #3 facing East

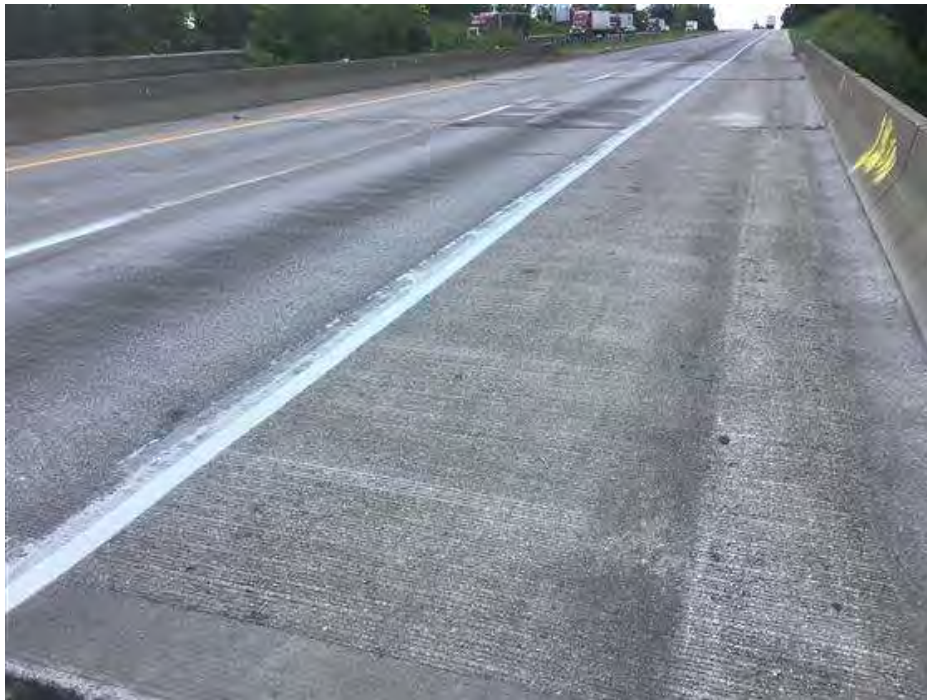
PHOTO 8 Condition  
Description Deck facing South

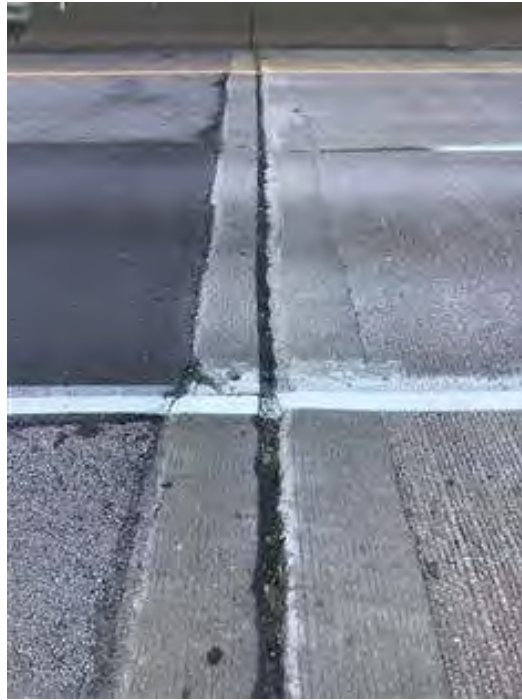
PHOTO 9 Condition  
Description North Joint facing East

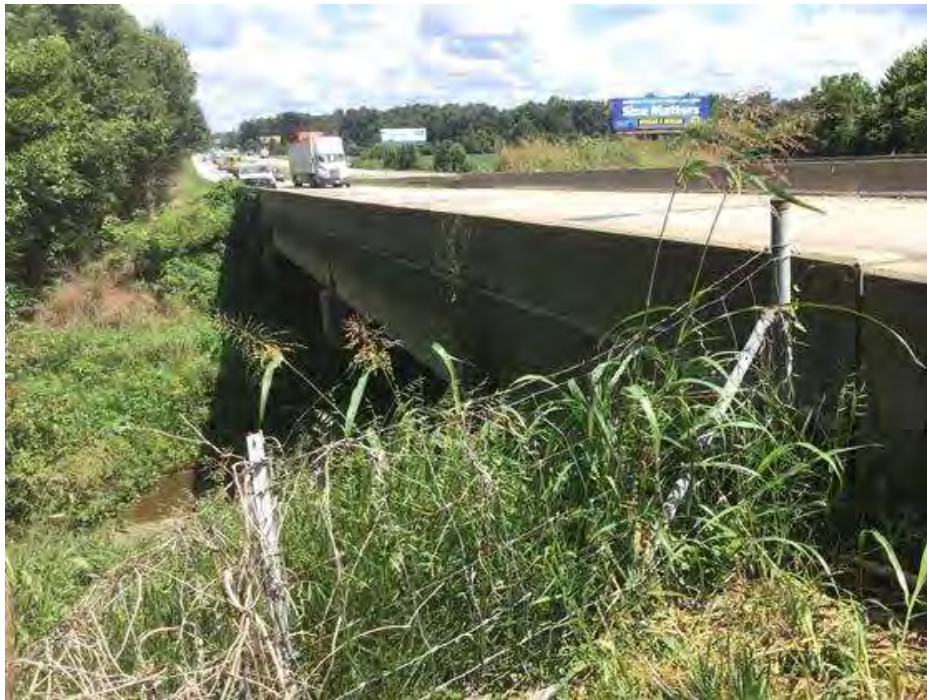
PHOTO 10 Elevation, Condition  
Description Side facing Northeast

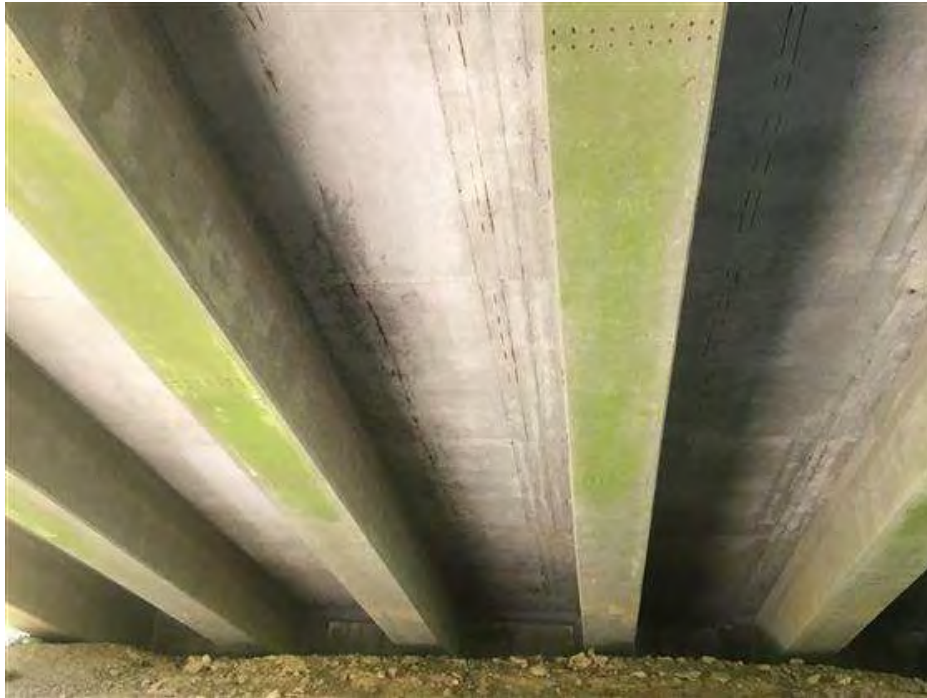
PHOTO 11 Condition  
Description Underside Span A and Abutment #1 facing South

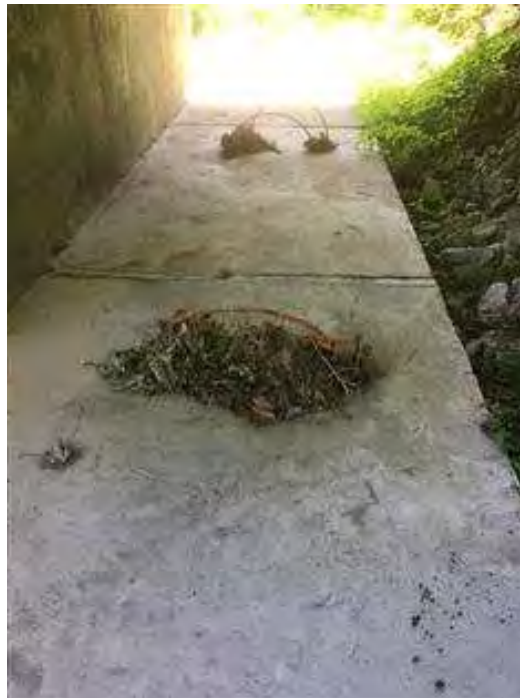
PHOTO 12 Condition  
Description Concrete Pad at South Side Pier #2 facing East
