## Appendix F – Traffic Data

## TRAFFIC DATA

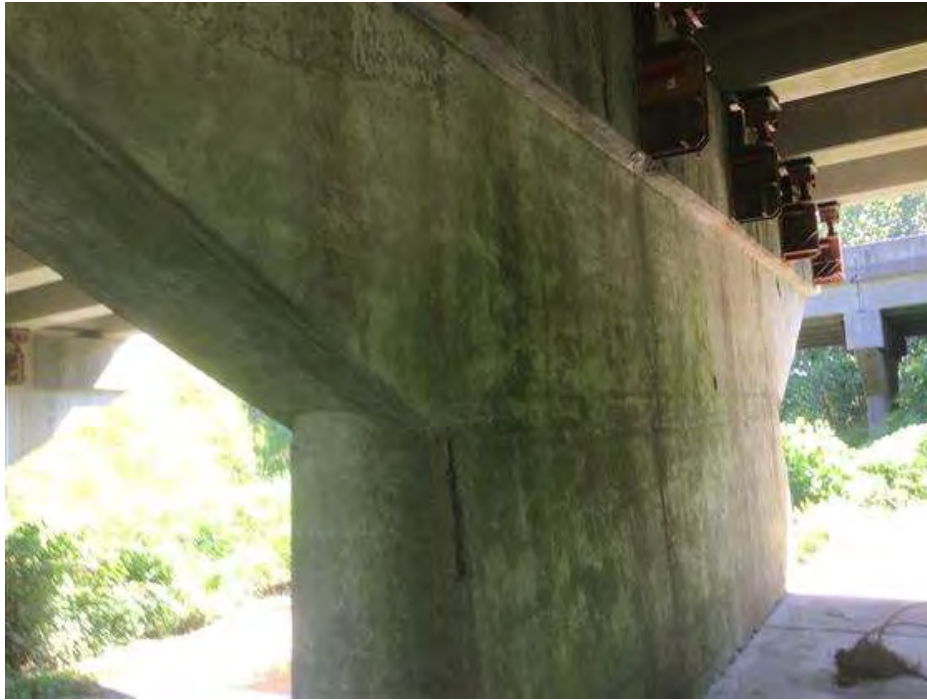
PHOTO 13 Condition  
Description Pier #2 facing Northeast

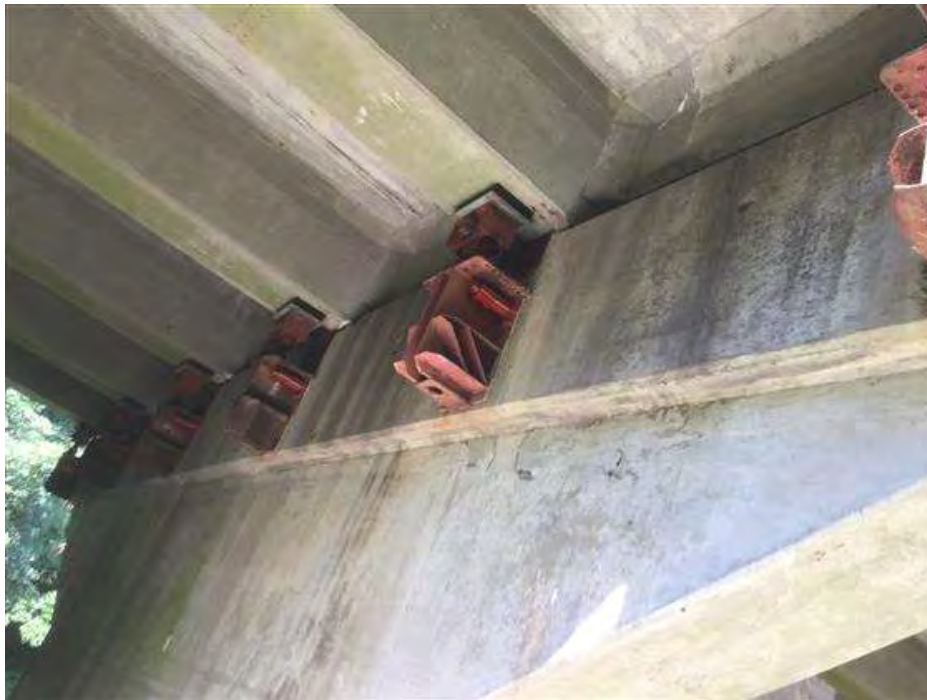
PHOTO 14 Condition  
Description Temporary Bearings on South Side Pier #2

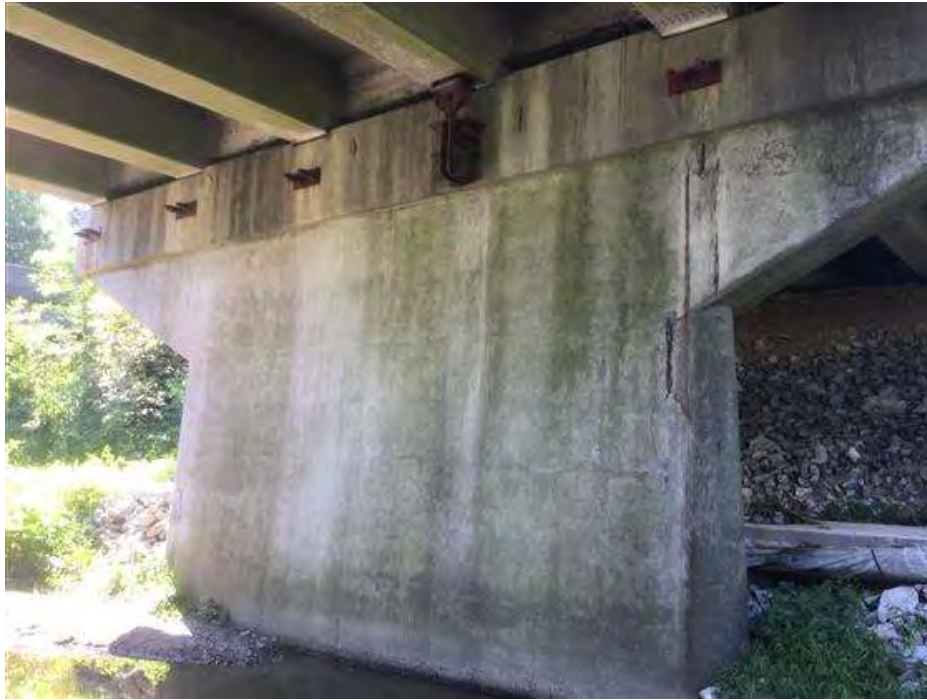
PHOTO 15 Condition  
Description Pier #2 facing South

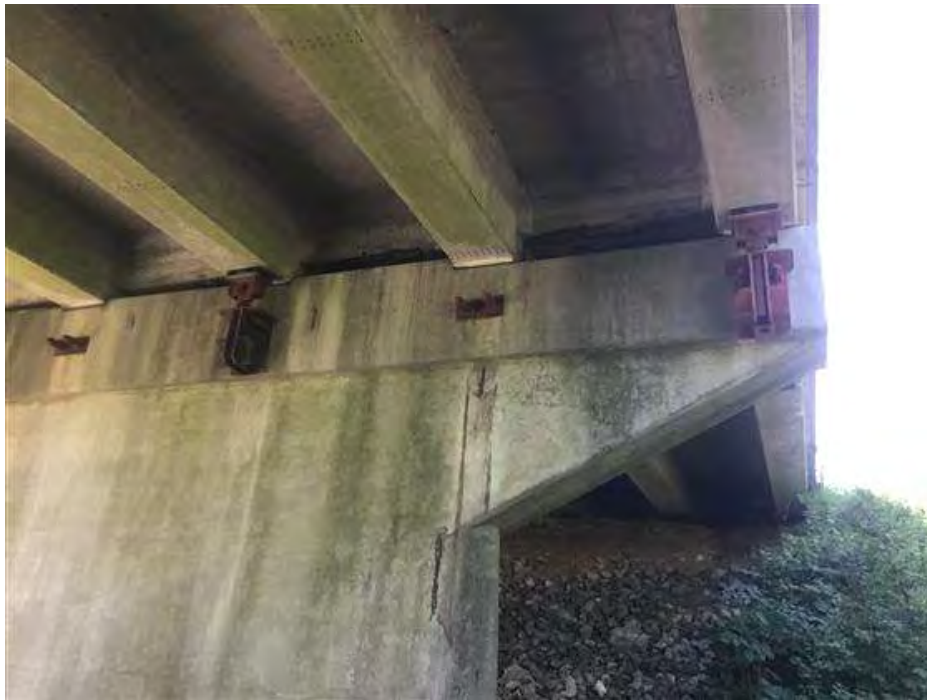
PHOTO 16 Condition  
Description Temporary Bearings on Pier #2 facing South

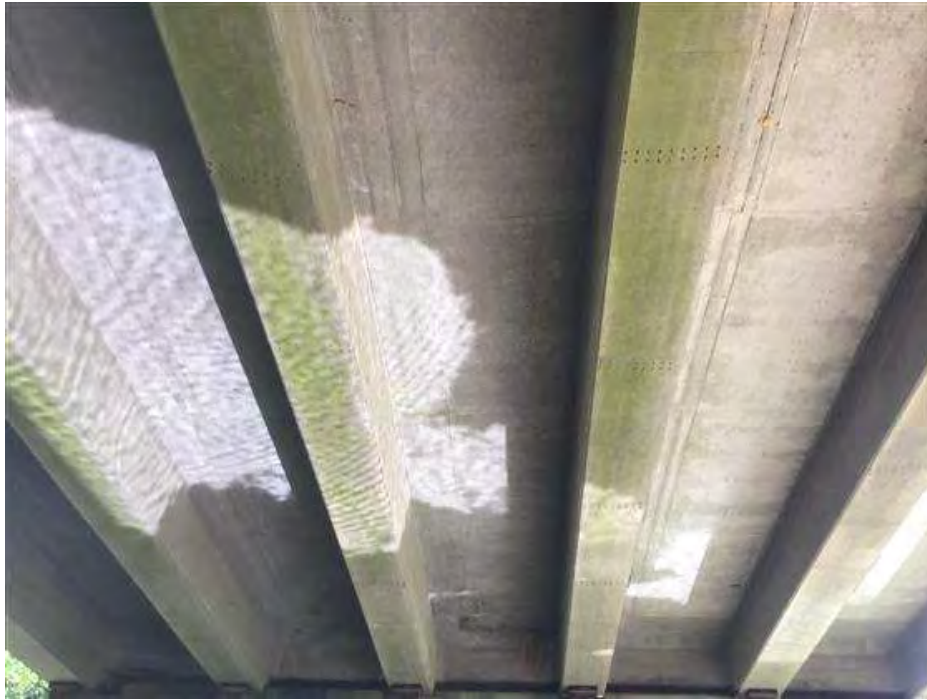
PHOTO 17 Condition  
Description Underside Span B facing North

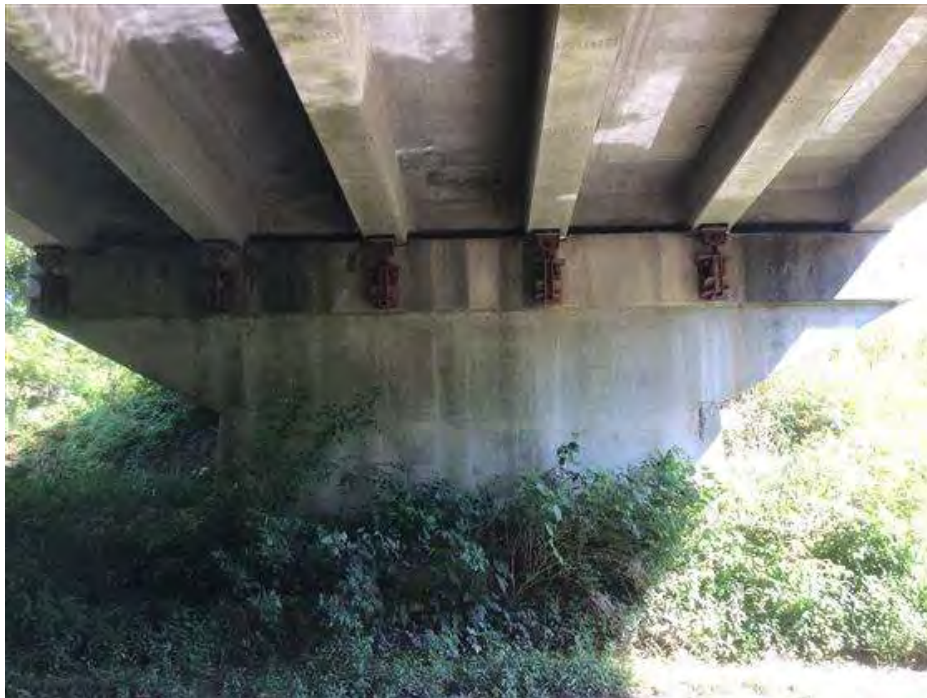
PHOTO 18 Condition  
Description Pier #3 facing North

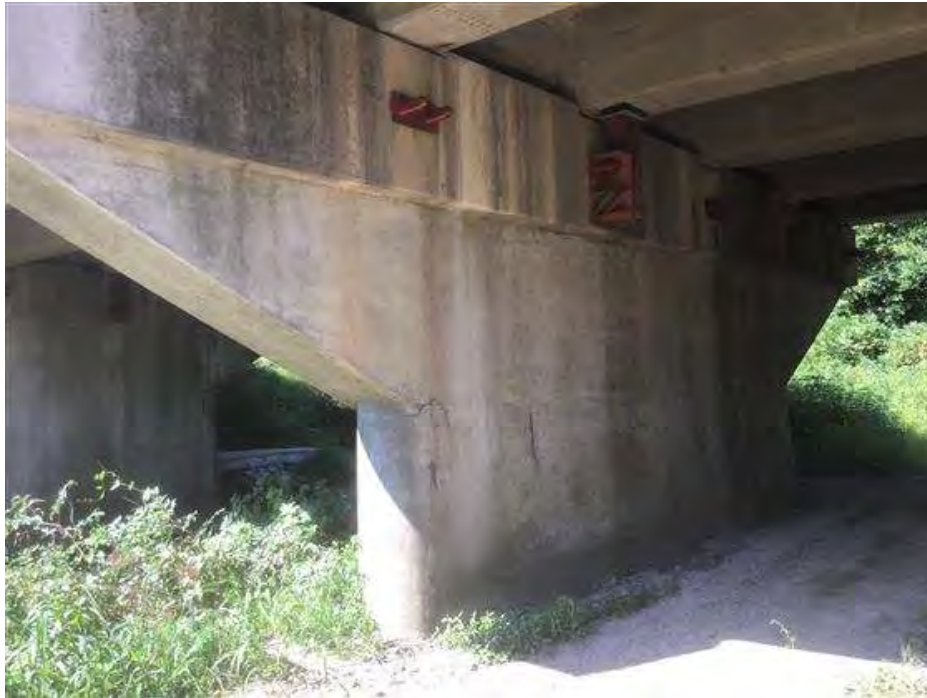
PHOTO 19 Condition  
Description Pier #3 facing Southwest

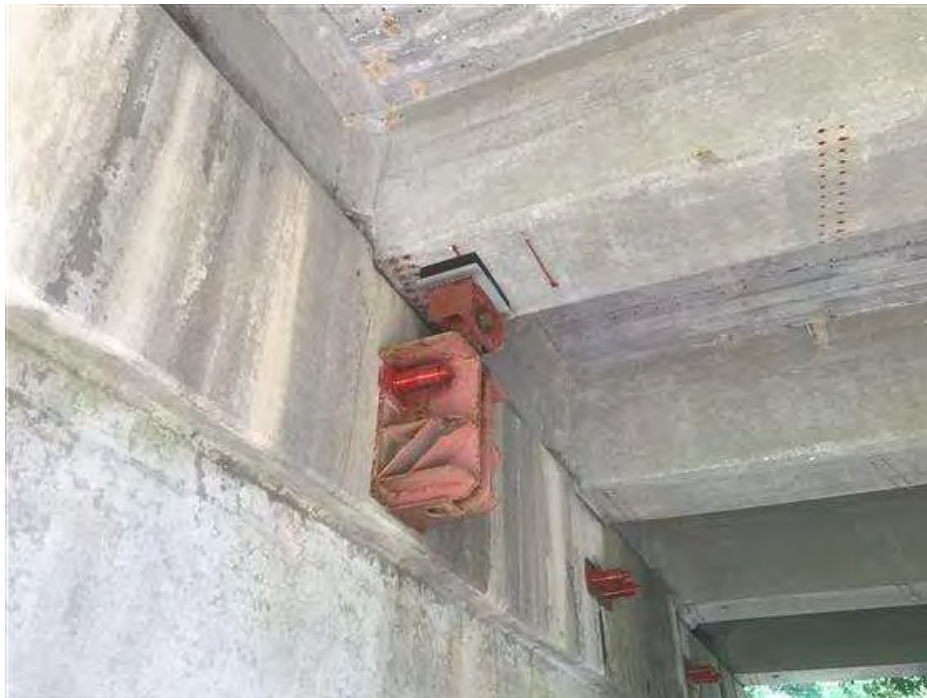
PHOTO 20 Condition  
Description Temporary Bearing on Pier #3

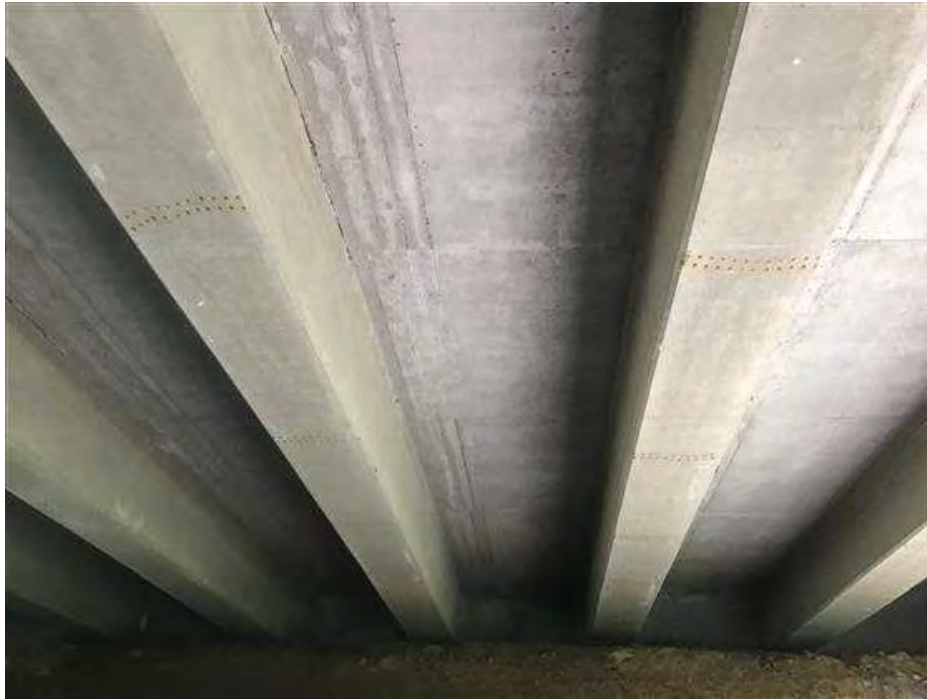
PHOTO 21 Condition  
Description Underside Span C facing North

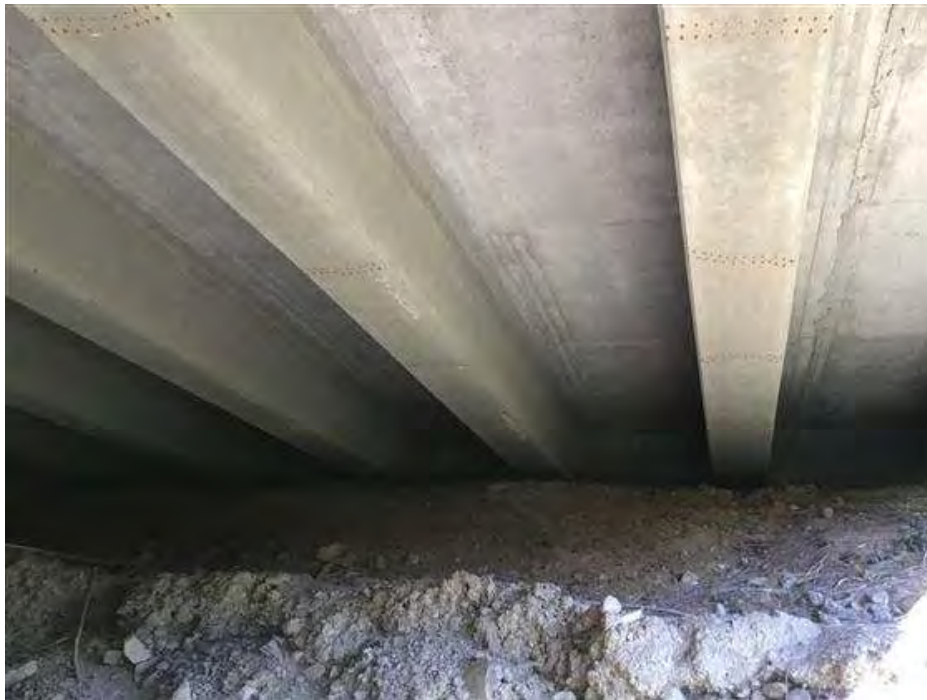
PHOTO 22 Condition  
Description Abutment #4 facing North

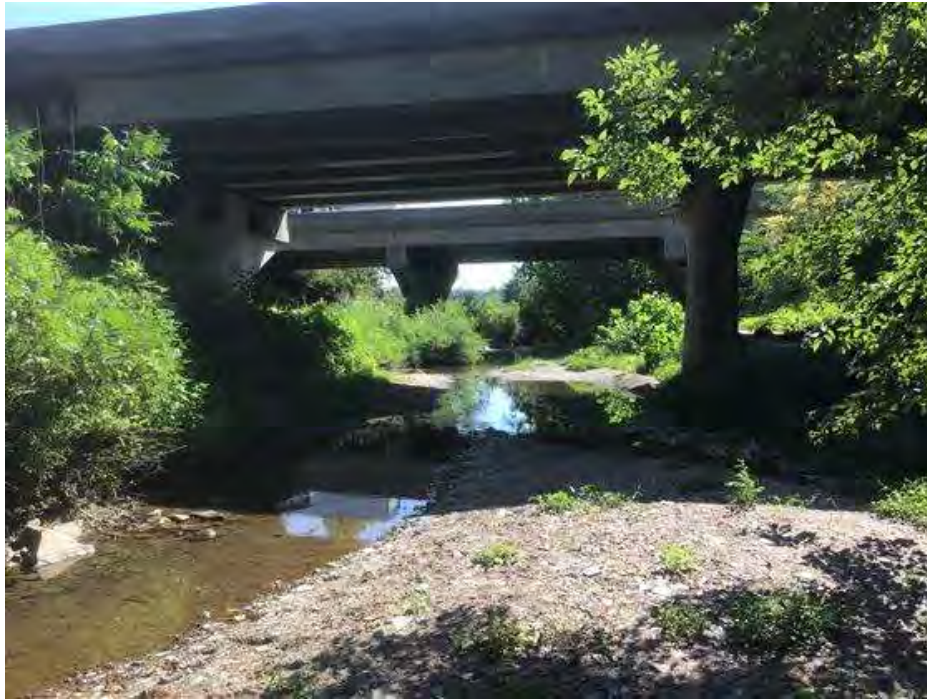
PHOTO 23 Condition  
Description Channel facing East

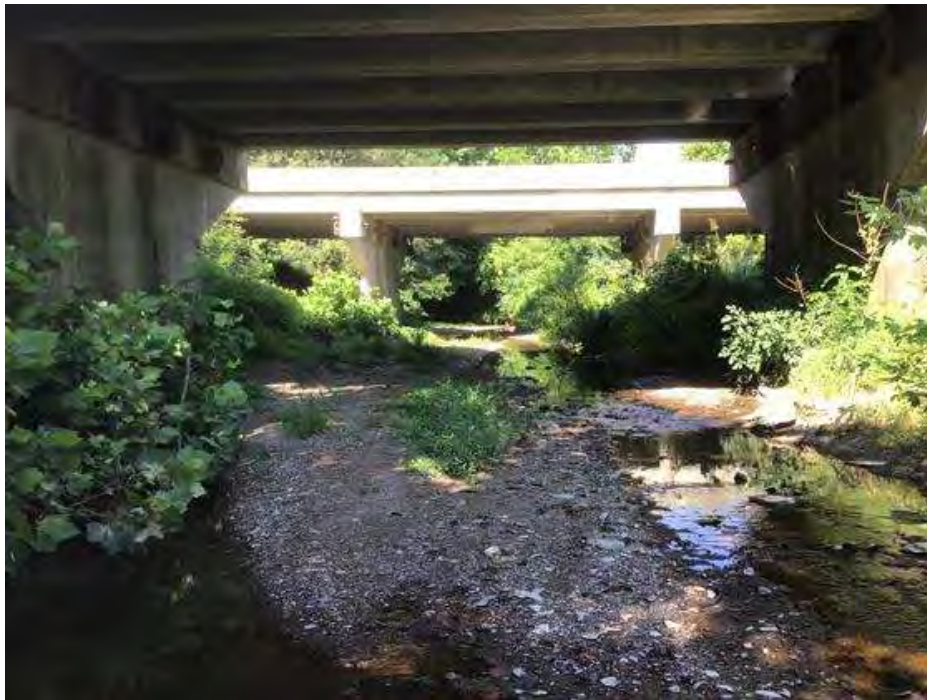
PHOTO 24 Elevation, Condition  
Description Channel facing West

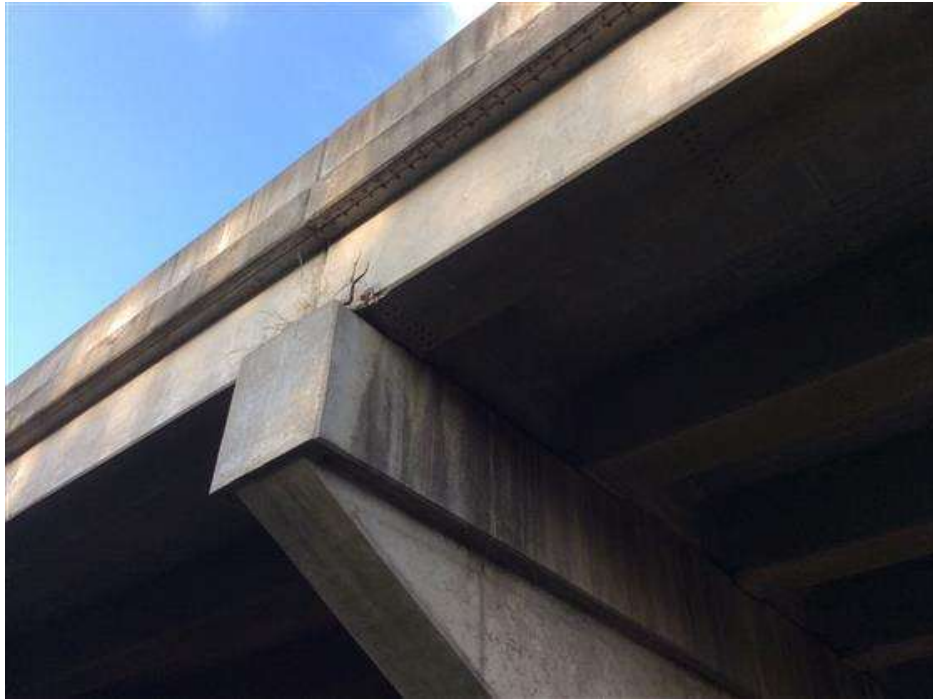
PHOTO 25 Condition  
Description South end beam 6 at pier 2 span b.

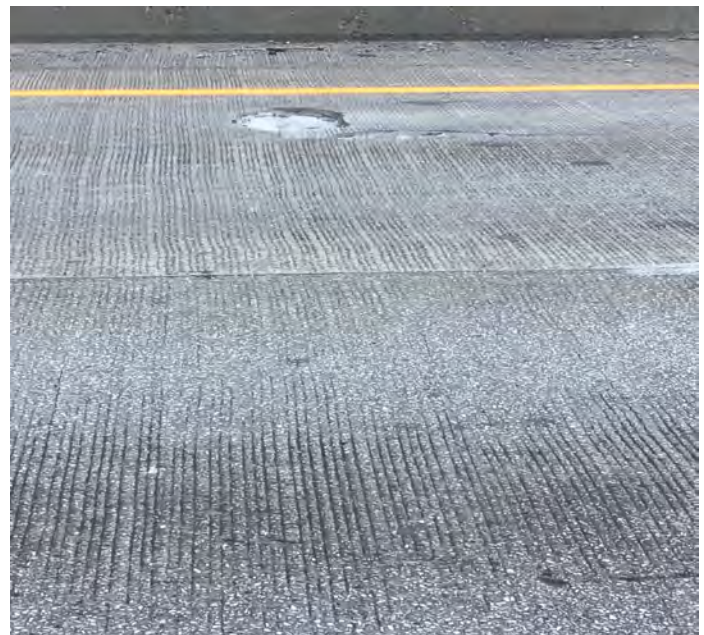
PHOTO 2 Description 3' X 3' Spall in the Passing Lane over Span B

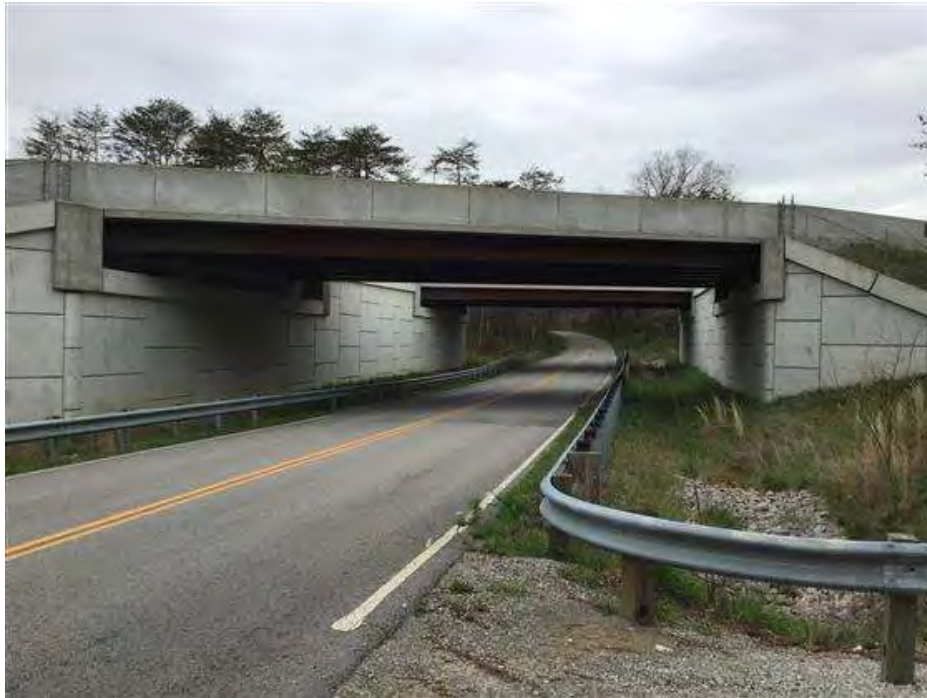
PHOTO 1 Elevation, Condition  
Description East side.

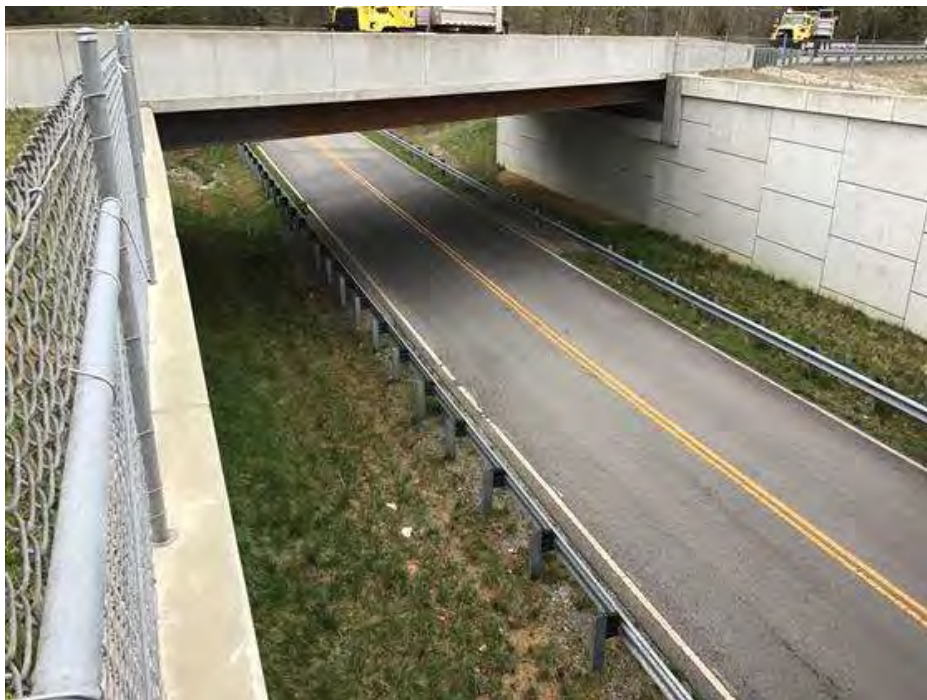
PHOTO 2 Condition  
Description West side.

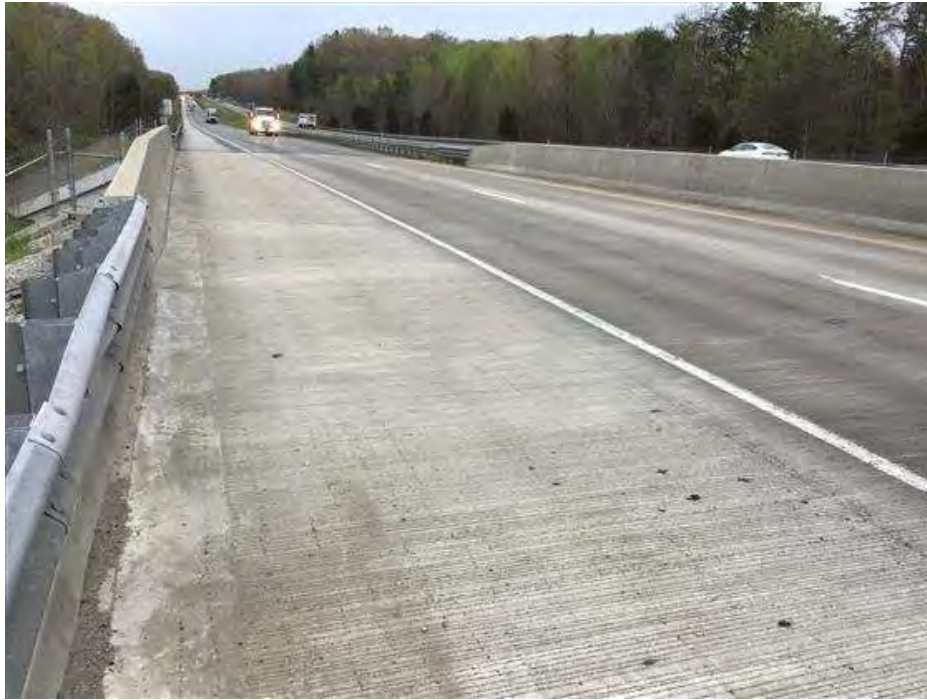
PHOTO 3 Condition  
Description Roadway south.

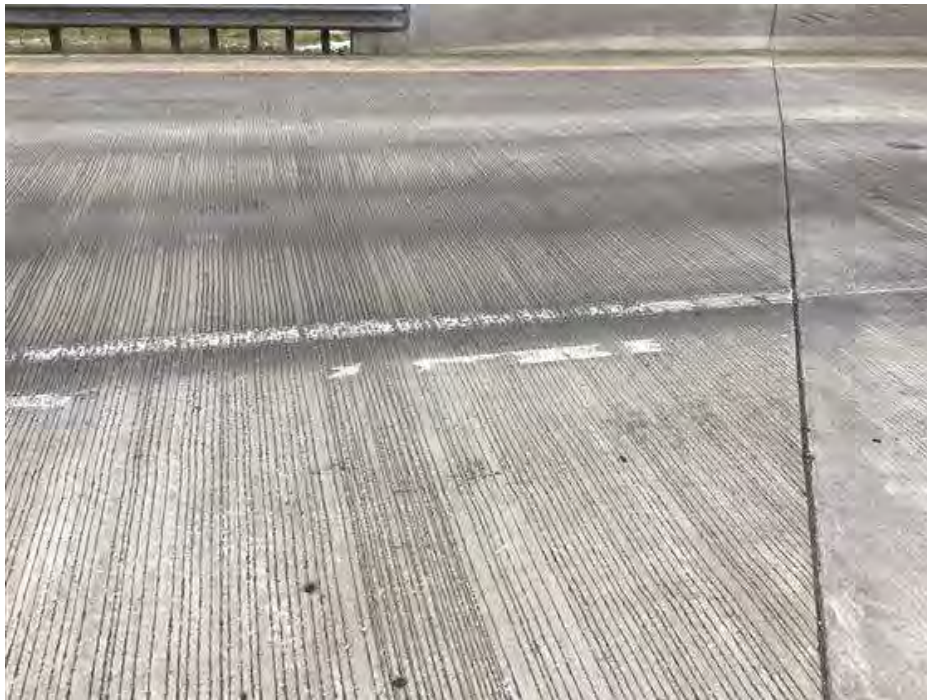
PHOTO 4 Condition  
Description South joint and approach slab.

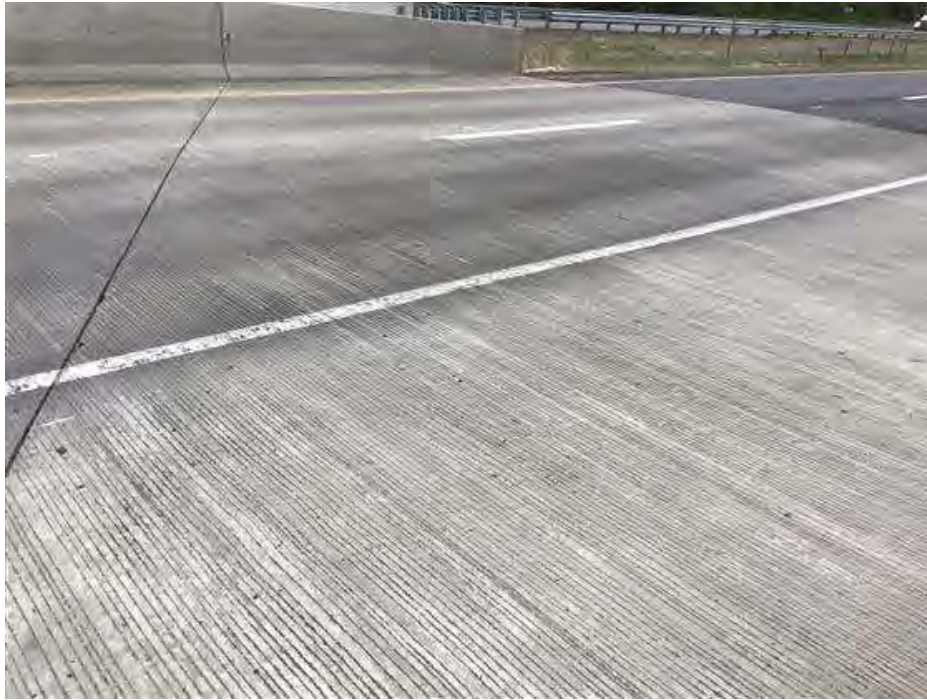
PHOTO 5 Condition  
Description North joint and approach slab.

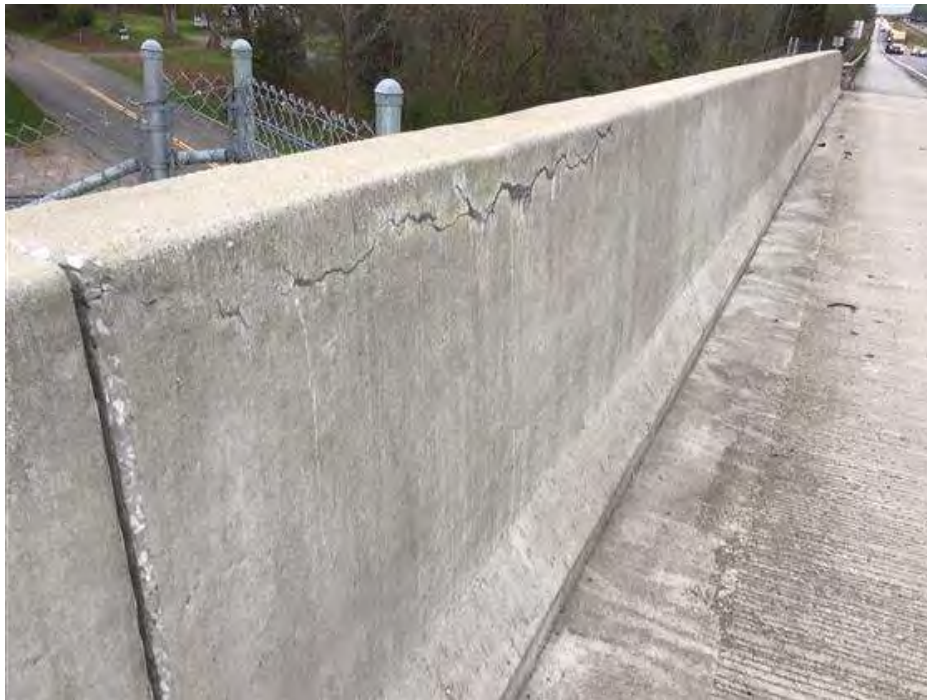
PHOTO 6 Condition  
Description East barrier wall.

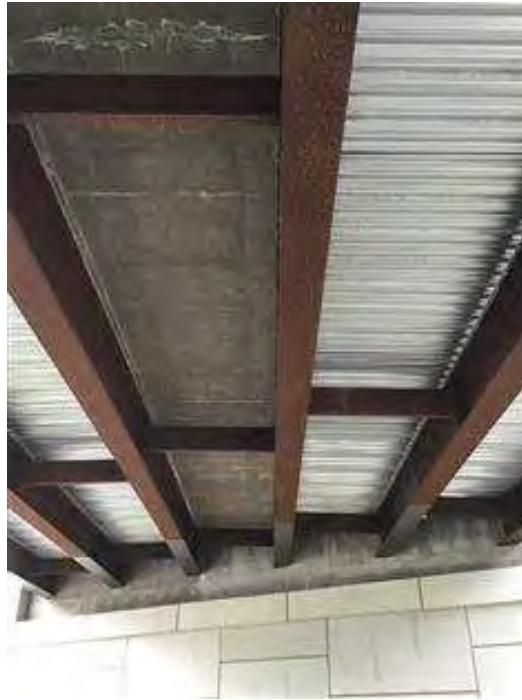
PHOTO 7 Condition  
Description Underside and north abutment.

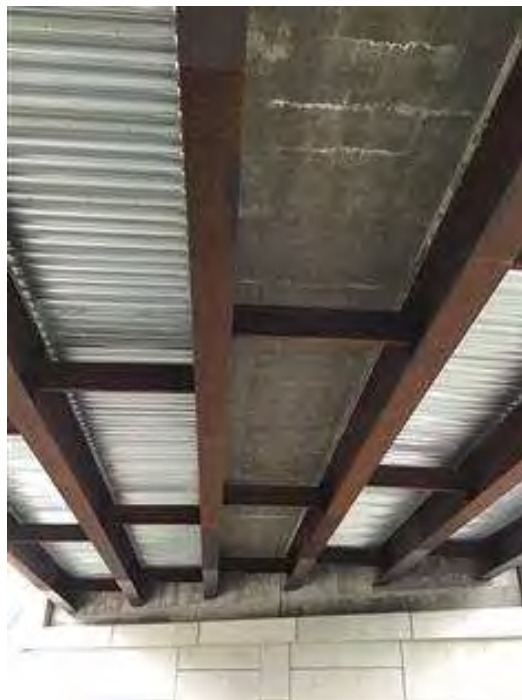
PHOTO 8 Condition  
Description Underside and south abutment.

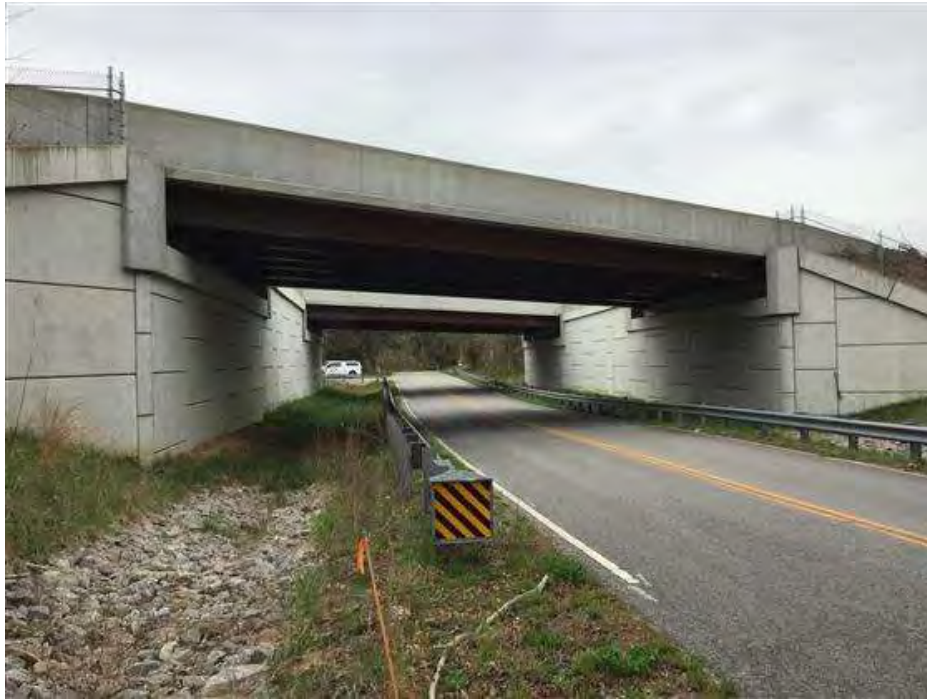
PHOTO 1 Elevation, Condition  
Description West side.

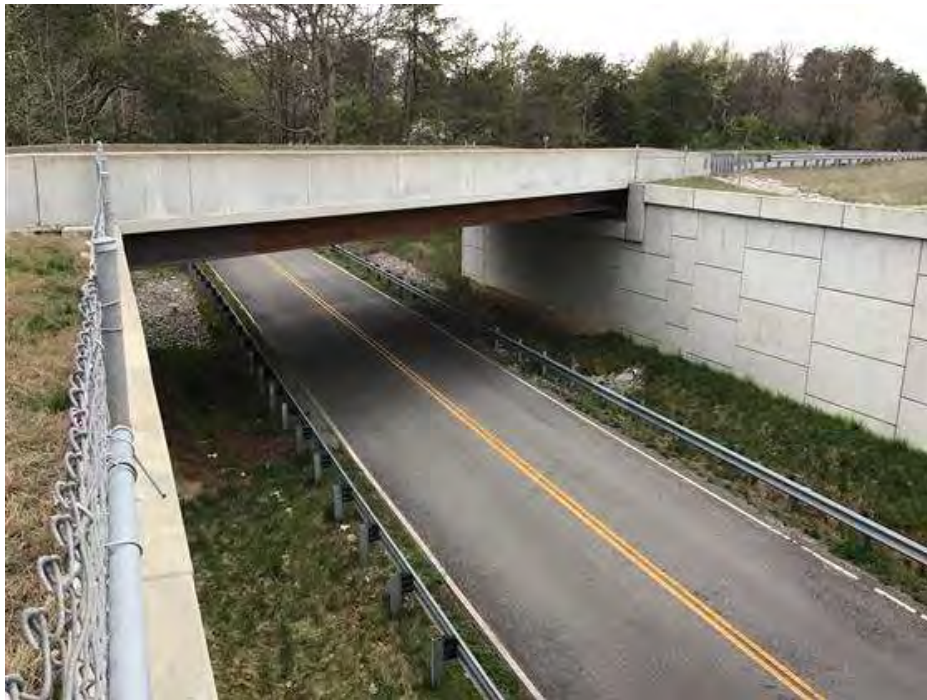
PHOTO 2 Elevation, Condition  
Description East side.

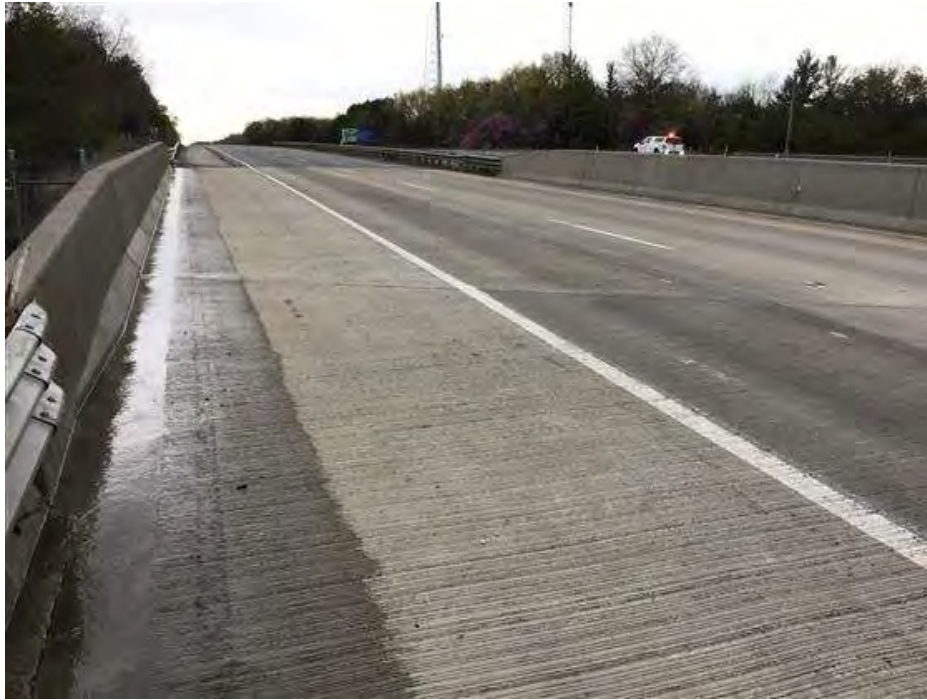
PHOTO 3    Condition  
Description    Roadway north.

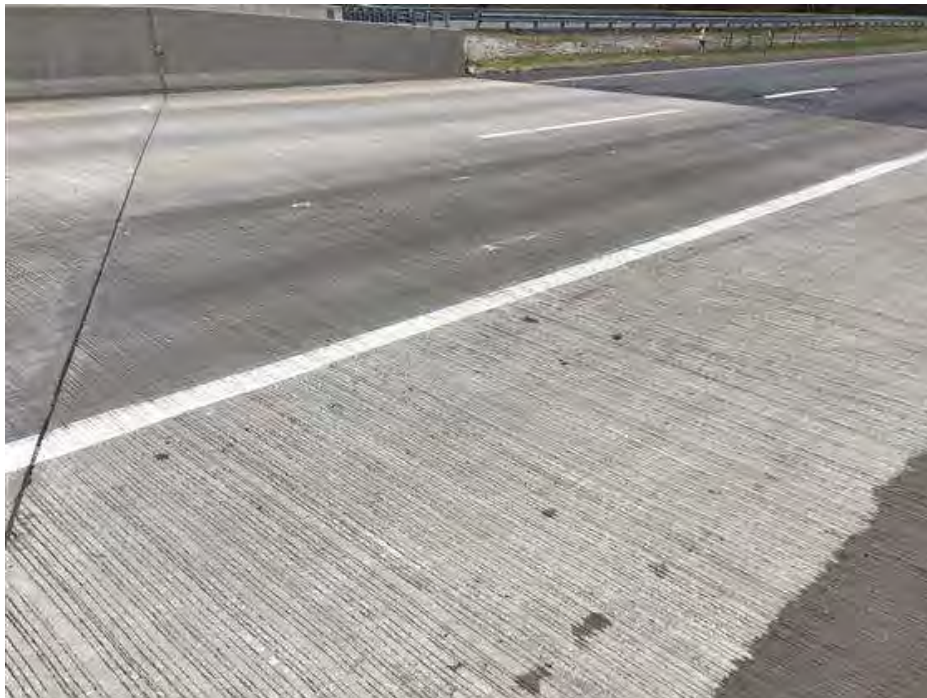
PHOTO 4    Condition  
Description    South joint and approach slab.

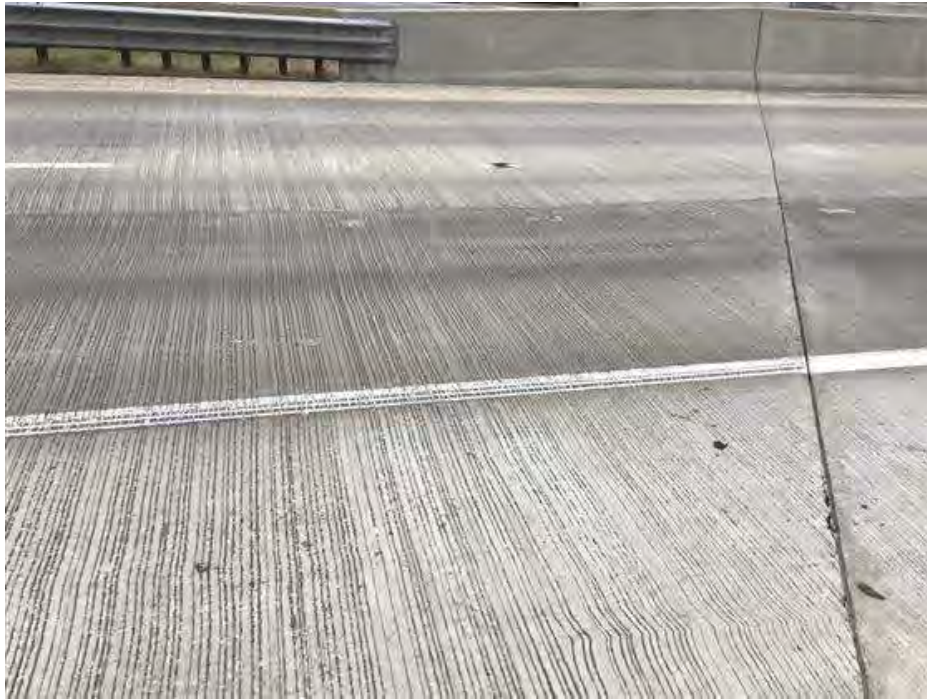
PHOTO 5 Condition  
Description North joint and approach slab.

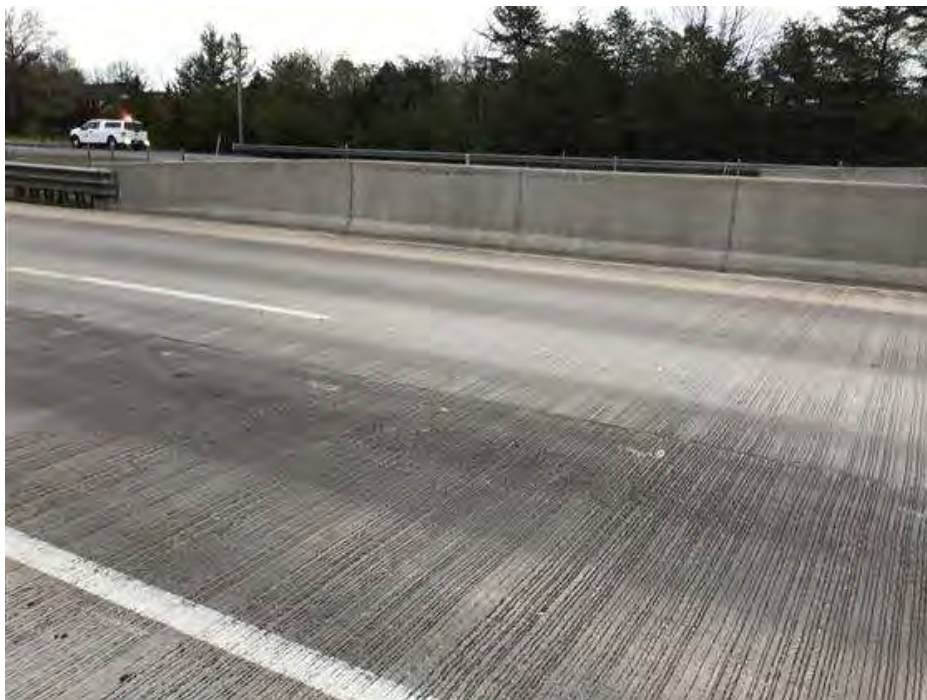
PHOTO 6 Condition  
Description East barrier wall.

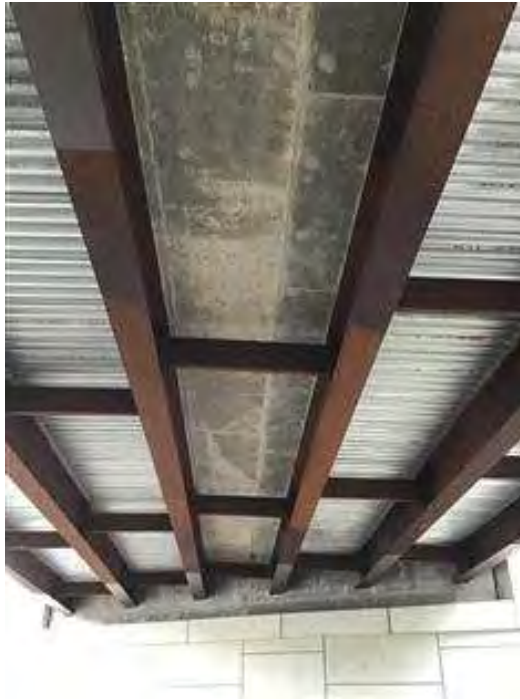
PHOTO 7 Condition  
Description Underside and south abutment.

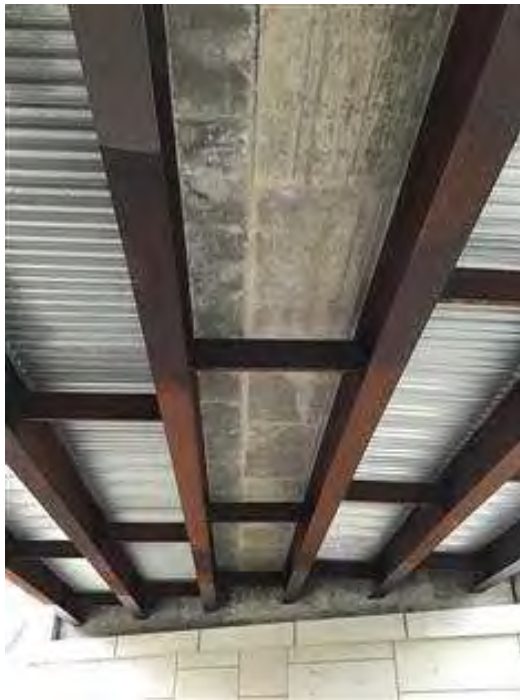
PHOTO 8 Condition  
Description Underside facing north.

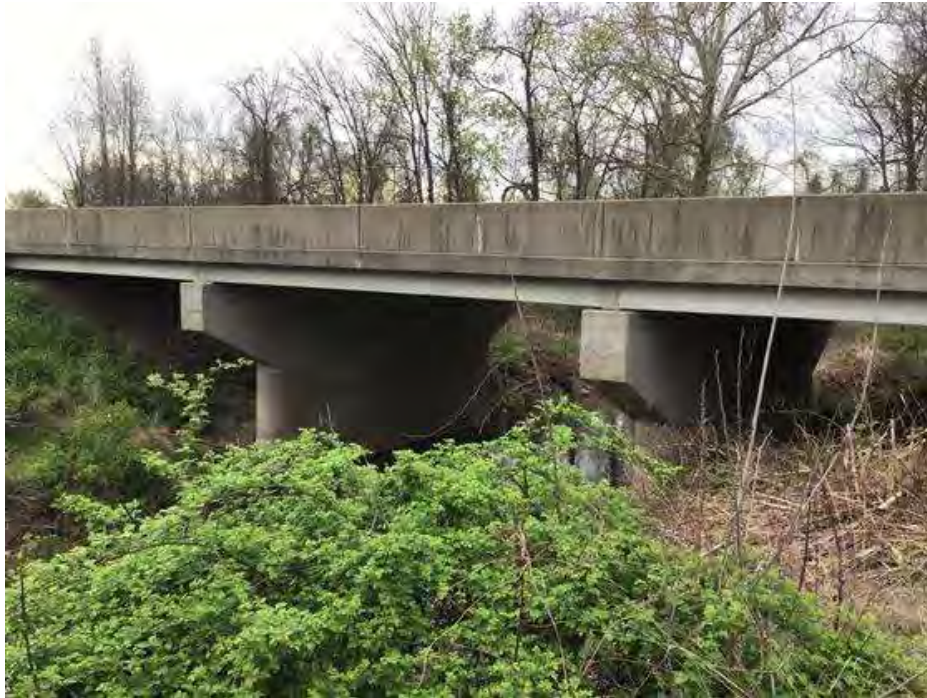
PHOTO 1 Elevation, Condition

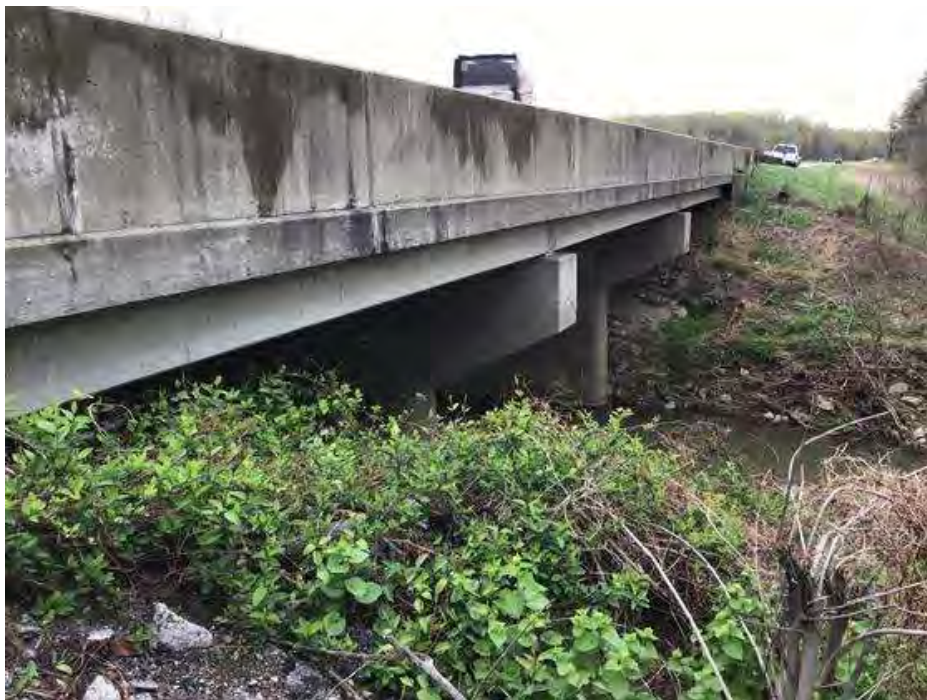
Description West side.

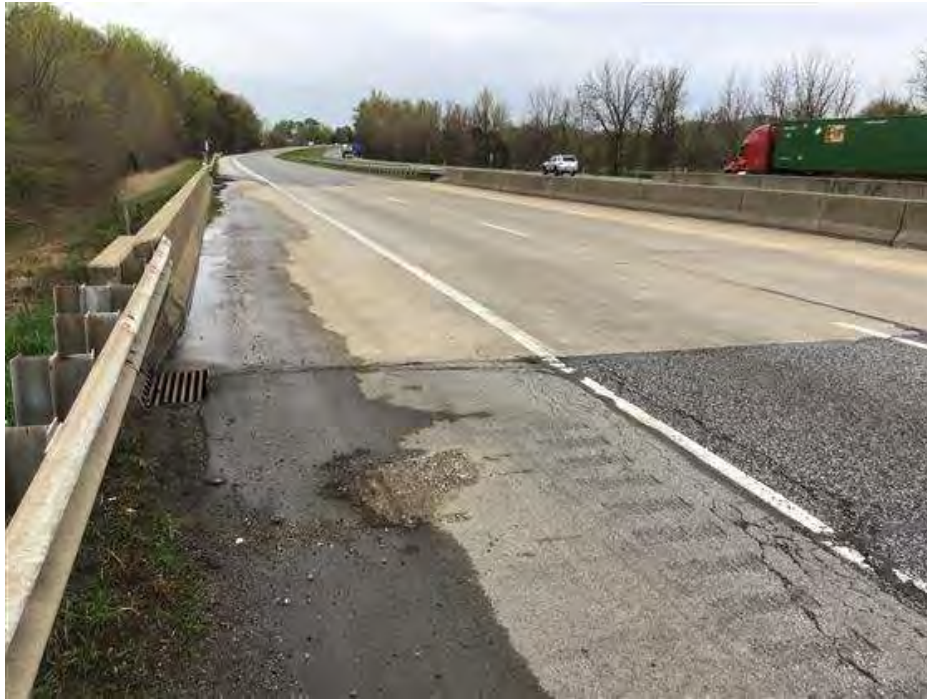
PHOTO 3 Condition  
Description Roadway south.

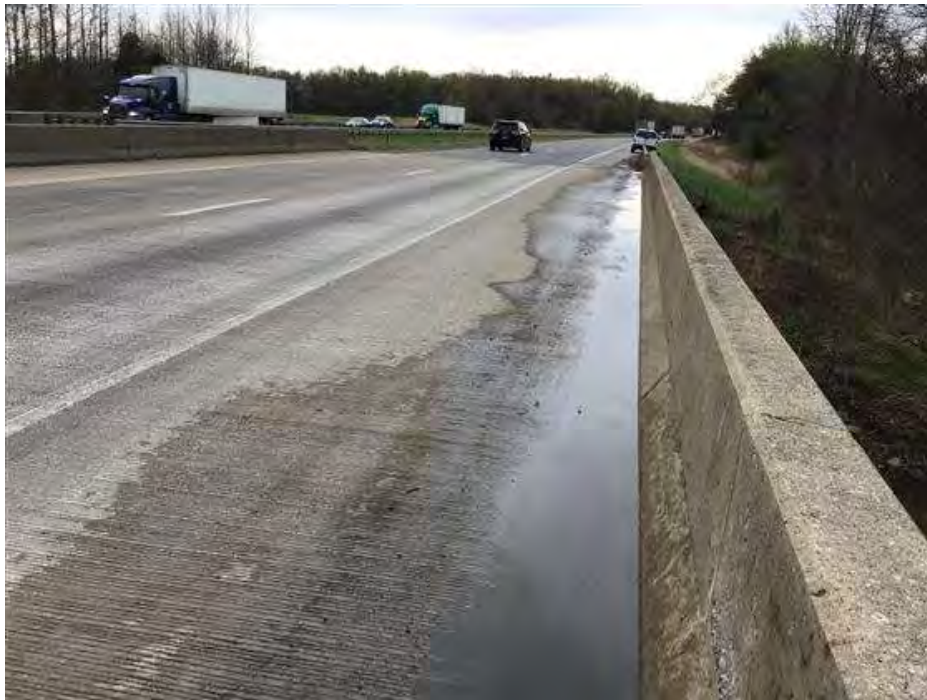
PHOTO 4 Condition  
Description Roadway north.

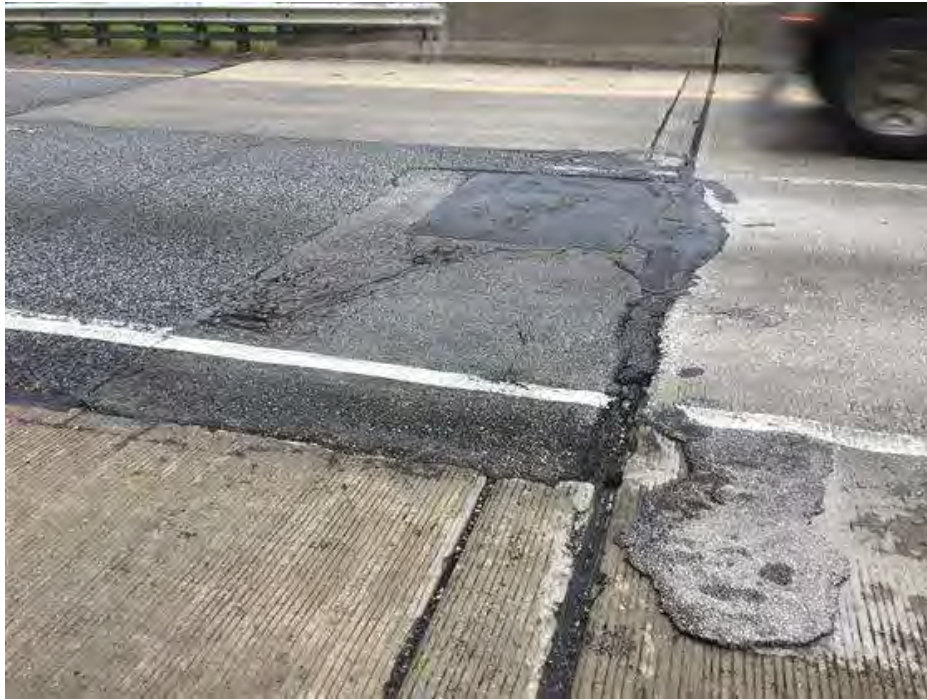
PHOTO 5 Condition  
Description South joint and approach slab.

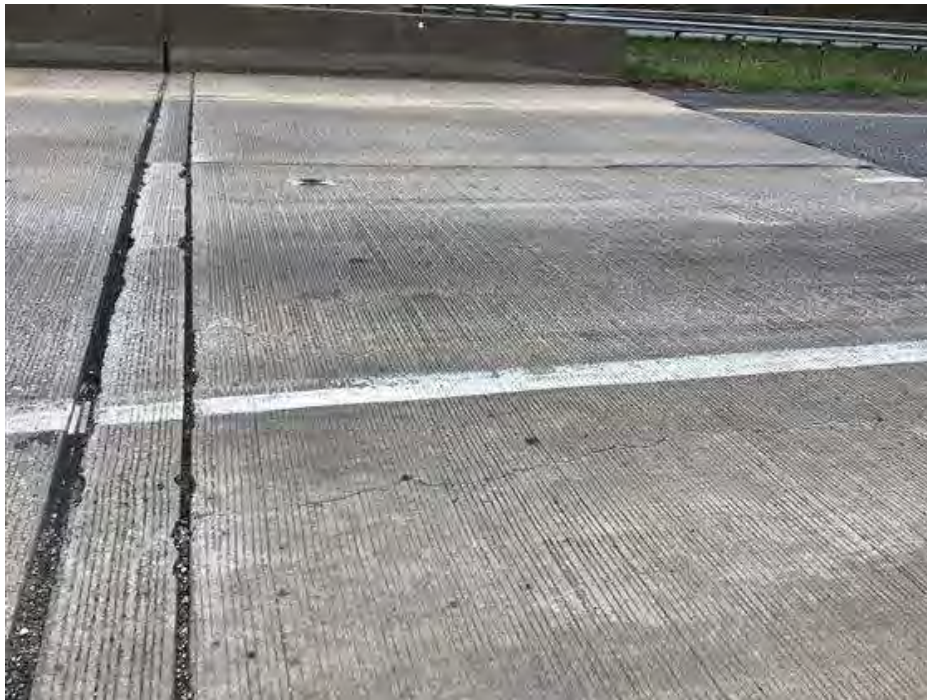
PHOTO 6 Condition  
Description North joint and approach slab.
