Indiana Classified Forest & Wildlands Forestry Best Management Practices

Monitoring Results • 1996-2022

By: Jennifer Sobecki & Duane McCoy

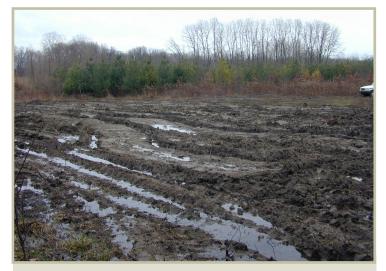
Wet and unstabilized landings can lead to many delays in the harvest and cause long-term damage to the site.

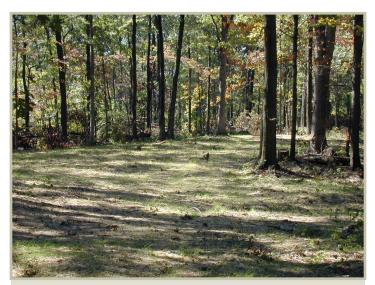
Seed and straw on a skid trail stabilize and protect soil until new vegetation can be established.

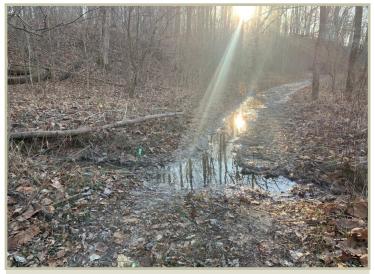
A skid trail crossing an unmapped intermittent diverts water from the stream down the skid trail.

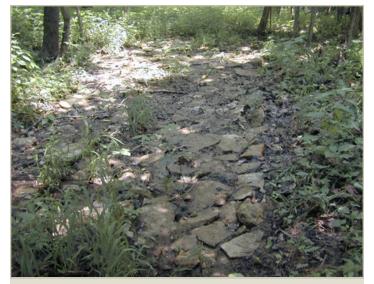
This stream crossing is lined with flat rocks that protect the approaches and stream bed.

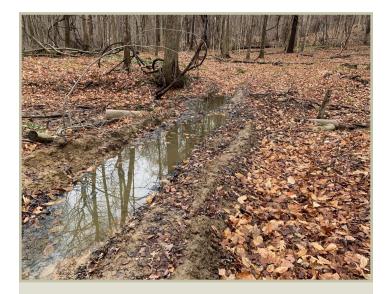
There are multiple issues with this stream crossing. The culvert is too small, causing a backup of water on the upstream side. Water was not diverted from the trail, and the trail was not armored as it crossed the stream, so there is ponding and very muddy conditions on the crossing.

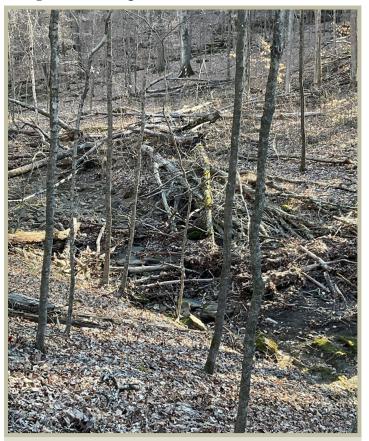
Tops felled into a stream cause debris to build up in the stream.

Obstructing debris logging in streams (Z2) has a score of 60.0% application and 62.1% effectiveness. RMZs "free of roads and landings" (Z7) with a 61.2% implementation rate, effectiveness was 80.4%. Water was not commonly diverted before entering RMZ (Z8) with application of 57.3% and effectiveness of 68.2%. When water was diverted, it was not always diverted onto stable areas of the forest floor (Z9); this process had 65.2% application and 72.1% effectiveness. Some ephemeral channels contained excavated materials (Z11) with a 69.6% application rate and 70.3% effectiveness rate.

• Importance of removal of these obstructions to stream flow needs to continue to be emphasized to landowners and loggers as this remains to be an area of concern, especially on private lands.

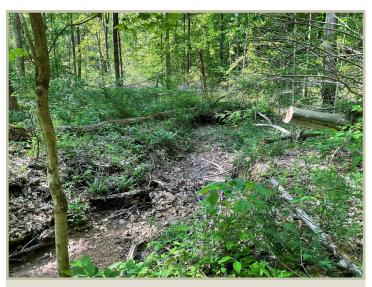
Harvest debris removed from a stream.
