CONSTRUCTION MEMORANDUM
11-04

SUBJECT: Annual Work Zone Findings Report for 2010

ANNUAL WORK ZONE REVIEW FINDINGS REPORT 2010 CONSTRUCTION SEASON

SUBJECT: Work Zone Review Summary
Contract IR-30710
I-465 North Leg
Marion County

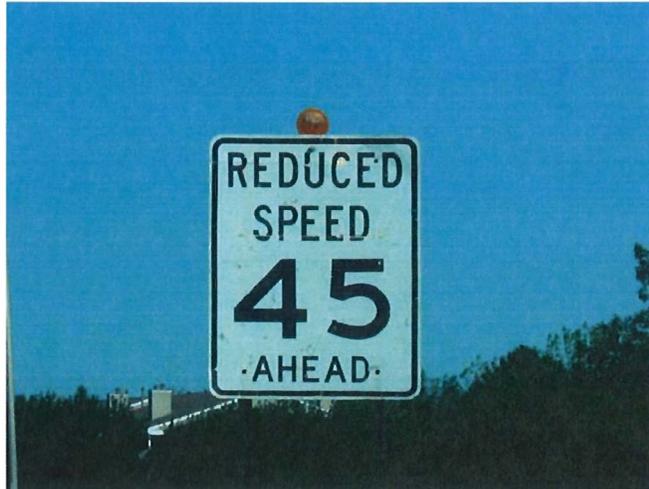
- Advance signage warning of the work zone was present and appropriate. "Added Penalty" signs were present in both directions on I-465.
- The Advance Speed Limit signs used on the project (spelled out) should be replaced with similar signs on an orange background, or a sign using the international advance arrow symbol.

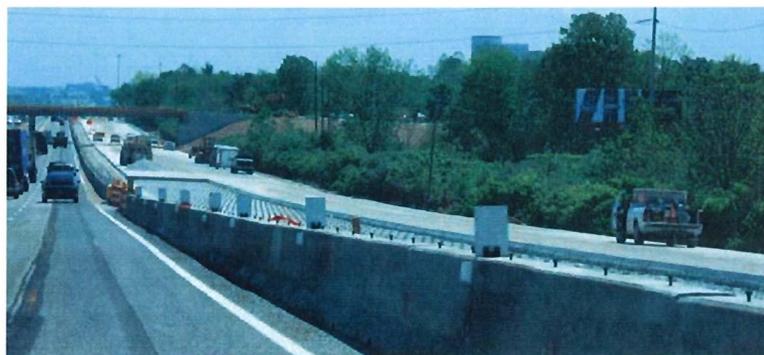
- Positive protection for the work site was provided by concrete barriers. The condition and placement of the barriers was excellent. All the barriers on I-465 and the ramps had proper attenuation. Reflectorization placement was very consistent and color coding to the edge lines was maintained.

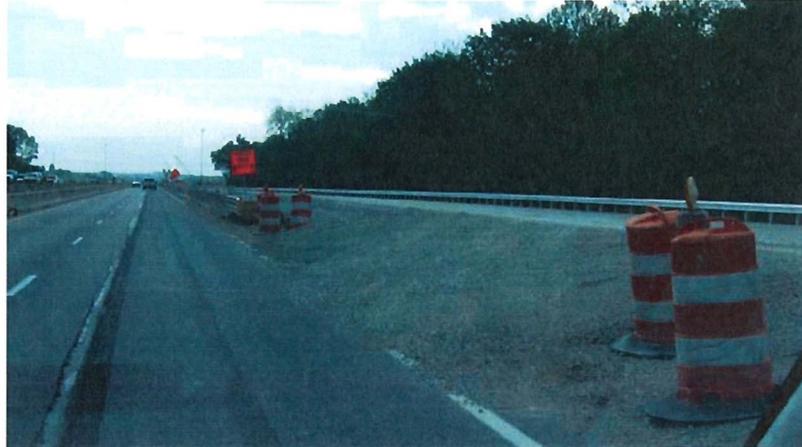
- Arrow Boards in use had proper illumination. Those not being used were properly placed in the down position.
- Stone debris encroached the traveled way in some locations EB where vehicles enter the work site through openings in the concrete barrier. The stones can cause damage to vehicles or workers. Most of the locations had the stone removed within two days of our review.

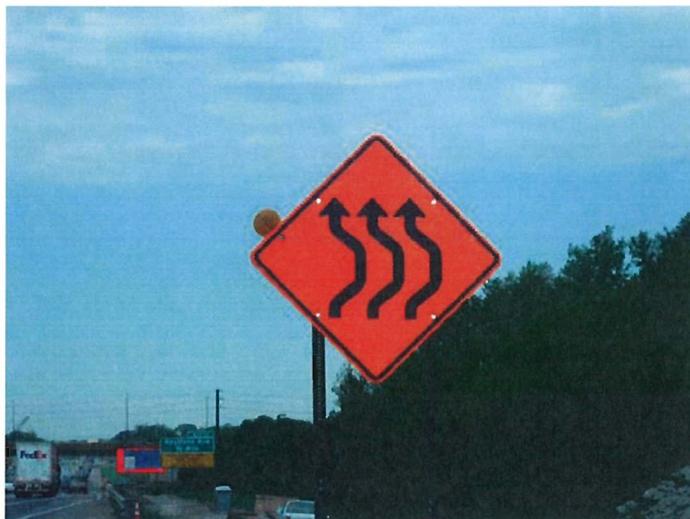
- Lane shifts were used extensively throughout the project. Double Reverse Curve Signs (W24-1b) were used effectively on the project. There were two locations at the end of the project EB where there were shifts but no shift signs were present.

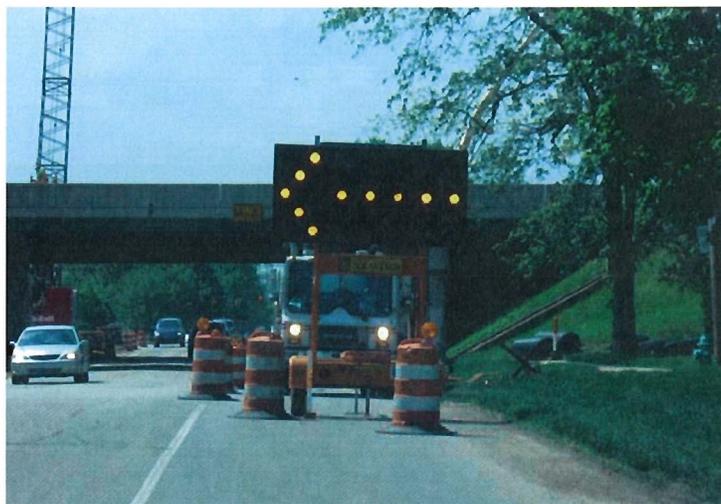
- A merge taper was used on College Avenue SB to close the right lane. There was no advance warning of the closure, and the taper was considerably less than the required 180 feet.

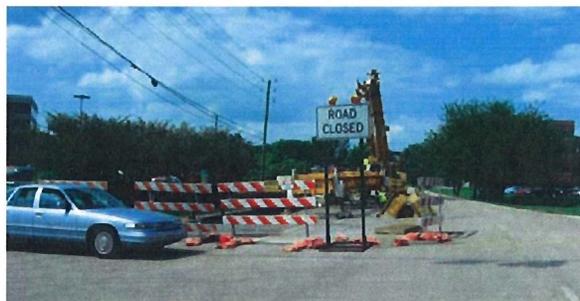
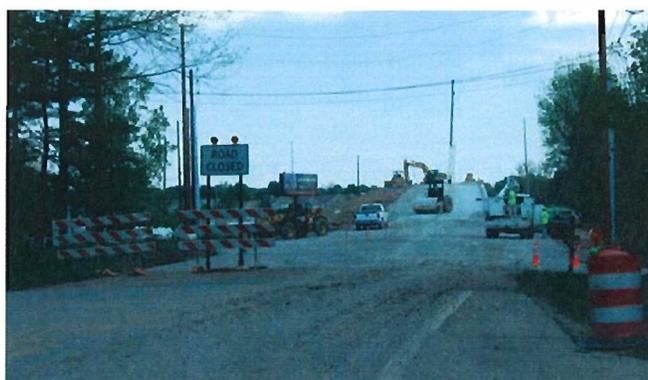
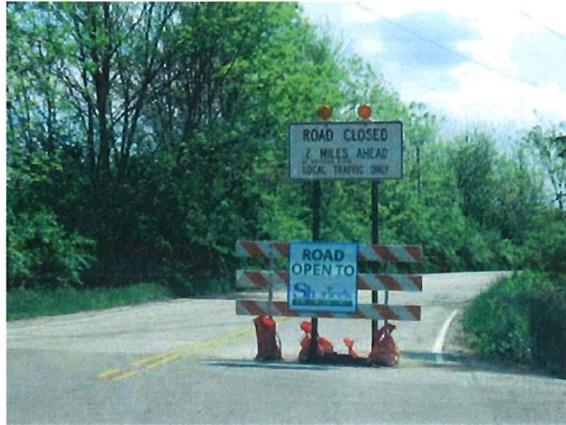
- ISP patrols had drivers pulled over in two different locations at the time of our review.
- Barricades were used to prevent access to closed roads. Several locations did not effectively prevent entrance, and a number of barricades had the wrong orientation. Barricades should be placed to completely prevent entry or staggered to allow necessary vehicle entry. Stripes on barricades for road closures should point to the Road Closed sign, or down towards where vehicles are supposed to drive. Also, cars should never be allowed to park in front of the barricades and signs are not allowed to be posted on barricades.

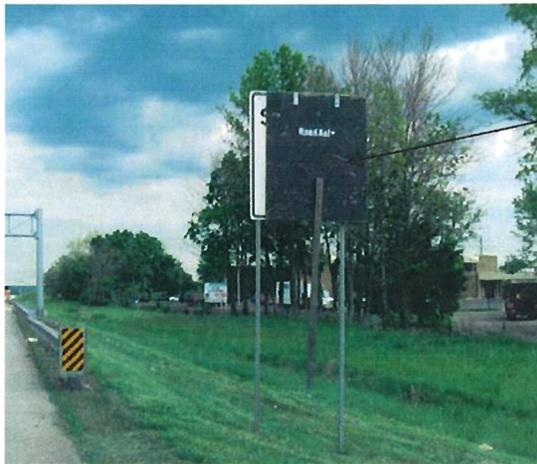
- Existing permanent speed limit signs were covered throughout the project. The cover shown in the photo below near MM 35 WB has a tail and should be replaced with a cover without one.

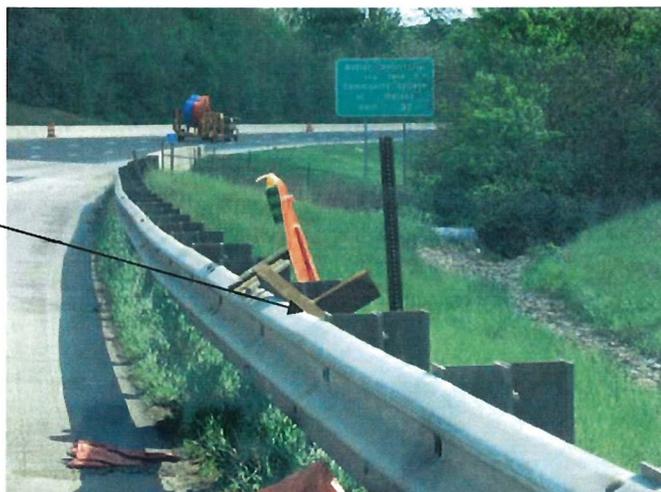
- A sign post was placed against the guardrail at approximately MM 30 EB. The post extends into an area where a vehicle could contact it and cause injury or damage to the motorist or vehicle. This should be moved.
