AMERICAN
STRUCTUREPOINT
INC.

September 21, 2012

Re: 448 West Norwood Street
Indianapolis, Indiana
Structural Condition Assessment
Project No. 201201484

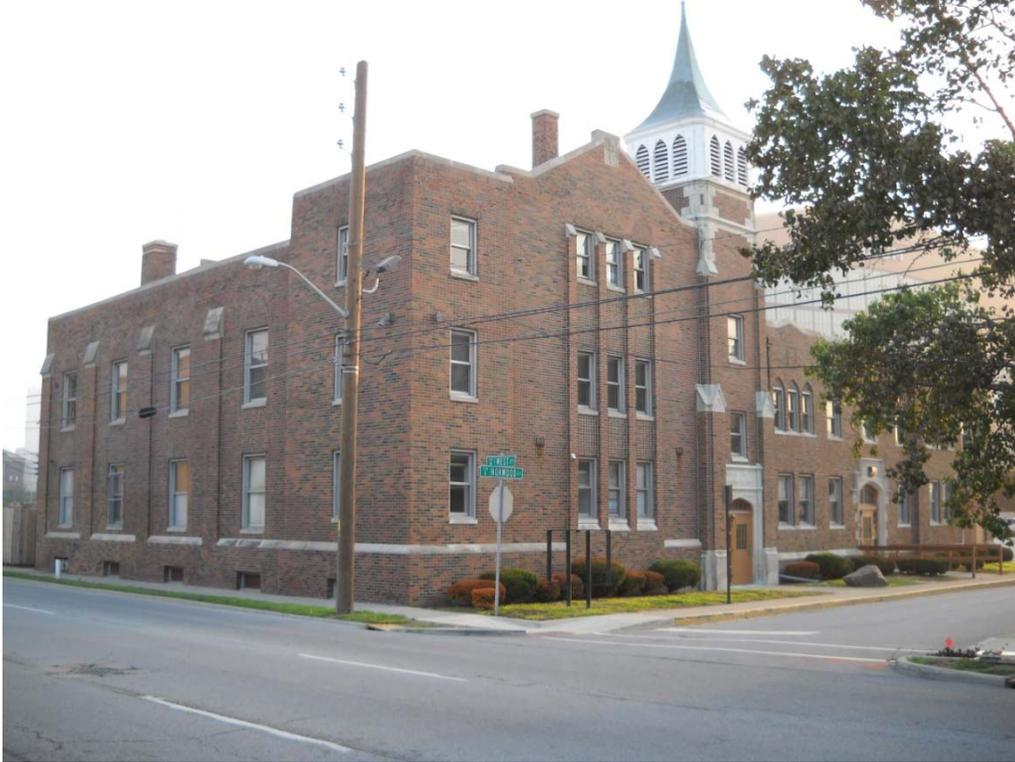
Photo 1: Overall view of the building, looking northeast

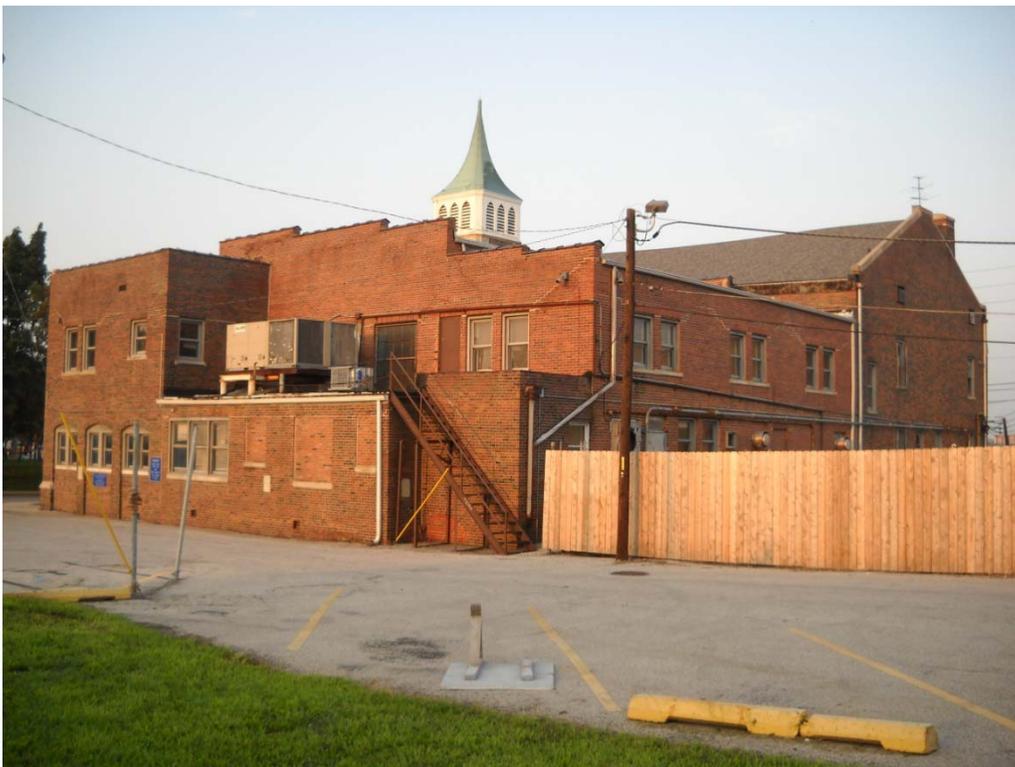
Photo 2: Overall view of the building, looking southwest

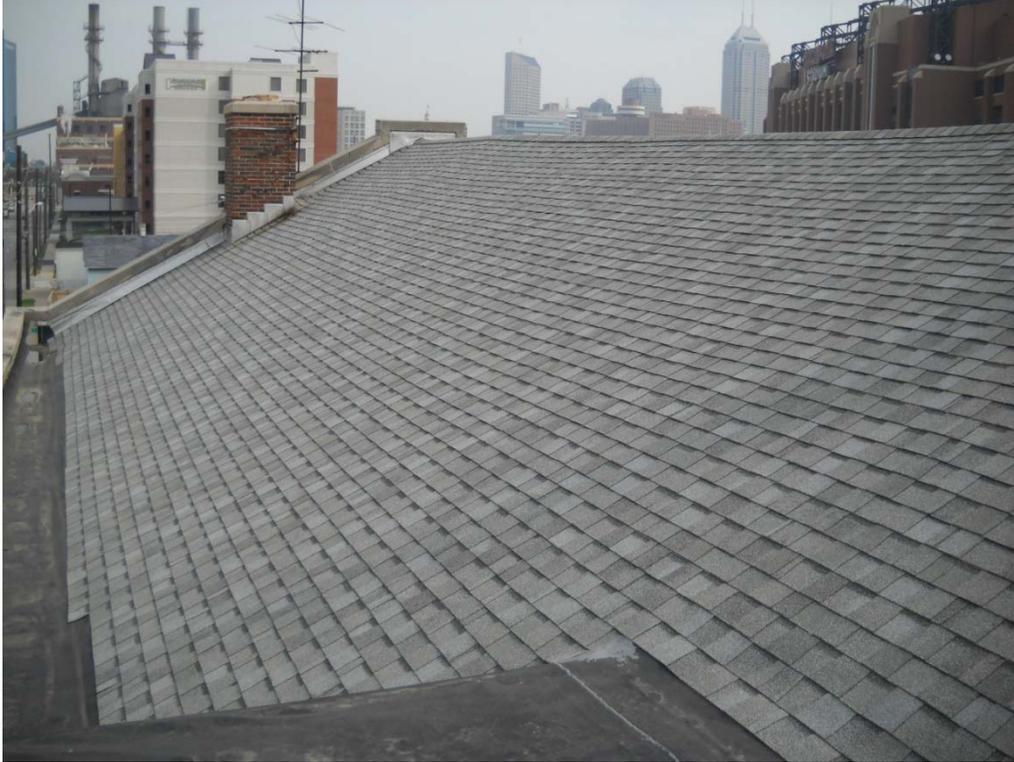
1. The western portion of the roof consisted of newer asphalt composition shingles on the high sloped roofs as well as newer EPDM membrane over gutters and low-slope roofs (Photo 3). Roofing materials were in overall good condition and the roof generally felt solid under foot.

Photo 3: Newer roofing over the western portion of the building

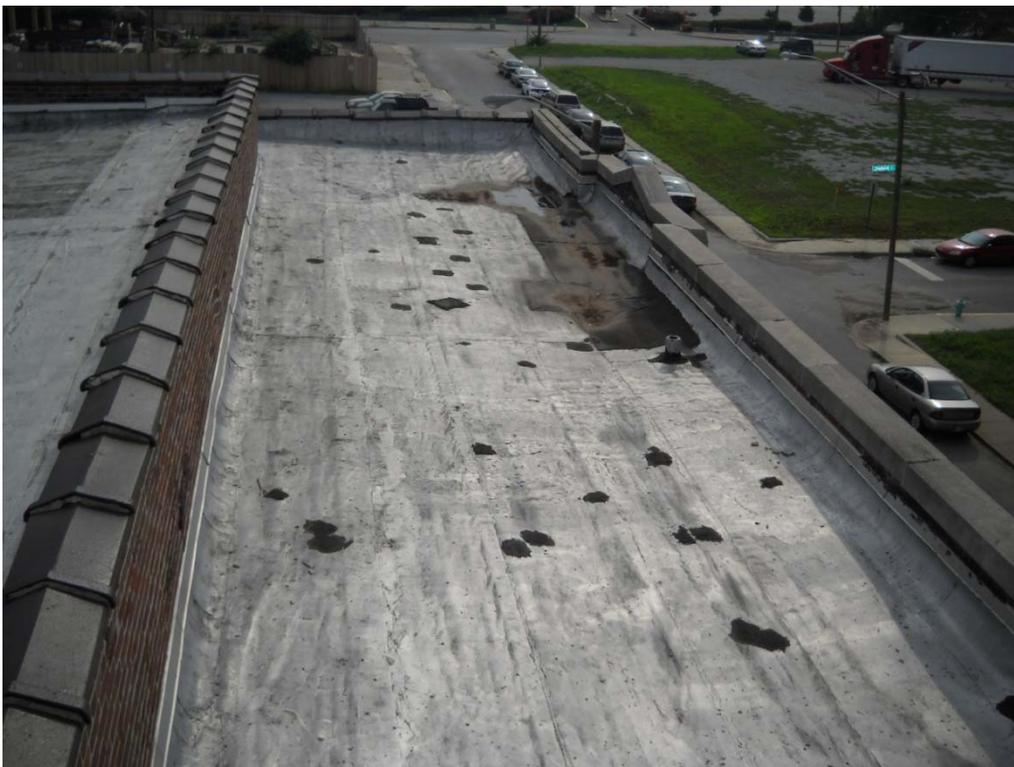
2. The eastern portion of the roof consisted of modified bitumen roofing in overall poor condition. Areas of the roof felt soft under foot (Photo 4).
3. Brick masonry exterior walls were in overall poor condition.

5. Roofing on the eastern portion of the building was in poor condition, beyond its useful life, and exhibited active leaks in multiple locations. Joists supporting the upper and lower roofs are inadequate as constructed. In addition, joists connected to the aforementioned east exterior wall have likely shifted with the wall. Significant deterioration of wood framing and roof decking

materials due to long term moisture exposure was observed in multiple locations. All wood roof joists, wood decking, and roofing materials should be replaced.

Photo 4: Roofing over the eastern portion of the building in poor condition

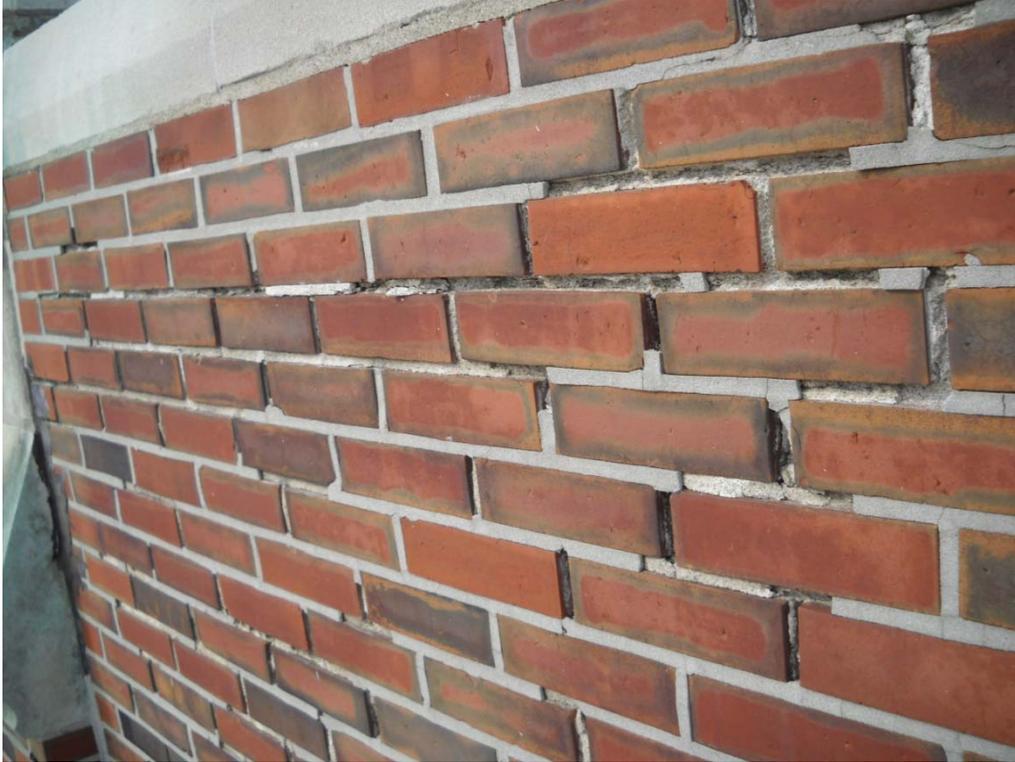
- a. Widespread spalled and missing mortar from the masonry joints was observed throughout the exterior (Photo 5).
 - b. Isolated minor stair-step cracking was observed on the western portion of the building (Photo 6). Some cracks had been previously repaired.

Photo 5: Deteriorated mortar joints near the roof on the west elevation

6. Repair the façade adjacent to the north stair to stop water infiltration. Repair or replace corroded steel supporting the north stair first floor landing.
7. Mortar joints of exterior brick masonry walls throughout the building were failing. All mortar joints should be re-pointed.
8. Sealants at windows and doors were typically deteriorated or missing; all sealants should be removed and replaced.

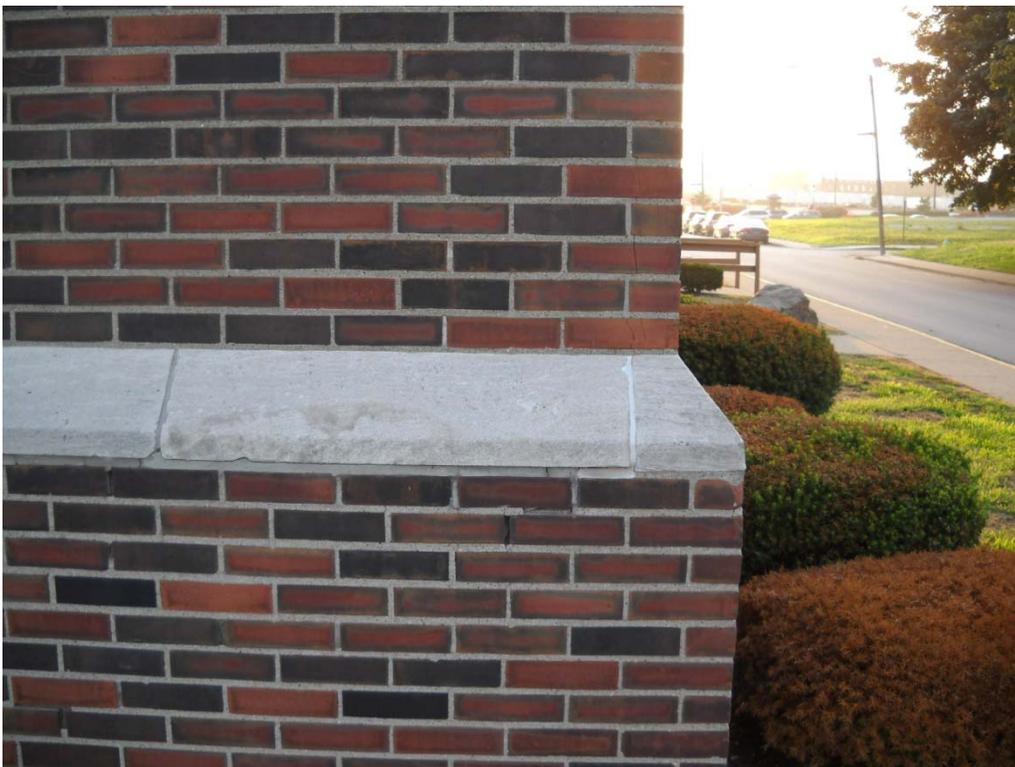
Photo 6: Cracked and deteriorated brick masonry at the southwest corner of the building

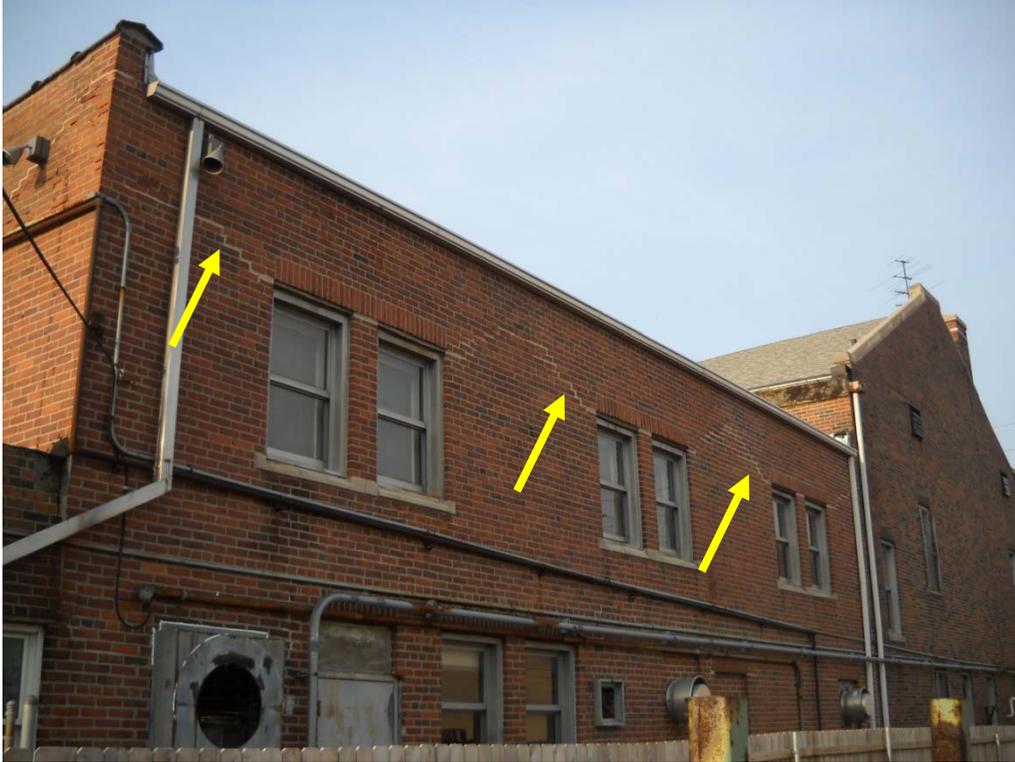
- c. The eastern portion of the building revealed many open and previously repaired cracks on the south, east and north elevations (Photos 7, 8, 9, and 10). These cracks were consistent with foundation settlement as well as thermal expansion and contraction of the walls and expansion (pack) rusting of the steel lintels. The east exterior wall appeared to have settled approximately one-half to one inch vertically.

Photo 7: Previously repaired cracks in brick masonry on the north elevation

2. Other exterior brick masonry walls at the east end of the building revealed cracking and numerous previous repairs consistent with foundation settlement, thermal movement, and expansion (pack) rusting of the steel lintels. These walls should be repaired or partially replaced. Significantly corroded steel lintels should be replaced.

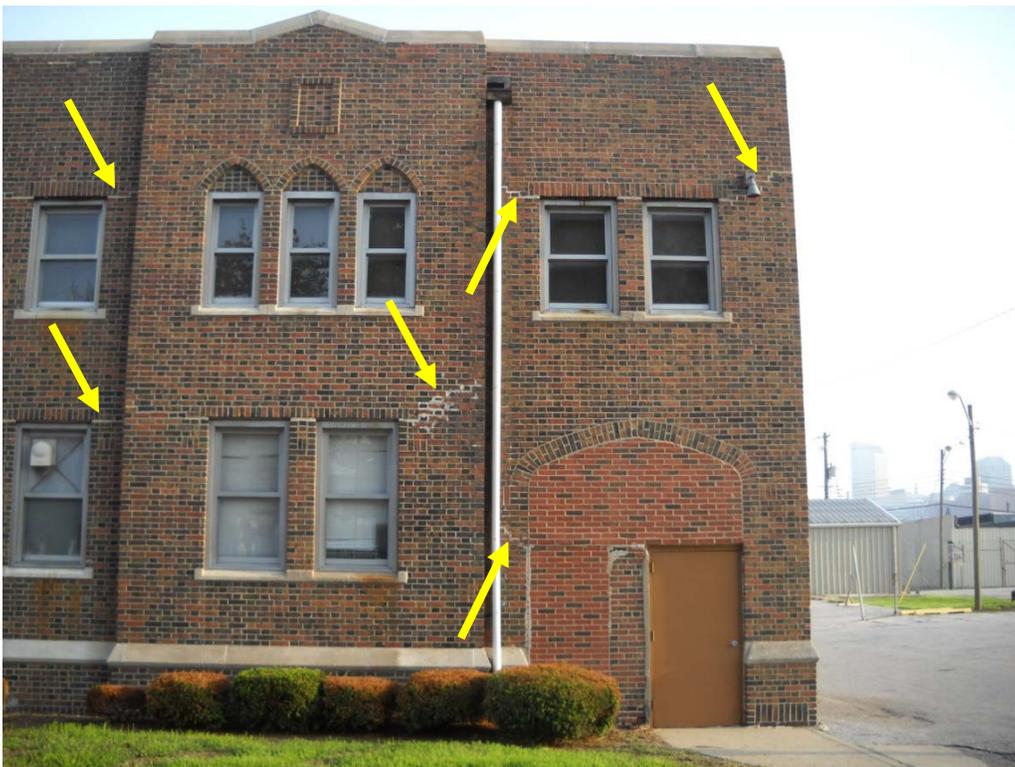
Photo 8: Previously repaired cracks in brick masonry on the south elevation

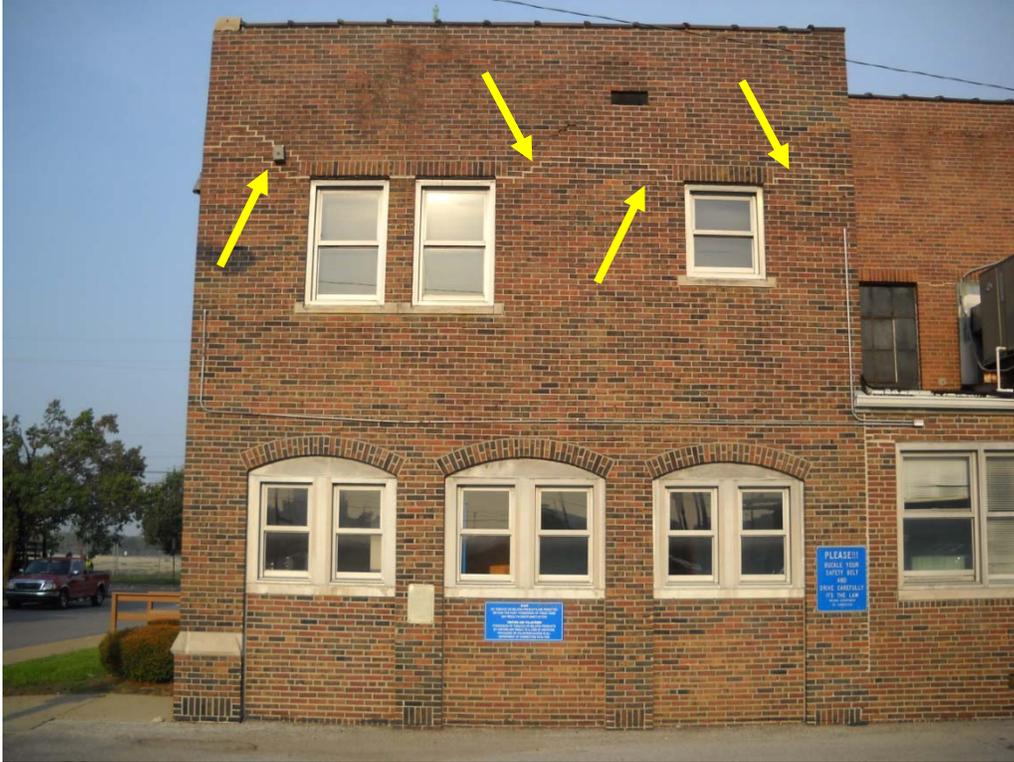
Photo 9: Previously repaired cracks in brick masonry on the east elevation

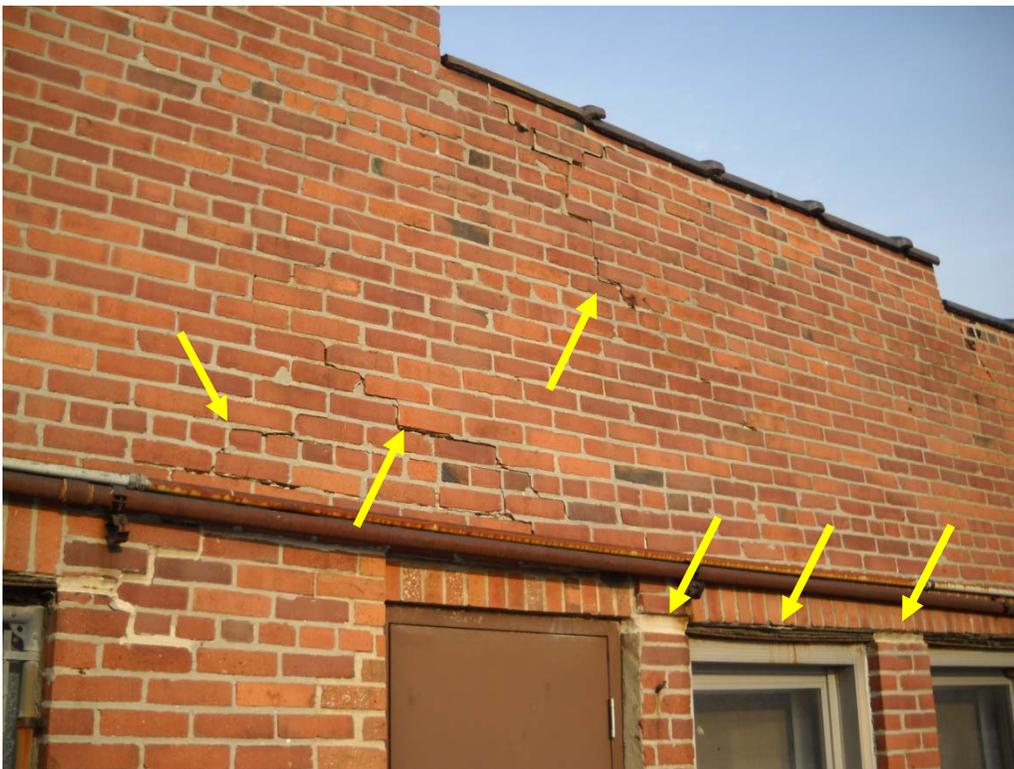
Photo 10: Open cracks, previously repaired cracks, corroded steel lintels on the east elevation above the lower roof

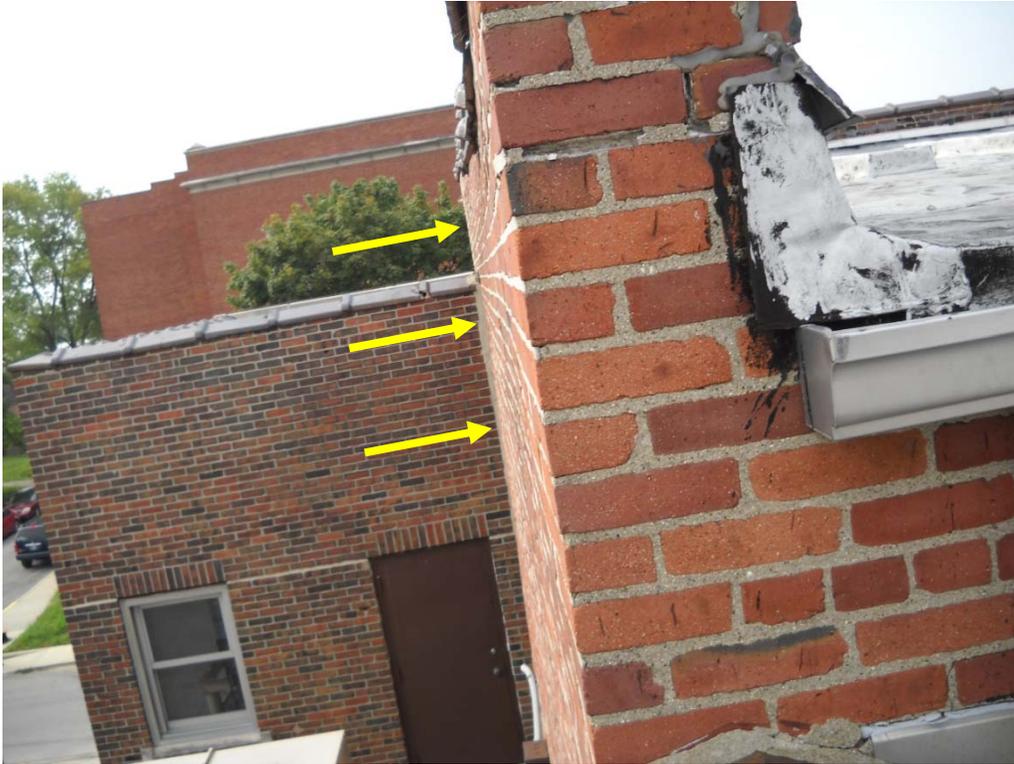
- d. The east exterior wall above the lower roof leans and bows eastward (Photo 11). We estimate the wall has shifted up to approximately six inches out of plumb at the top. Open cracks, displaced brick, and corroded steel lintels were also observed on this wall.

1. The east exterior brick masonry wall above the lower roof revealed significant deterioration, numerous past repairs, and severe westward leaning and bowing. This wall is unstable; it should be removed and reconstructed.

Photo 11: Leaning and bowing brick masonry wall on the east elevation above the lower roof

We do not recommend occupying the eastern portion of the building until deficiencies in the floor framing and east exterior wall are stabilized or corrected.

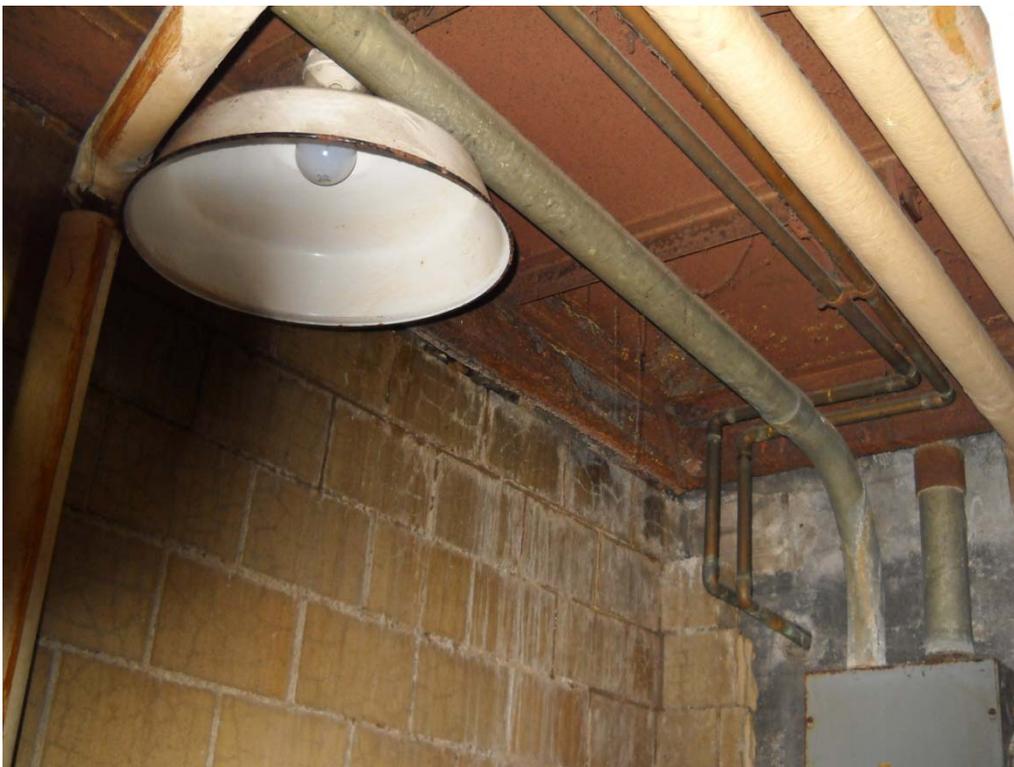
4. The western portion of the building consisted of cast in place reinforced concrete foundation walls, unreinforced multi wythe brick exterior load bearing walls, and wood framed floors and roof.
5. Evidence of long-term water infiltration was observed at the north stair on the exterior wall, including corroded steel support of the first floor landing (Photo 12).
6. Wood trusses supporting the roof over G-dorm on the second floor were reinforced with steel rod collar ties. No evidence of distress or deterioration of the trusses was observed from the floor level.

Photo 12: Corroded steel support for the first floor landing

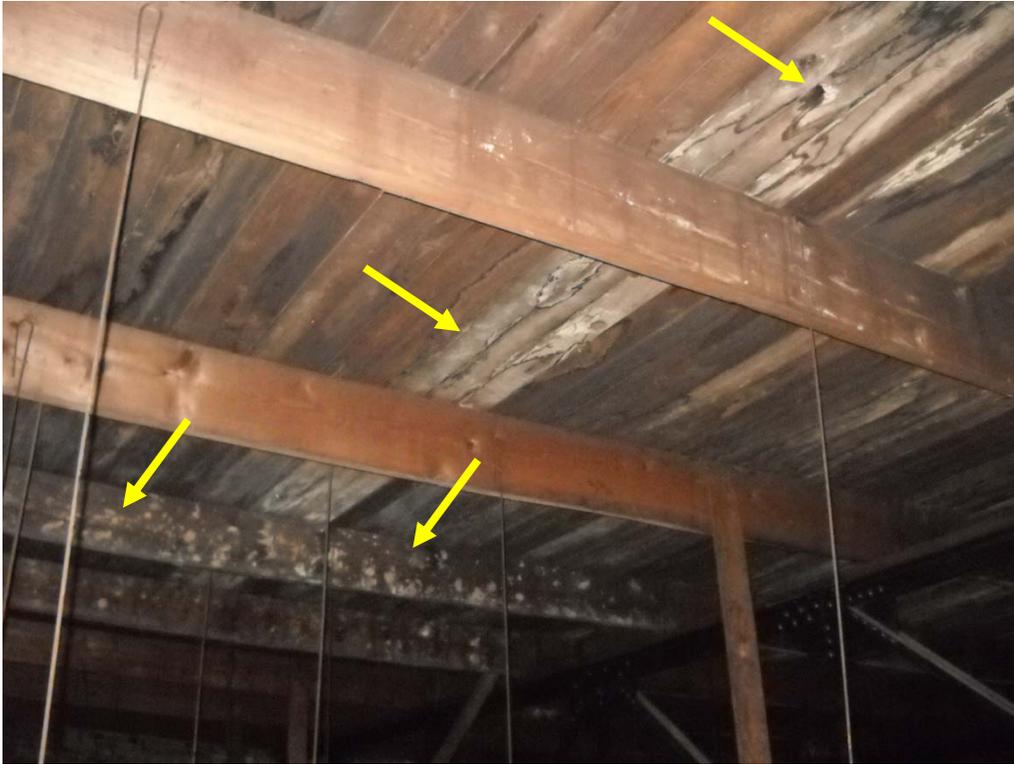
8. Wood joists supporting the roof were excessively spaced by observation. Areas of moisture deterioration as well as apparent mold growth were observed in the attic space (Photo 13).

Photo 13: Moisture deterioration of wood roof decking and apparent mold growth of roof joists

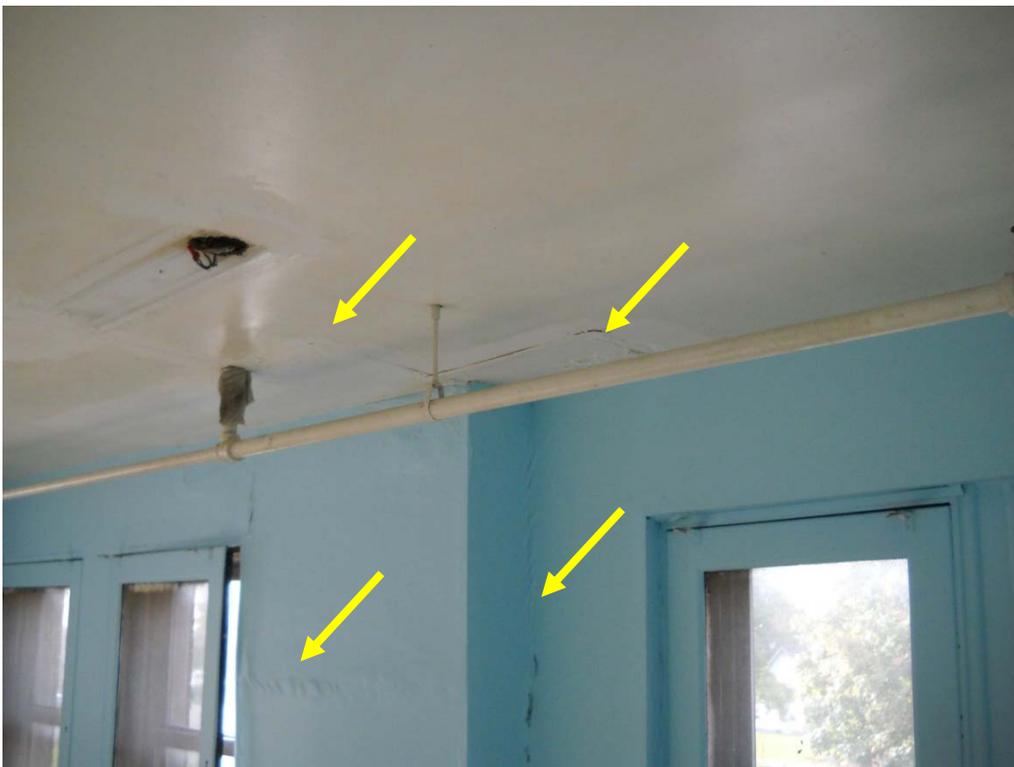
9. Active roof leaks were observed at multiple locations in the southern two-story area, and were typically accompanied by deteriorated wood roof and floor framing as well as deteriorated and water-stained finish materials (Photos 14 and 15). Some previously repaired finishes were observed.

Photo 14: Previously repaired and deteriorated ceiling and south exterior wall in F-Dorm on the second floor

4. The east end of the building exhibited multiple areas of active water infiltration. Long term exposure to moisture has caused significant deterioration to wood framing members. These members should be repaired or replaced where appropriate.

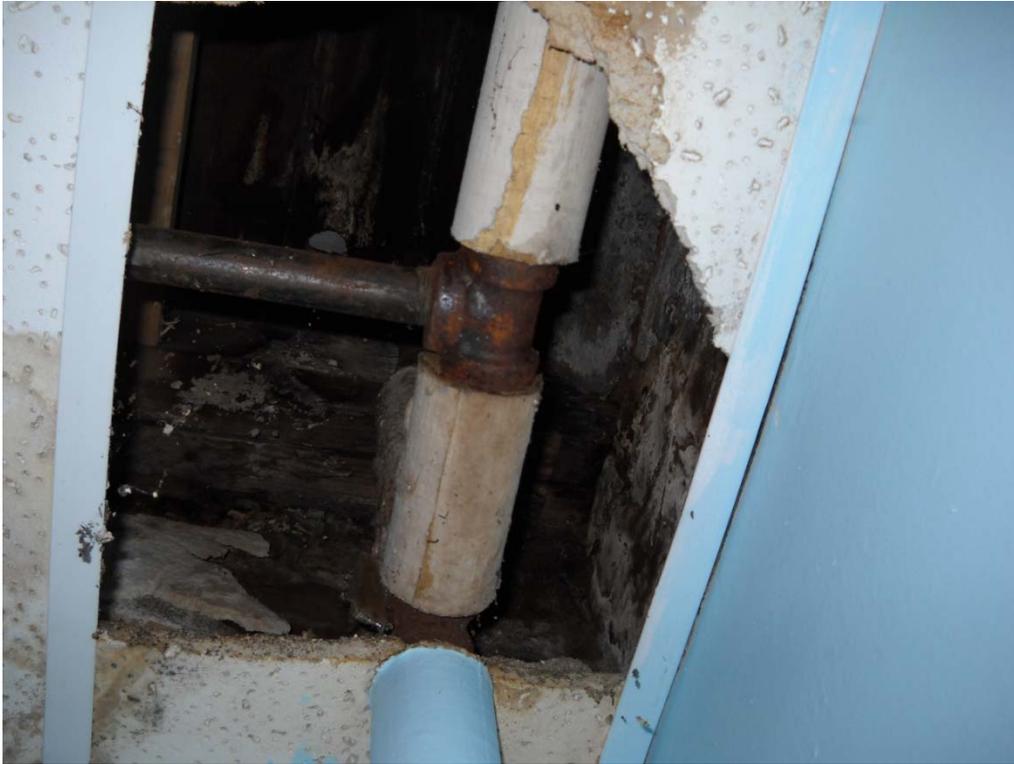
Photo 15: Deteriorated wood framing supporting the floor below F-Dorm

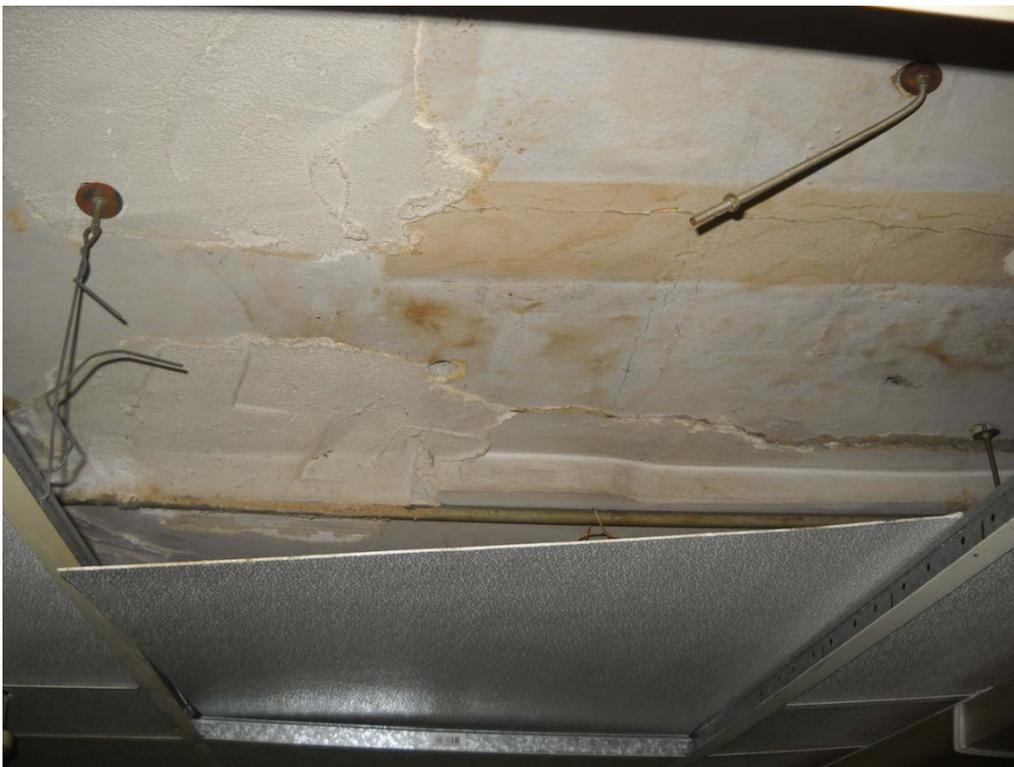
10. A severe sag or deflection of the second level floor structure was observed in the northern two-story area containing A, B and C Dorms. The sag measured approximately three inches maximum and was greatest below a wall along the corridor. . The plaster ceiling in the kitchen below revealed numerous cracks and past repairs (Photo 16).

3. Floor framing supporting the northeast corner of the second floor (A, B and C Dorms plus corridor) exhibits severe permanent deformation, likely caused by long term support of the upper level wall where deformation is highest. The floor structure supporting these spaces must be reinforced or replaced.

Photo 16: Repairs and cracks in the plaster ceiling above the kitchen
