Pavement Condition Report

Anderson Municipal Airport

Project 1480370

January 2014

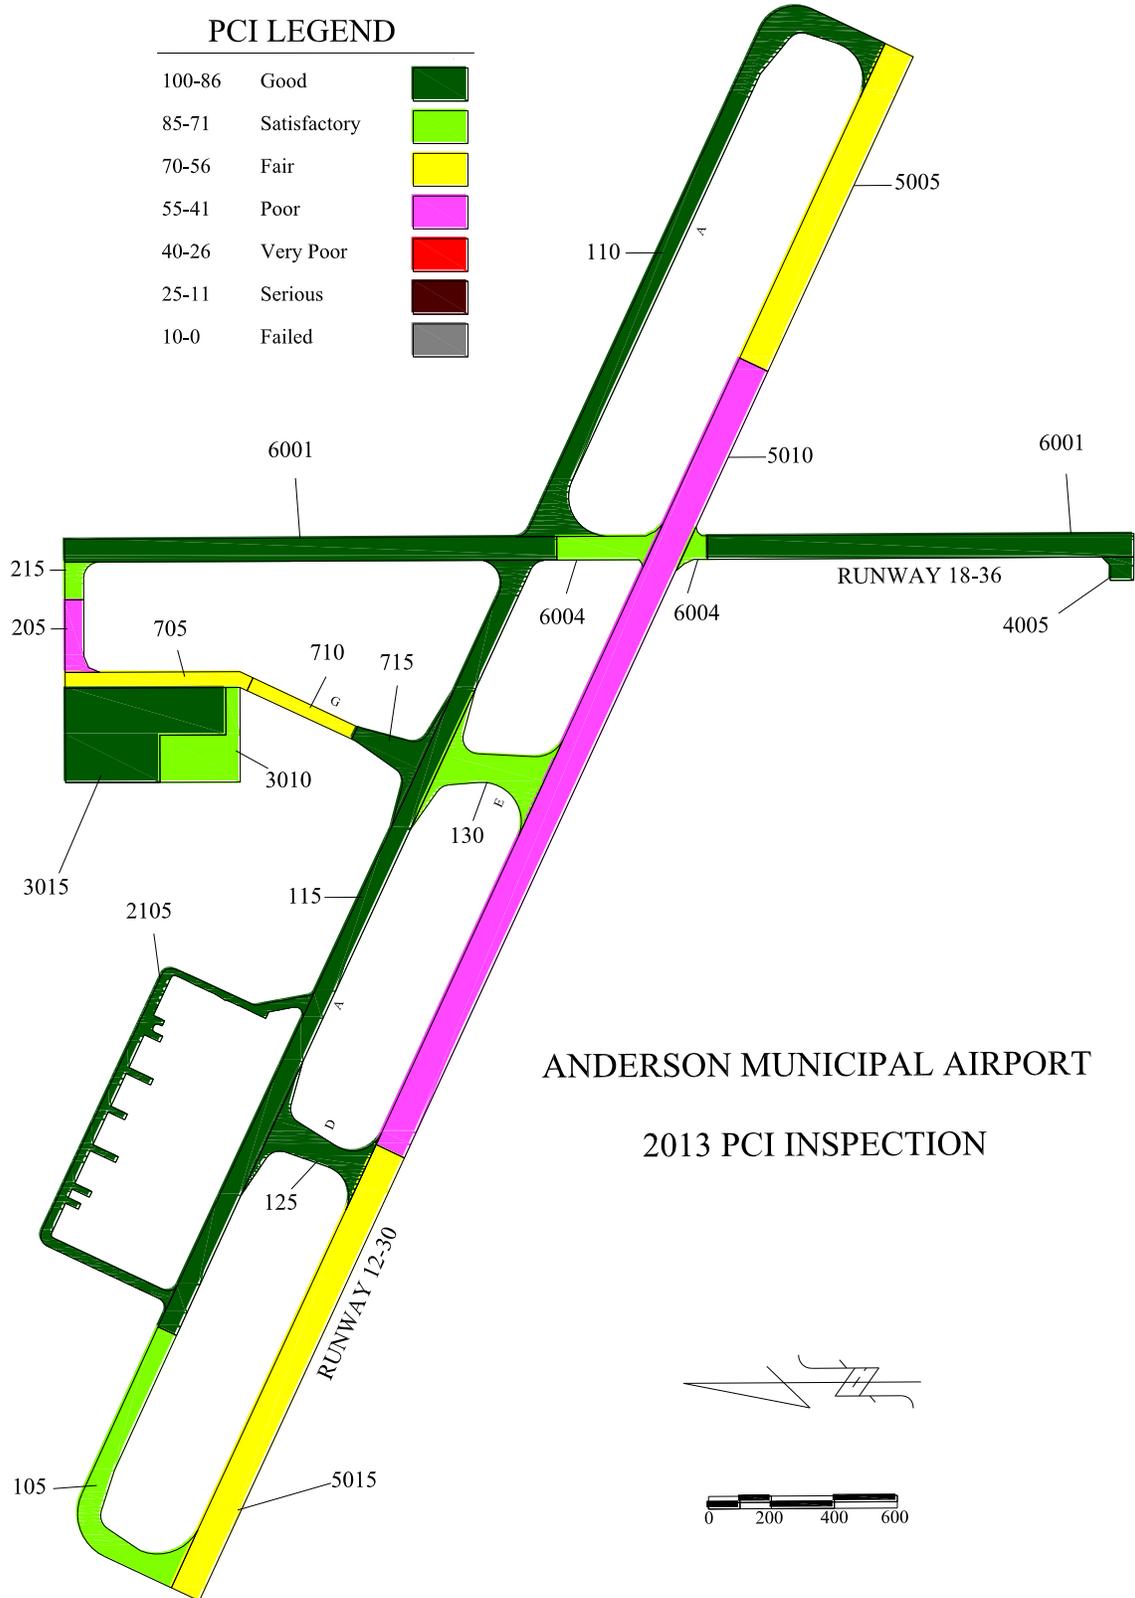
Figure 2-1. Inspected Pavement Condition

The pavement within each of the PCI condition categories is shown in Figure 2-1. The inspected PCI is summarized by branch use in Figure 2-2, and the photographs in Figure 2-3 through Figure 2-7 provide examples of the condition categories.

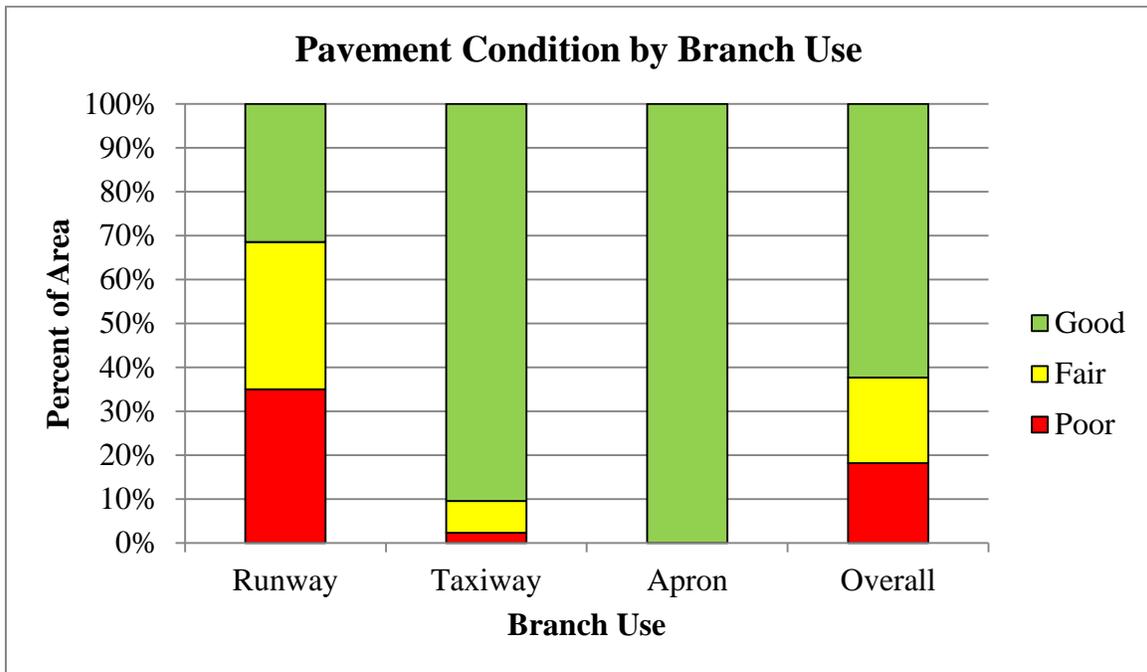
Figure 2-2. Pavement Condition by Branch Use

The overall Pavement Condition Index (PCI) for the airfield pavements was 78. Runways had an average inspected PCI of 66 and were above the desired MSL of 60. Taxiways had an average inspected PCI of 90, and ramps had an average inspected PCI of 94.

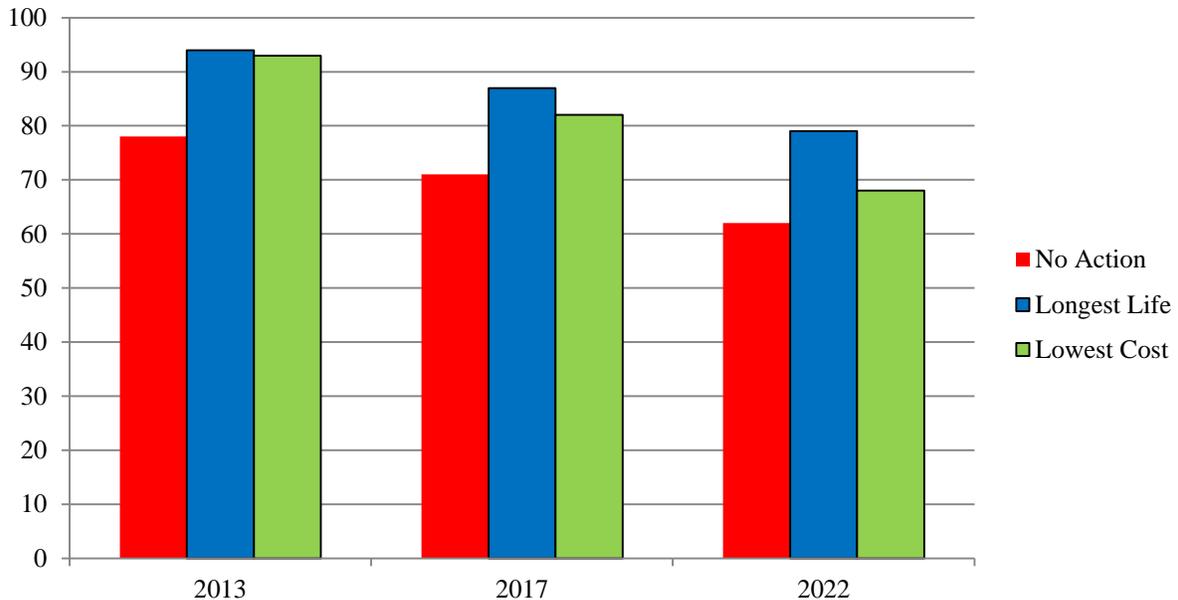
Figure 3-1. Programmed CIP

The table below provides a summary of the projected pavement rehabilitation needs for the next 5 years of the capital improvement program, starting in 2013. The estimated cost for the rehabilitation actions that provide the greatest increase in pavement service life is approximately \$860,000 in 2013 dollars. If no action is taken, the overall PCI is projected to drop to 71 by 2017.

Project Year	Calendar Year	Amount
Year 1	2013	55,197
Year 2	2014	-
Year 3	2015	188,901
Year 4	2016	36,175
Year 5	2017	-
5-Year Total		\$ 856,668

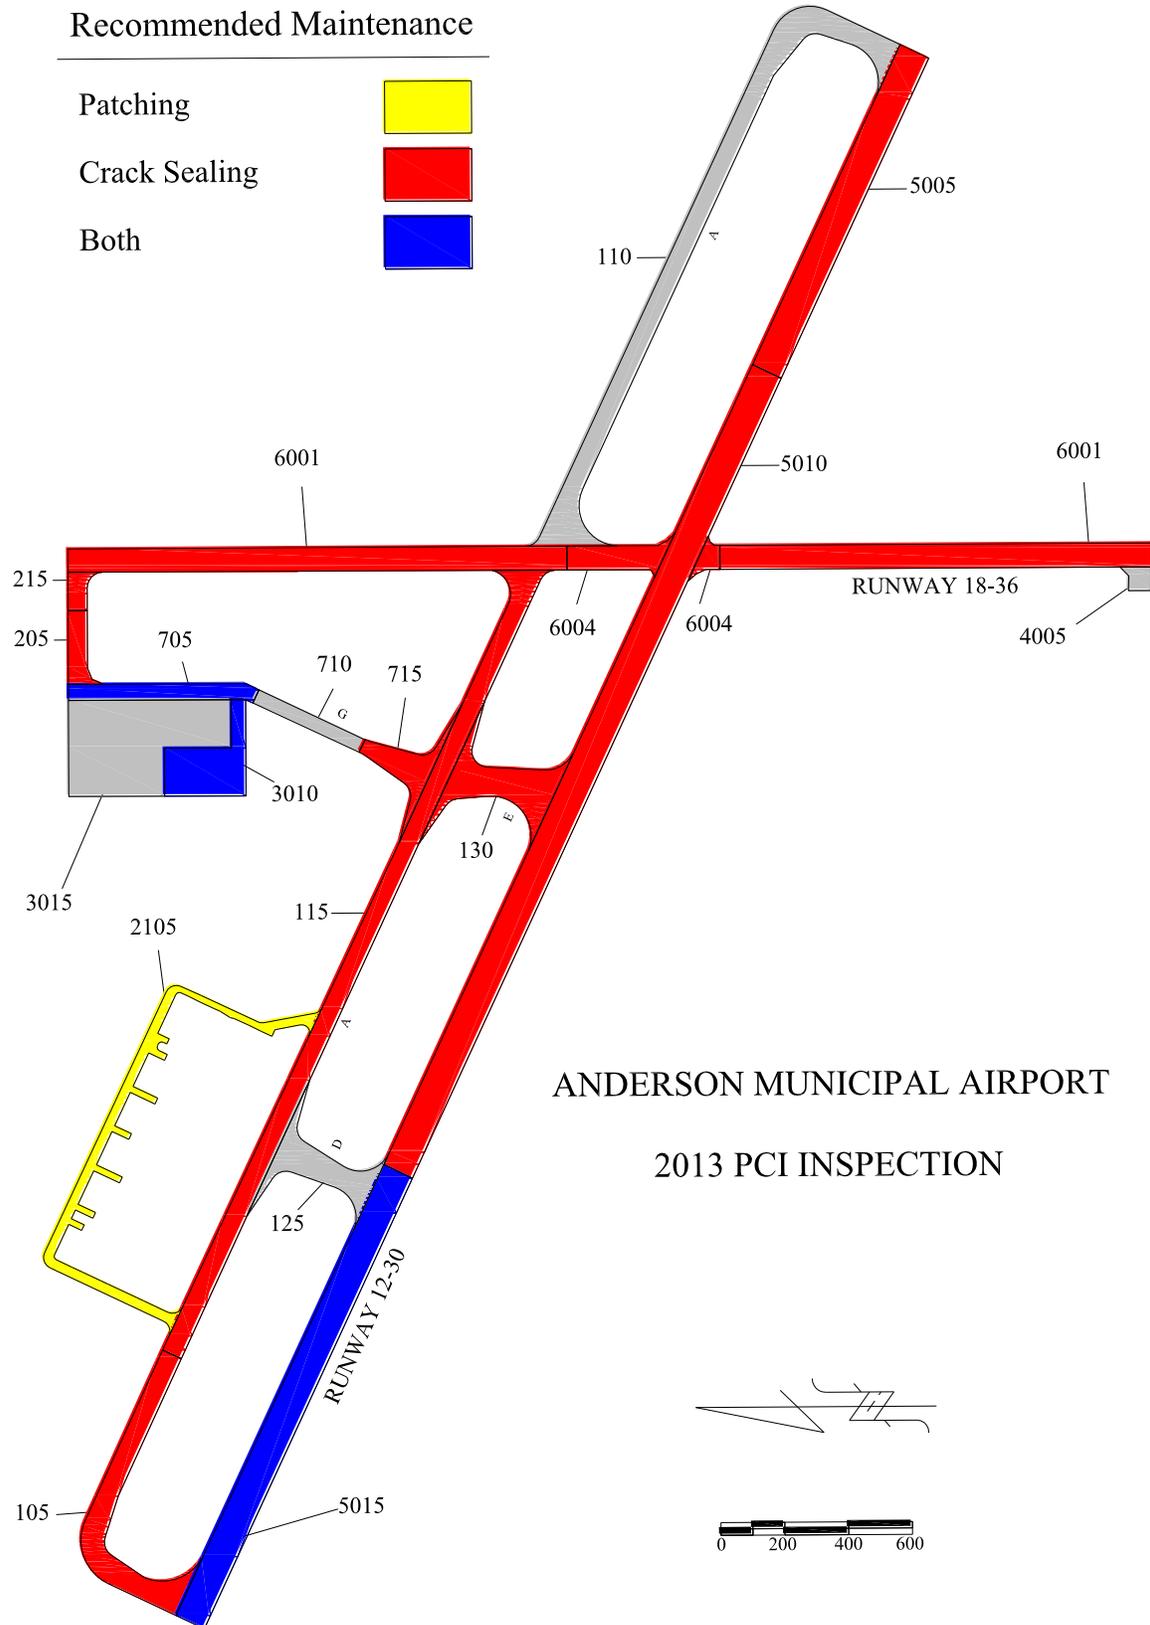
Figure 4-1. Recommended Maintenance

Analysis of potential maintenance projects identified approximately 1,800 square feet of patching needs and approximately 28,000 linear feet of crack sealing and crack repair needs, at an estimated total cost of approximately \$60,000.

Work Item	Quantity	Unit	Cost
AC PATCH	211	SF	\$1,834
AC RESTORATIVE CRACK REPAIR	12,867	LF	\$15,955
AC SUSTAINING CRACK REPAIR	8,747	LF	\$7,568
PCC RESTORATIVE CRACK REPAIR	6,202	LF	\$13,913
PCC SLAB REPLACEMENT	1,120	LF	\$13,983
PCC PATCHING	429	SF	\$7,138
Total:			\$ 60,391
