Pavement Condition Report

Bloomington-Monroe County Airport

Project 15805741

February 2015

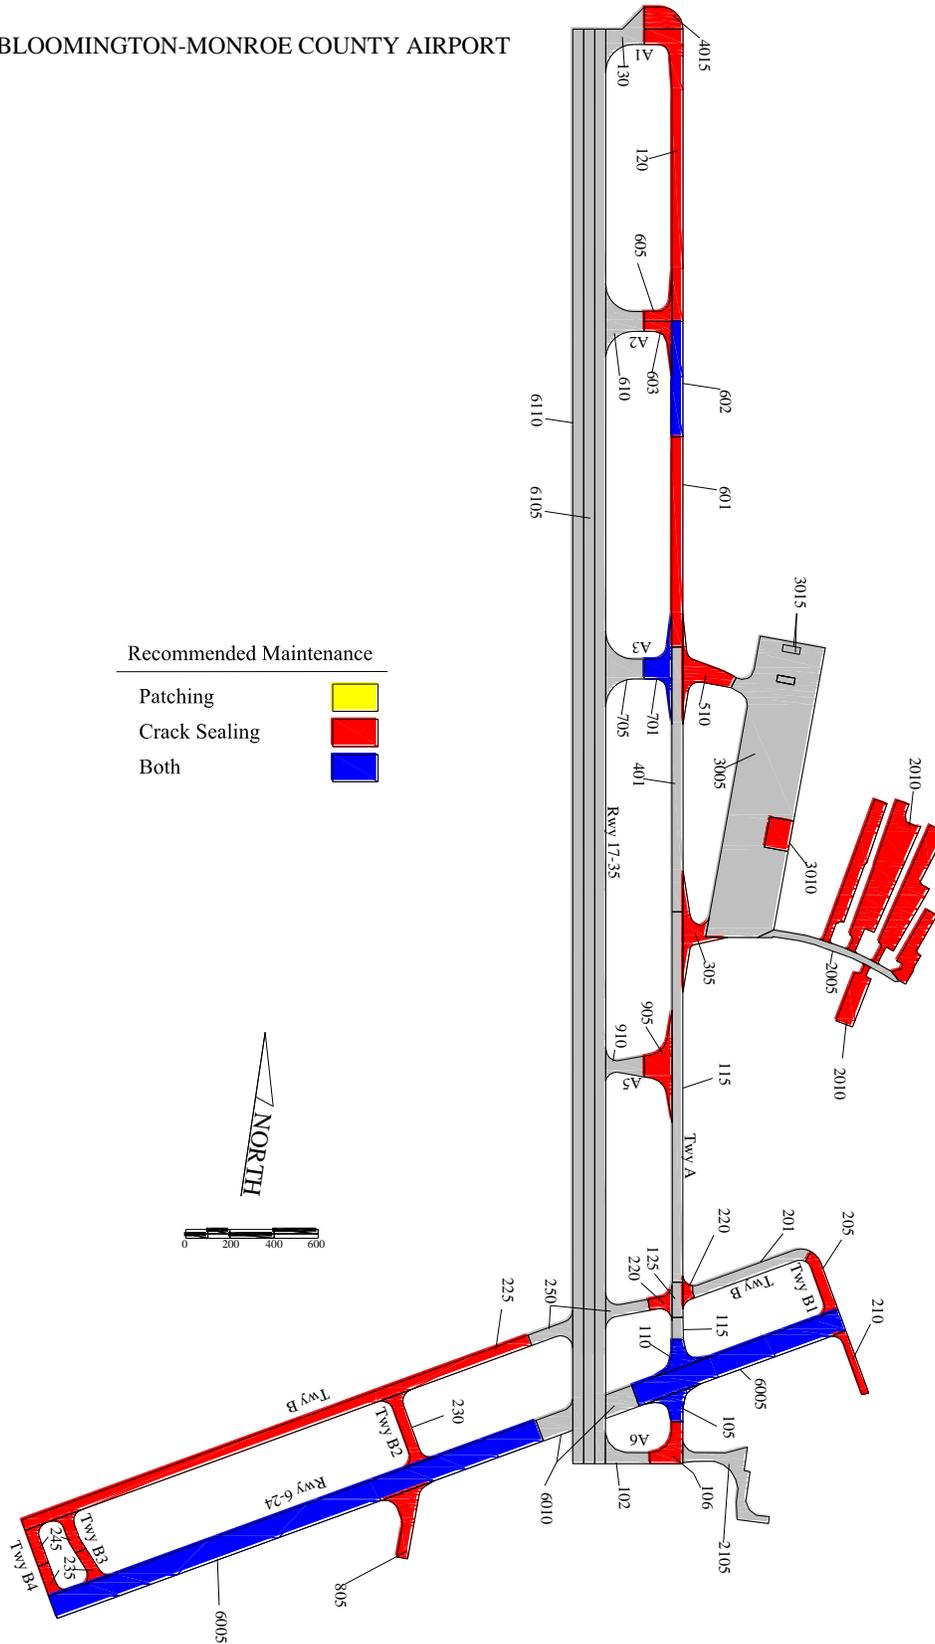
Figure 4-1. Recommended Maintenance

Analysis of potential maintenance projects identified approximately 2,300 square feet of patching needs and approximately 26,000 linear feet of crack sealing and crack repair needs, at an estimated total cost of approximately \$49,000
