Pavement Condition Report

Frankfort Municipal Airport

Project 13801869

January 2013

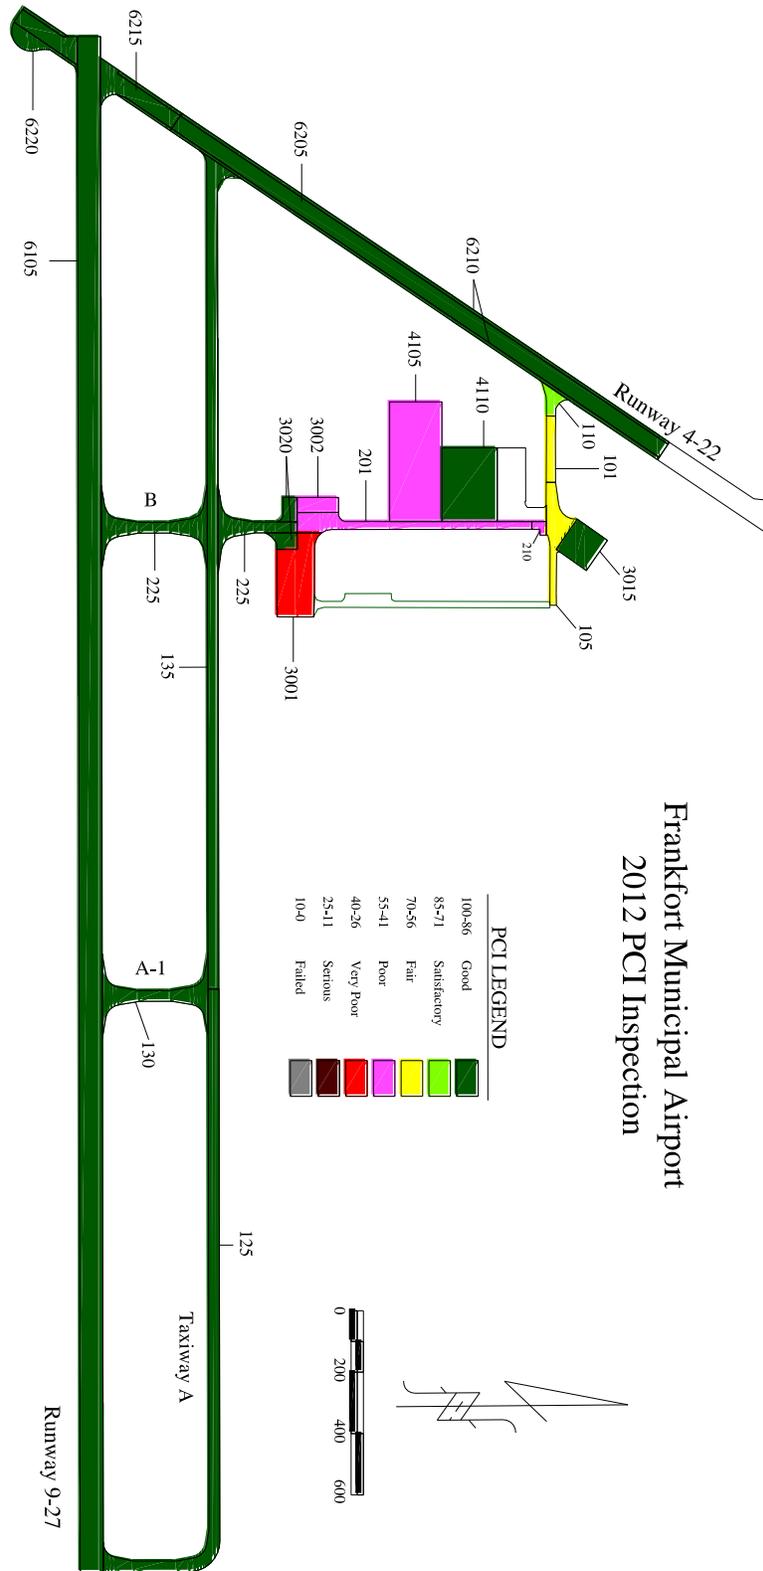
Figure 2-1. Inspected Pavement Condition

Five pavement sections had a simplified PCI rating of Poor, indicating that intensive maintenance and/or major M&R is needed to maintain serviceability. The pavement within each of the PCI condition categories is shown in Figure 2-1. The inspected PCI is summarized by branch use in Figure 2-2, and the photographs in Figure 2-3 through Figure 2-7 provide examples of the condition categories.
