Pavement Condition Report

French Lick Municipal Airport

Project 15805741

February 2015

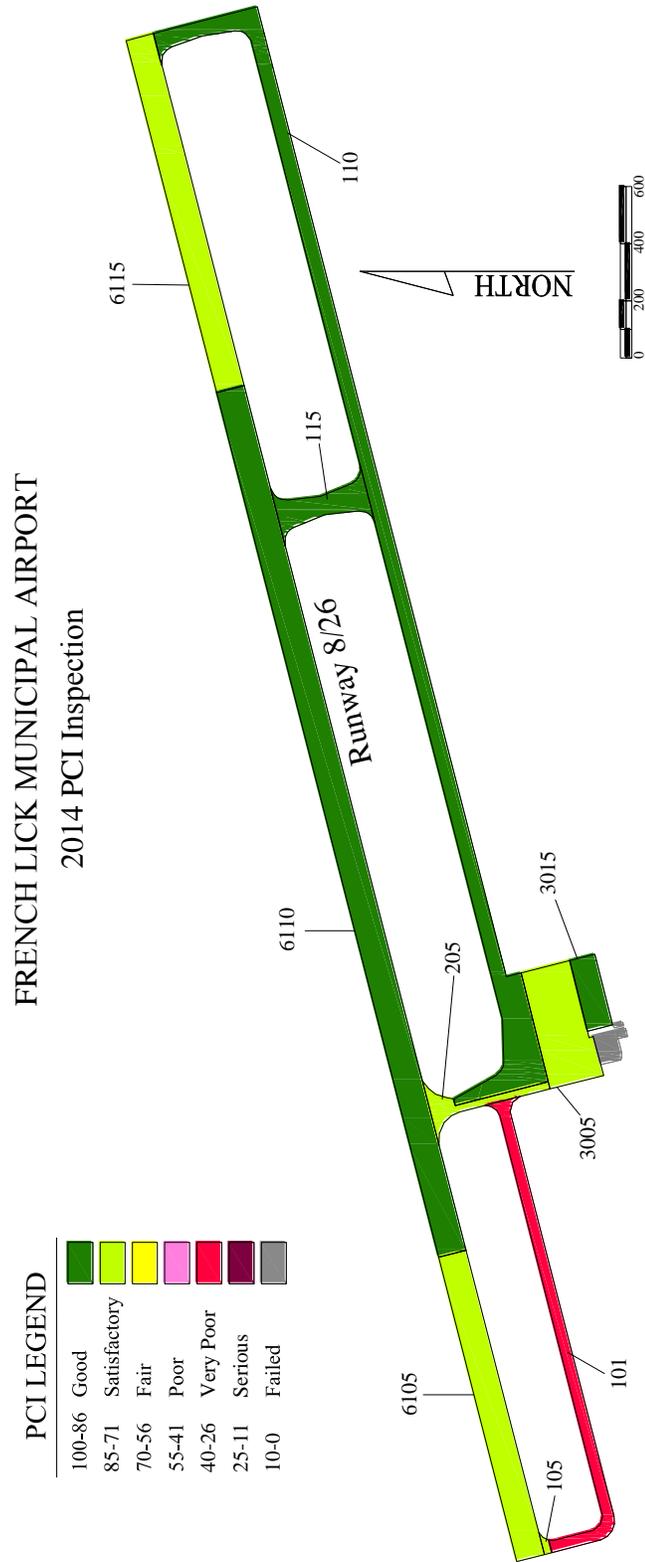
Figure 2-1. Inspected Pavement Condition

The average inspected Pavement Condition Index (PCI) for all the airfield pavements was 85. Runways had an average inspected PCI of 85 and were above the desired MSL of 60. Taxiways had an average inspected PCI of 83, and ramps had an average inspected PCI of 87.
