# Pavement Condition Report

## Gary/Chicago International Airport

Project 13801869

**January 2013**

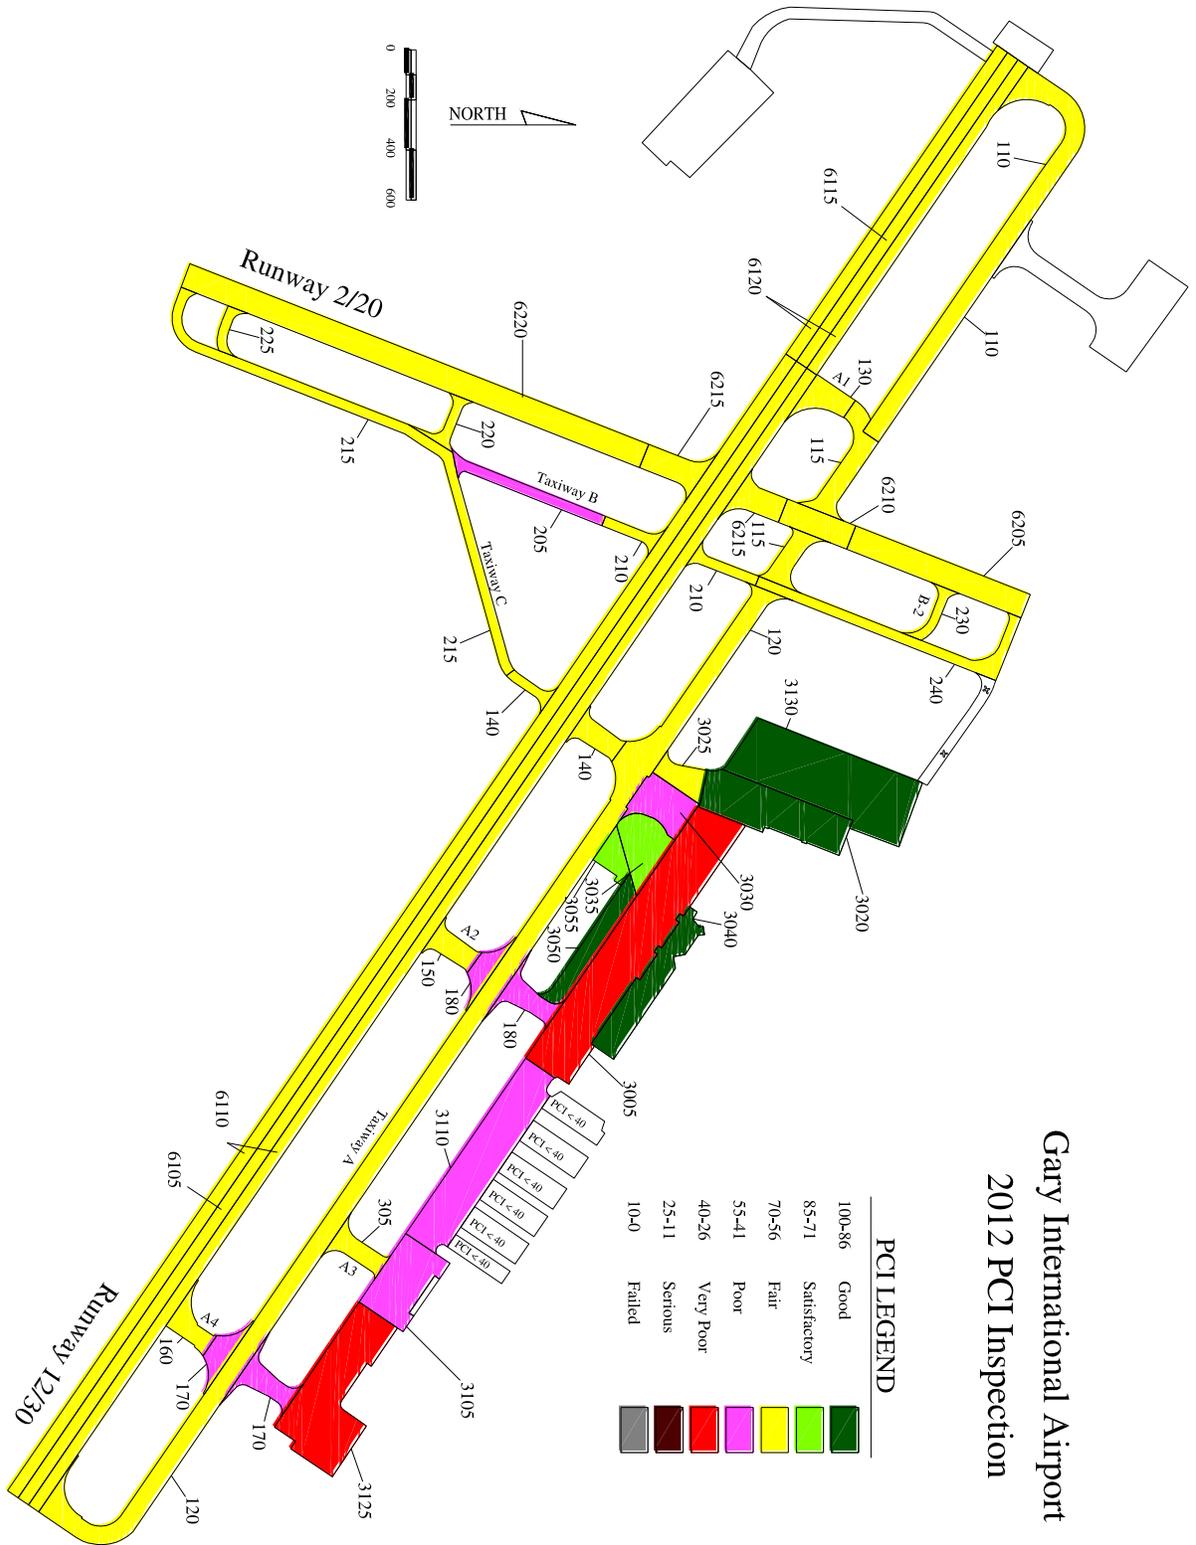
Figure 2-1. Inspected Pavement Condition

Pavement sections 3005 (Terminal Ramp) and 3125 (FBO Ramp) had PCI range ratings of Very Poor, indicating intensive pavement rehabilitation is needed to maintain serviceability. Six pavement sections including: 170 (Twy A-4), 180 (Twy A-2), 205 (Twy B), 3030 (Ramp), 3105 (FBO Ramp), and 3110 (FBO Ramp) had PCI range ratings of Poor, indicating that either major M&R is needed or that near-term maintenance needs may be extensive in order to maintain serviceability. The pavement within each of the PCI condition categories is shown in Figure 2-1. The inspected PCI is summarized by branch use in Figure 2-2, and the photographs in Figure 2-3 through Figure 2-7 provide examples of the condition categories.

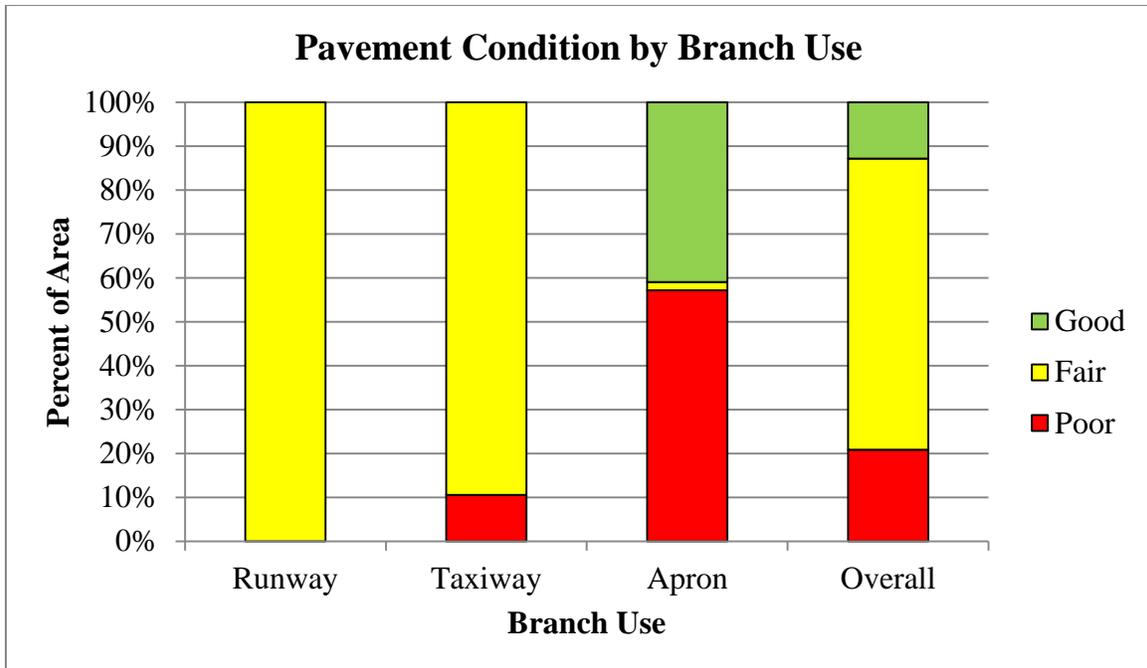
Figure 2-2. Pavement Condition by Branch Use

The overall Pavement Condition Index (PCI) for the airfield pavements was 64. Runways had an average inspected PCI of 66 and were below the desired MSL of 70. Taxiways had an average inspected PCI of 65, and ramps had an average inspected PCI of 61.

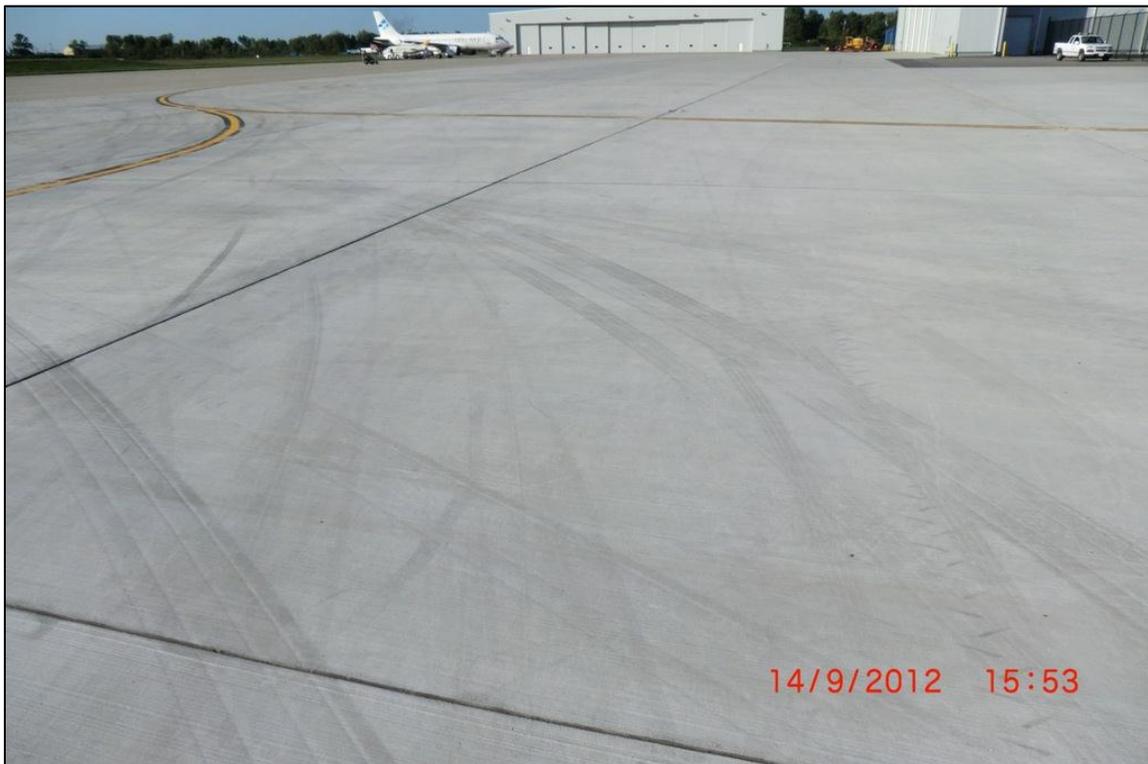
Figure 2-3. Typical Good PCC Pavement (Feature 3020)

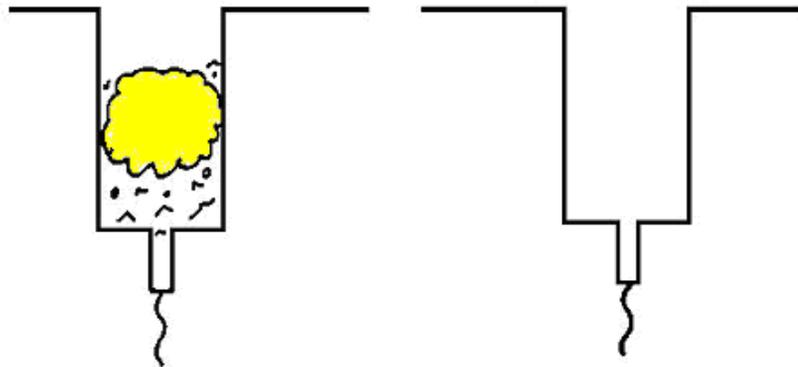
Typical failed joint sealant, w/ debris and incompressibles.

Clean joints exposing fresh, clean concrete and stone. Retain existing reservoir shape.
