Pavement Condition Report

Indianapolis Metropolitan Airport

Project 13801869

January 2013

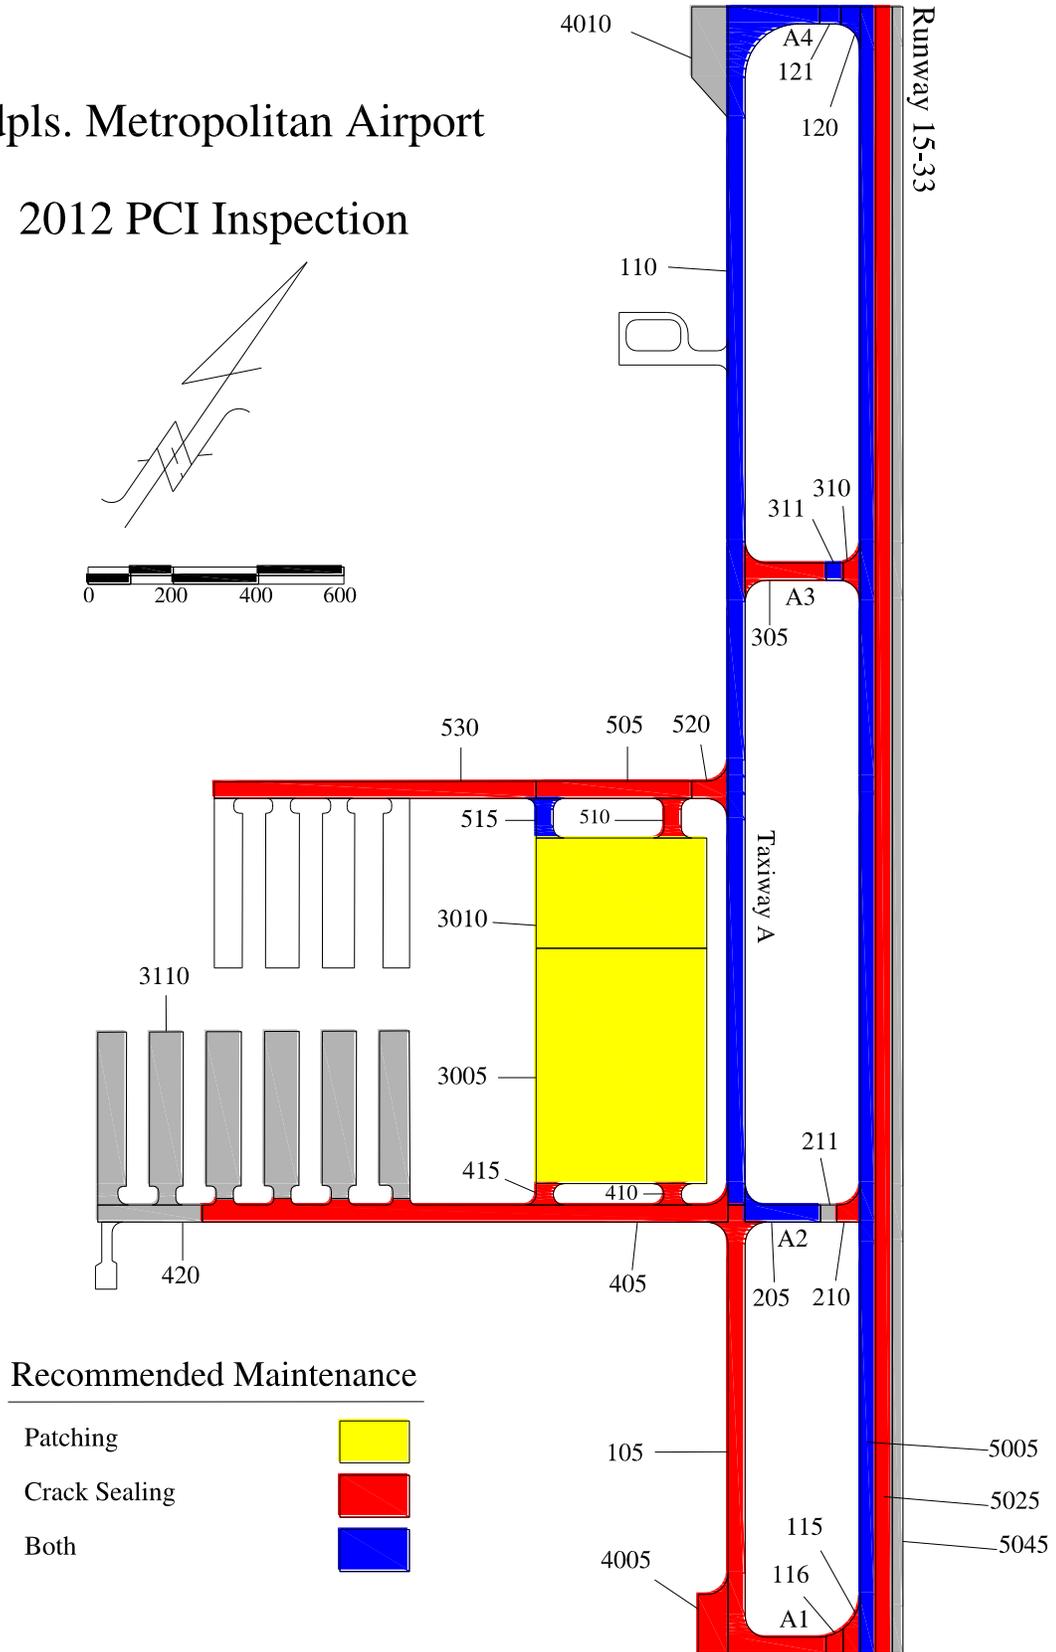
2012 PCI Inspection

The overall Pavement Condition Index (PCI) for the airfield pavements was 72. The runway had an average inspected PCI of 48 and was below the desired MSL of 60. Taxiways had an average inspected PCI of 62, and ramps had an average inspected PCI of 94.

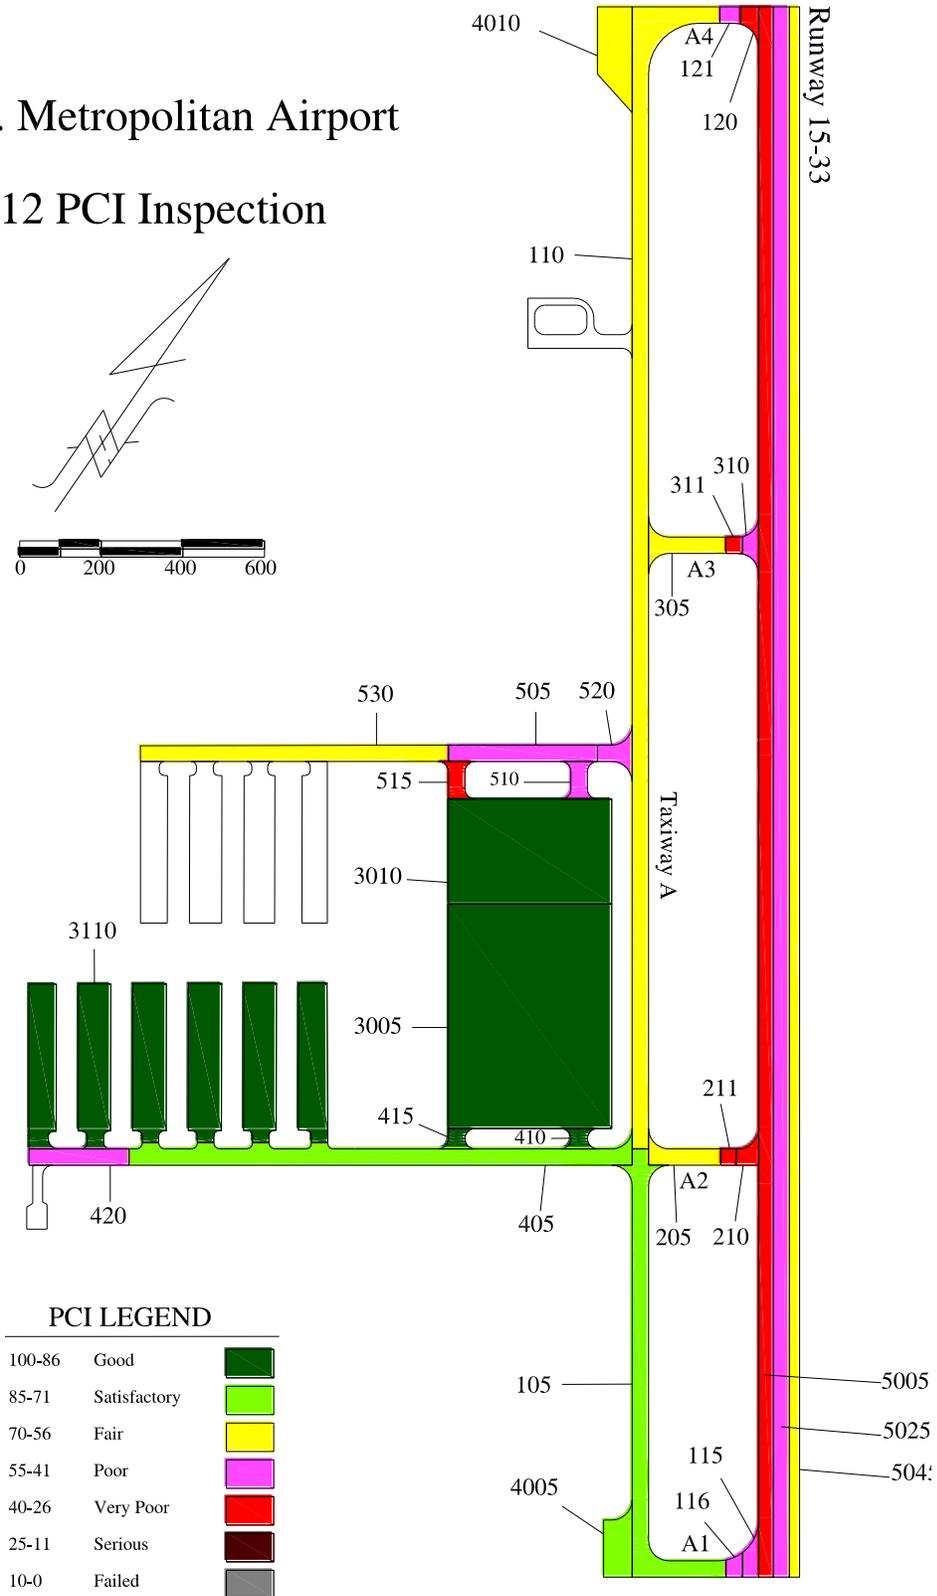
Figure 2-1. Inspected Pavement Condition

Pavement sections 120, 210, 211, 311, 515 and 5005 had simplified PCI ratings of Very Poor, indicating that near-term maintenance needs will be extensive in nature in order to maintain serviceability. The pavement within each of the PCI condition categories is shown in Figure 2-1. The inspected PCI is summarized by branch use in Figure 2-2, and the photographs that follow provide examples of the condition categories.

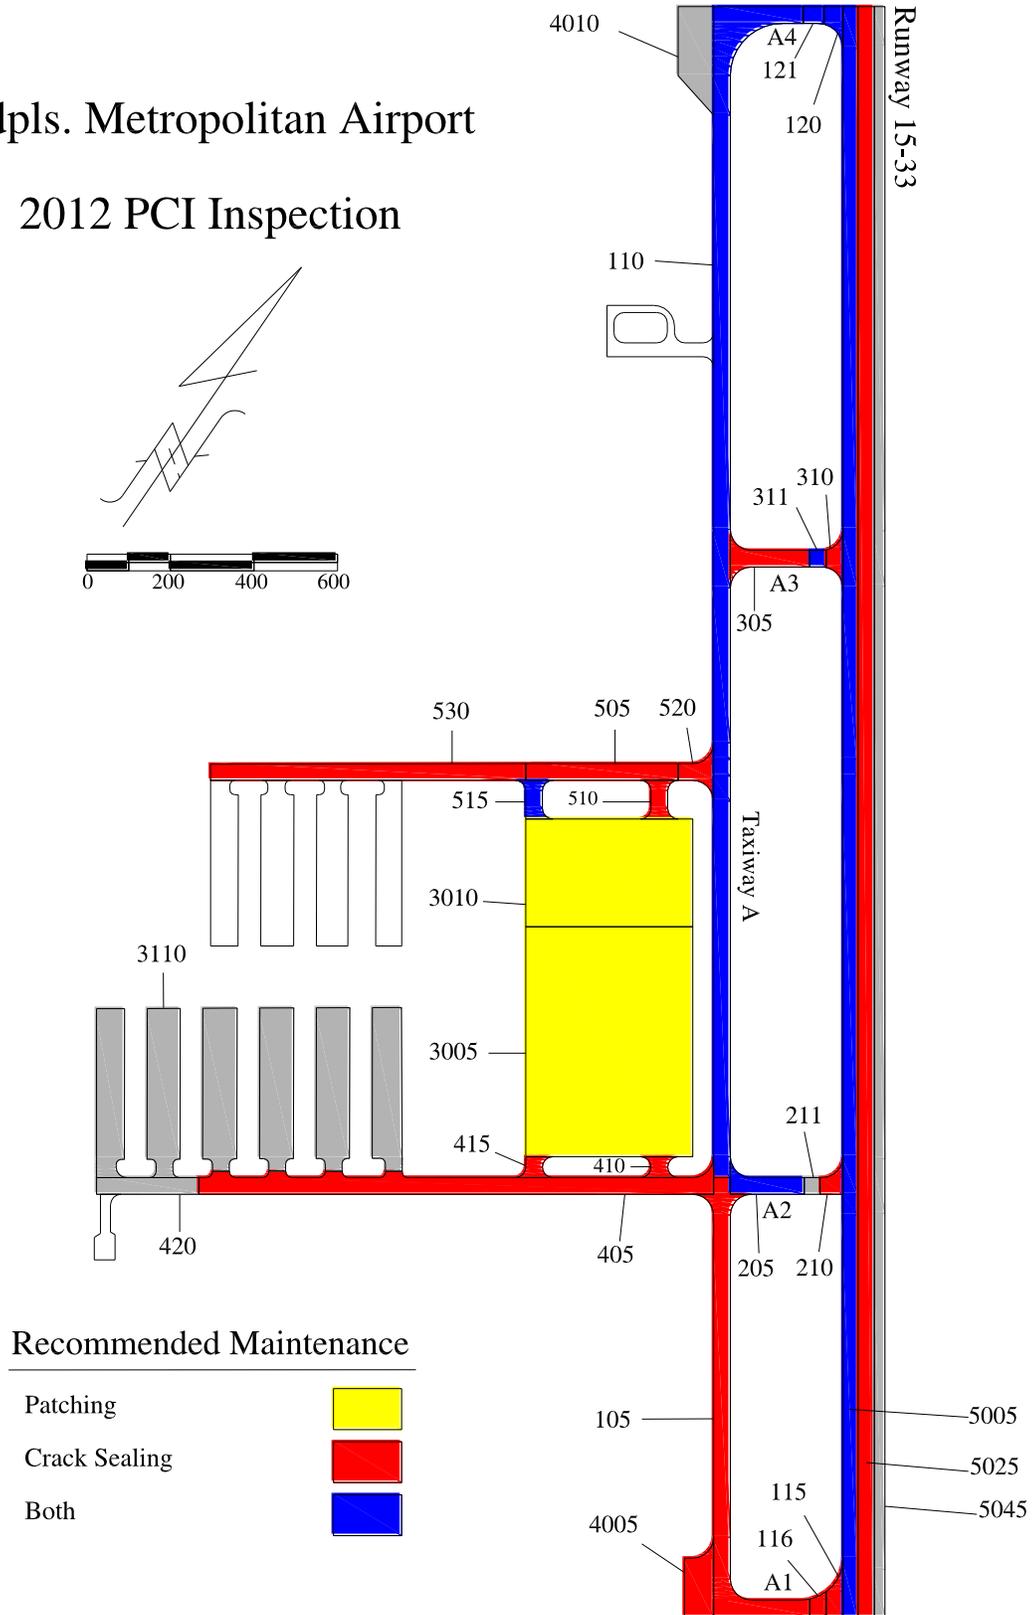
Figure 4-1. Recommended Maintenance

Analysis of potential maintenance projects identified approximately 2,400 square feet of patching needs and approximately 12,000 linear feet of crack sealing and crack repair needs, at an estimated total cost of approximately \$ 41,000.

Work Item	Quantity	Unit	Cost
AC PATCH	597	SF	\$5,080
AC RESTORATIVE CRACK REPAIR	3,326	LF	\$4,057
AC SUSTAINING CRACK REPAIR	9,197	LF	\$7,838
PCC PATCHING	451	SF	\$7,390
SLAB REPAIR/REPLACEMENT	1,388	SF	\$16,997
Total:			\$41,362

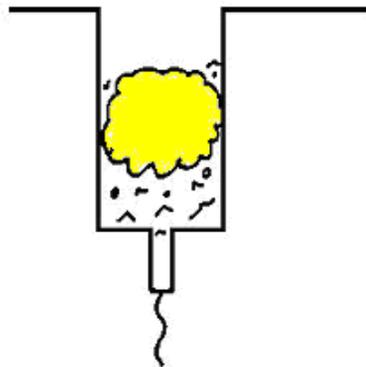
Typical failed joint sealant, w/ debris and incompressibles.
