# Pavement Condition Report

## North Vernon Airport

Project 13801869

**January 2013**

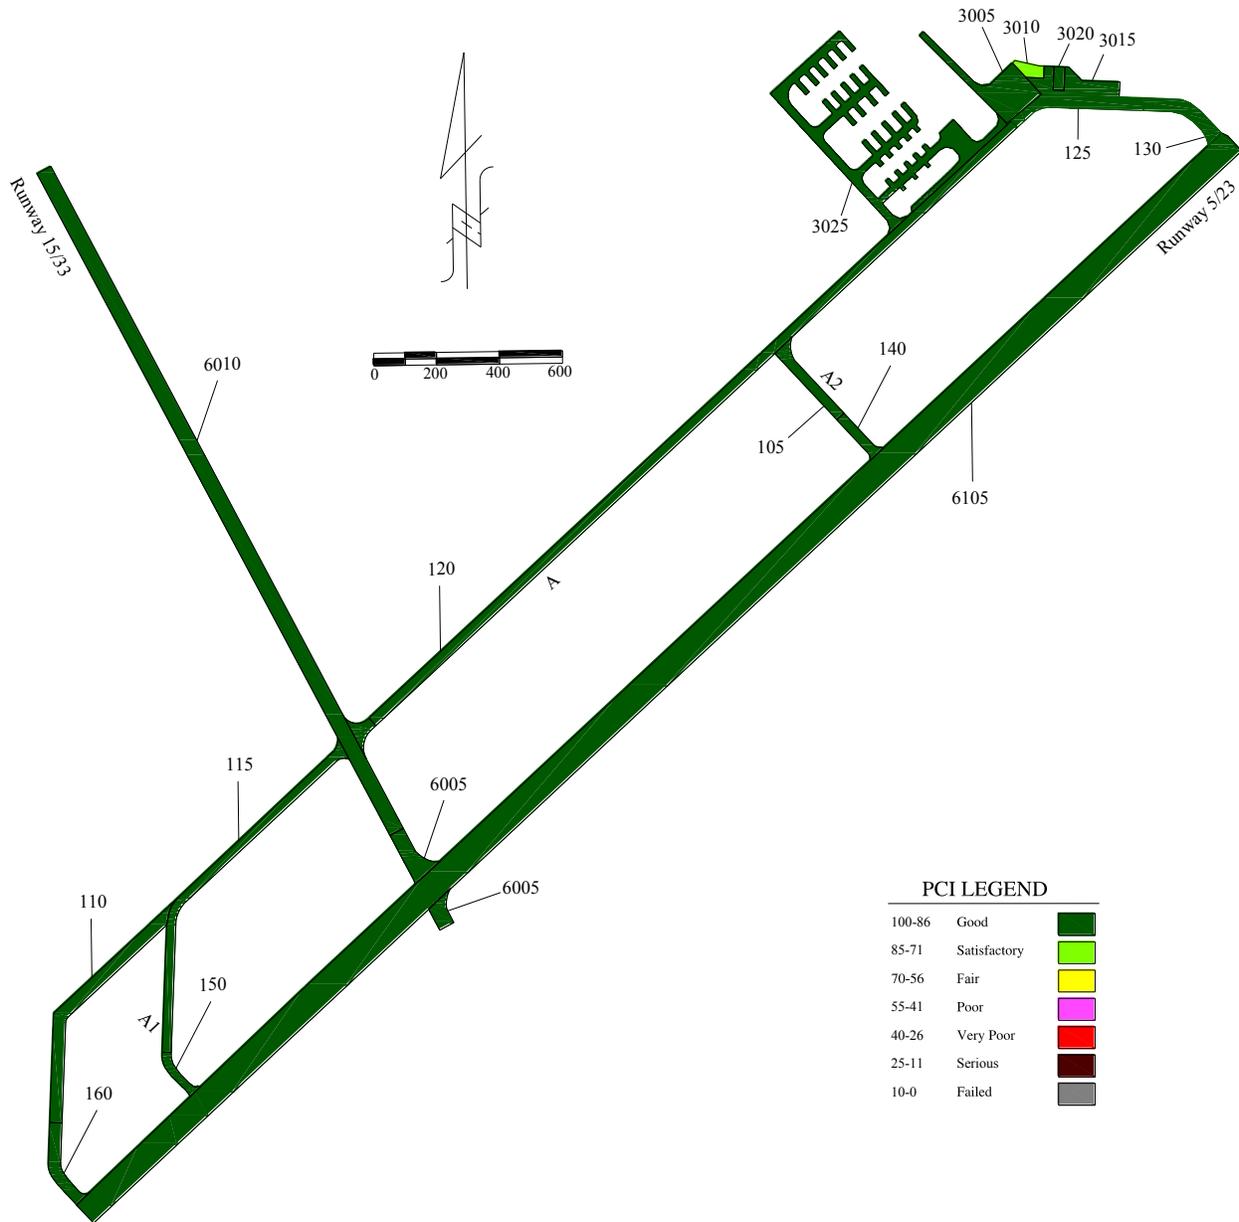
Figure 2-1. Inspected Pavement Condition

Much of the OVO airfield was recently reconstructed and all of the pavement areas are in good or satisfactory condition. The pavement within each of the PCI condition categories is shown in Figure 2-1. The inspected PCI is summarized by branch use in Figure 2-2, and the photographs that follow provide examples of the condition categories.

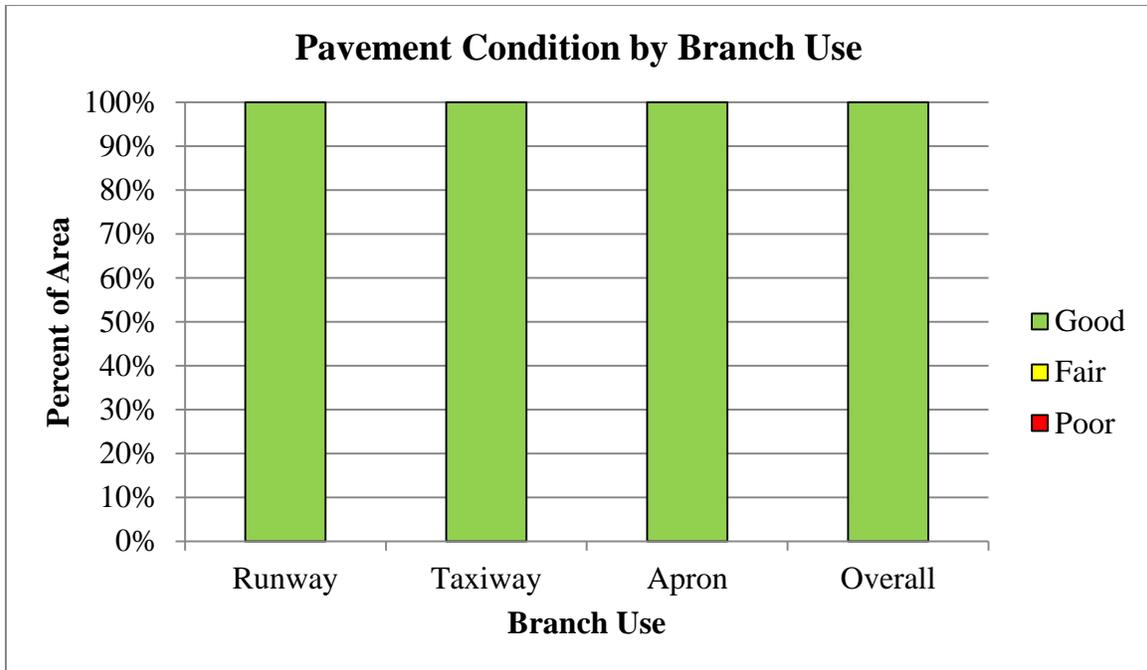
Figure 2-2. Pavement Condition by Branch Use

The overall Pavement Condition Index (PCI) for the airfield pavements was 98. Runways were newly constructed and had an inspected PCI of 100 and were above the desired MSL of 60. Taxiways had an average inspected PCI of 96, and ramps had an average inspected PCI of 96.

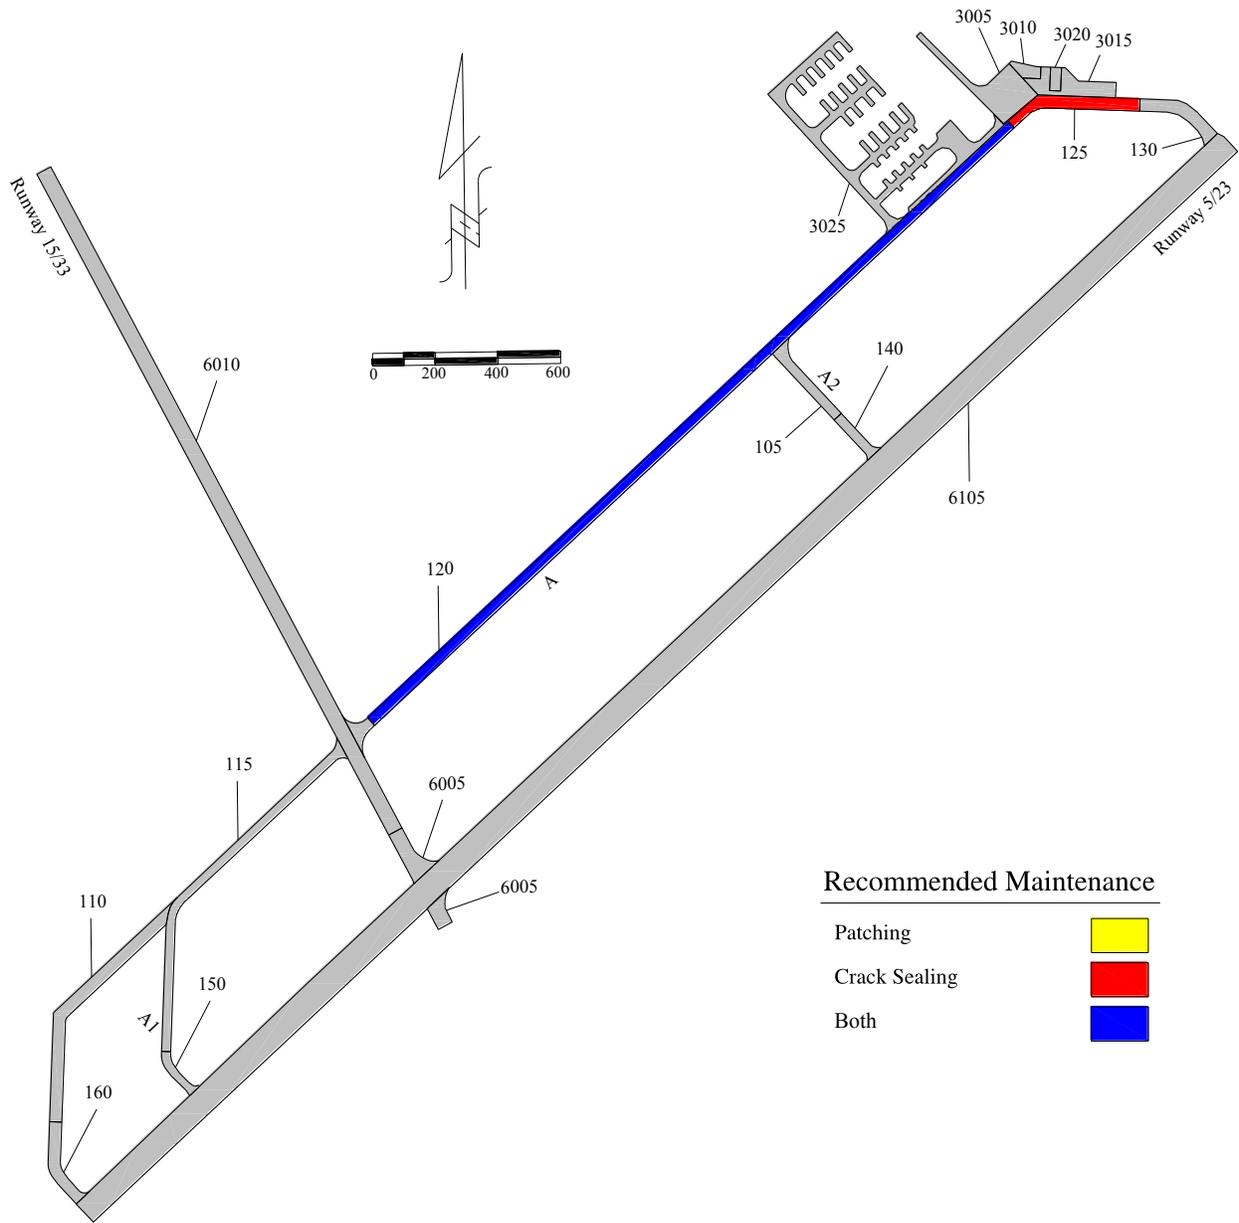
Figure 4-1. Recommended Maintenance

Analysis of potential maintenance projects identified approximately 100 square feet of patching needs and approximately 120 linear feet of crack sealing and crack repair needs, at an estimated total cost of less than \$1,000.

Work Item	Quantity	Unit	Cost
AC PATCH	90	SF	\$765
AC RESTORATIVE CRACK REPAIR	71	LF	\$86
AC SUSTAINING CRACK REPAIR	50	LF	\$43
<b>Total:</b>			<b>\$ 894</b>
