Pavement Condition Report

Lafayette-Purdue University Airport

Project 13801869

January 2013

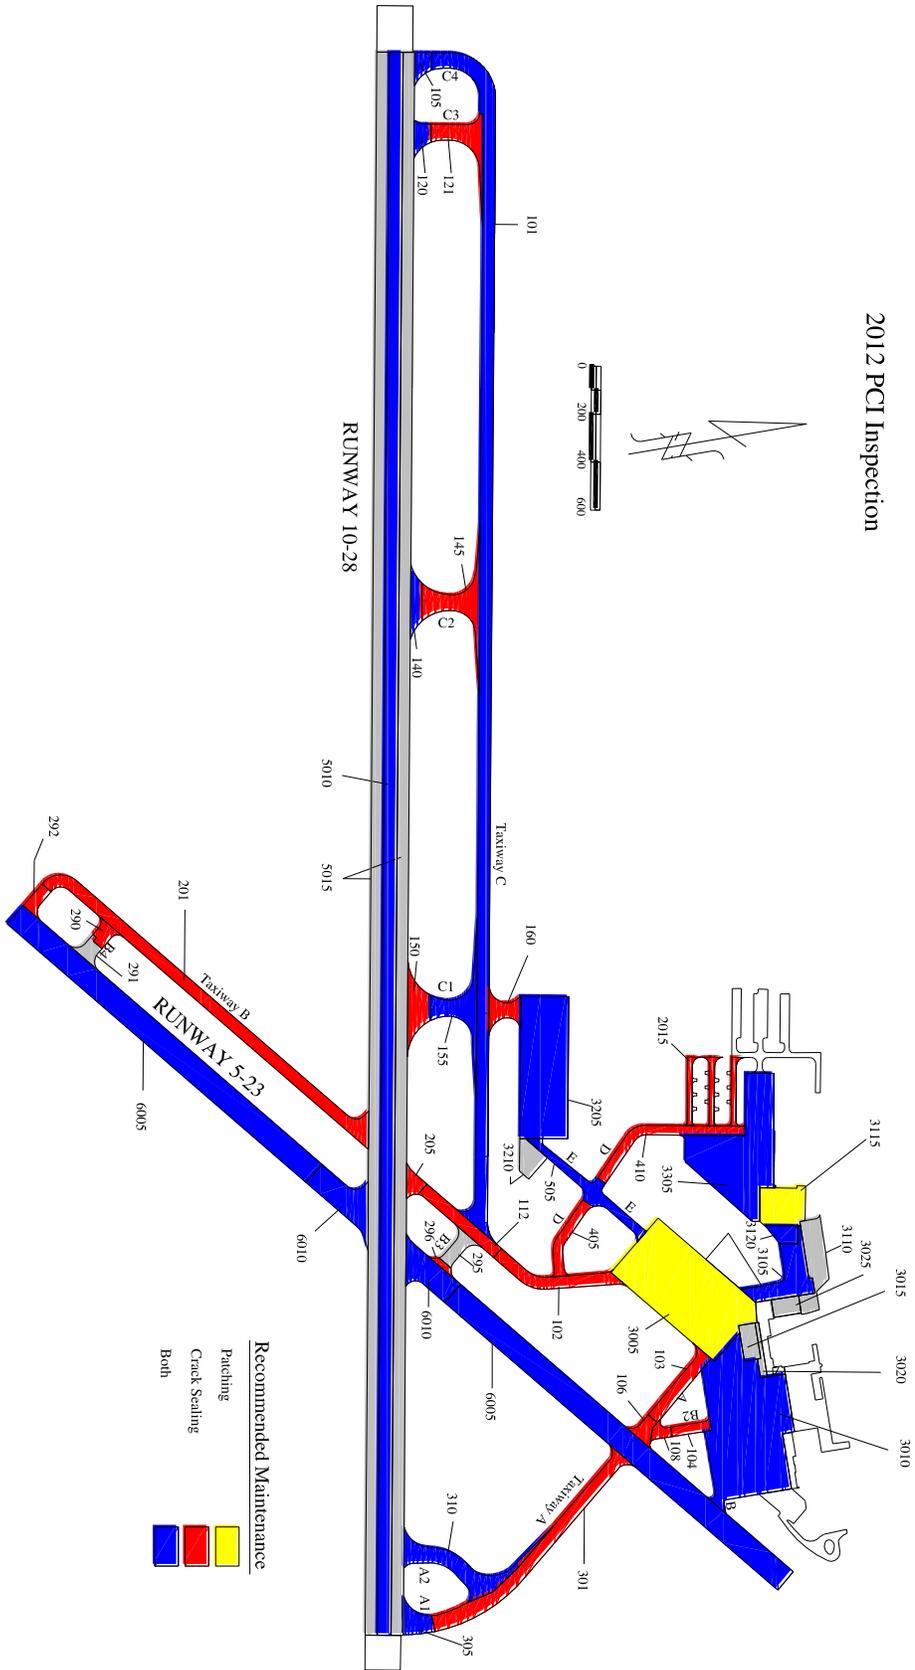
LAFAYETTE - PURDUE UNIVERSITY AIRPORT
2012 PCI Inspection

Analysis of potential maintenance projects identified approximately 1,900 square feet of patching needs and approximately 140,000 linear feet of crack sealing and crack repair needs, at an estimated total cost of approximately \$280,000.

Specific recommendations to help prioritize airfield maintenance are found in chapter 4 of this report. A summary of all identified maintenance needs is shown in the table below and in the figure on the following page.

Work Item	Quantity	Unit	Cost
AC PATCH	1,368	SF	\$11,643
AC RESTORATIVE CRACK REPAIR	32,883	LF	\$40,117
AC SUSTAINING CRACK REPAIR	7,261	LF	\$6,188
PCC PATCHING	559	SF	\$9,164
PCC RESTORATIVE SEAL REPAIR	96,561	LF	\$212,436
Total:			\$278,548

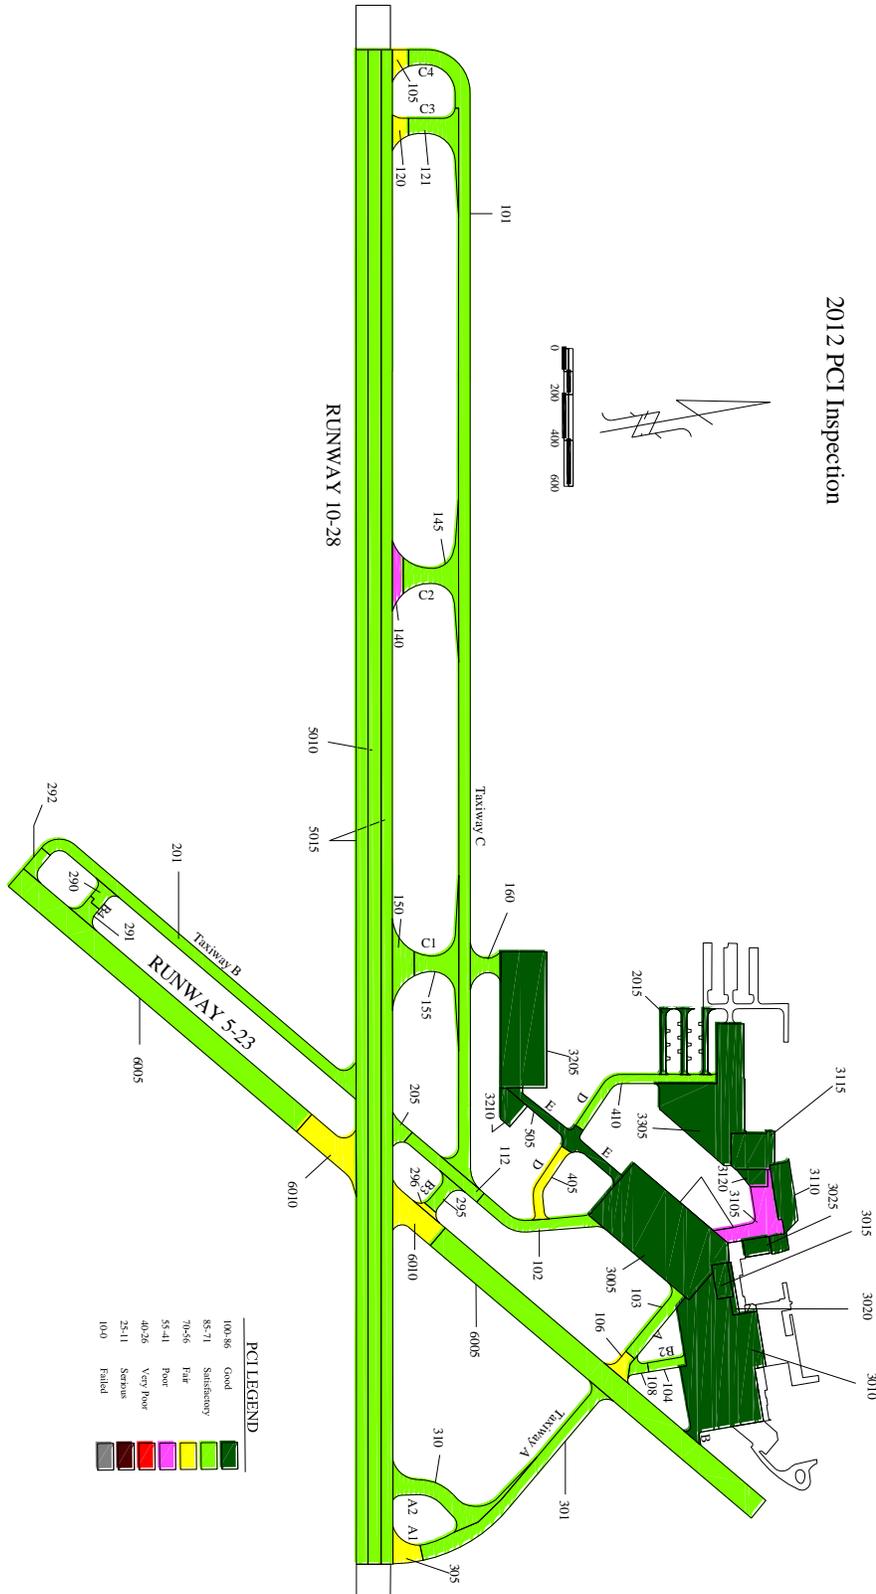
Figure 2-1. Inspected Pavement Condition

Two pavement sections had simplified PCI ratings of Poor, indicating that major M&R may be needed. The pavement within each of the PCI condition categories is shown in Figure 2-1. The inspected PCI is summarized by branch use in Figure 2-2, and the photographs that follow provide examples of the condition categories.
