# Pavement Condition Report

## Ft Wayne-Smith Field Airport

Project 1480370

**January 2014**

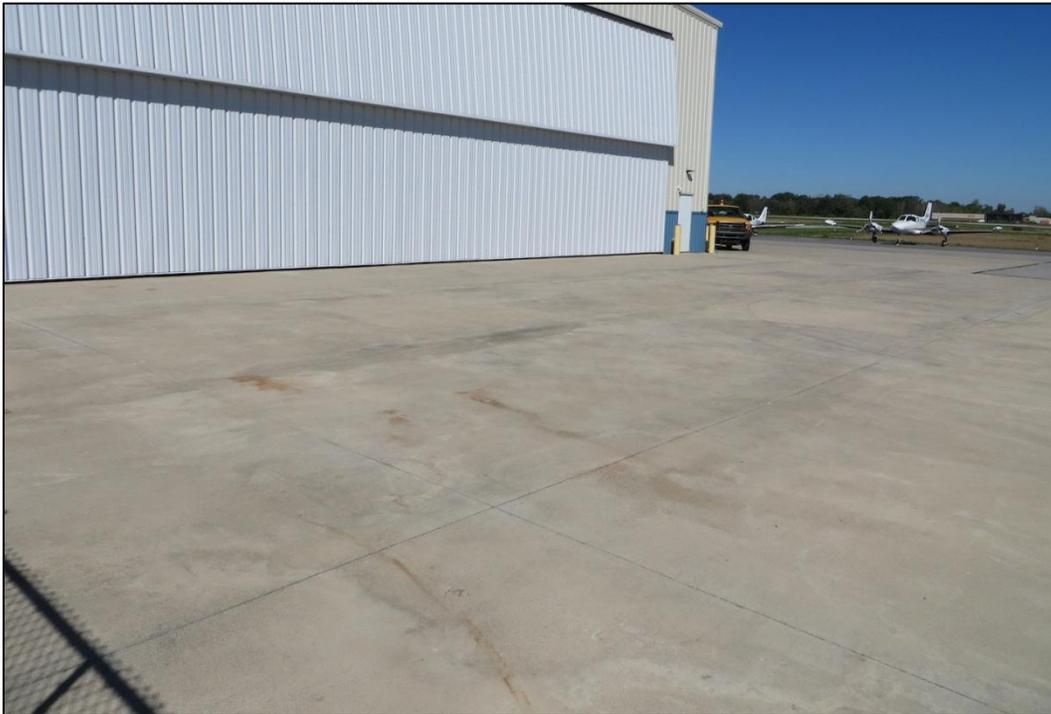
Figure 2-7. PCC LTD Crack (Feature 4110)

The 4100 ramp consists of 1 section of AC and 1 section of PCC pavement. The branch had a total area of 31,802 ft<sup>2</sup> with an area-weighted average PCI of 95 (Good). In in the AC pavement, the only recorded distress was L&T cracking. In the PCC pavement, recorded distresses included: corner breaks, shrinkage cracks, and LTD cracks.
