Pavement Condition Report

Sullivan County Airport

Project 13801869

January 2013

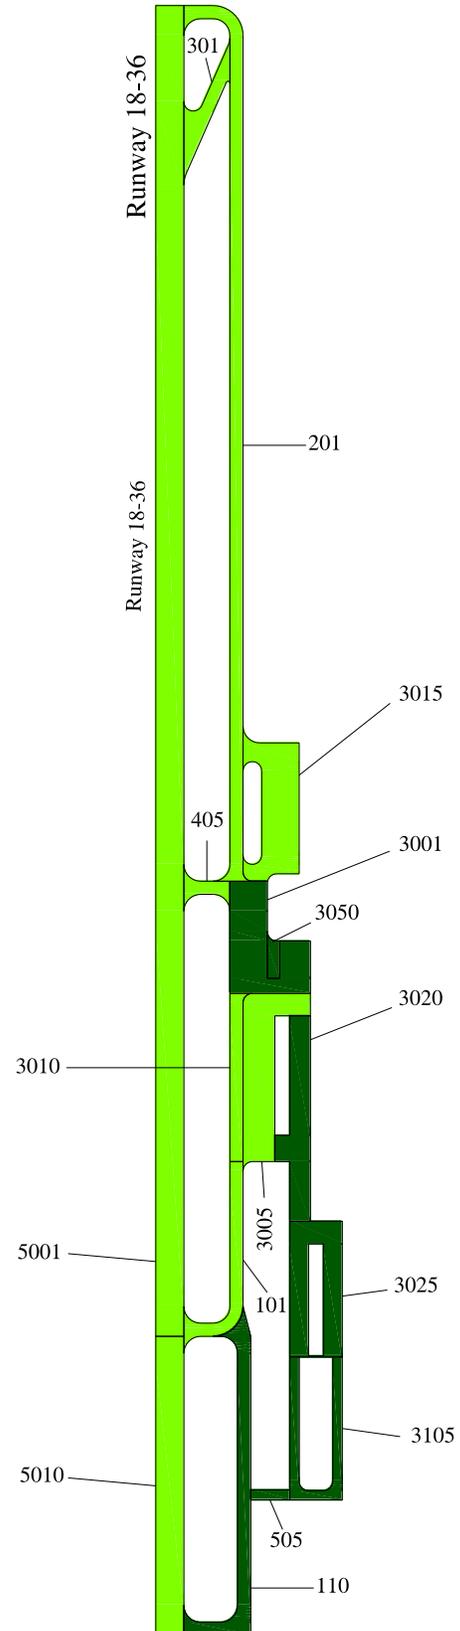
Figure 2-1. Inspected Pavement Condition

All inspected airside pavement had a simplified PCI rating of good. The pavement within each of the PCI condition categories is shown in Figure 2-1. The inspected PCI is summarized by branch use in Figure 2-2, and the photographs that follow provide examples of the condition categories.

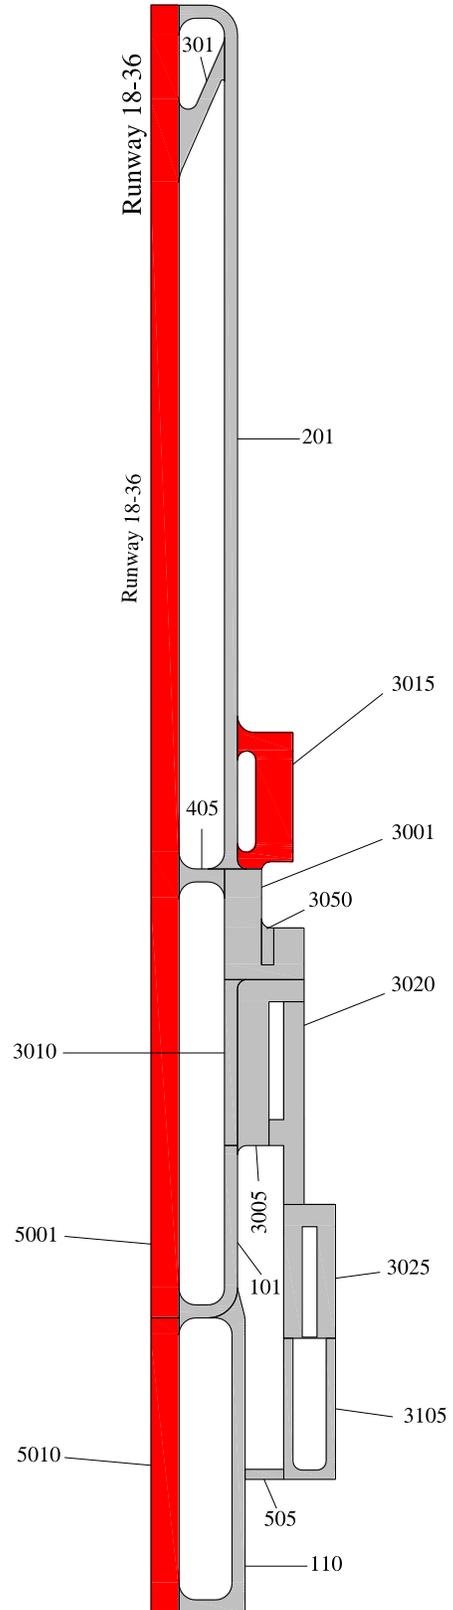
Figure 4-1. Recommended Maintenance

Of the inspected pavement, 96 percent of the cracks were rated at low severity and require no maintenance beyond ongoing inspection and spot repair. About 4 percent of the cracks were rated at medium severity and would benefit from sealing and repair. Less than 1 percent of the cracks were rated at high severity and warrant patching to maintain safe operations.

Work Item	Quantity	Unit	Cost
AC RESTORATIVE CRACK REPAIR	962	LF	1,173
AC SUSTAINING CRACK REPAIR	992	LF	845
Total:			\$ 2,018
