Pavement Condition Report

Tell City-Perry County Municipal Airport

Project 15805741

February 2015

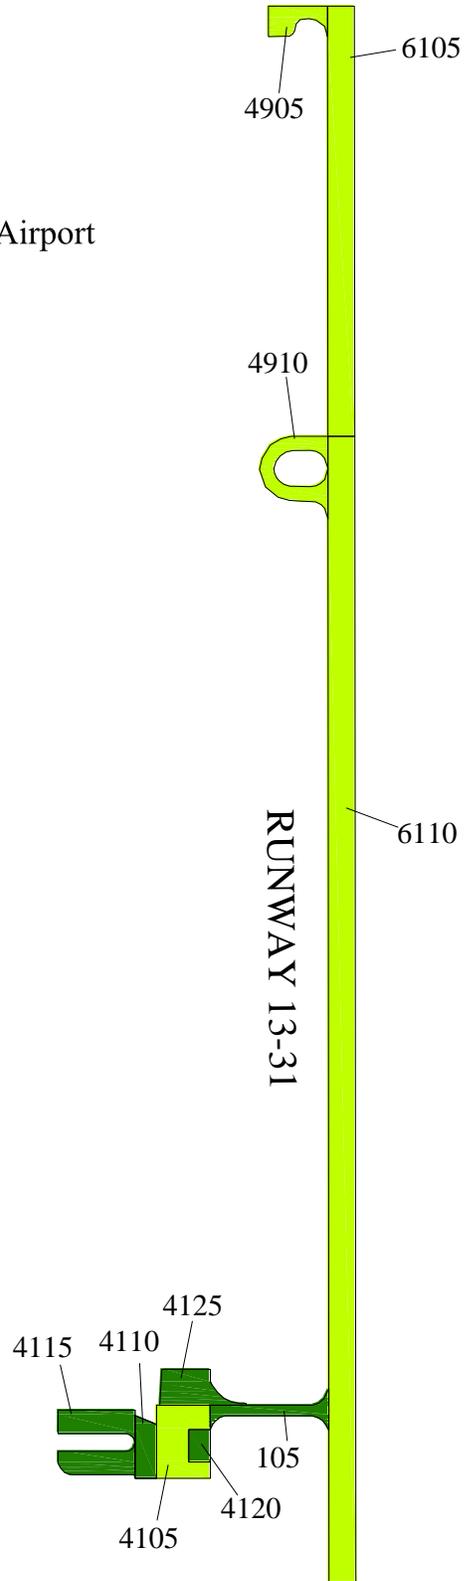
Figure 2-1. Inspected Pavement Condition

The pavement within each of the PCI condition categories is shown in Figure 2-1. The inspected PCI is summarized by branch use in Figure 2-2, and the photographs in Figure 2-3 through Figure 2-5 provide examples of the condition categories.

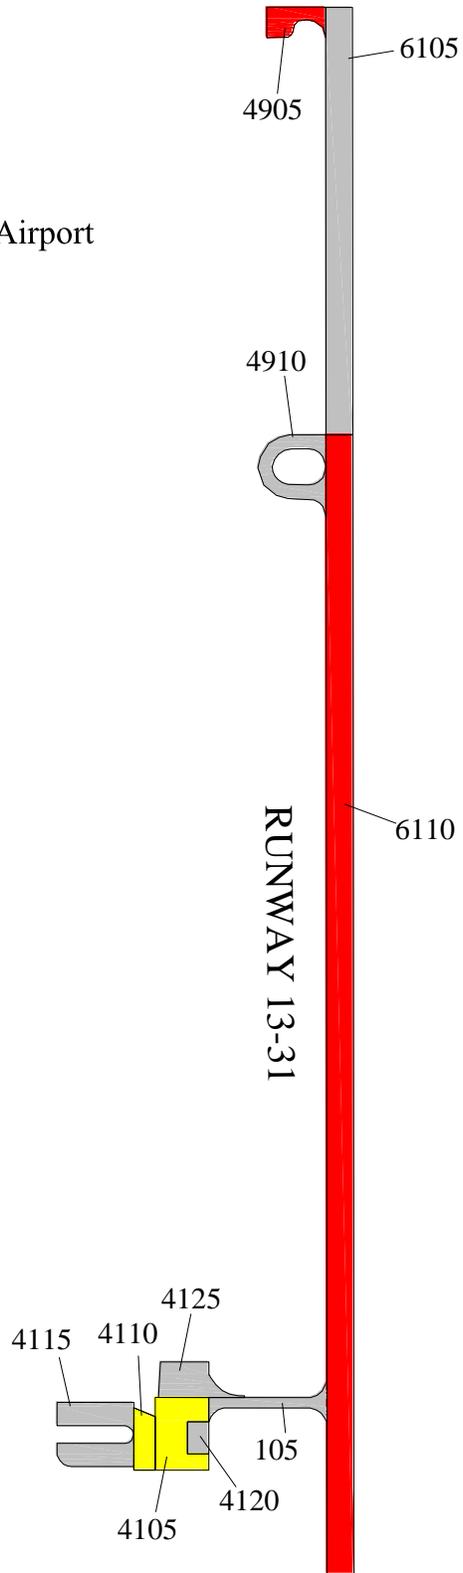
Figure 4-1. Recommended Maintenance

Of the inspected pavement, 93 percent of the cracks were rated at low severity and require no maintenance beyond ongoing inspection and spot repair. About 7 percent of the cracks were rated at medium severity and would benefit from sealing and repair. None of the cracks were rated at high severity.

Most pavement distress is classified by severity (low, medium, or high). As a general rule, high-severity distresses should be patched, and medium-severity distress should be sealed. A detailed matrix of recommended maintenance policies to address various distress types is provided near the end of this section.
