Pavement Condition Report

Connersville-Mettel Field Airport

Project 16801839

January 2016

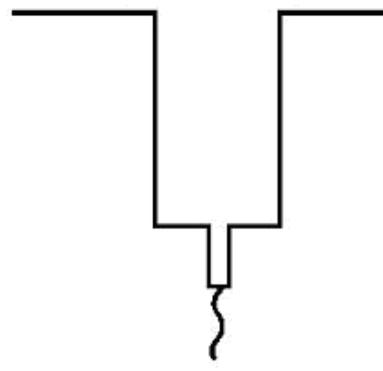
Typical failed joint sealant, w/ debris and incompressibles.

Clean joints exposing fresh, clean concrete and stone. Retain existing reservoir shape.

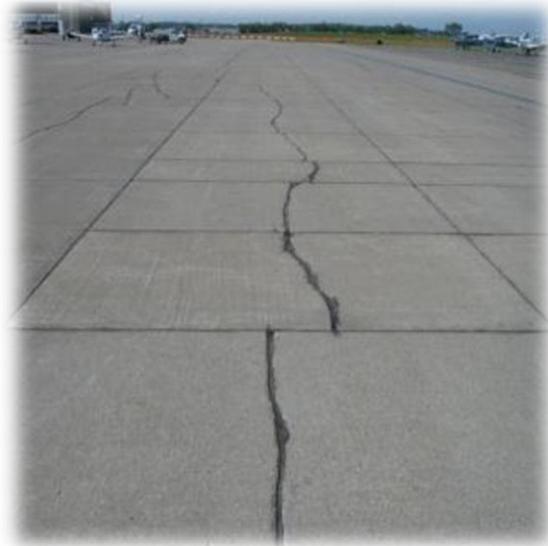
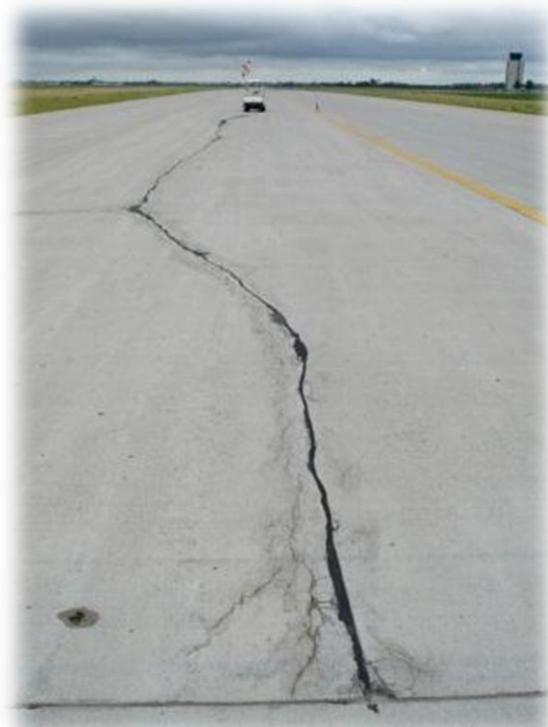
A slab divided into four or more pieces is said to be “divided” or “shattered.” Shattered slab is a separate distress category and indicates a significant structural failure. A shattered slab has lost its ability to distribute loads. Shattered slabs are rated in three severities, but the recommended action in any case is slab replacement.

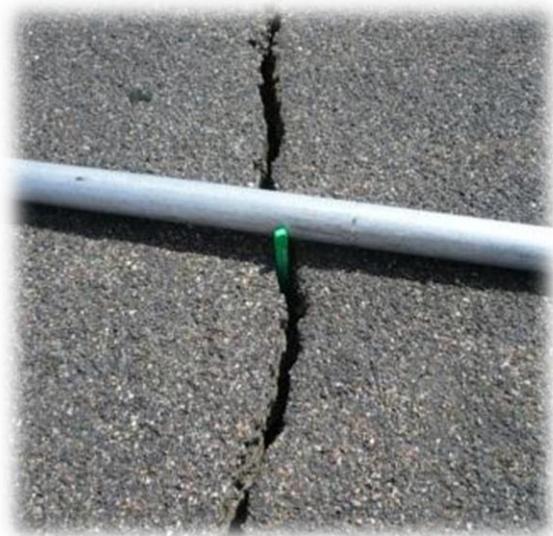
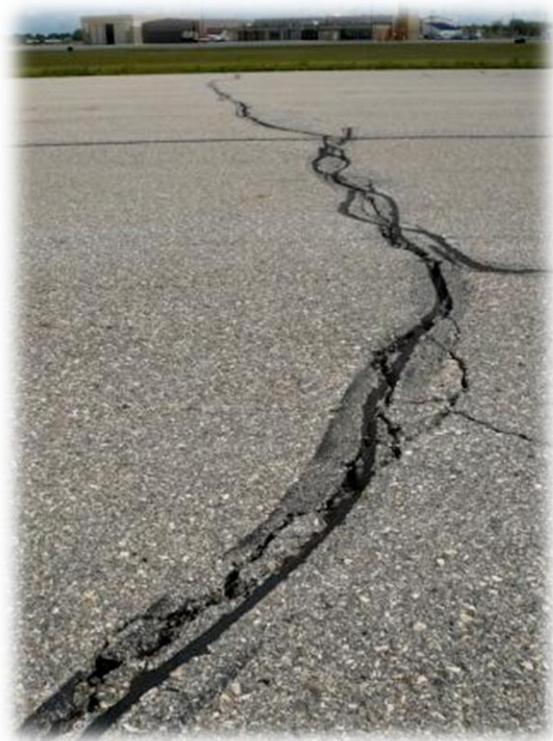
Low-severity L&T cracks are less than ¼ inch wide, or if sealed with suitable filler material in satisfactory condition can be any width less than 3 inches, if they are not spalled. Maintenance usually is not indicated for low-severity cracking. Moderately spalled cracks and cracks wider than ¼ inch which are not satisfactorily sealed are at medium severity. Medium-severity cracks should be sealed with a high-quality crack filling material. Severely spalled cracks and cracks wider than 3 inches are at high severity. High-severity L&T cracks normally require patching.

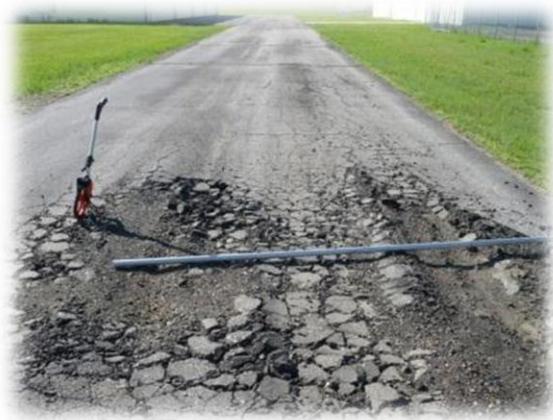
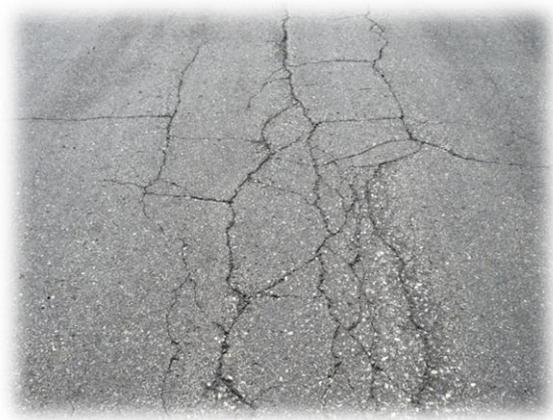
Alligator Cracking

Alligator cracking is a serious structural failure that cannot be repaired with sealant. The proper repair is patching.

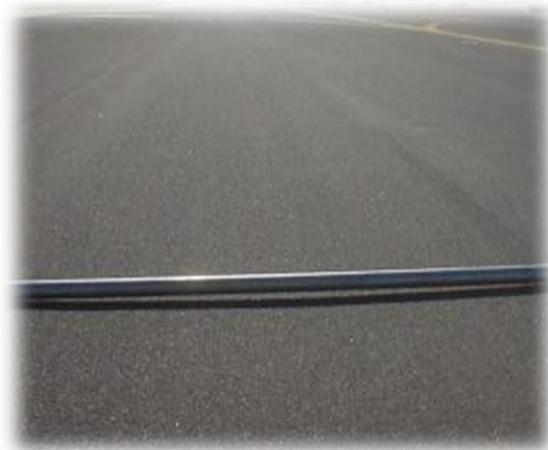
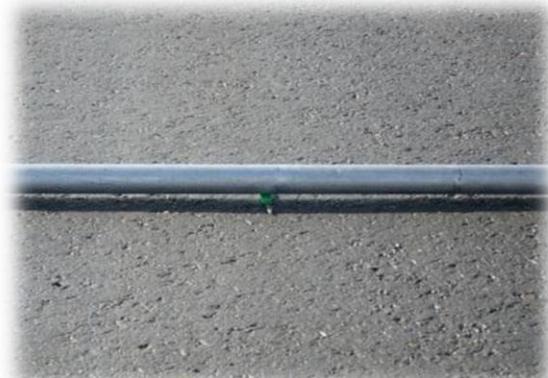
Rutting

At low severity, ruts have an average depth of ¼ to ½ inches. At medium severity, ruts have an average depth of ½ to 1 inch. At high severity, ruts have an average depth greater than 1 inch. Patching is the appropriate repair for ruts.
