# Pavement Condition Report

## LaPorte Municipal Airport

Project 16801839

January 2016

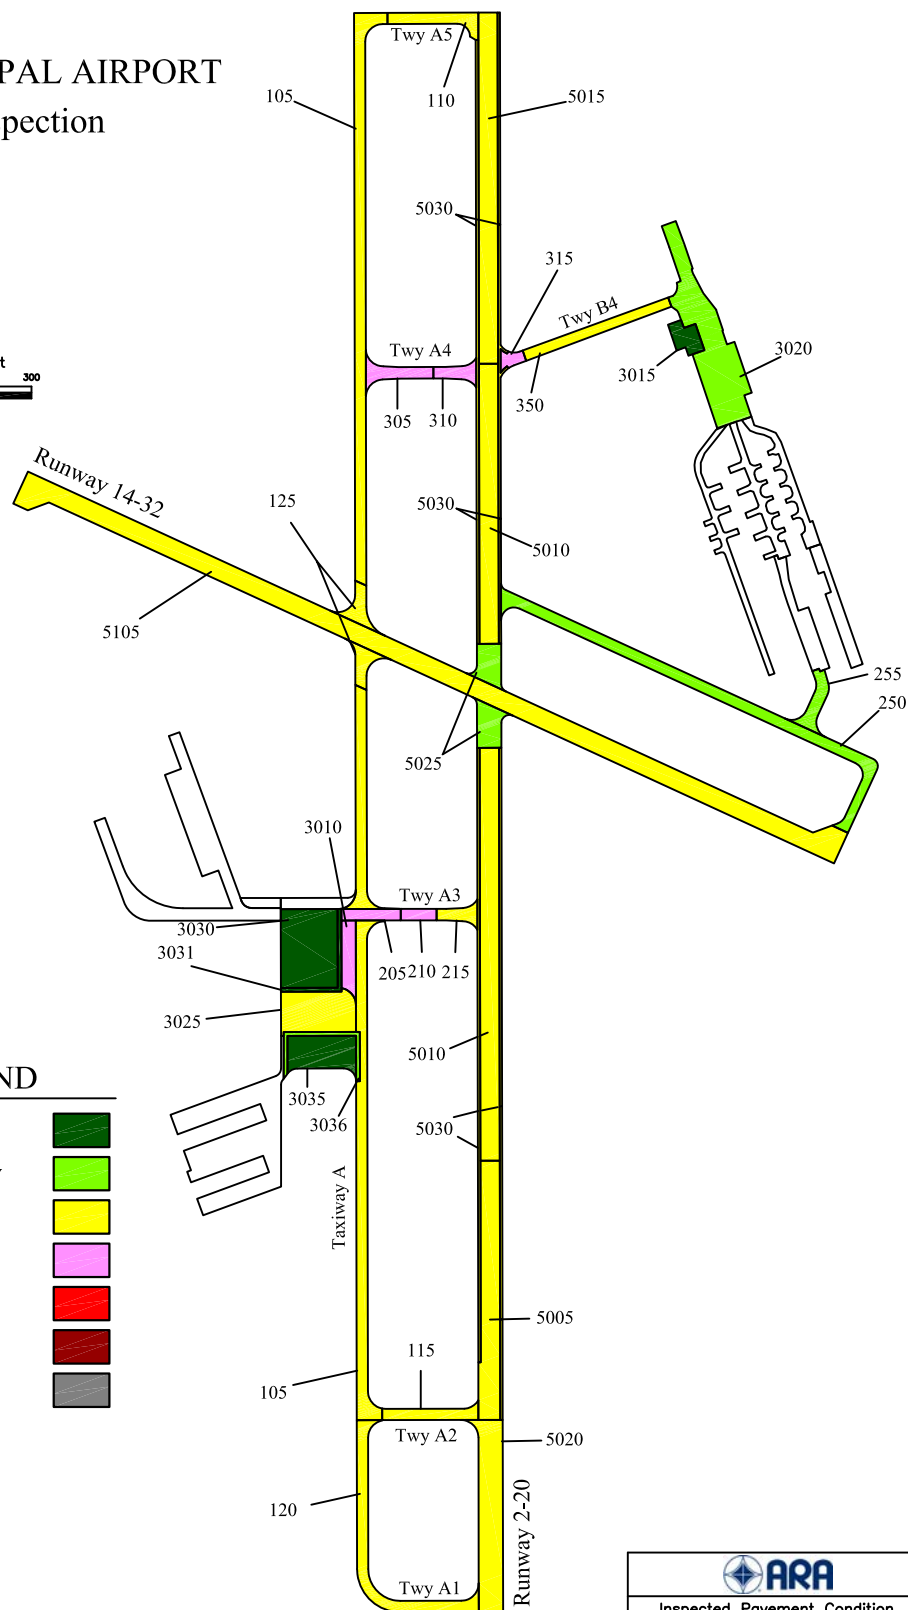
Figure 2-1. Inspected Pavement Condition at LaPorte Municipal Airport (PPO).

The pavement within each of the PCI condition categories is shown in Figure 2-1. The inspected PCI is summarized by branch use in Figure 2-2, and the photographs in Figure 2-3 through Figure 2-6 provide examples of the condition categories.

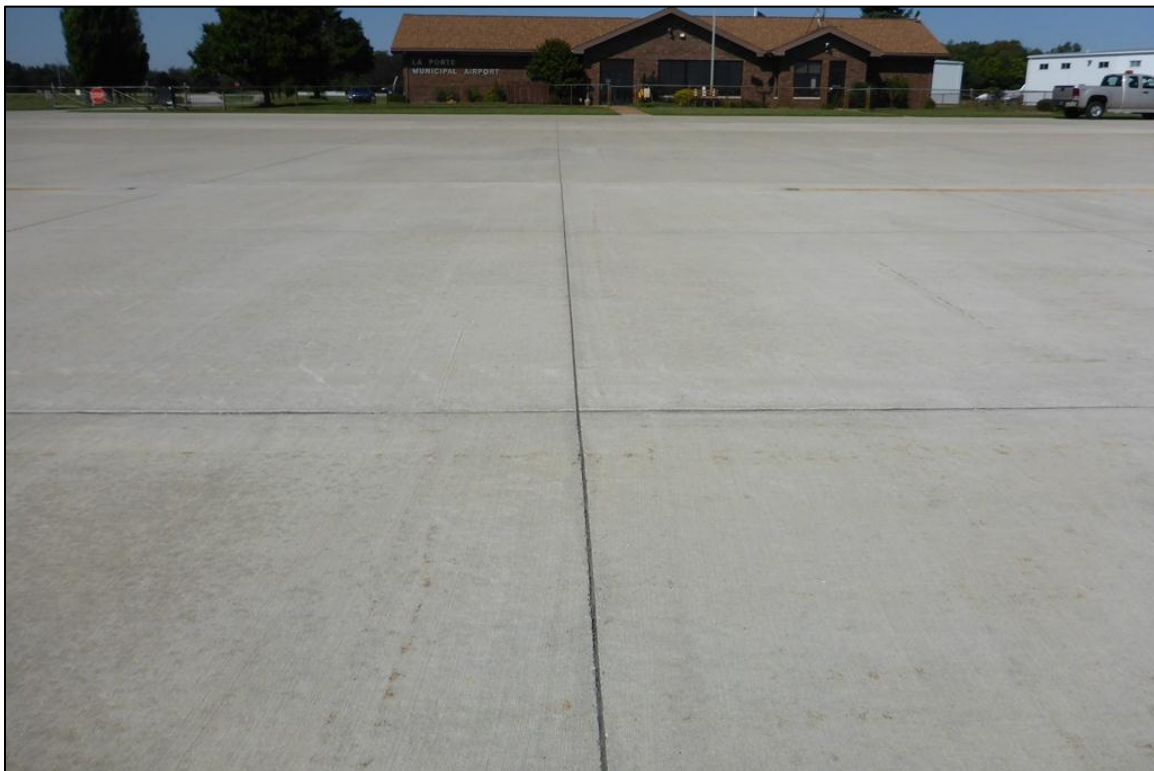
Figure 2-3. Typical PCC Pavement in Good Condition (Feature 3030)

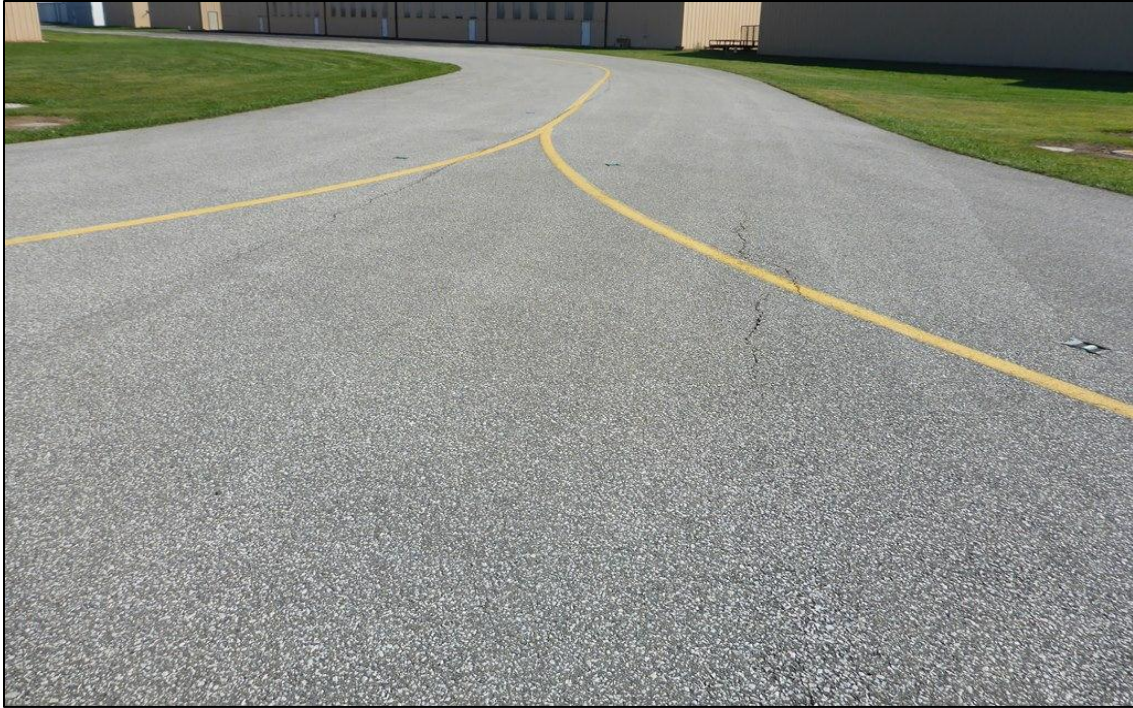
Figure 2-4. Typical AC Pavement in Good Condition (Feature 255)

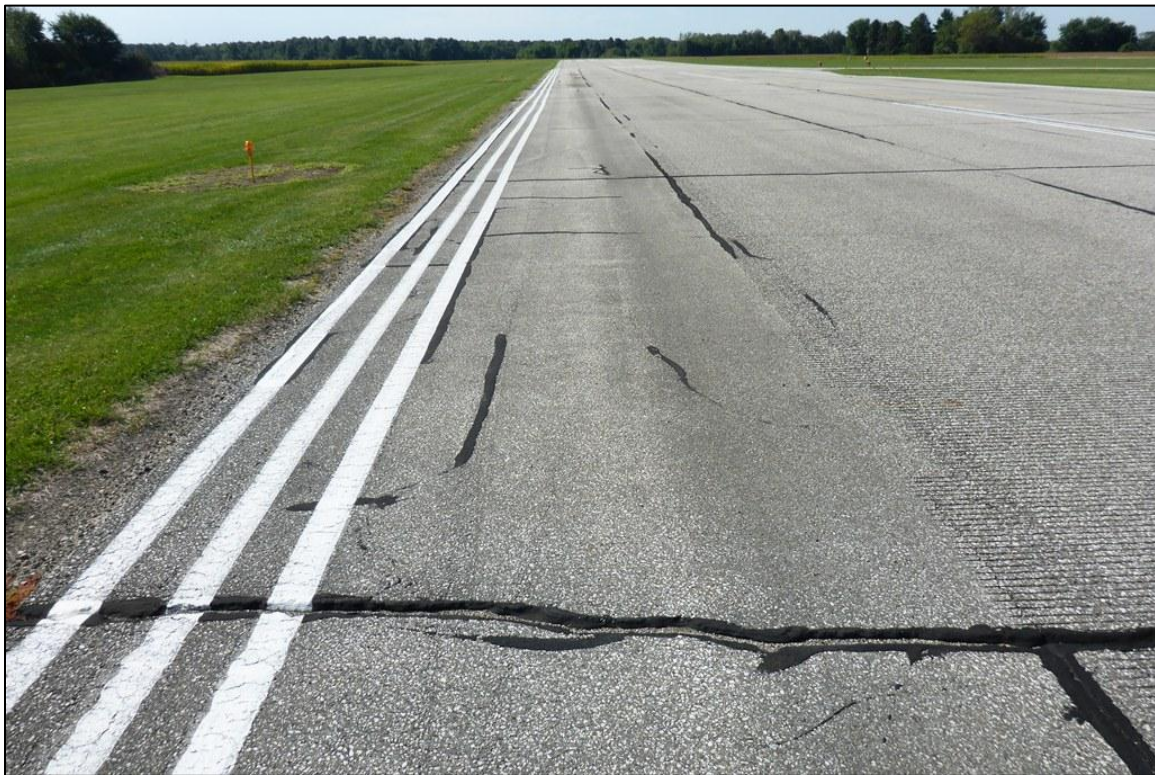
Figure 2-5. Typical AC Pavement in Fair Condition (Feature 5030)

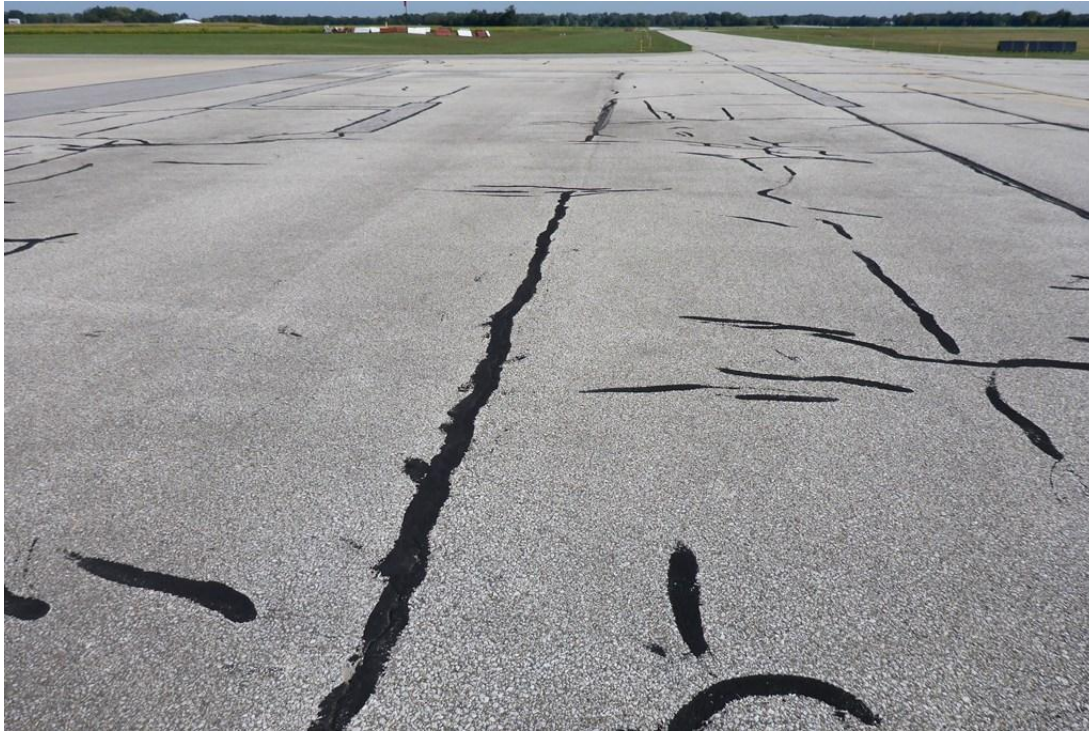
Figure 2-6. Typical AC Pavement in Poor Condition (Feature 3010)
