Pipeline Safety Division Investigation Report

Investigation regarding: Guthrie Development Group

UPPAC Database Record ID: 1532

Damage Address: 1420 Edgewater Ct. Lot #3

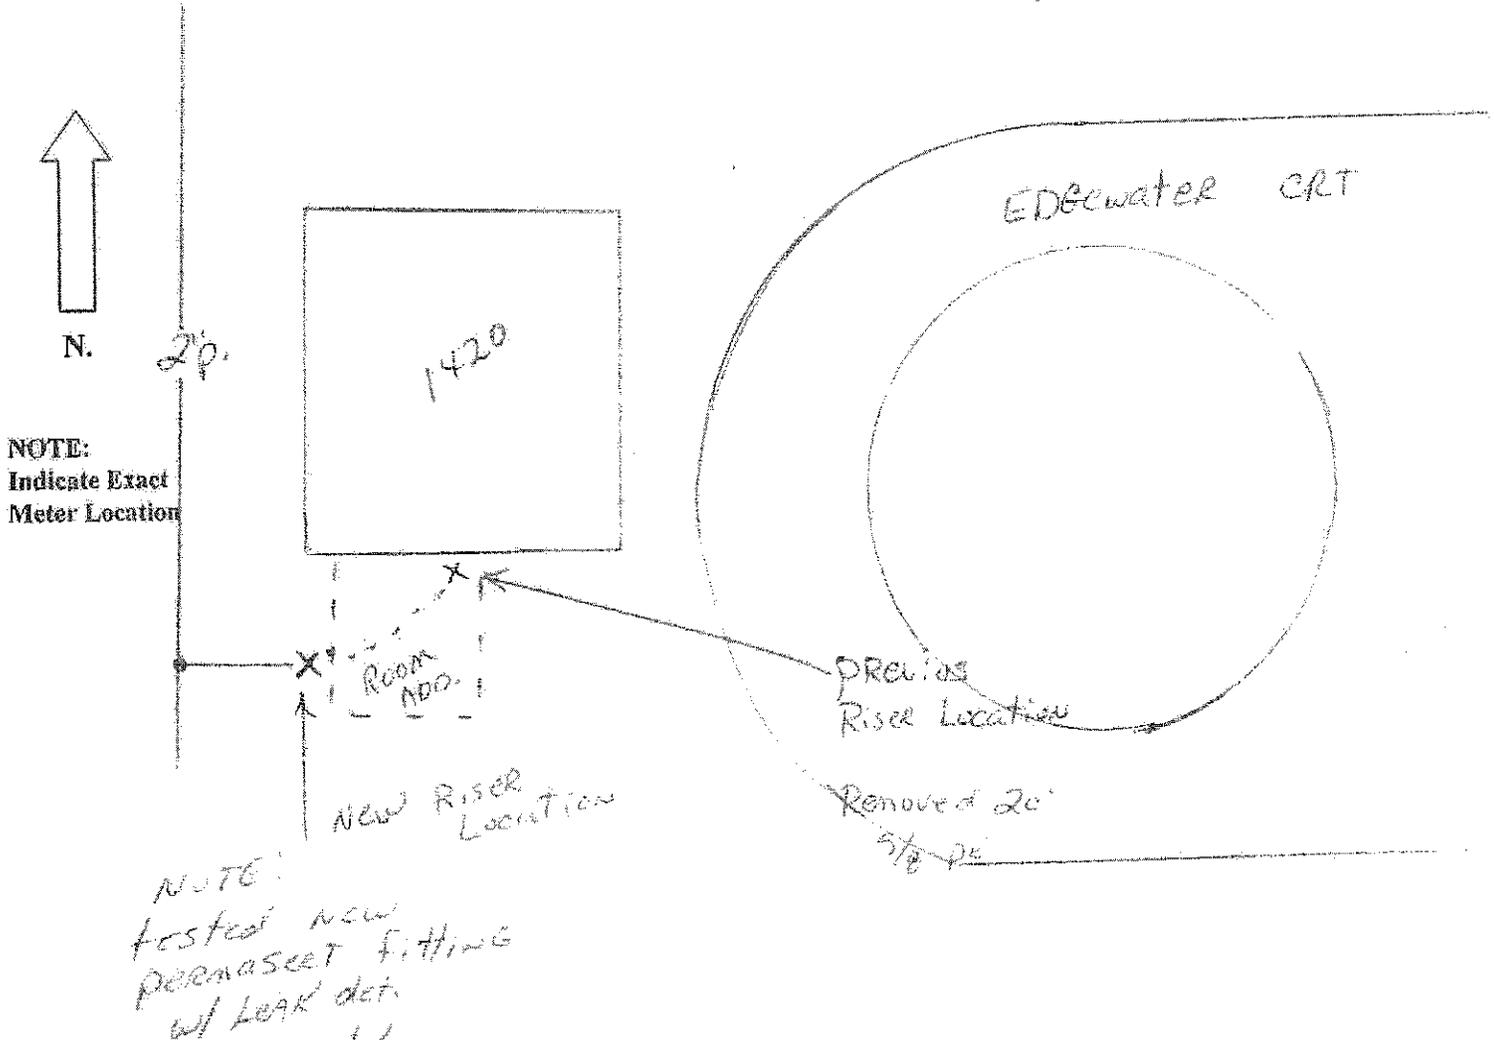
NOTE:
tested new
perma-seal fitting
w/ LEAK det.

DESCRIPTION OF WORK TO COMPLETE: Relocate service line
