Pipeline Safety Division Investigation Report

Investigation regarding: Miller Pipeline

UPPAC Database Record ID: 4111

Synopsis: Excavator struck and damaged an underground natural gas main while performing water work.

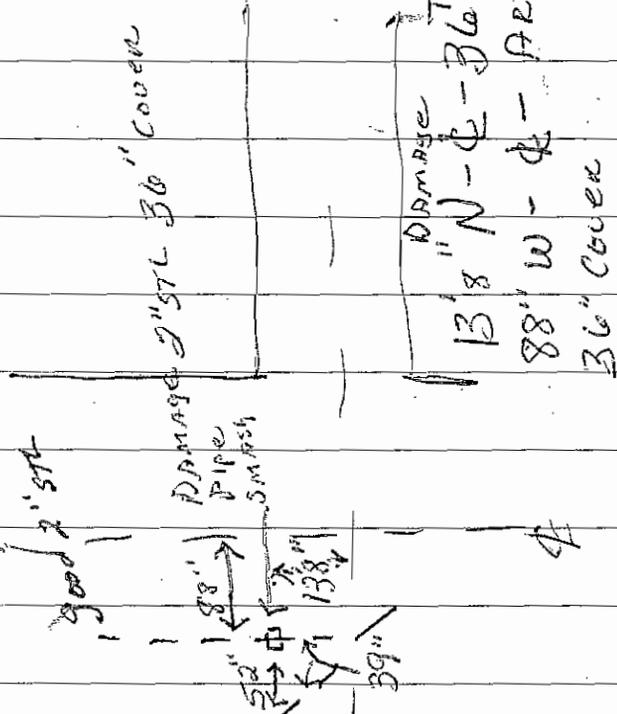
old
dead
2" cover
43" cover

ARTHINGTON BLVD

LOCATE MARKS
N - End of Ditch 52" off
S - End of Ditch 39" off

REPAIR ~~with~~ with oversize
Pipe used Has pumpkin

(1 - JOINT + REST.
Then HIT live shot
Production down)

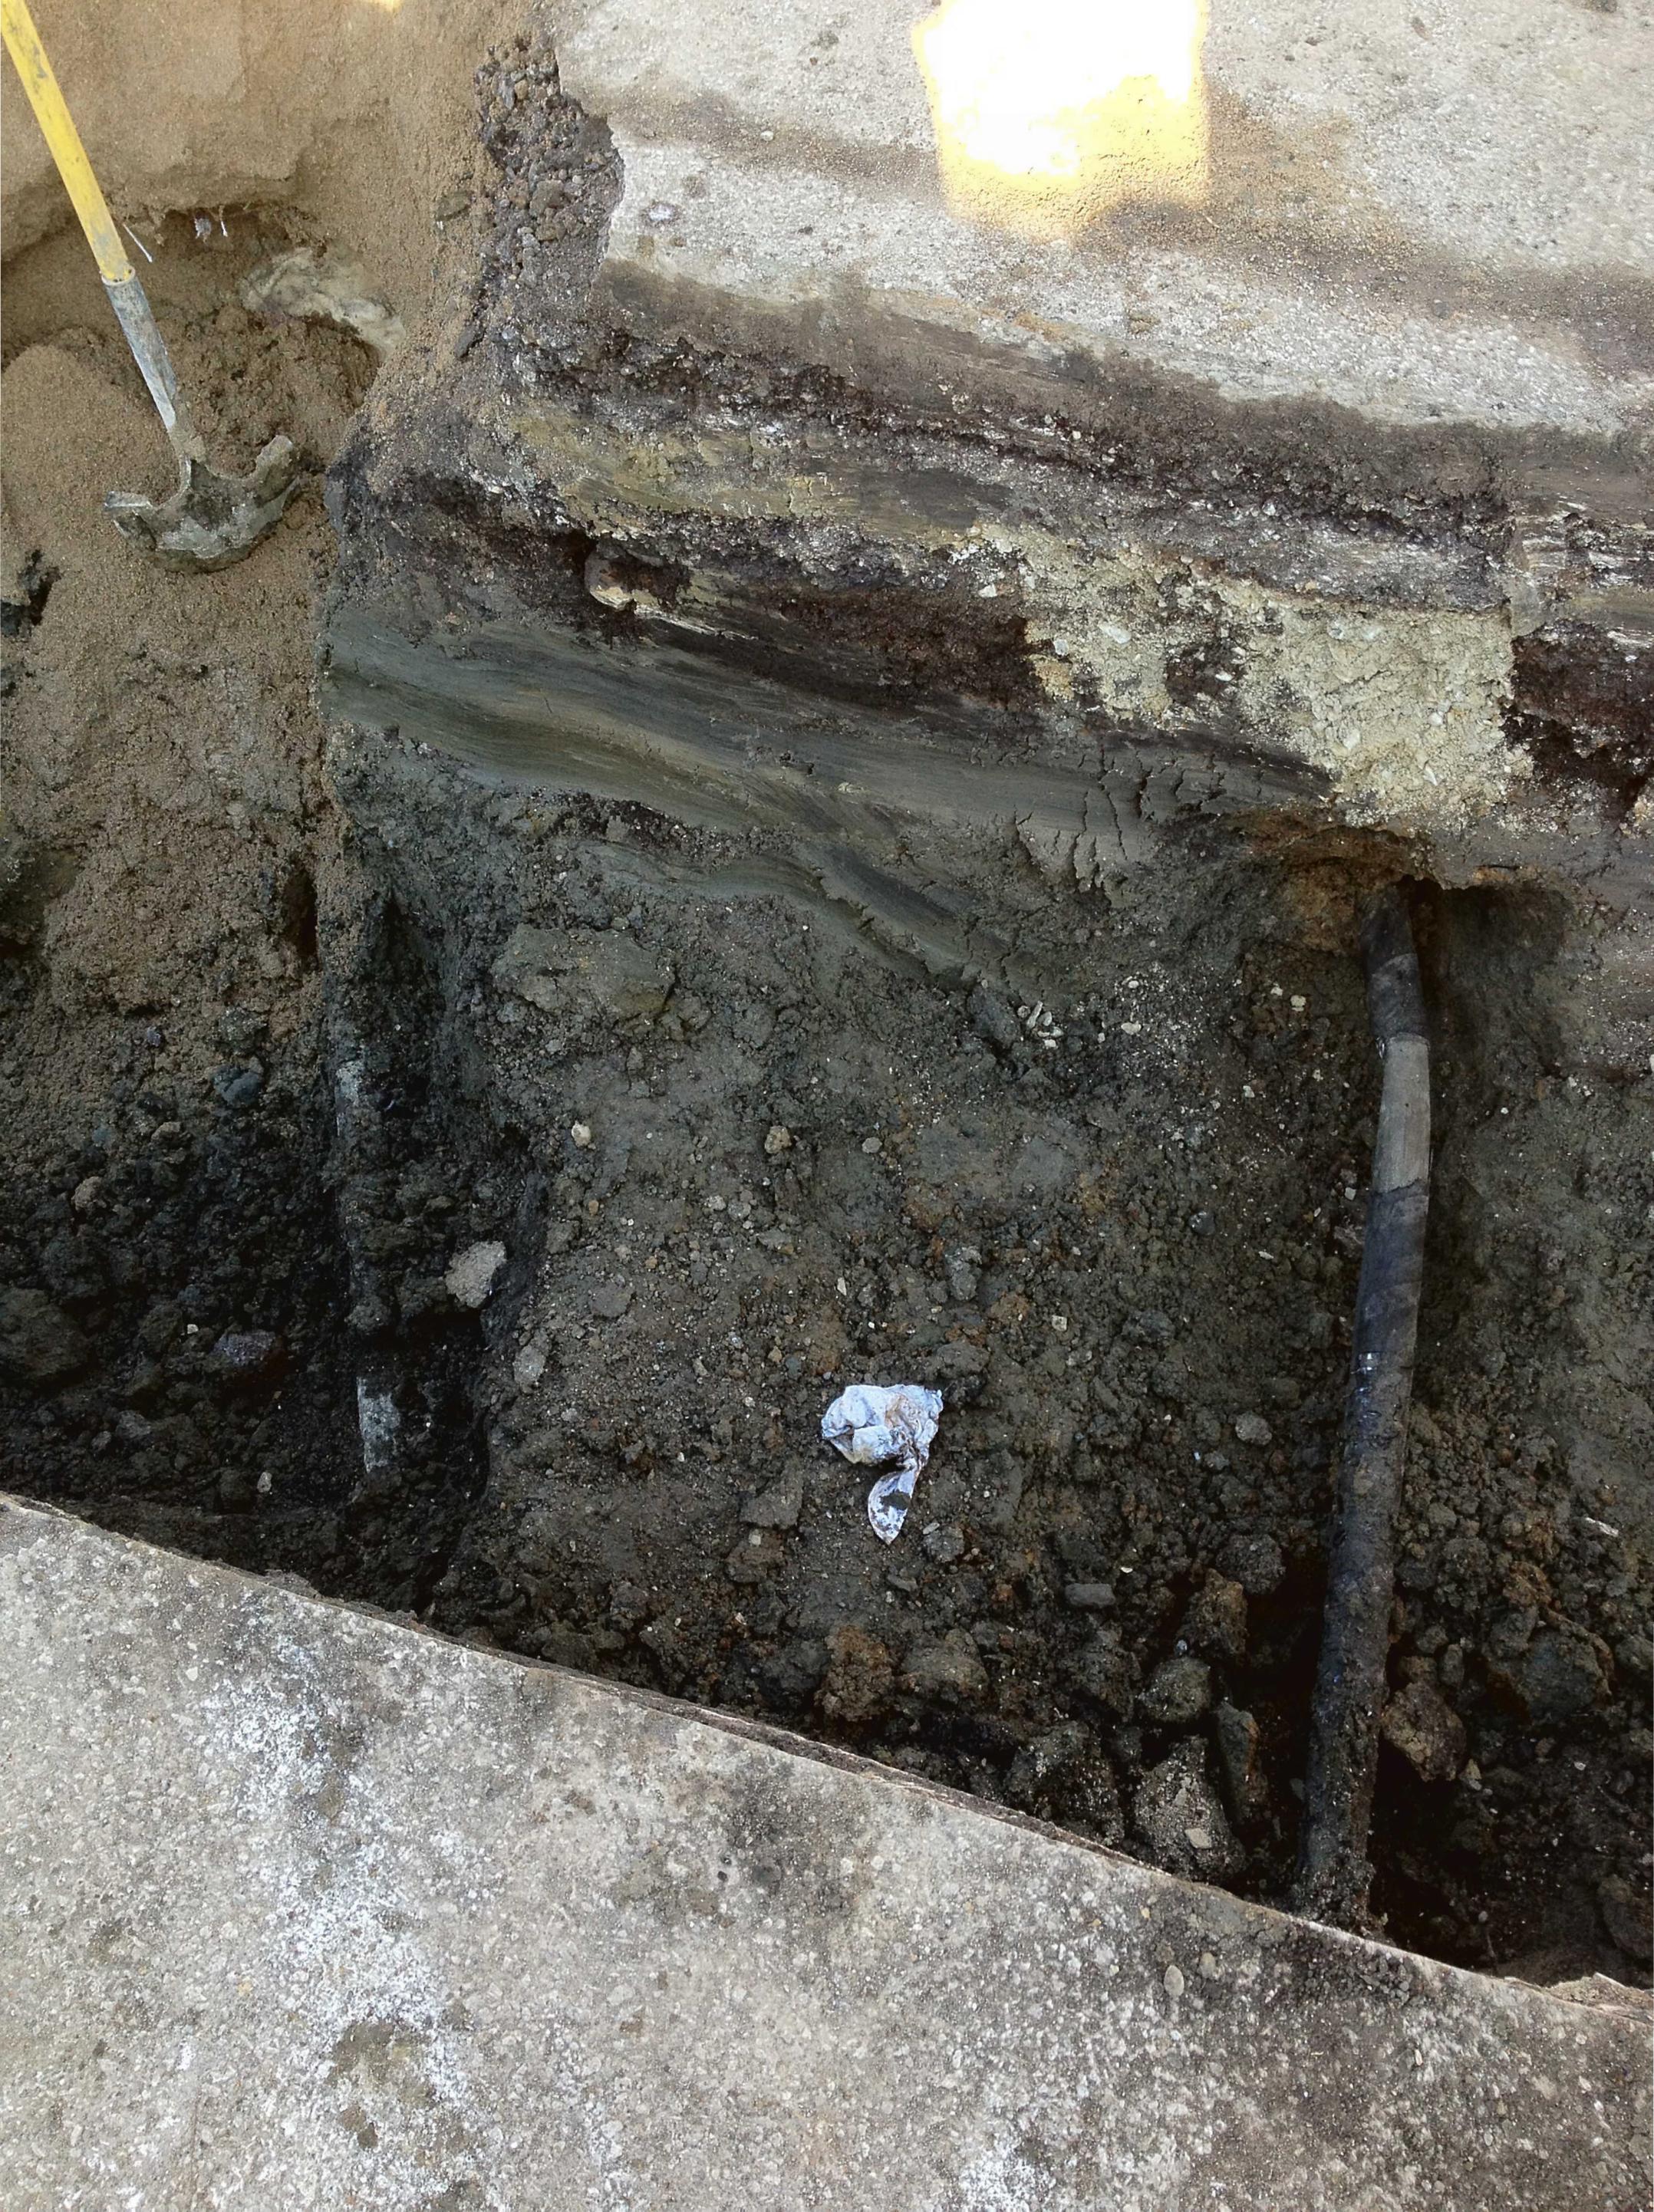
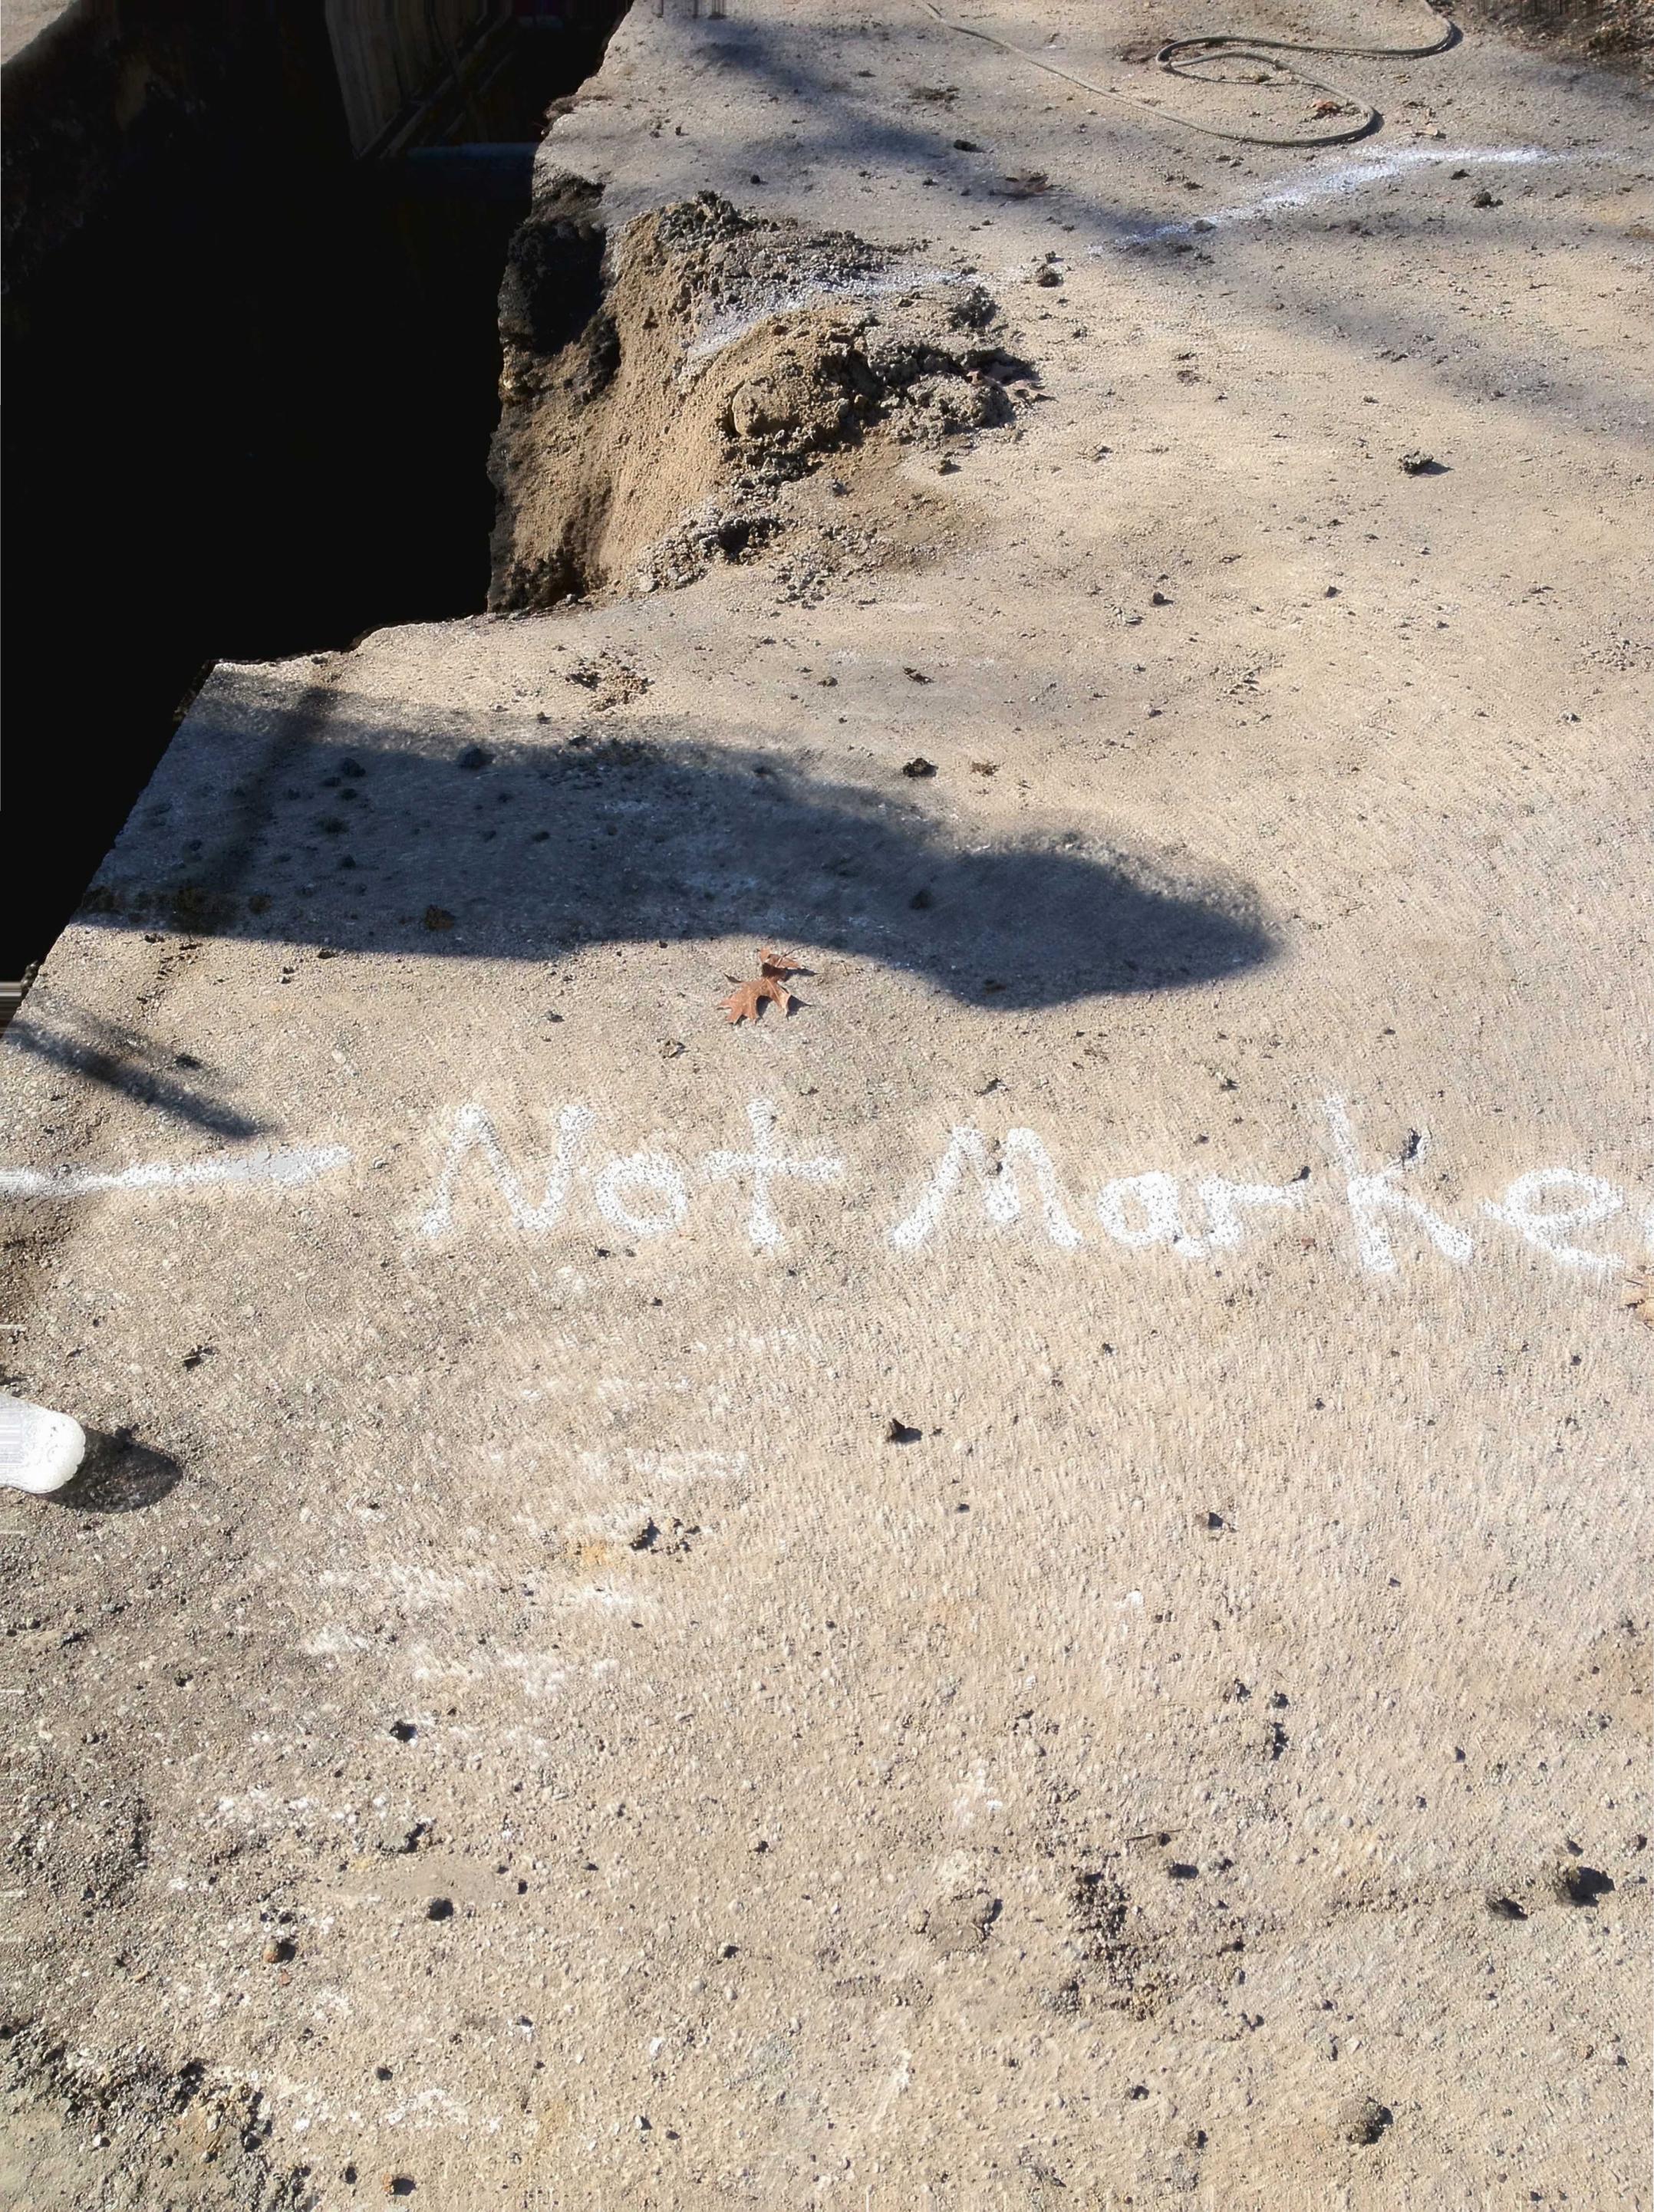
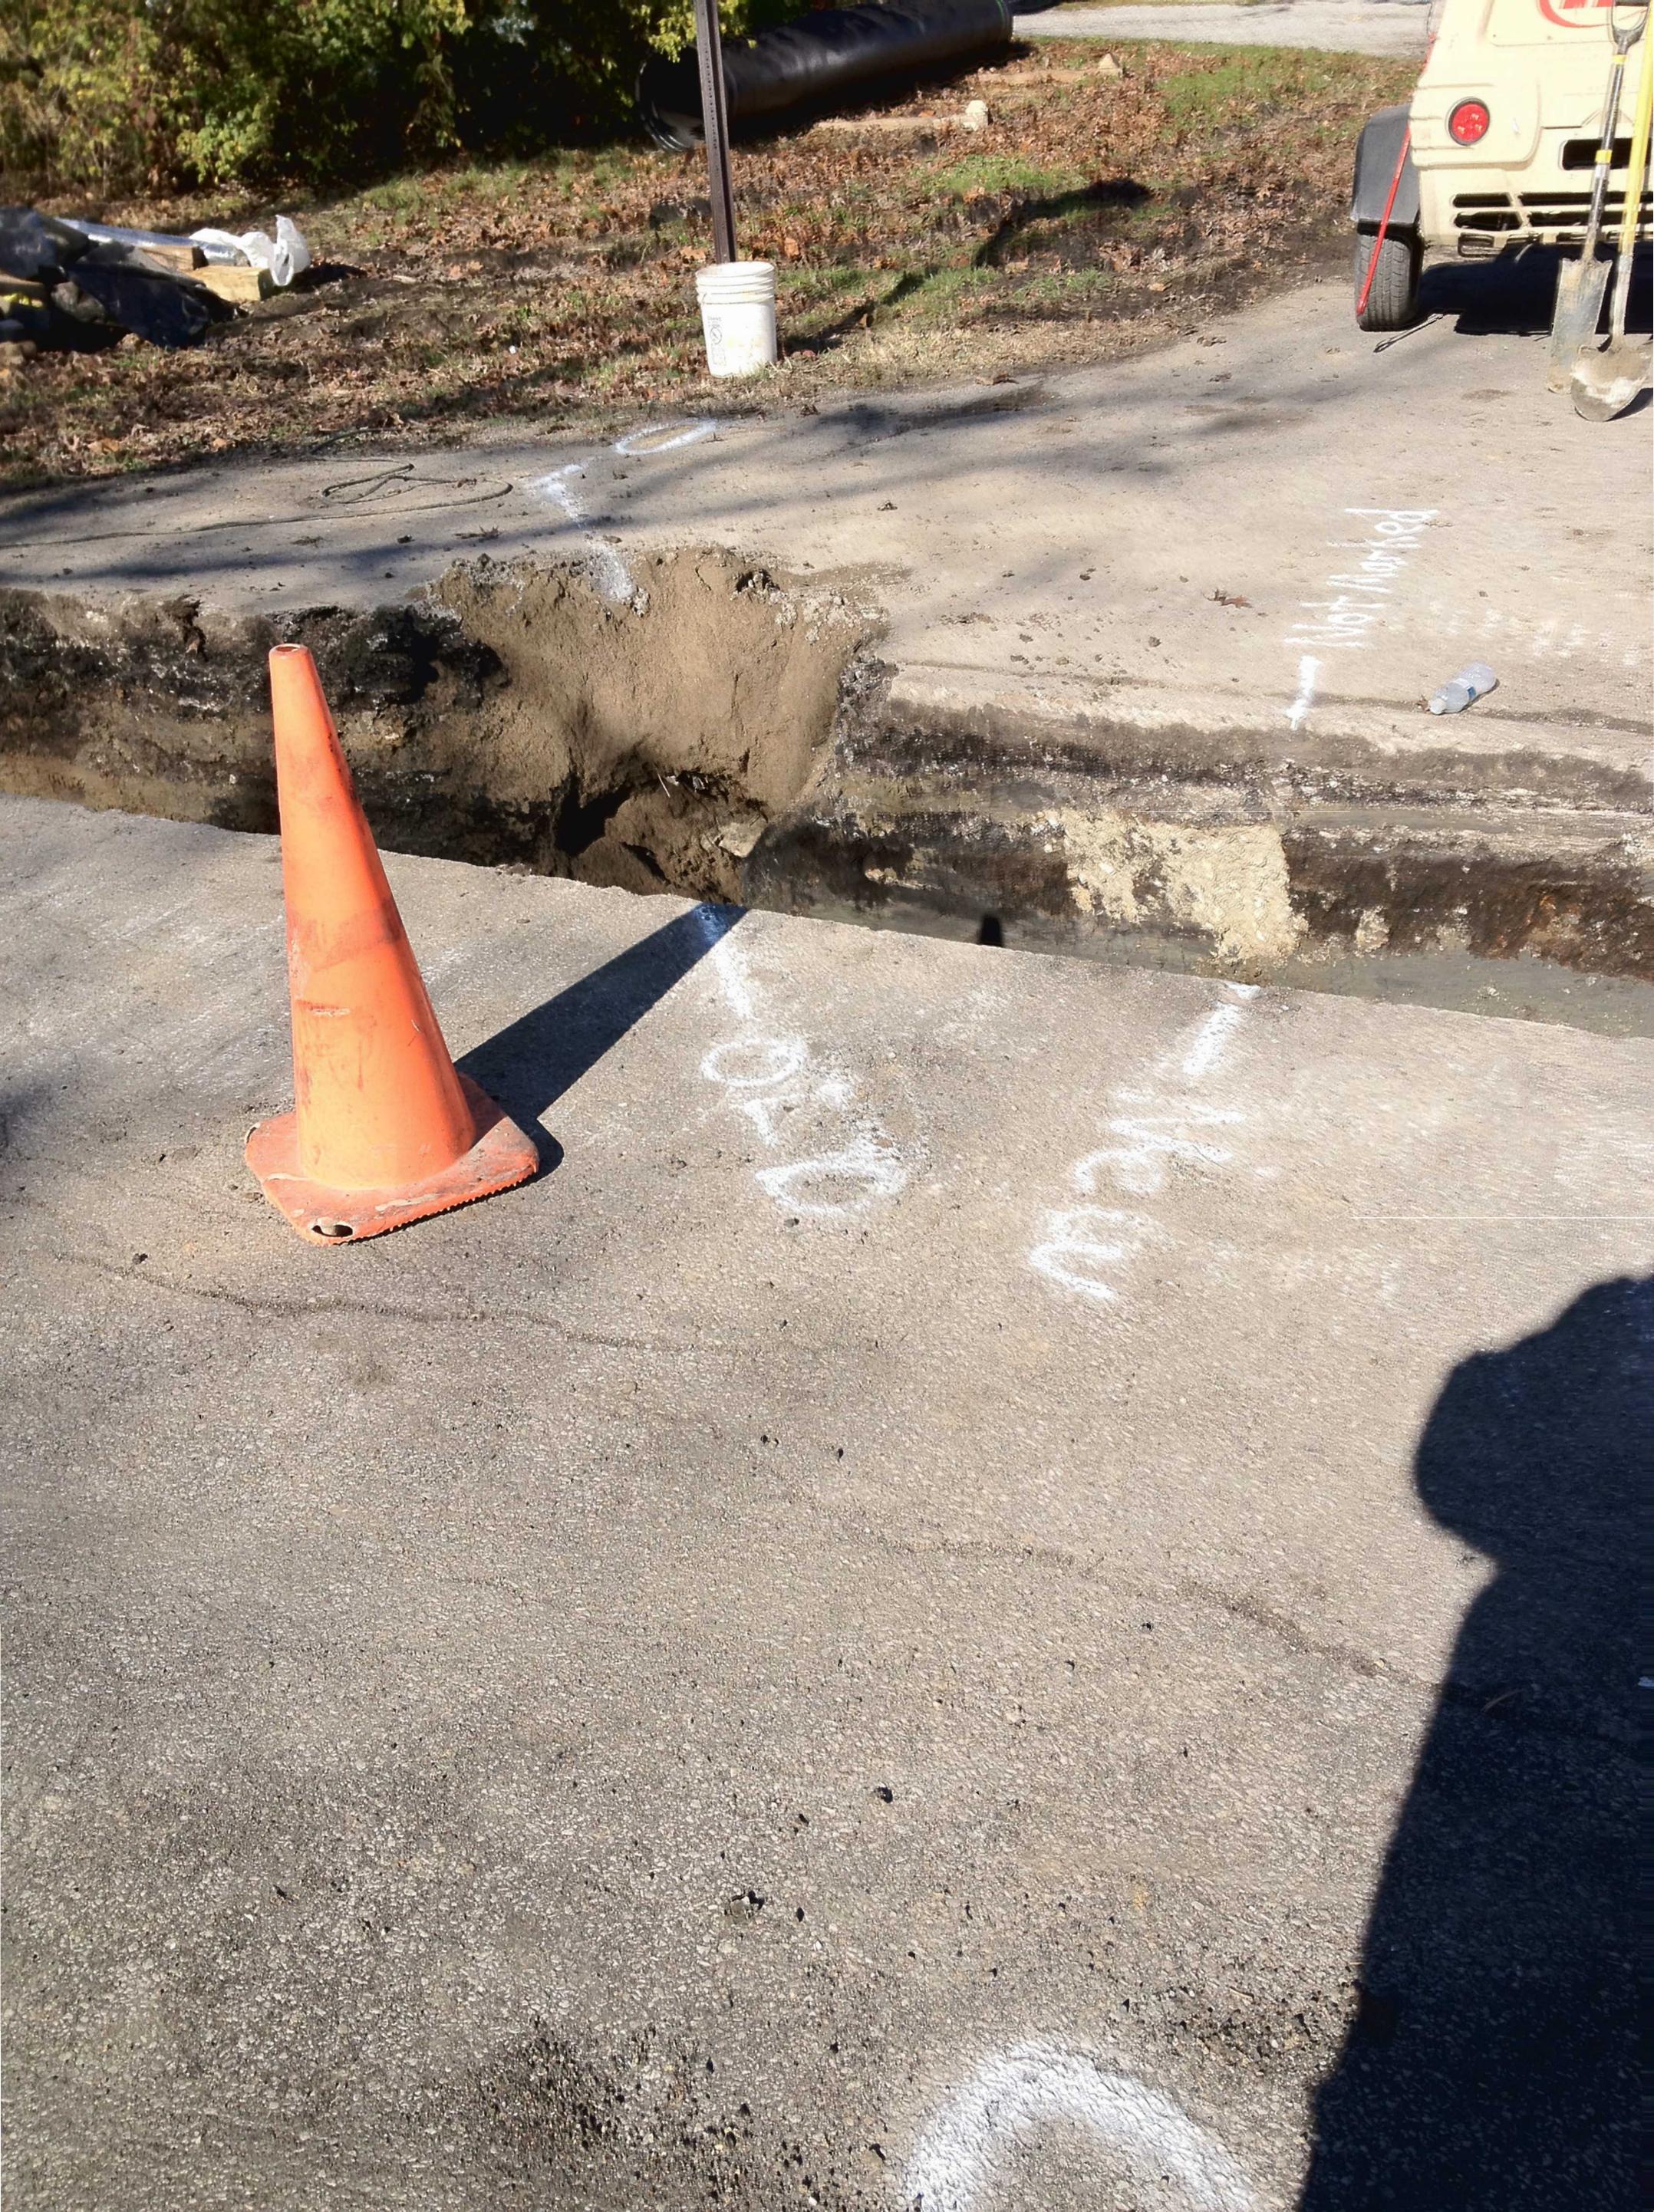
We hand spotted a 2" main on the locate marks and moved to dig backside of line with track hoe and hit a second 2" steel gas line that was not marked. We just put small dent in 2" steel line and it did not puncture or leak. We notified gas company and they made repair. The nearest locate marks were 39" off on the south-side of ditch and 52" on the north-side of the ditch. See attached pictures and drawing. I would be happy to explain pictures and drawing if you call me.
