Pipeline Safety Division Investigation Report

Investigation regarding: Indiana American Water Company

UPPAC Database Record ID: 4132

Synopsis: Excavator struck and damaged an underground natural gas service while performing water work.

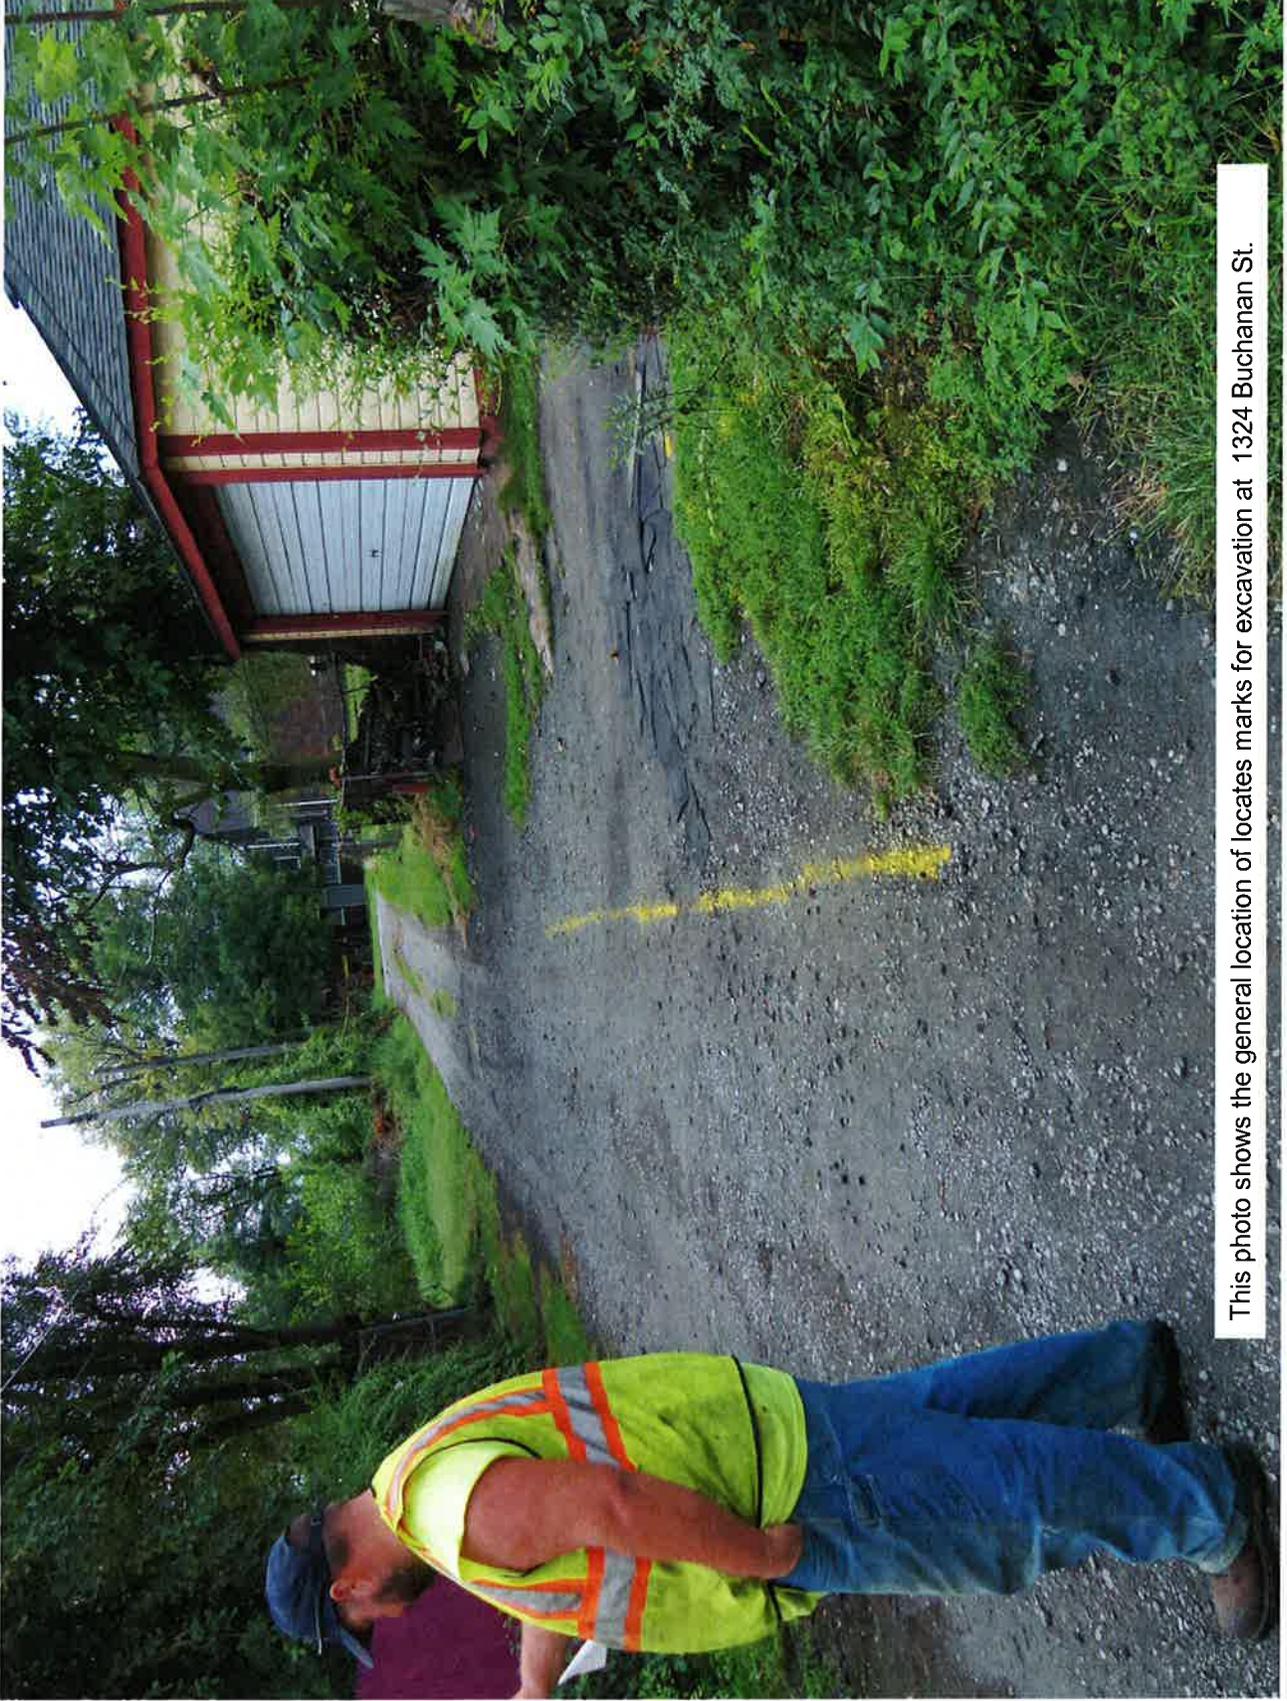
This photo shows the general location of locates marks for excavation at 1324 Buchanan St.

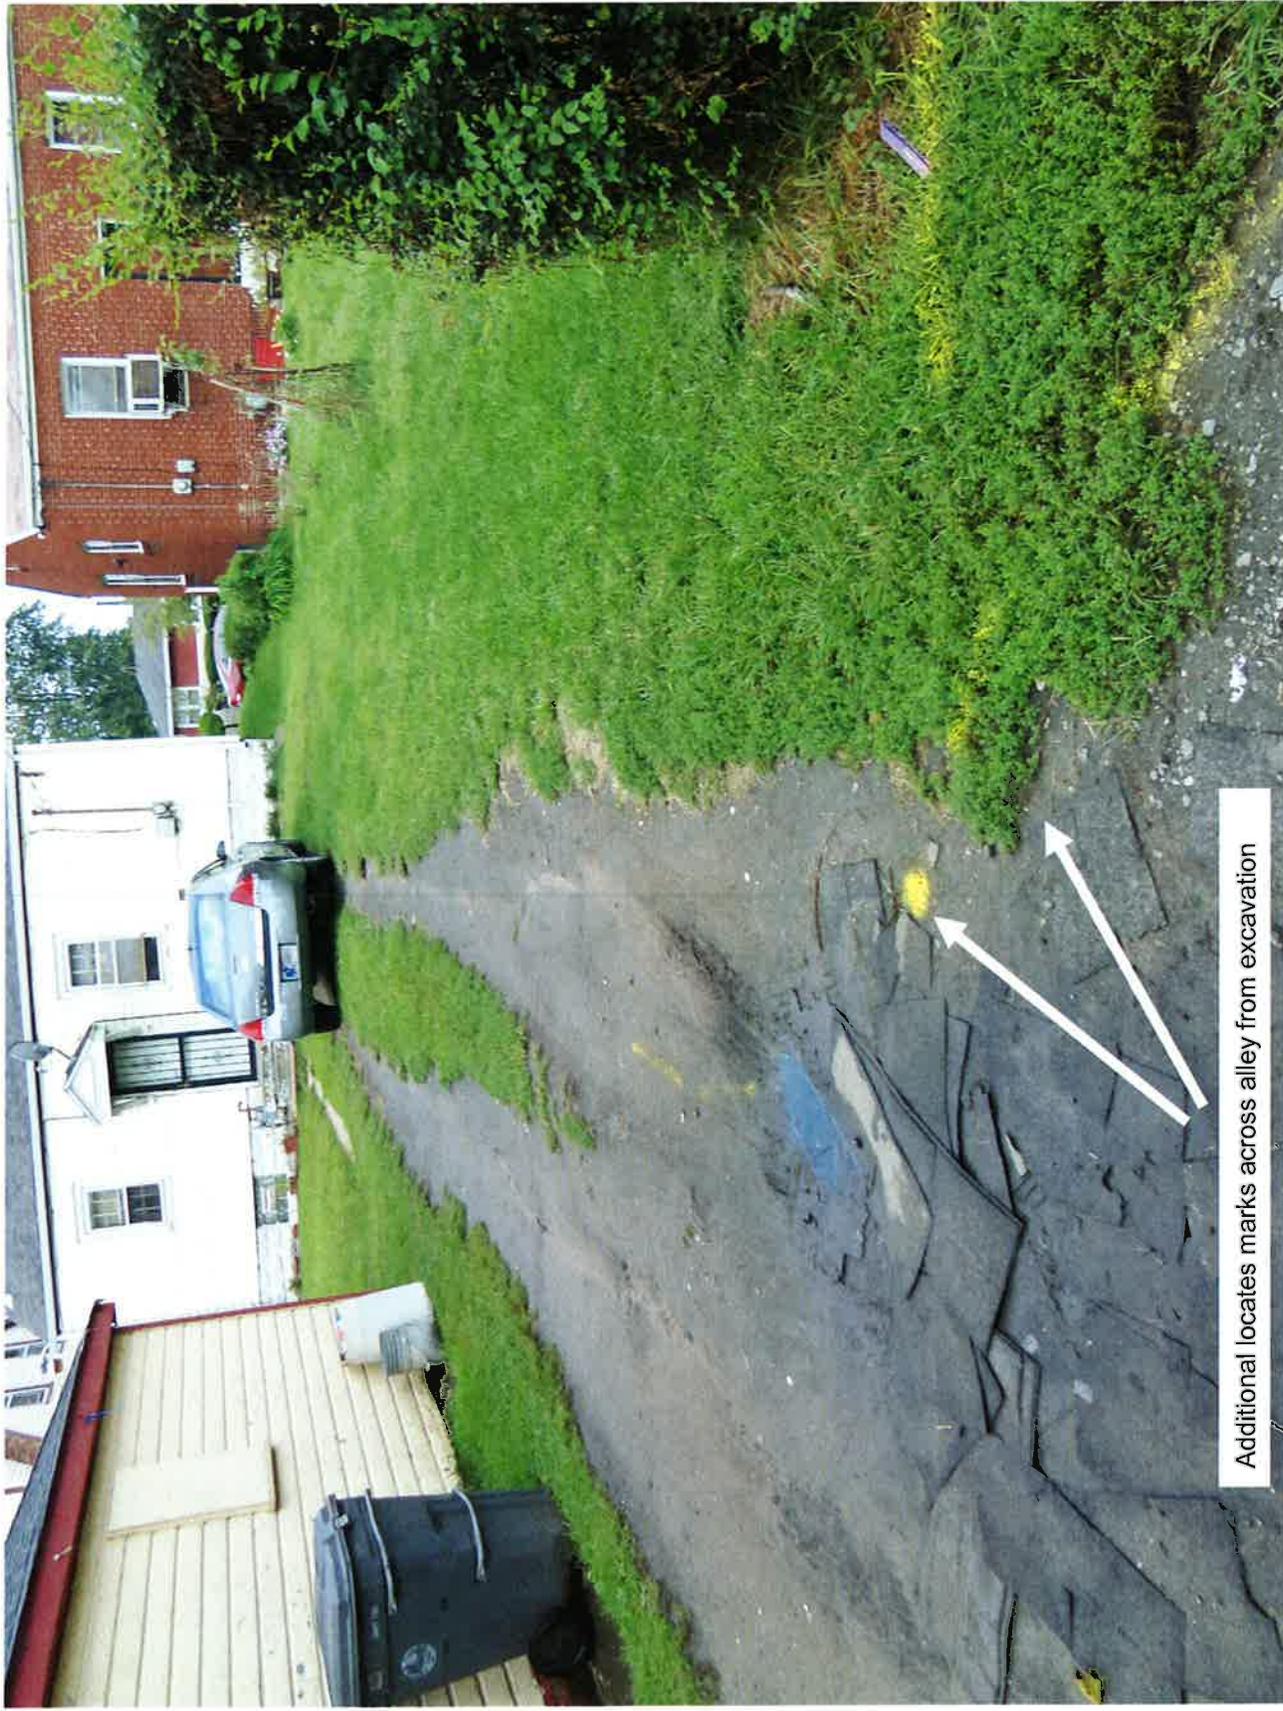
Additional locates marks across alley from excavation

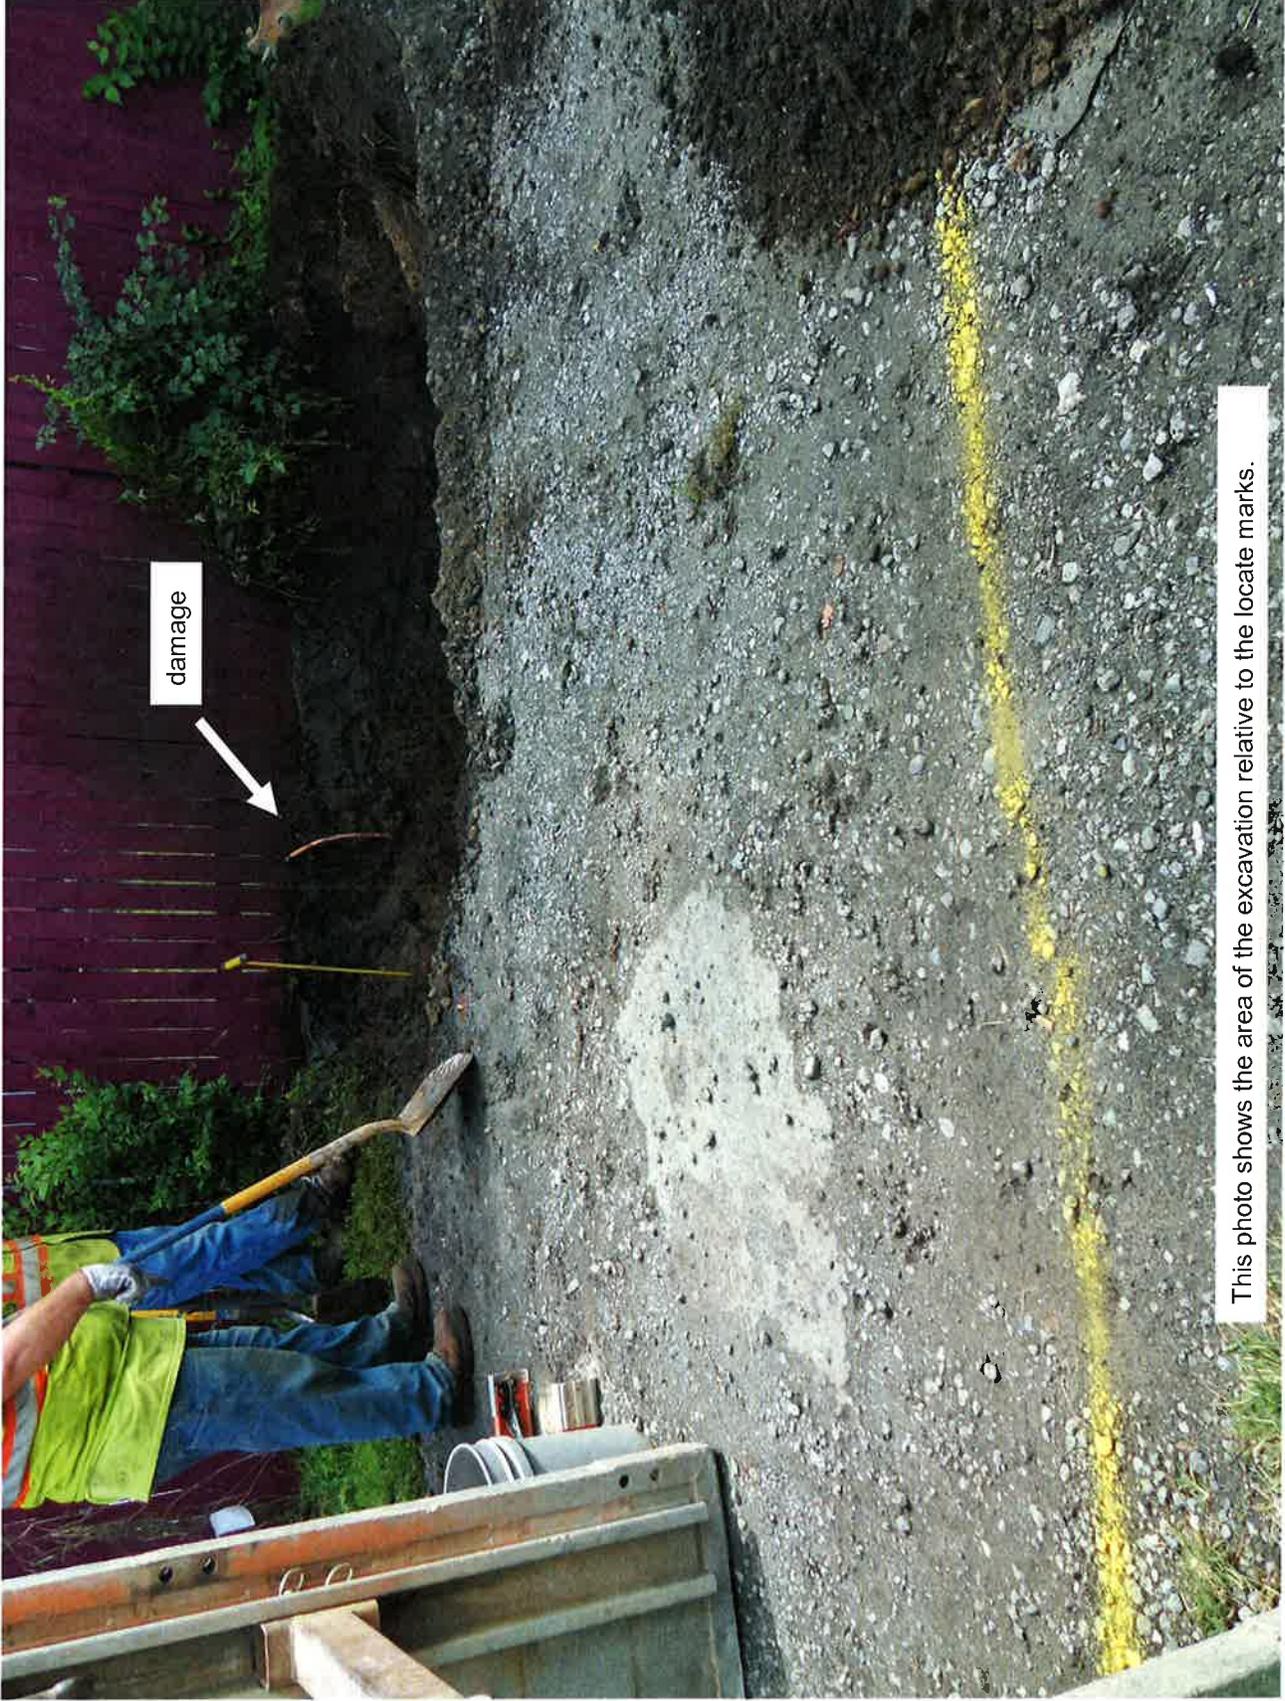
damage

This photo shows the area of the excavation relative to the locate marks.

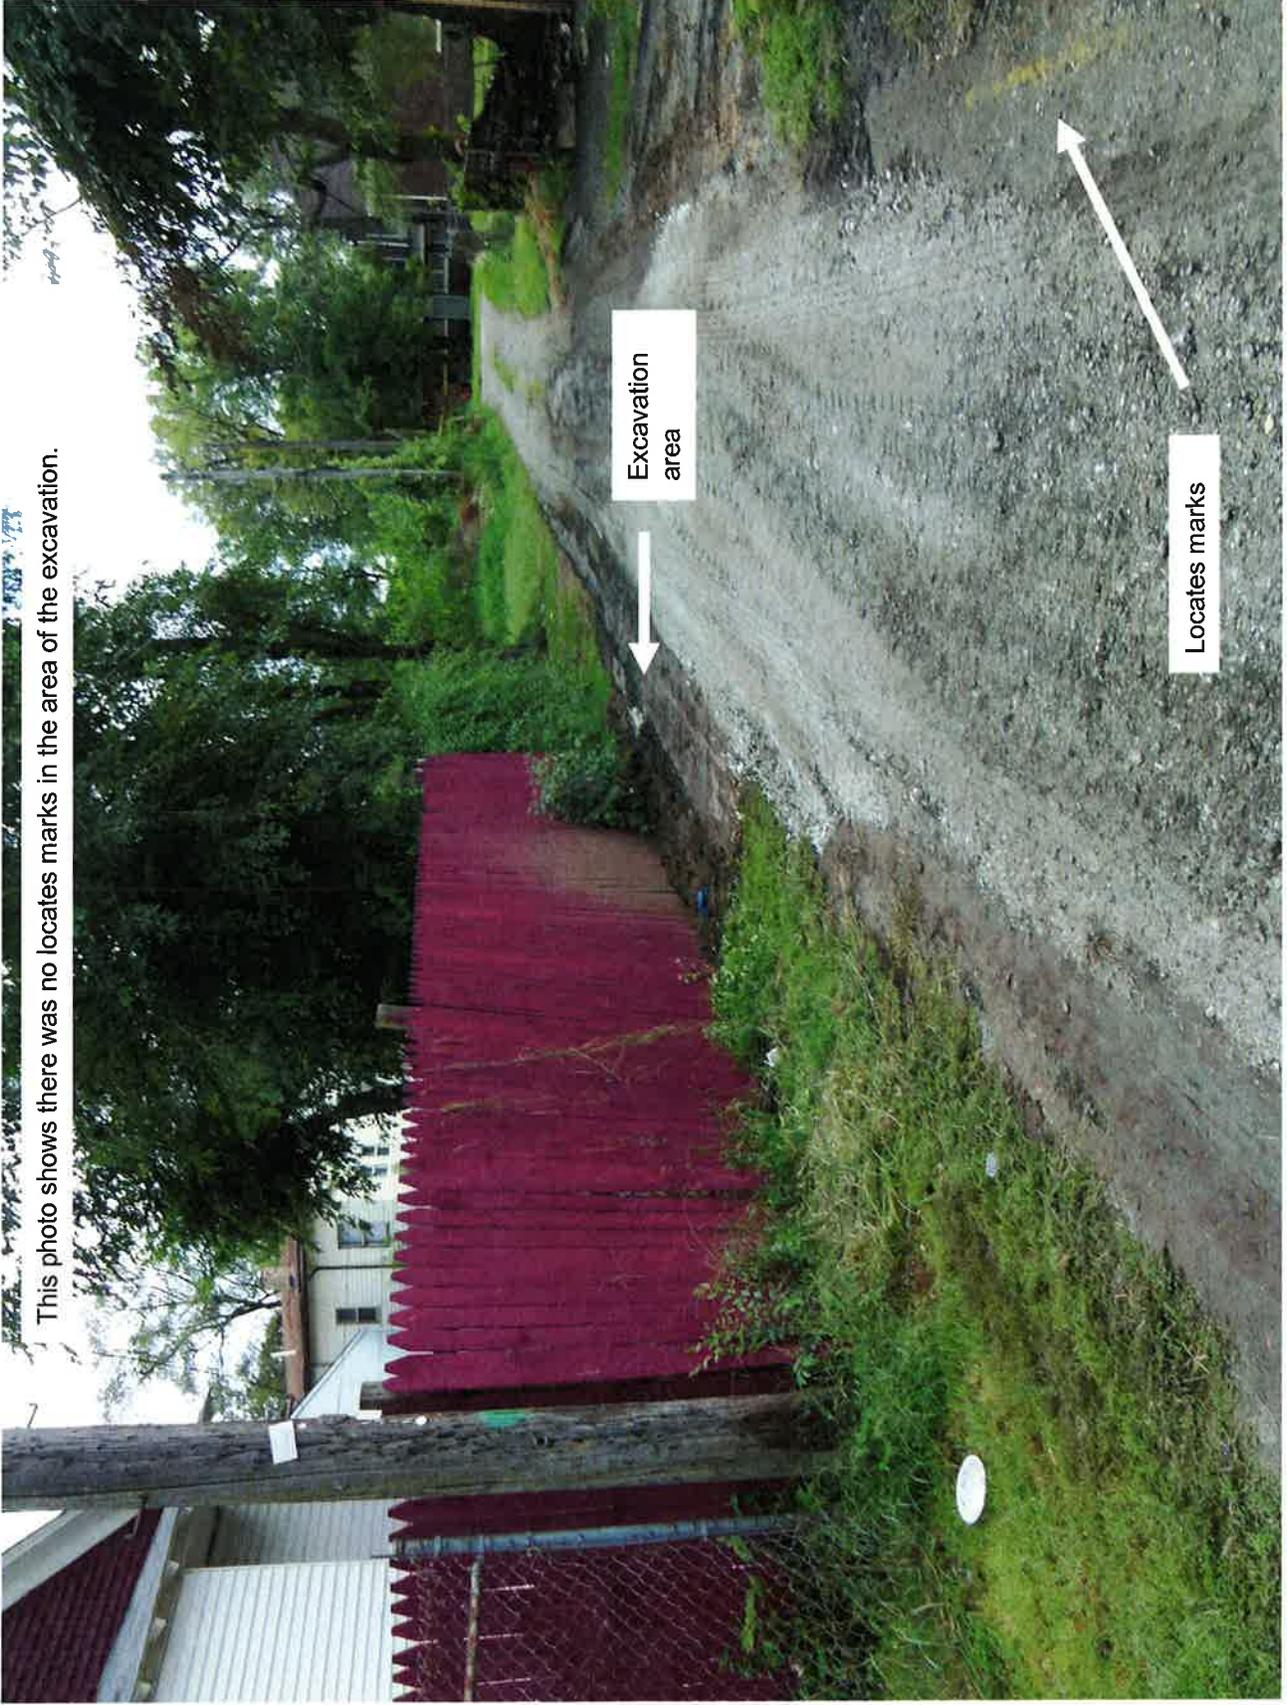
Indiana American Water was excavating in the alley behind 1324 Buchanan St. in order to repair a leaking water service line at this location. Excavation was along fence line in alley as shown by photos sent by Indiana American Water. Photos taken before and after excavation clearly show no locate marks in the planned area of the excavation. Instead locate marks are shown across the alley from where the excavation took place. This non-marking or mis-marking of gas utilities indicated to the construction crew there was no other utilities in the area of the excavation.

This photo shows there was no locates marks in the area of the excavation.

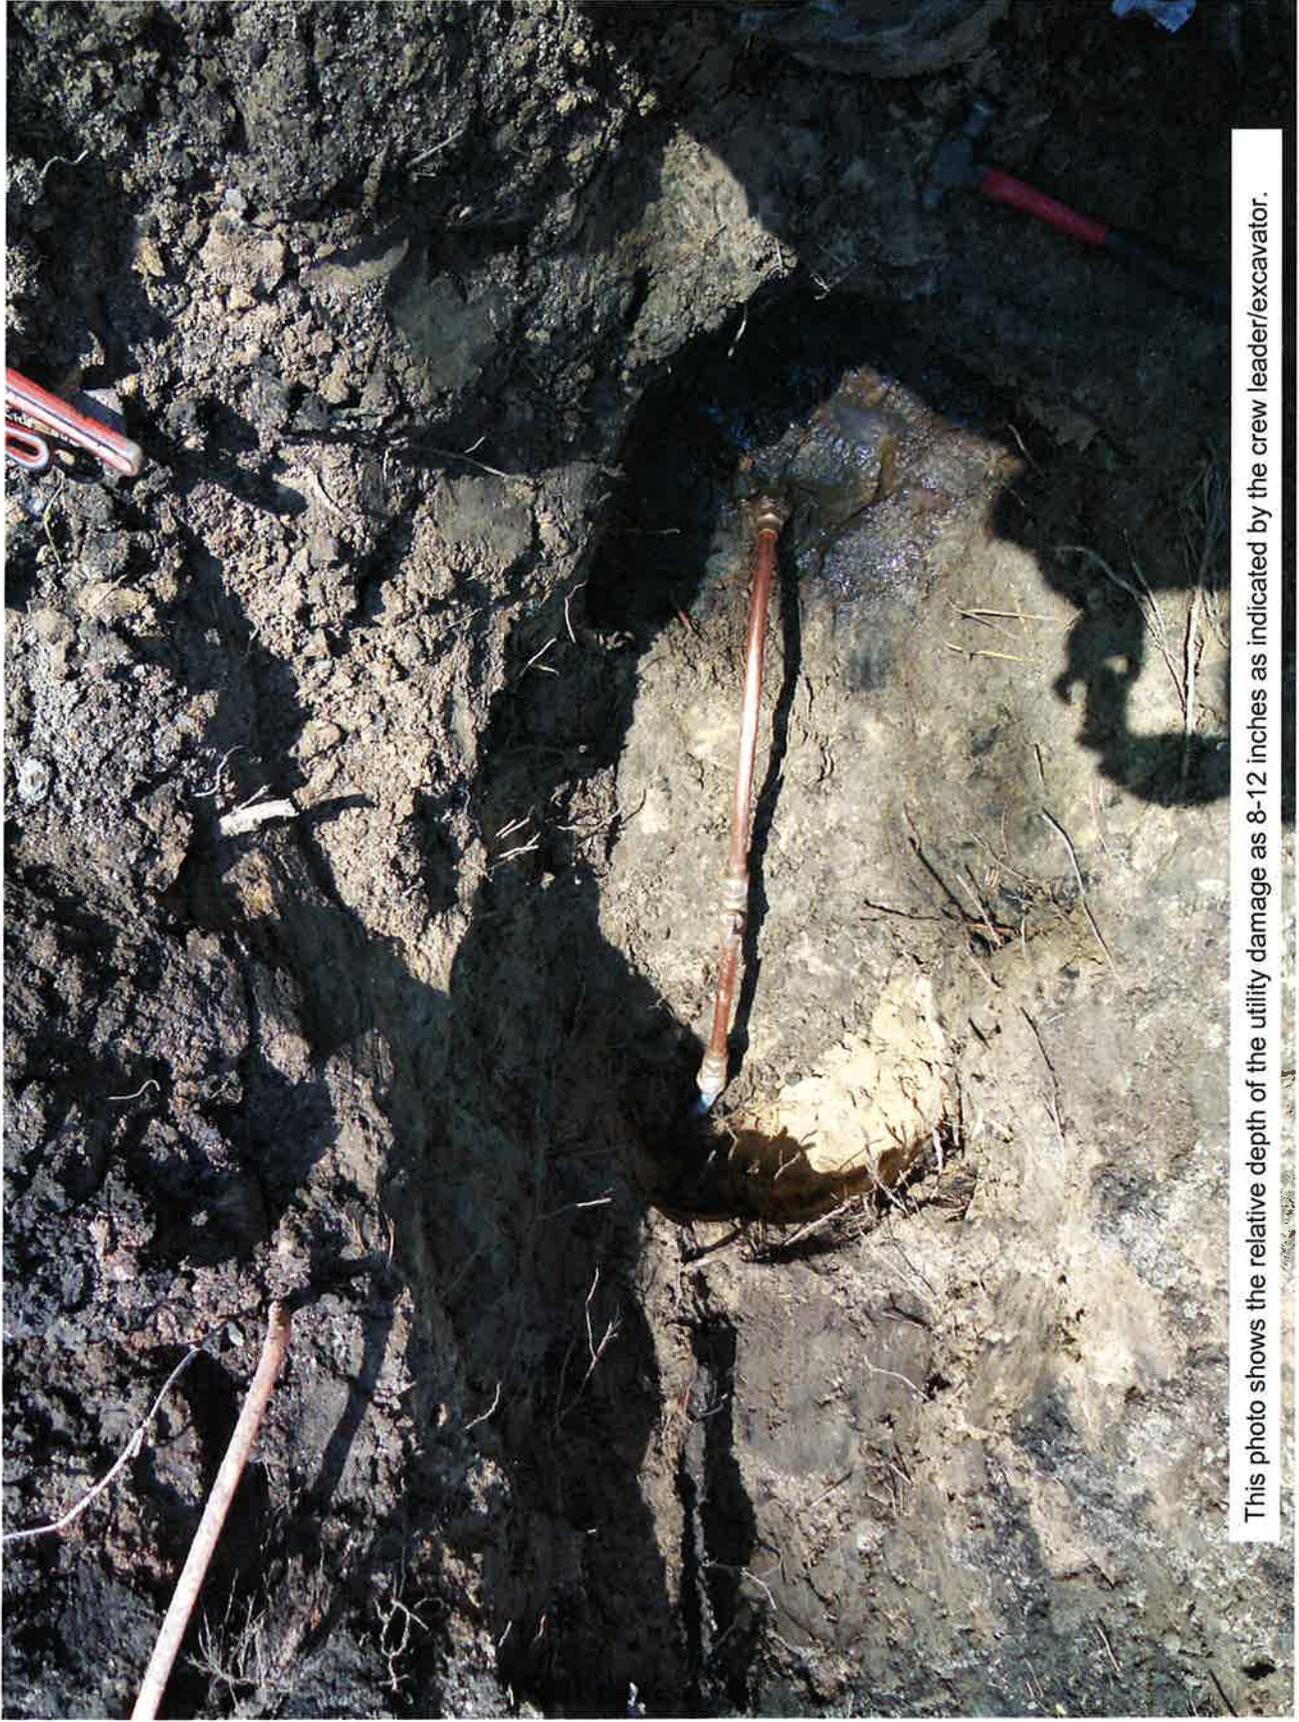
Excavation was done by carefully by hand and backhoe around the area of the water shut-off box. An unmarked gas line was struck by the backhoe approximately 8-12 inches below the surface of the ground according to Indiana American Water crew leader, Mark Laing.

Gas Service was maybe 8-12 inches down from top of ground I took pictures before, during and after the job

This photo shows the relative depth of the utility damage as 8-12 inches as indicated by the crew leader/excavator.
