Pipeline Safety Division Investigation Report

Investigation regarding: Hi Speed Utility

UPPAC Database Record ID: 4276

Synopsis: Excavator struck and damaged an underground natural gas service while performing telecommunications work.

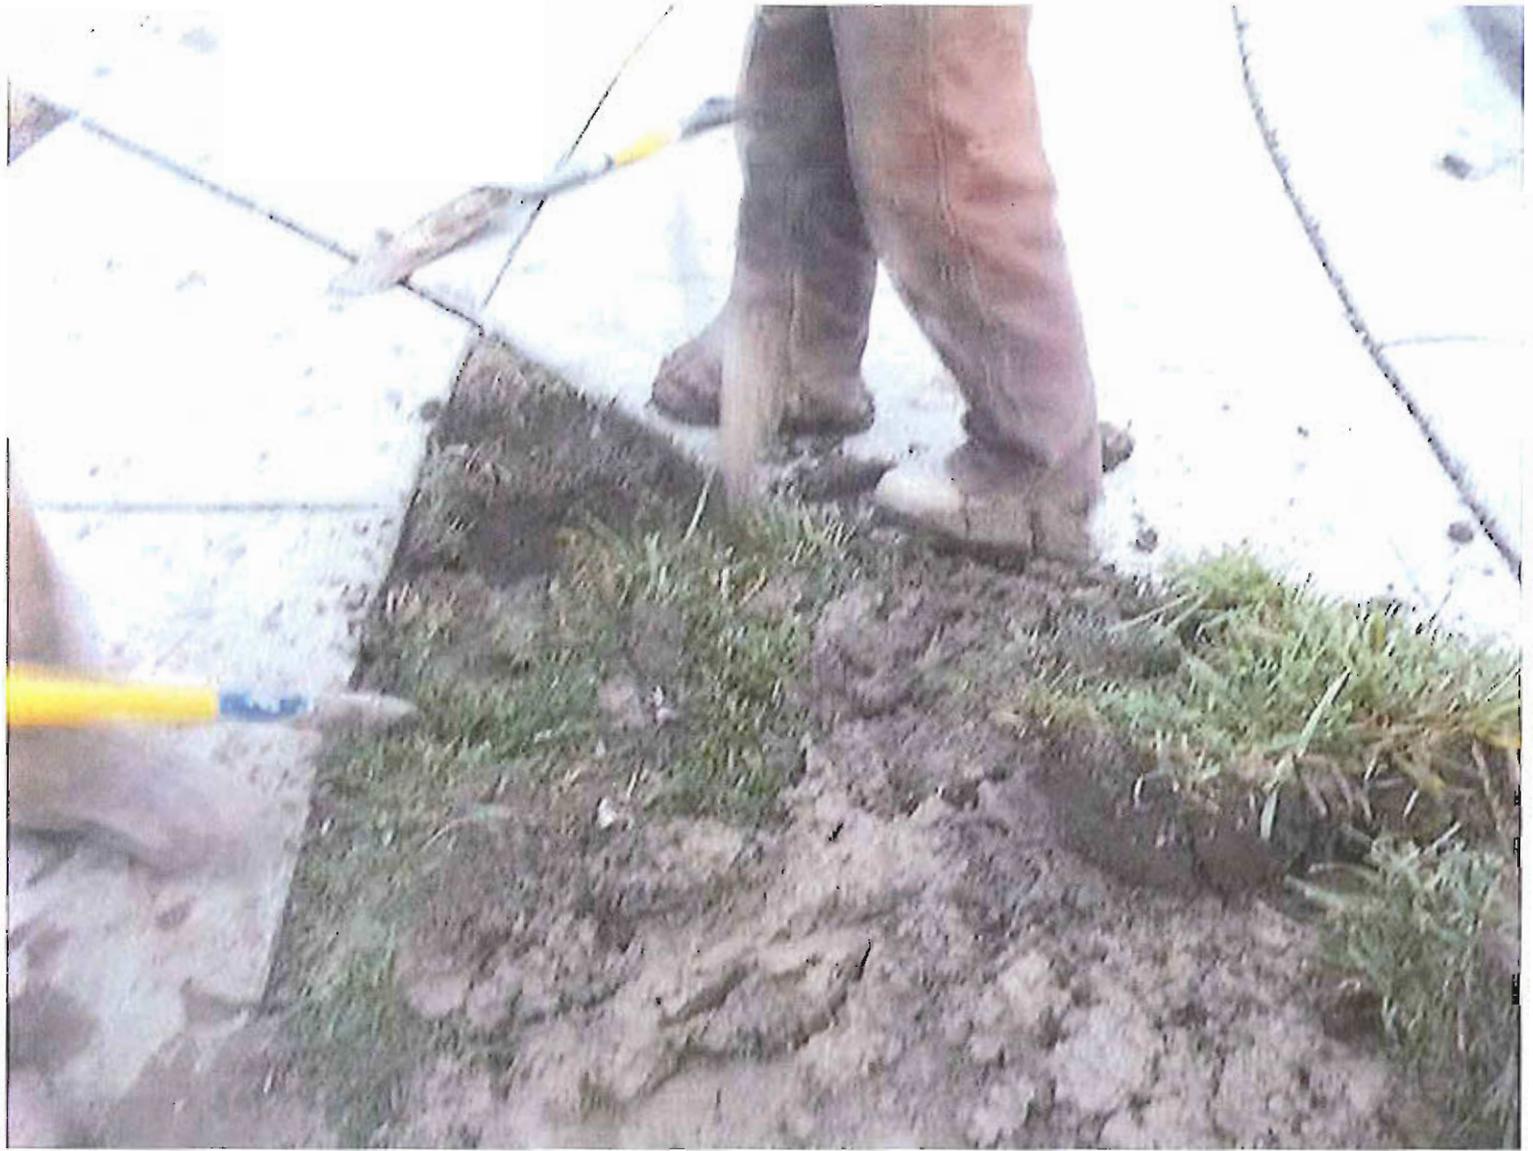
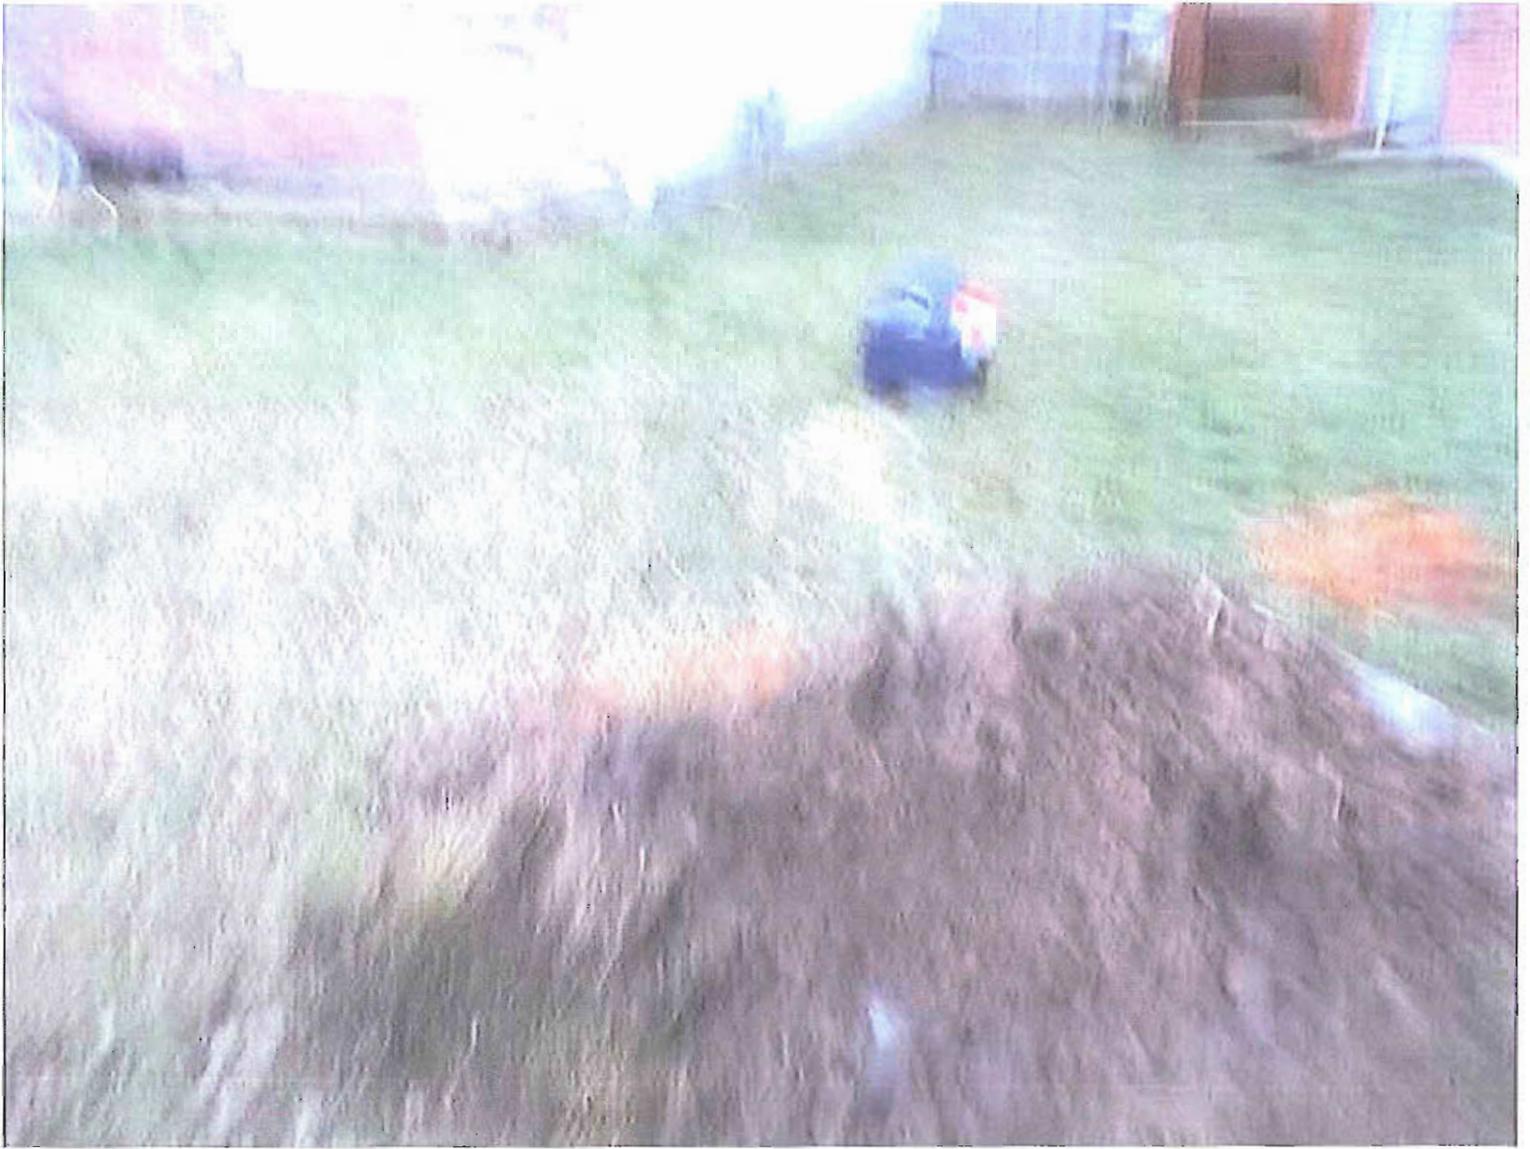
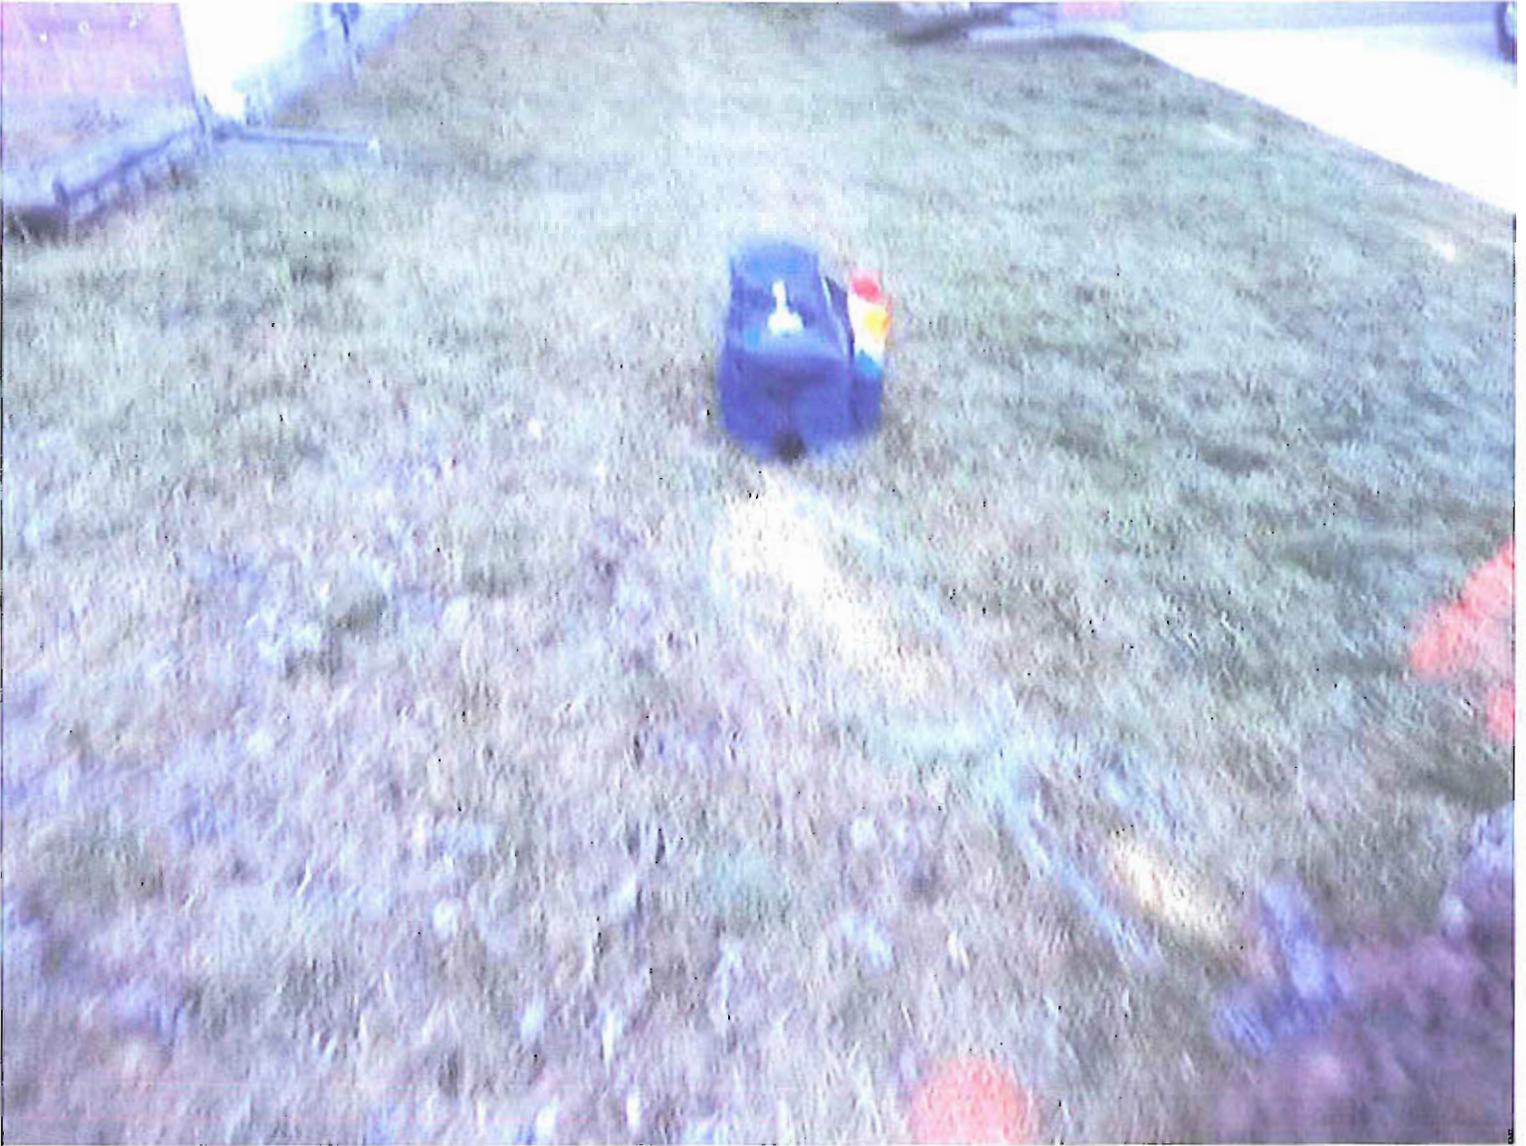
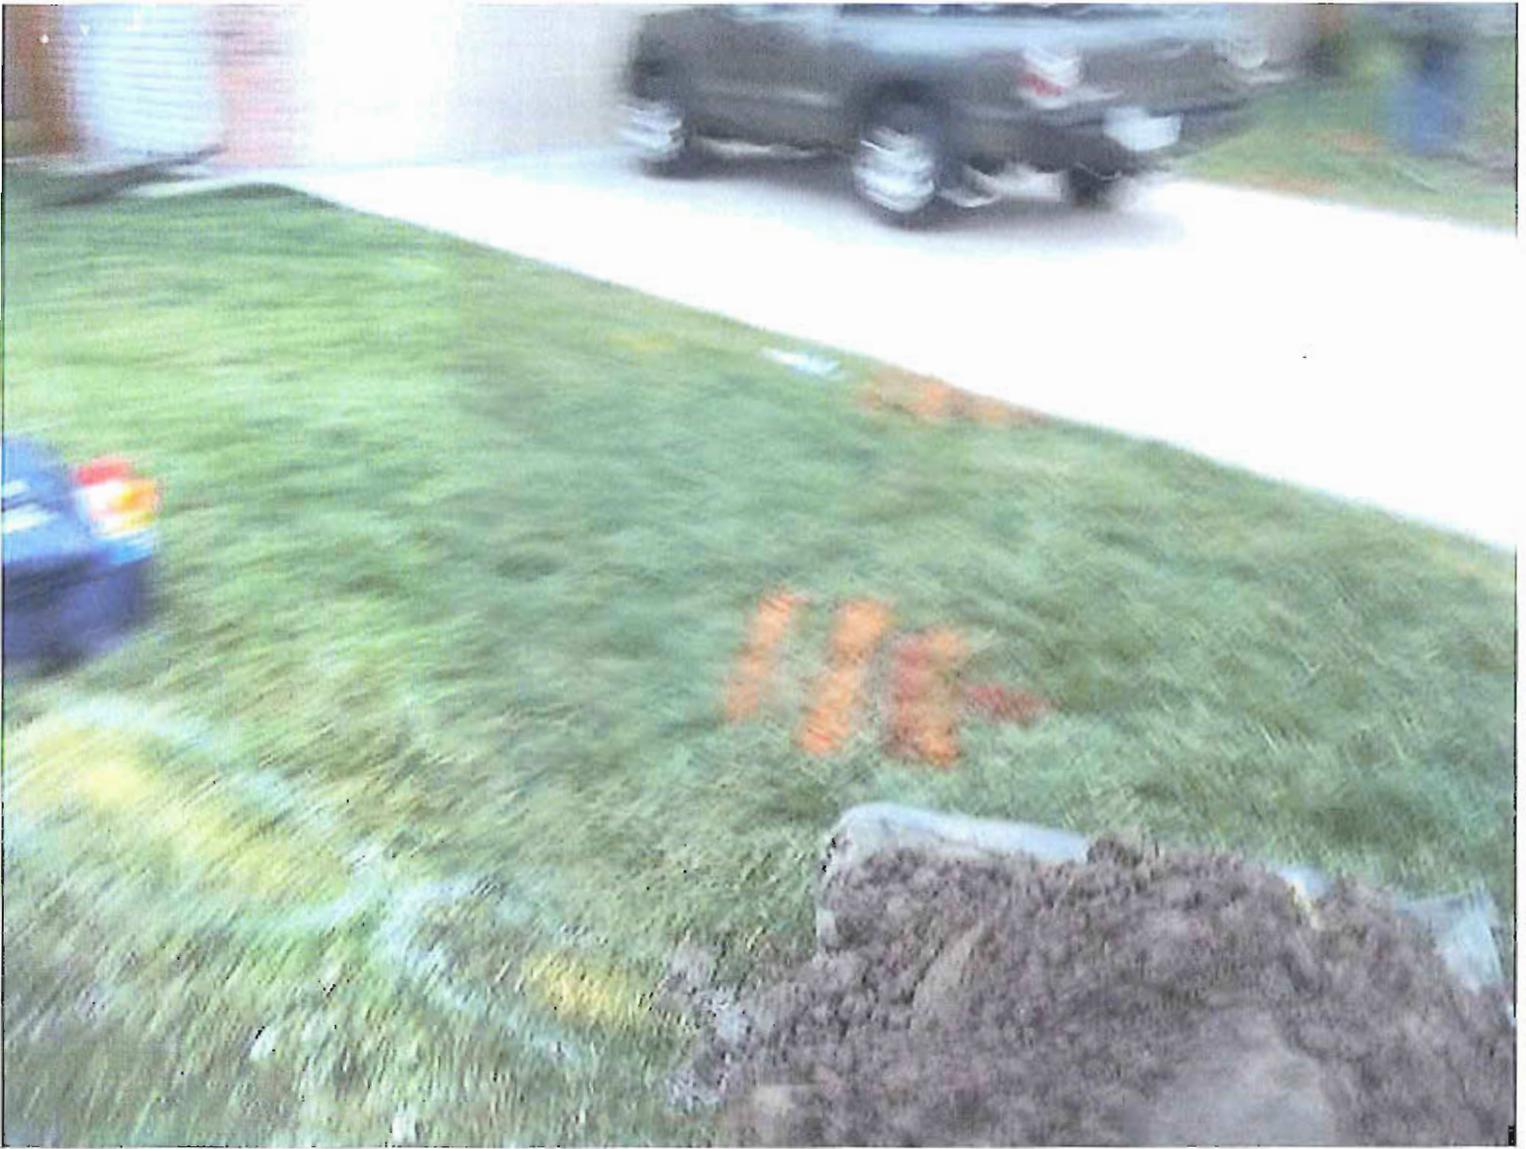
1" plastic service damaged by bore. Incomplete Locate.

Address: 1043 MOSSWOOD CIRCLE, FRANKLIN
1" PLASTIC SERVICE DAMAGED BY BORE. INCOMPLETE.
