## Pipeline Safety Division Investigation Report

### Investigation regarding: Fairview Park Water Utility

UPPAC Database Record ID: 4314

Report Date: 7/15/2013

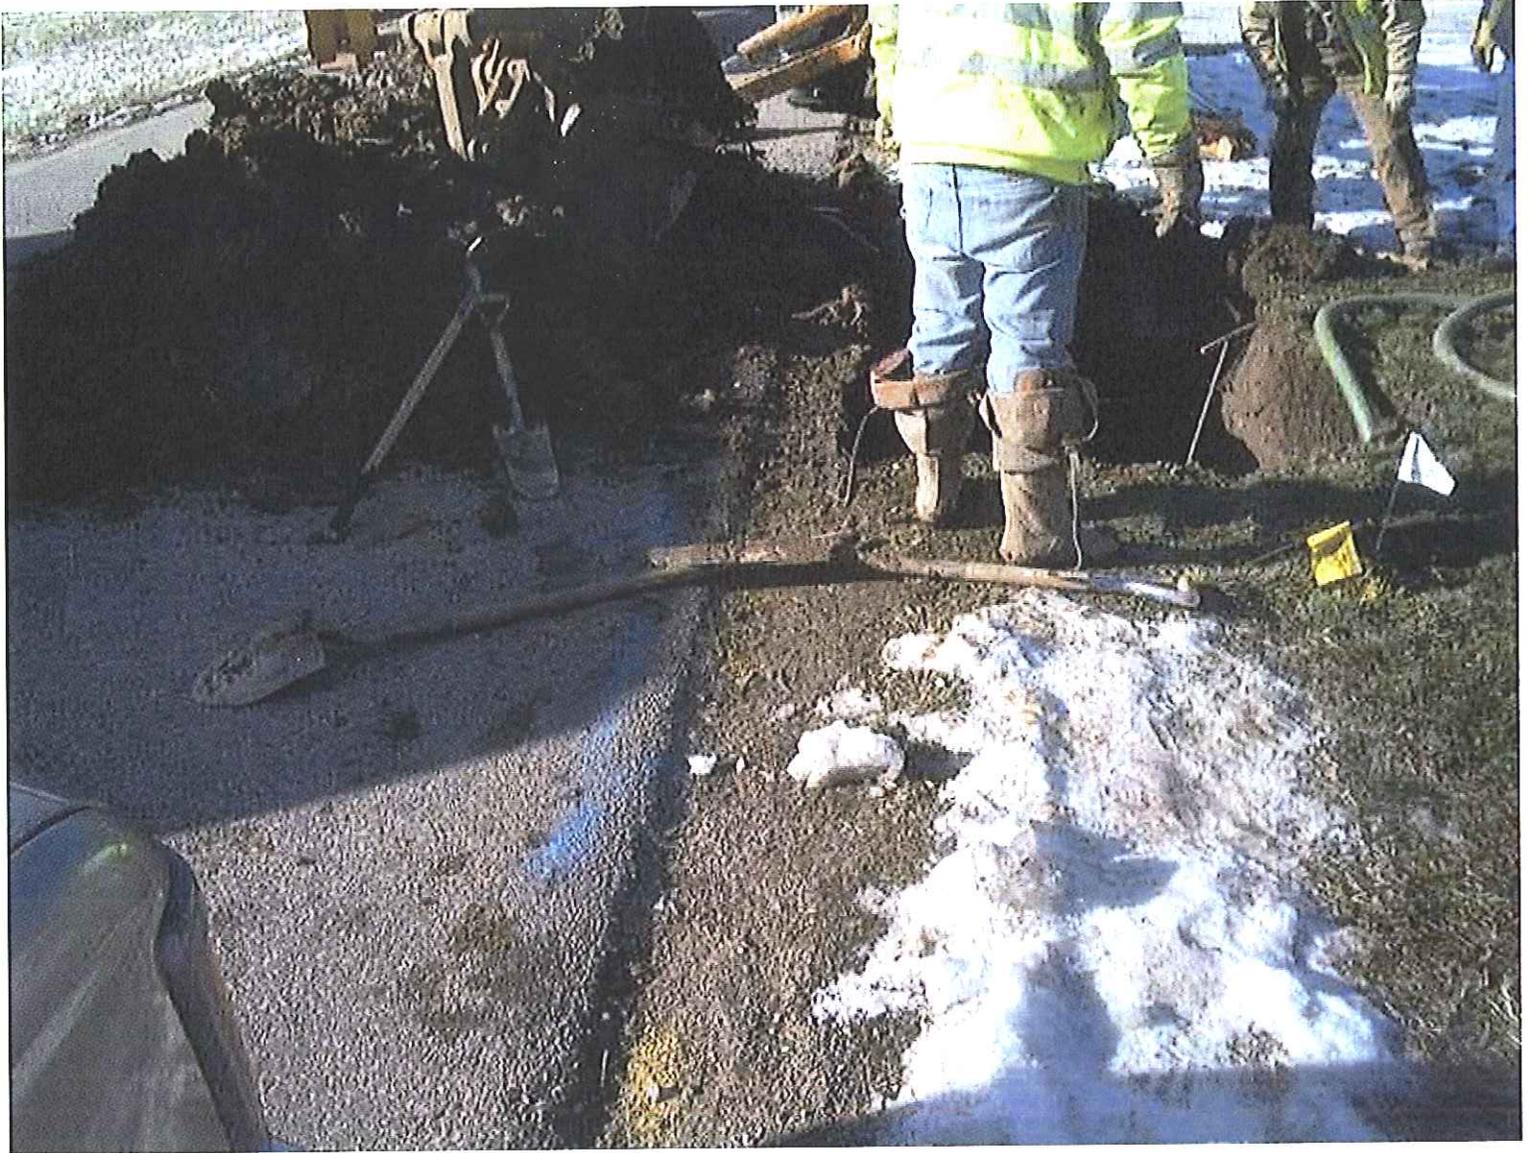
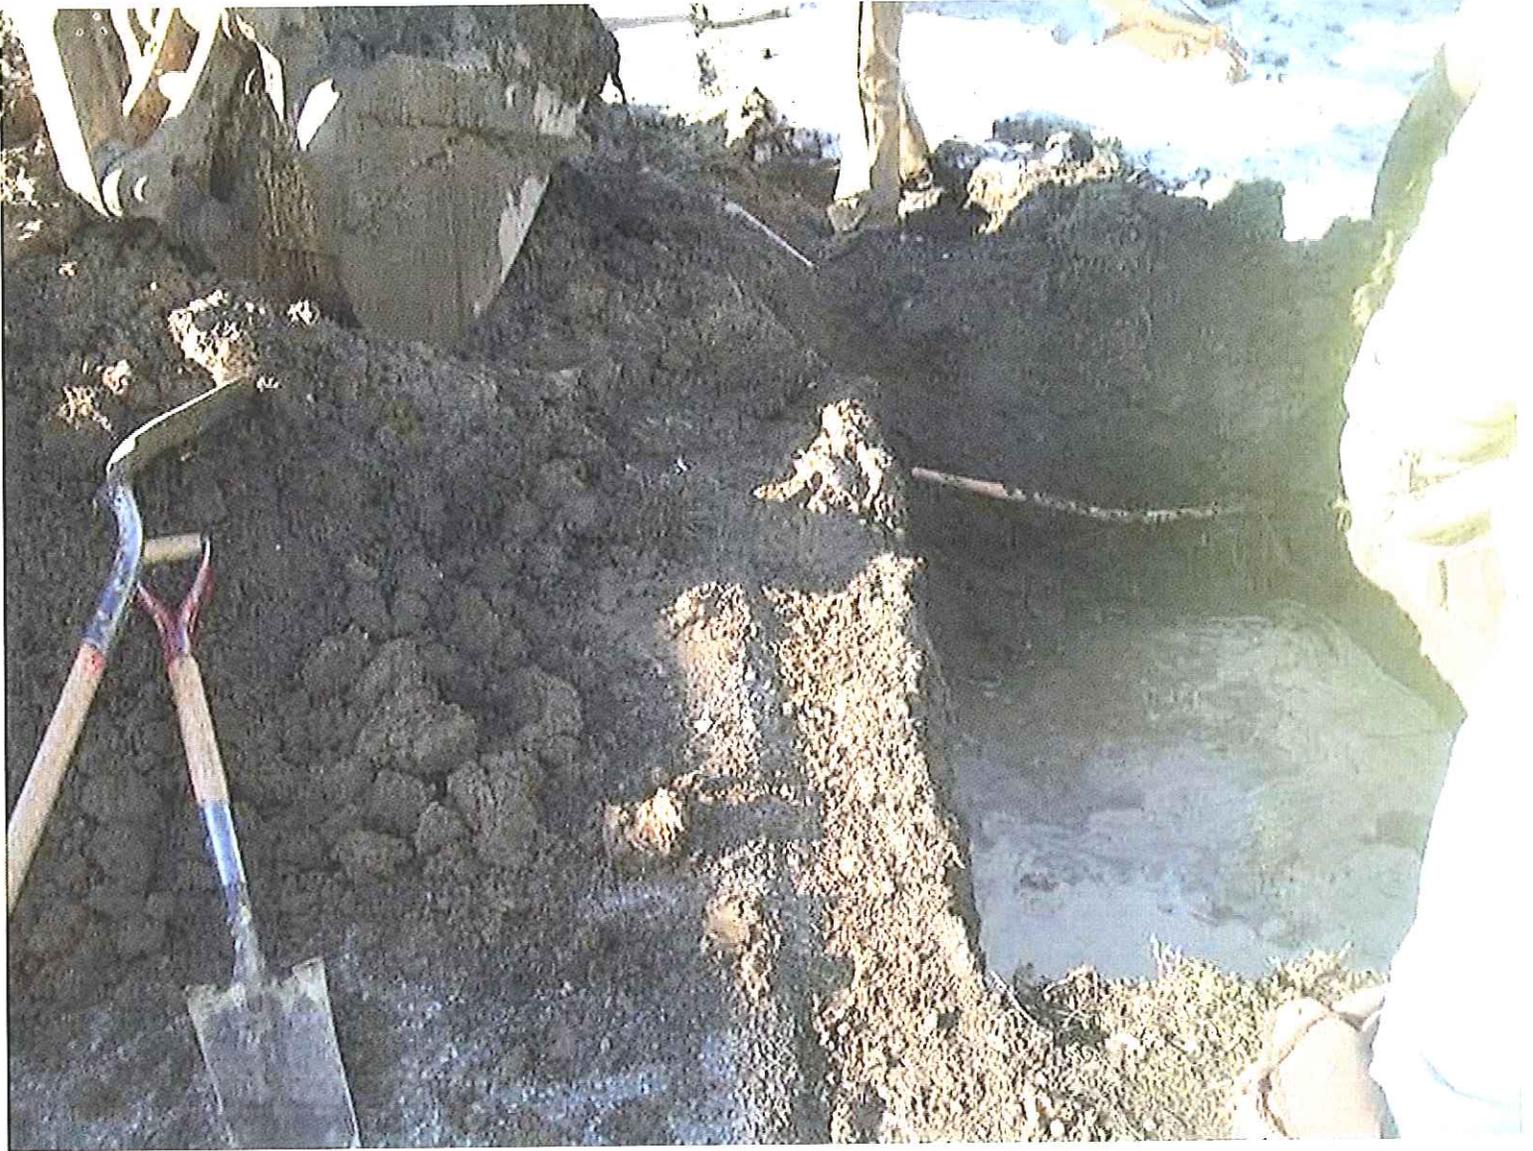
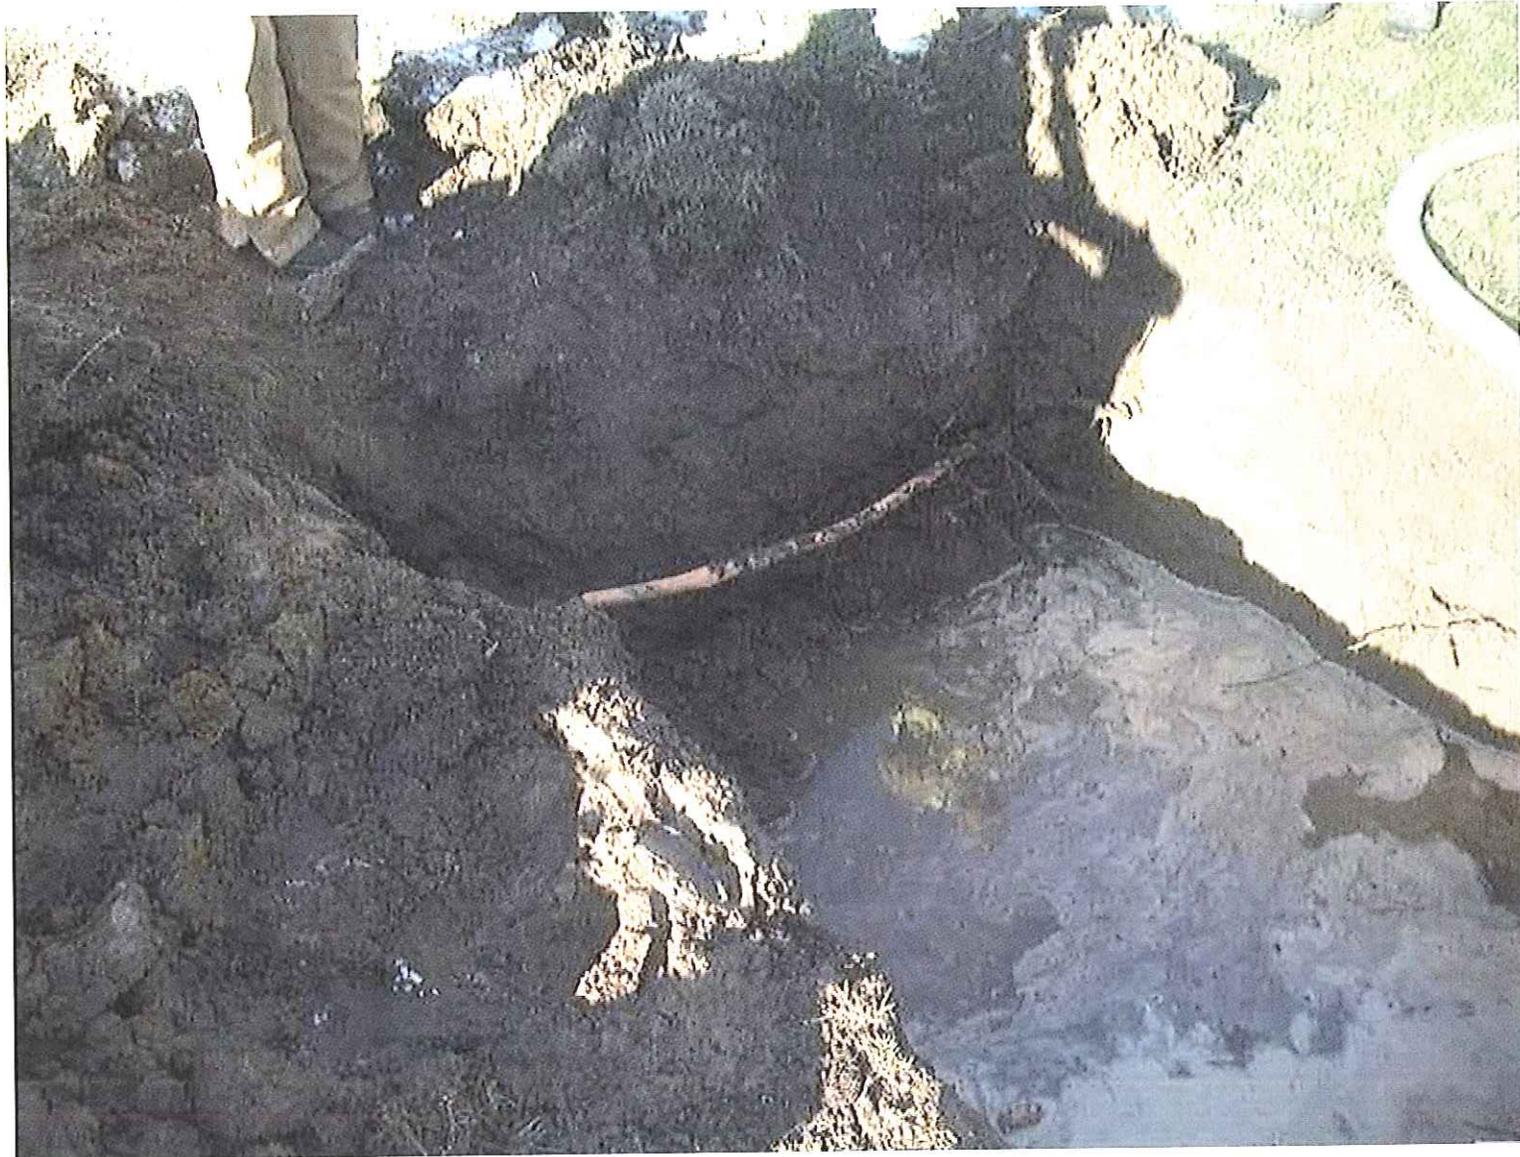
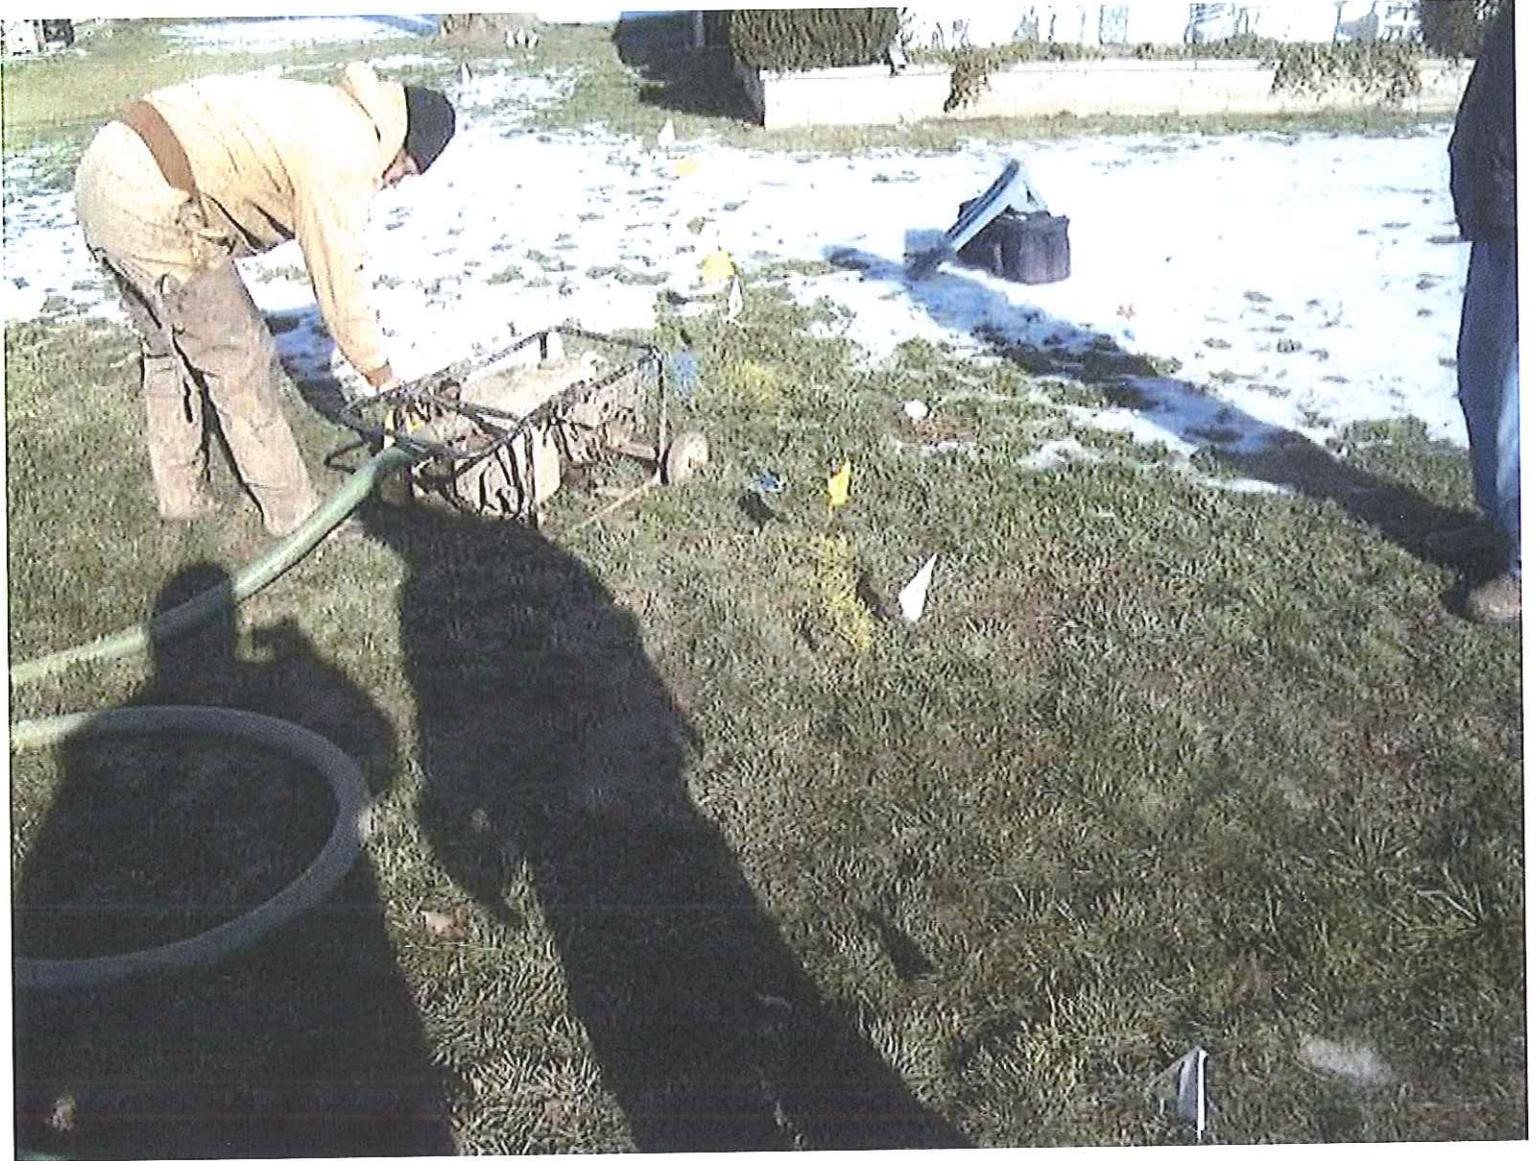
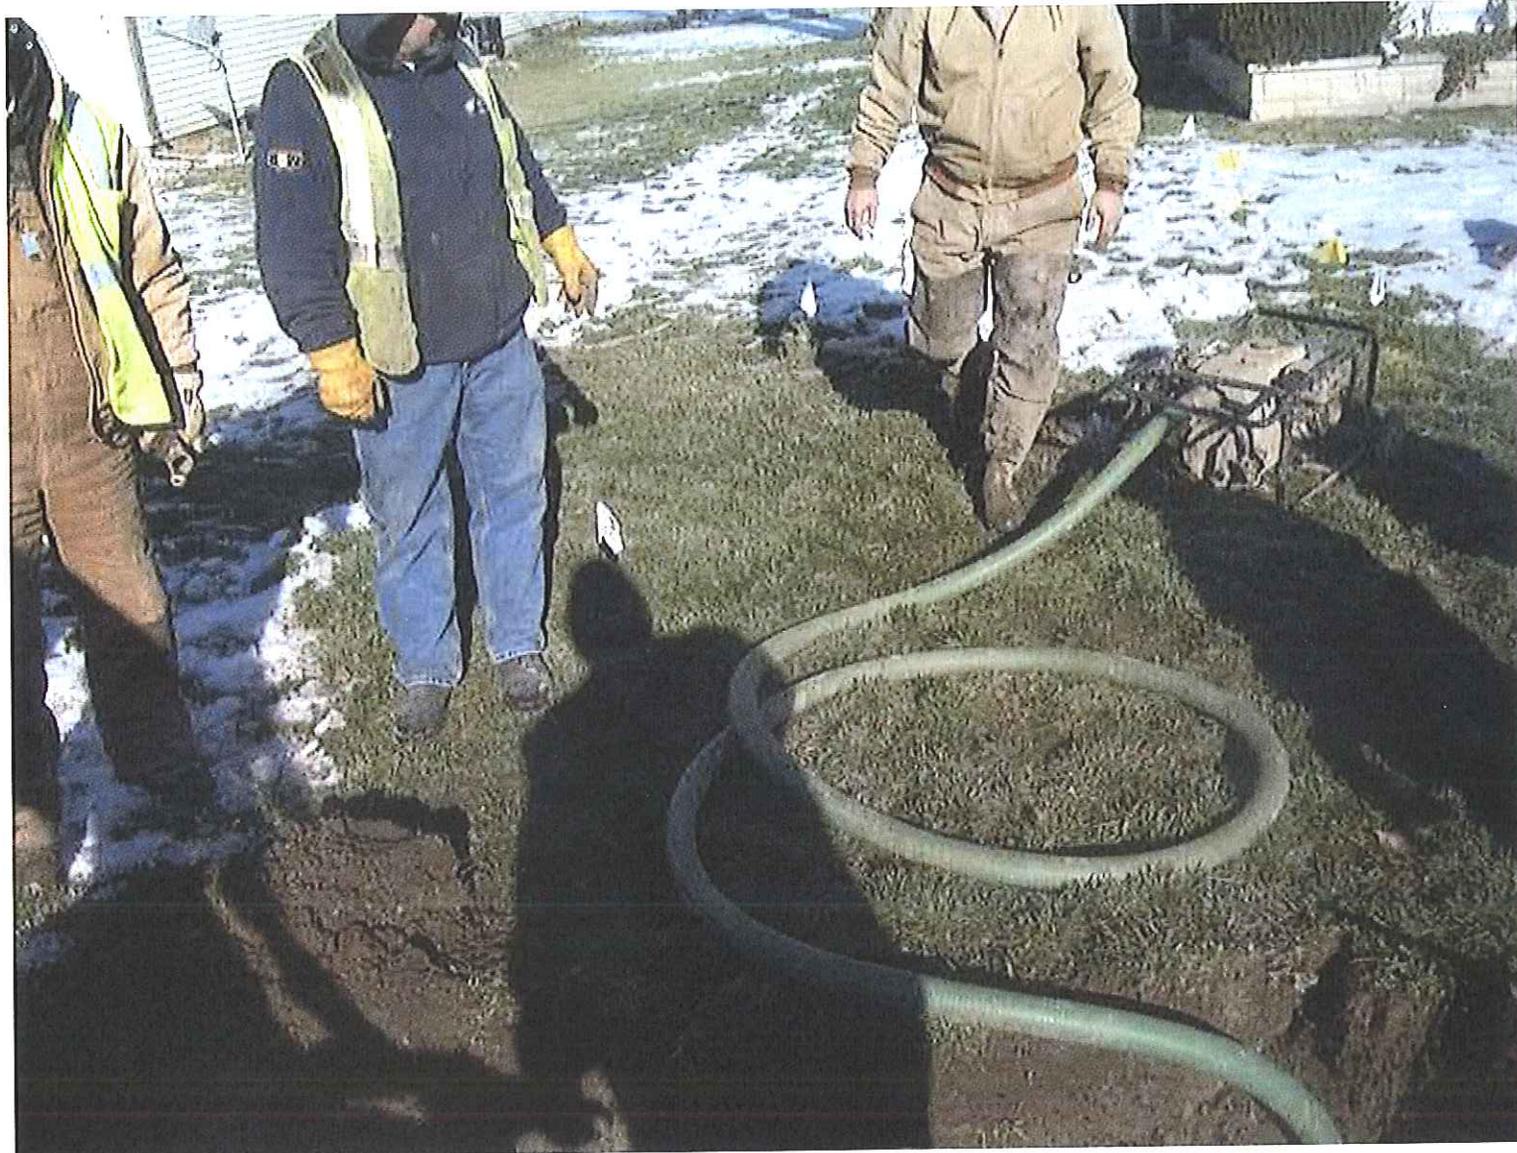
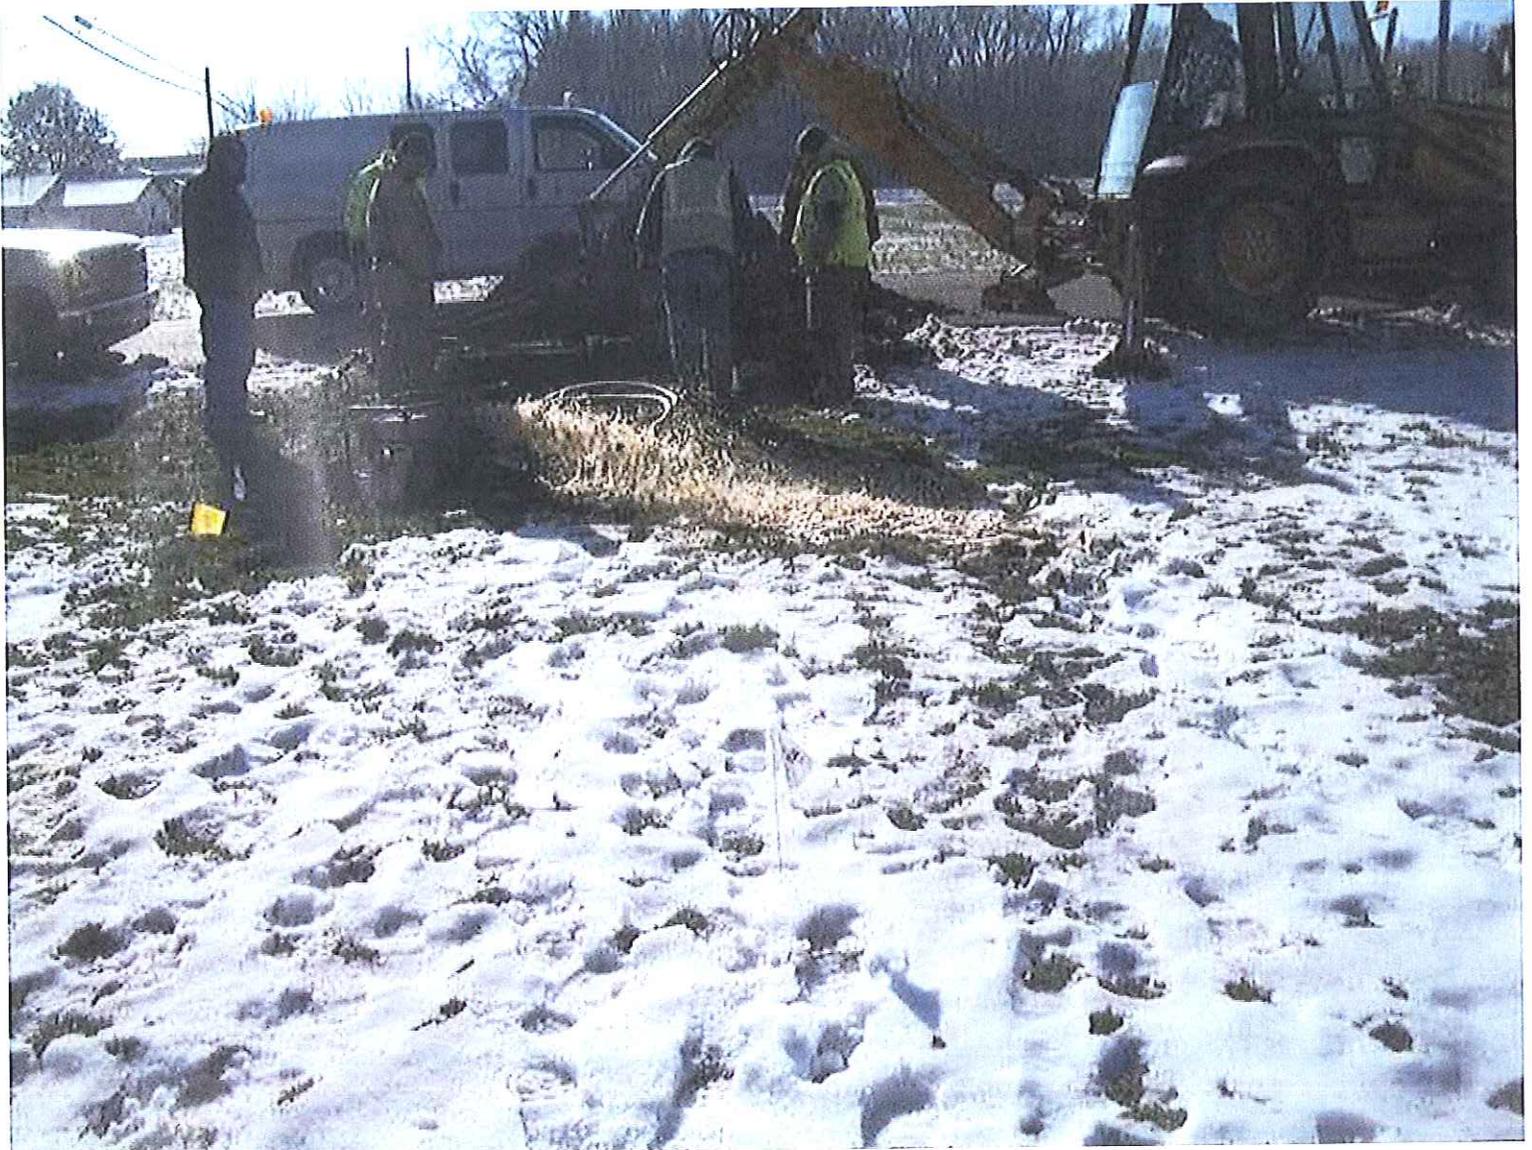
1" plastic service severed by hoe. > 24"

**SERVICE WAS LOCATED APPROX. 8 FT EAST OF ACTUAL LOCATION OF SERVICE.**
