## Pipeline Safety Division Investigation Report

### Investigation regarding: Miller Pipeline

UPPAC Database Record ID: 4446

Damage Address: 213 S Dexter Ave, Knight, Vanderburgh

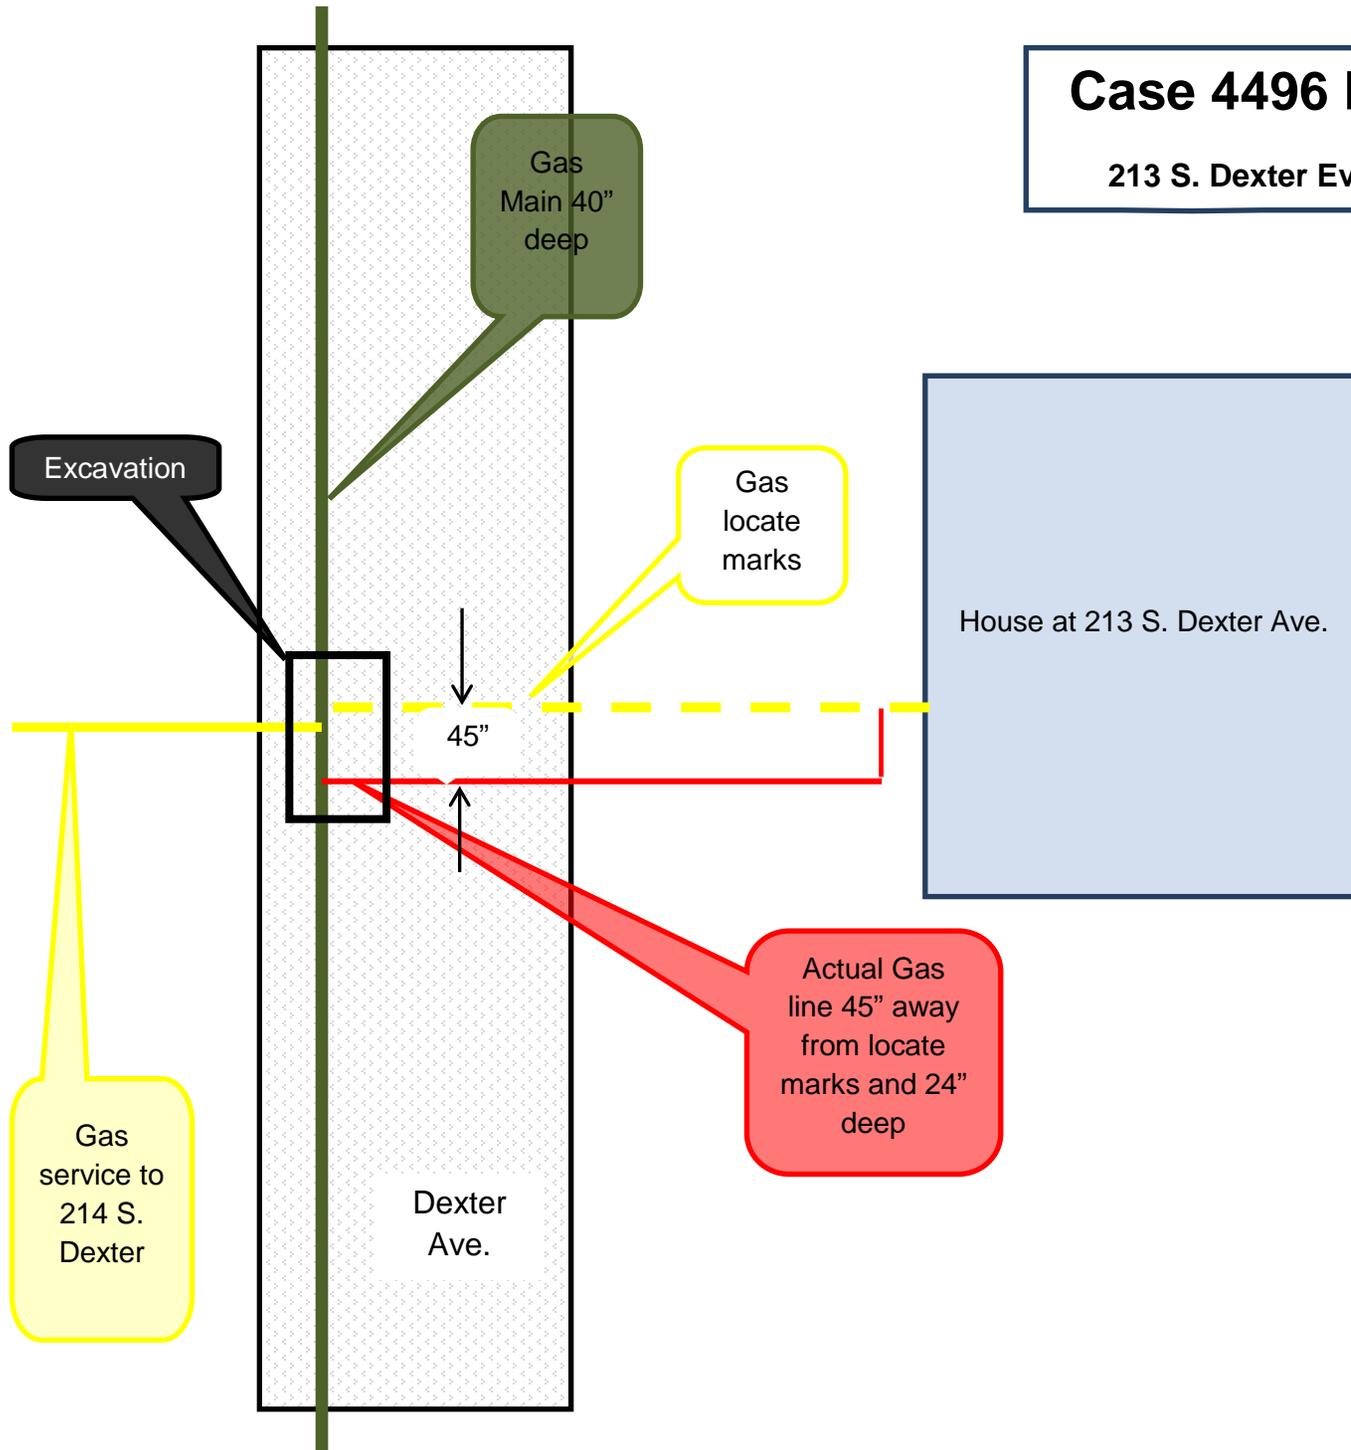
# Case 4496 Drawing

We were digging a bell hole for a service renewal and hand spotted main and found service tee for house across the street (214 S. Dexter). We began digging down 2 feet away from main and locate marks and when back-hoe operator curled his bucket he struck gas service 45" away from locate marks. see drawing and photos enclosed
