## Pipeline Safety Division Investigation Report

### Investigation regarding: **Brad Roy**

UPPAC Database Record ID: 4505

Damage Address: 617 Oakdale Dr, Ossian, Wells

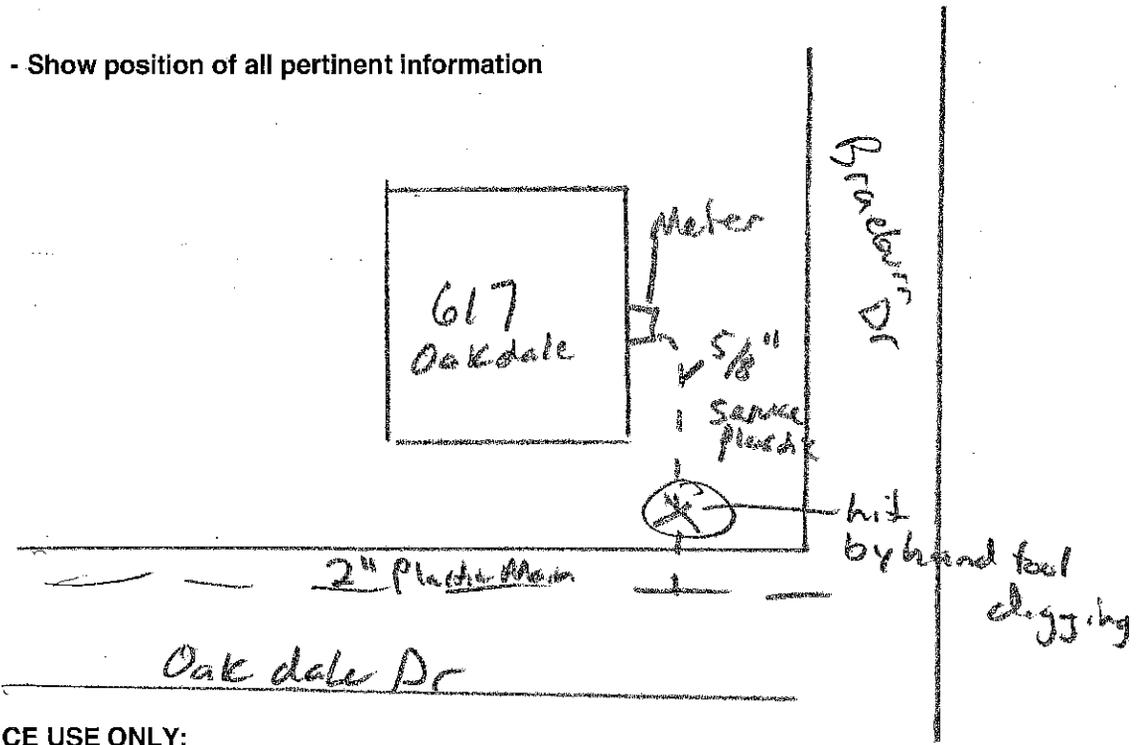
SKETCH: - Show position of all pertinent information

COMMENTS: Friend of homeowner digging down to install  
mail box. Hit Service. No Locates

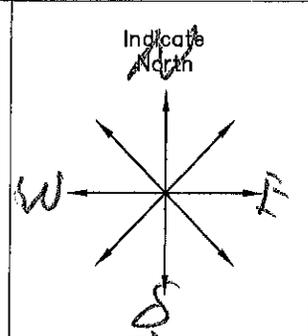
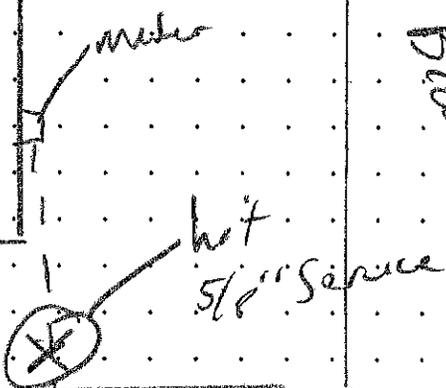
Comments: hit 5/8" Service by home owner installing Mail box.  
JD 574628

Oakdale Dr 2" Plastic Man
