## Pipeline Safety Division Investigation Report

### Investigation regarding: **Ka Miner Excavating Inc**

UPPAC Database Record ID: 4921

Report Date: 7/31/2013

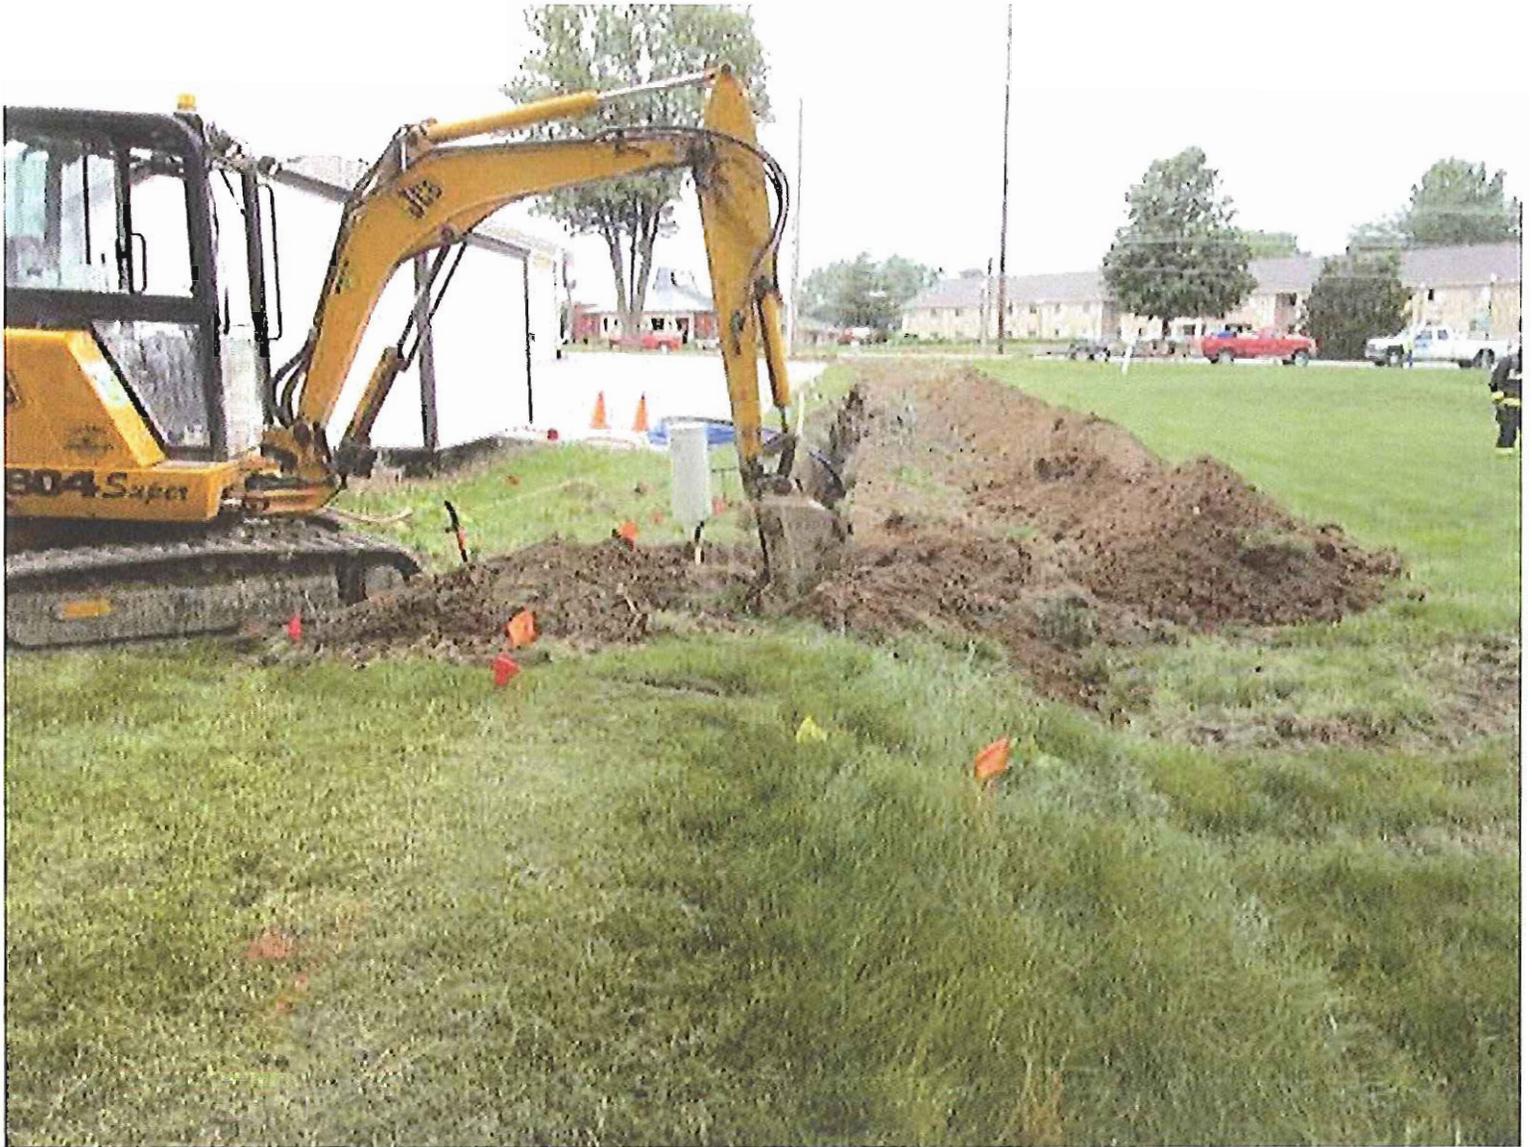
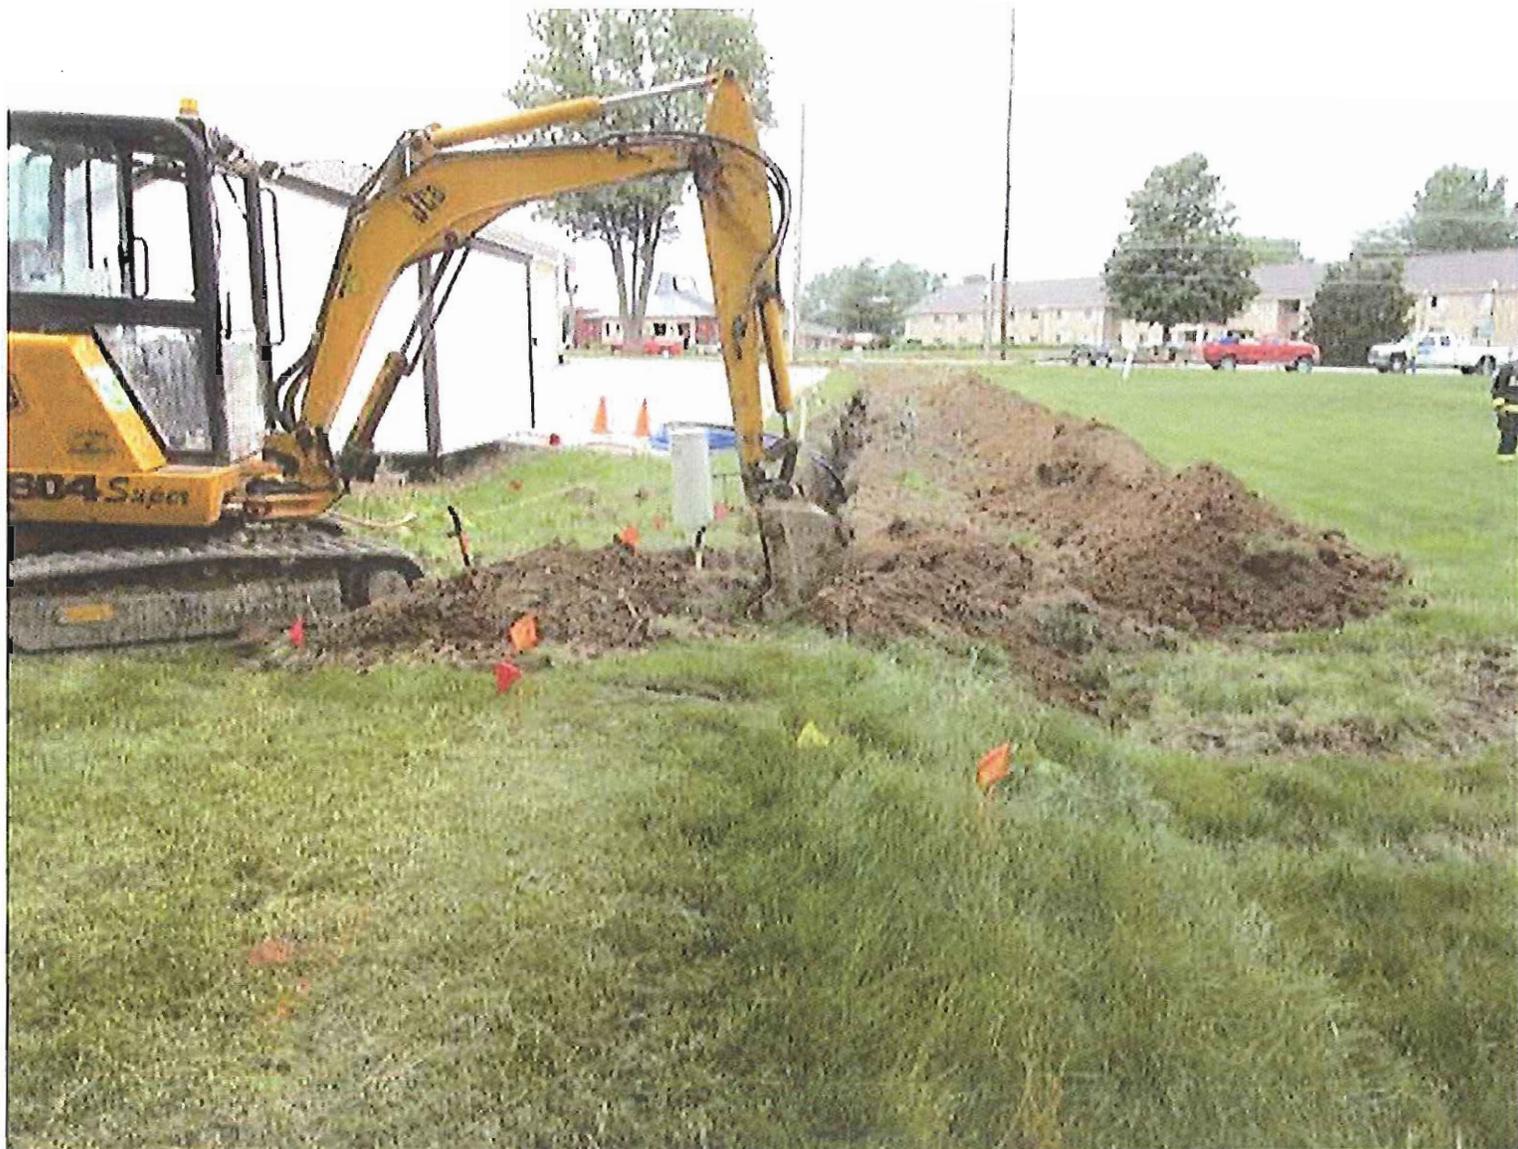
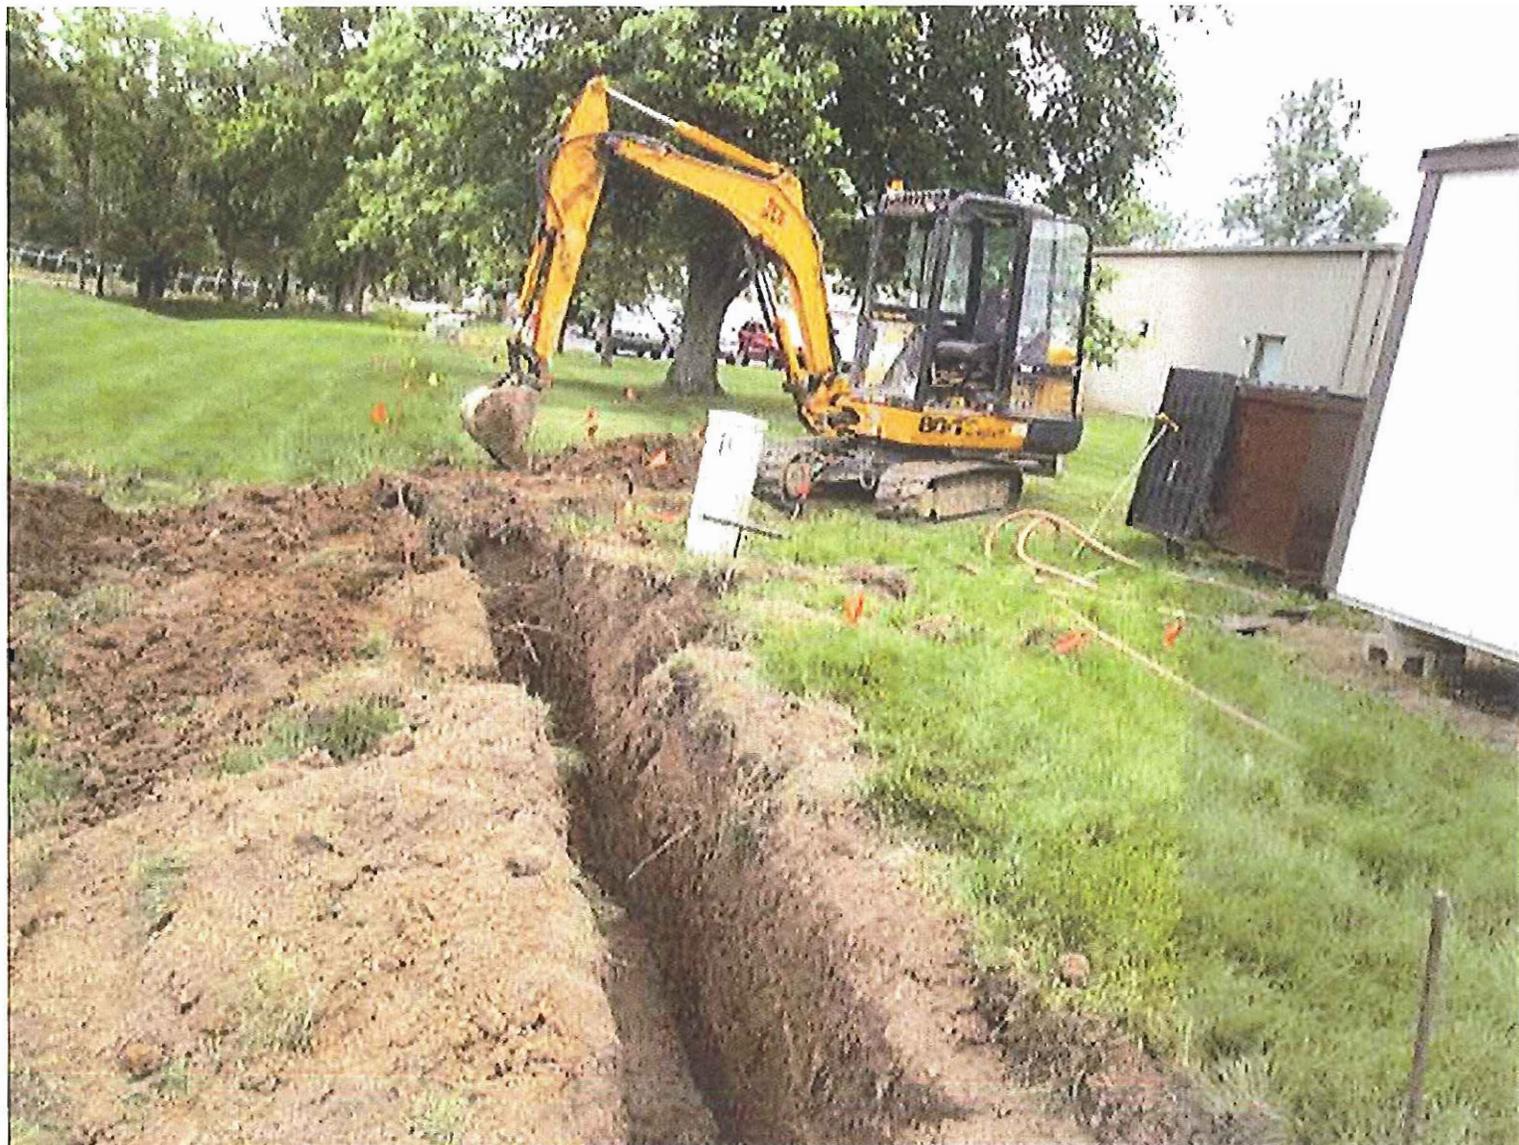
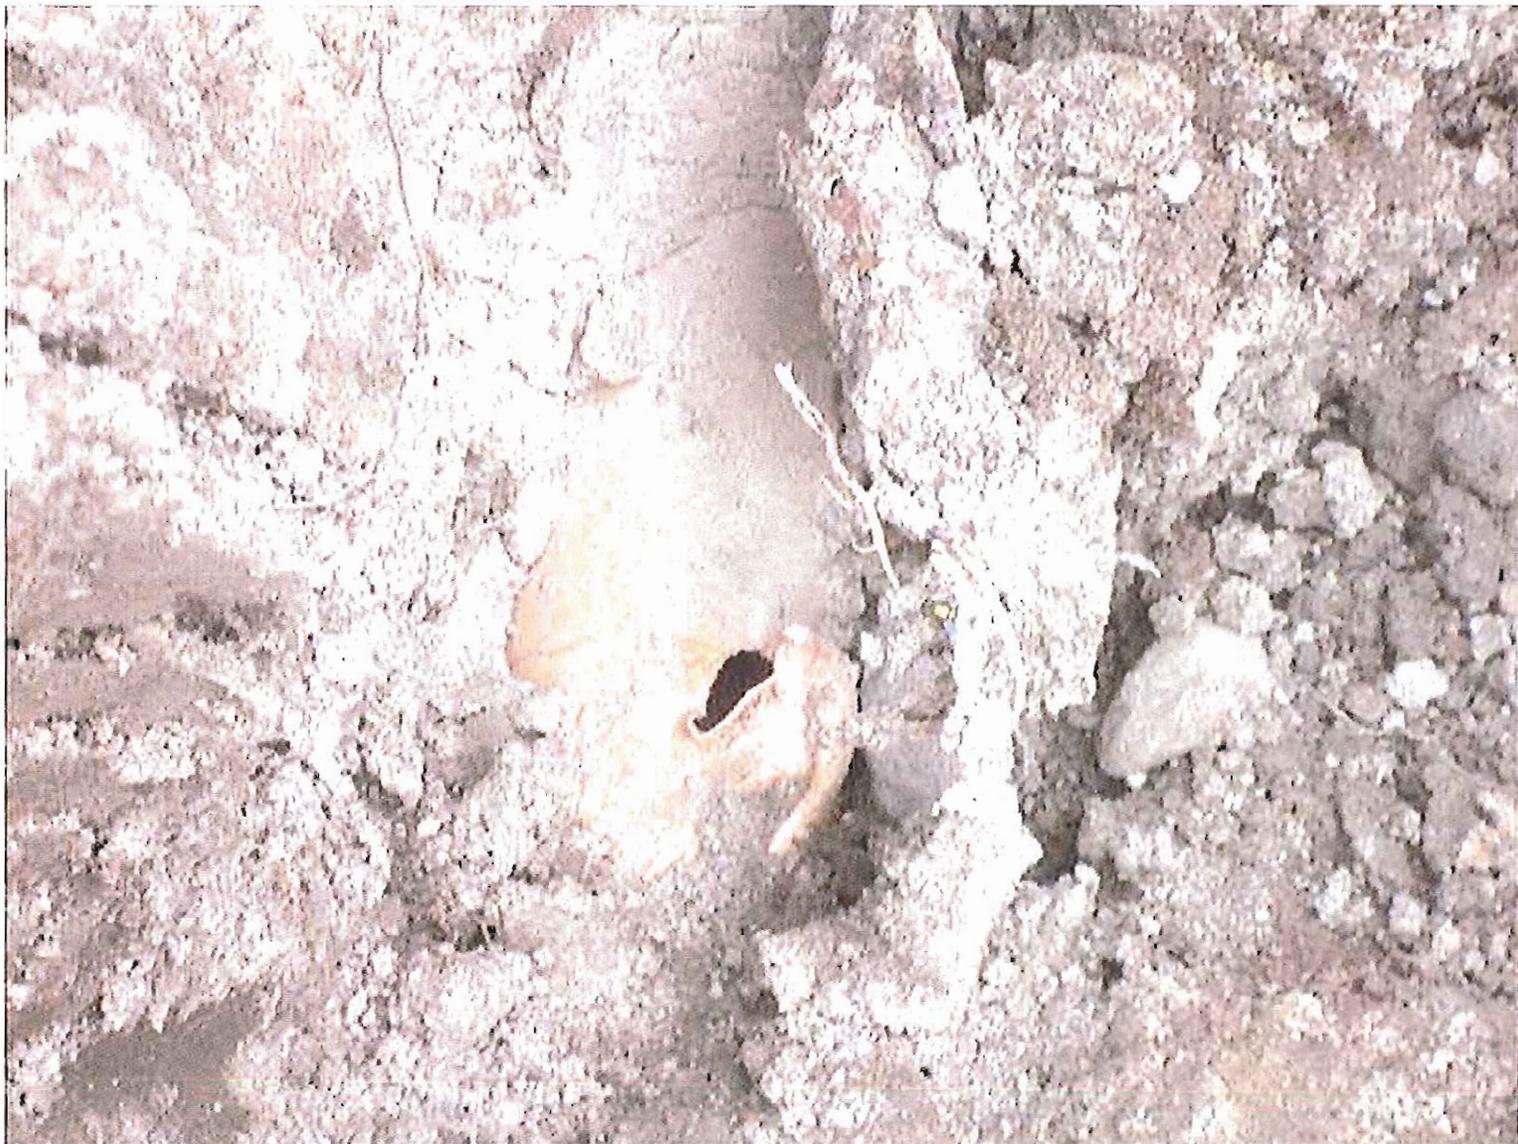
**Findings:** Reported by Indiana 811; excavator's response to initial notice was received on 7/25/2013. The excavator had a valid locate ticket and the gas operator provided accurate locate markings; however, the excavator used the backhoe within the two (2) feet tolerance zone.

2" PLASTIC MAIN DAMAGED BY MINI EXCAVATOR. FAILURE TO MAINTAIN CLEARANCE.

CONTRACTOR HAD MAIN SPOTTED EVERY 10'. HE WAS MAKING A TURN WITH HIS DITCH WHEN HIS BUCKET TOOTH PUNCTURED THE MAIN.

\*\*CONTRACTOR CUT 2" PL MAIN, COMPANY CREW ONSITE UPON ARRIVAL, MAIN ALREADY SQUARED OFF, CREW ONSITE MAKING REPAIRS, LEFT OK, RPOORE
