Pipeline Safety Division Investigation Report

Investigation regarding: Austgen Electric Inc.

UPPAC Database Record ID: 5120

Synopsis: Excavator struck and damaged an underground natural gas service while performing electric work.

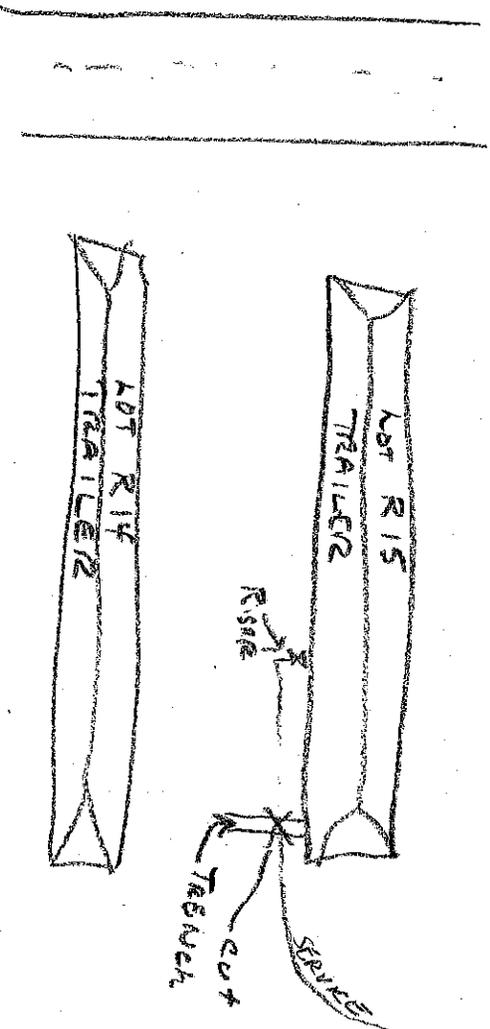
SKETCH: - Show position of all pertinent information

Contractor Rau Tremner has Gas Service.

Paint was still visible in grass.

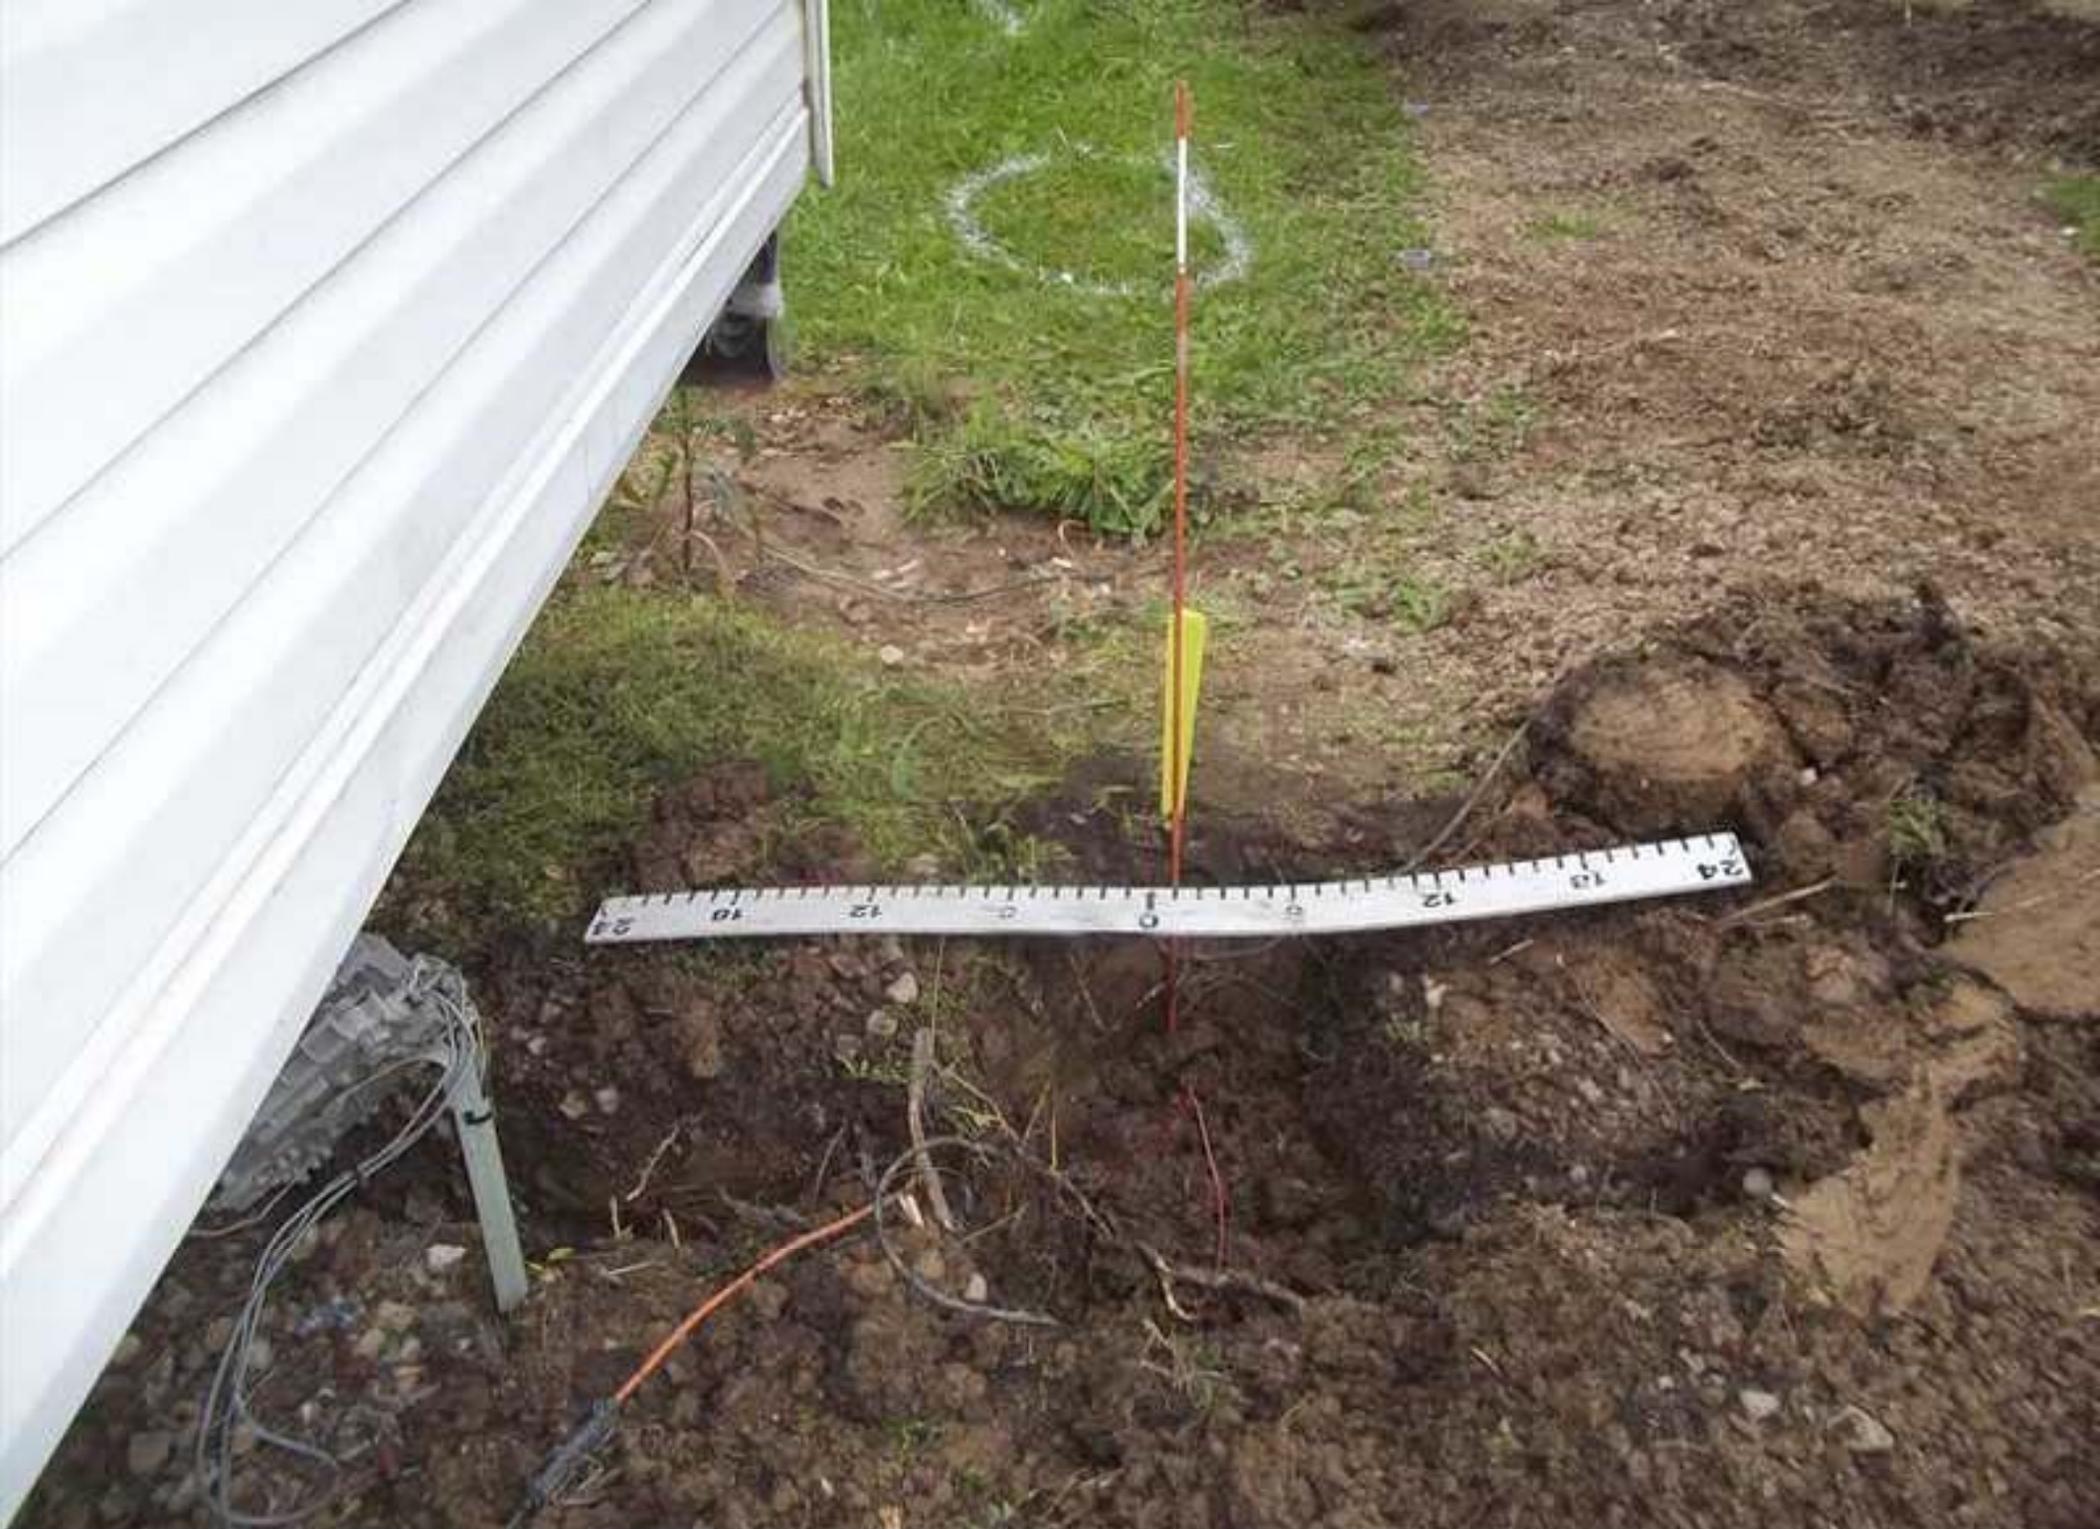
Photo taken on 6/4/2013 2:12:22 PM

The line was damaged while trenching electric on the property. The line was marked accurately. NIPSCO confirmed the marks were correct.

cut service line

2'
