Pipeline Safety Division Investigation Report

Investigation regarding: Tecton Construction Management

UPPAC Database Record ID: 5149

Synopsis: Excavator struck and damaged an underground natural gas service while performing curb/sidewalk work.

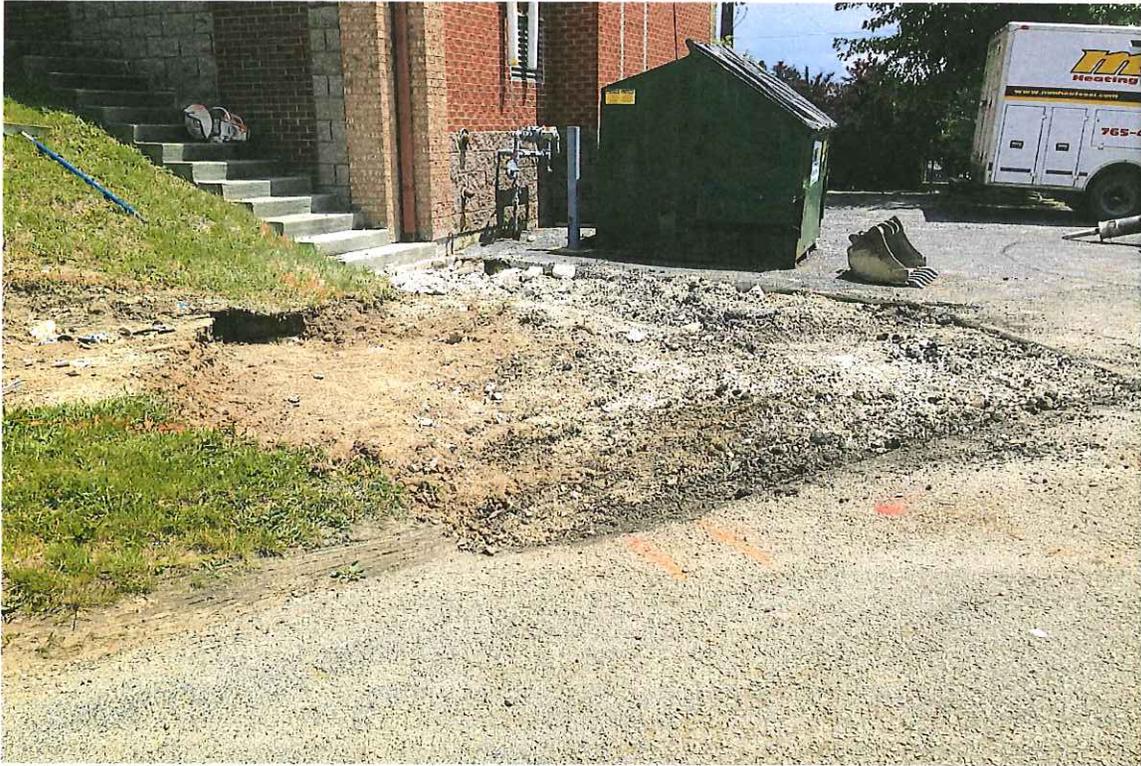
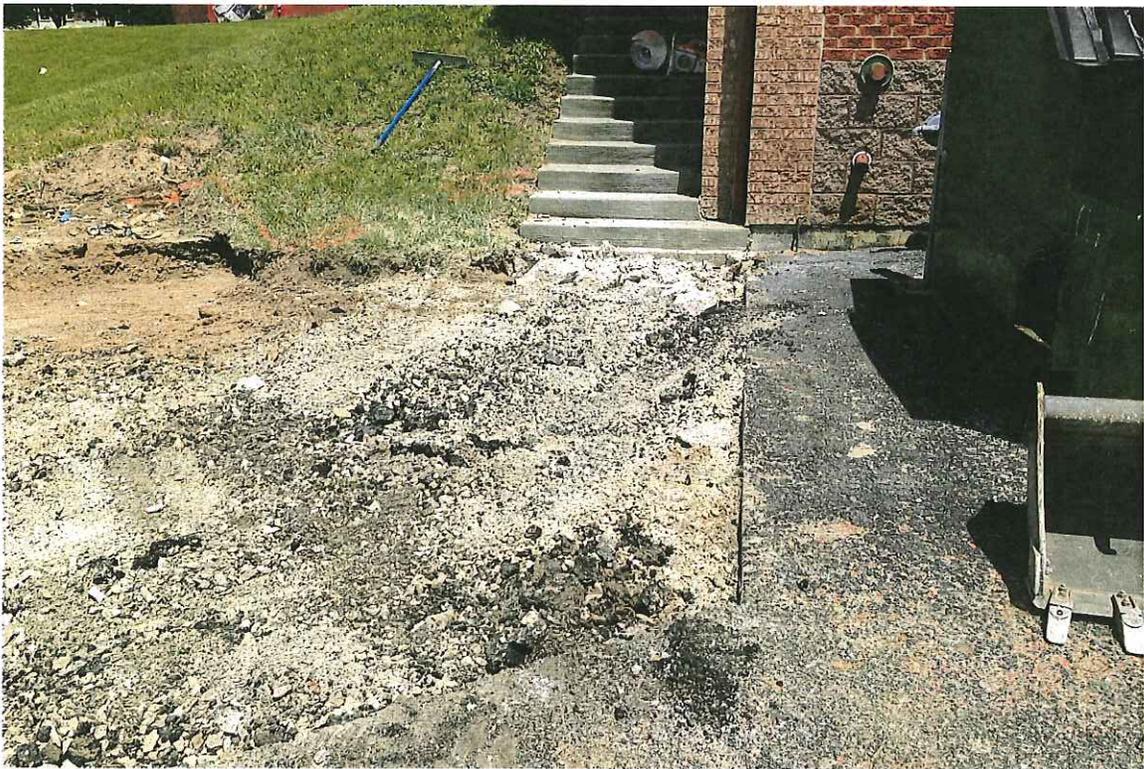
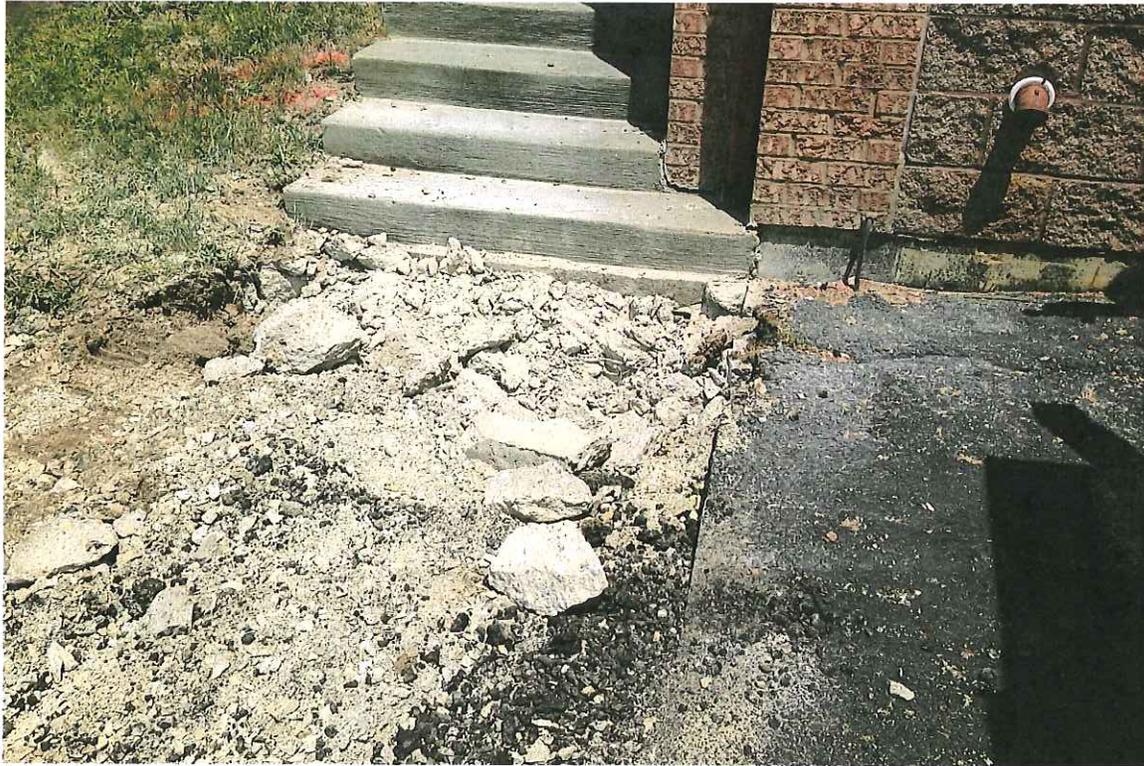
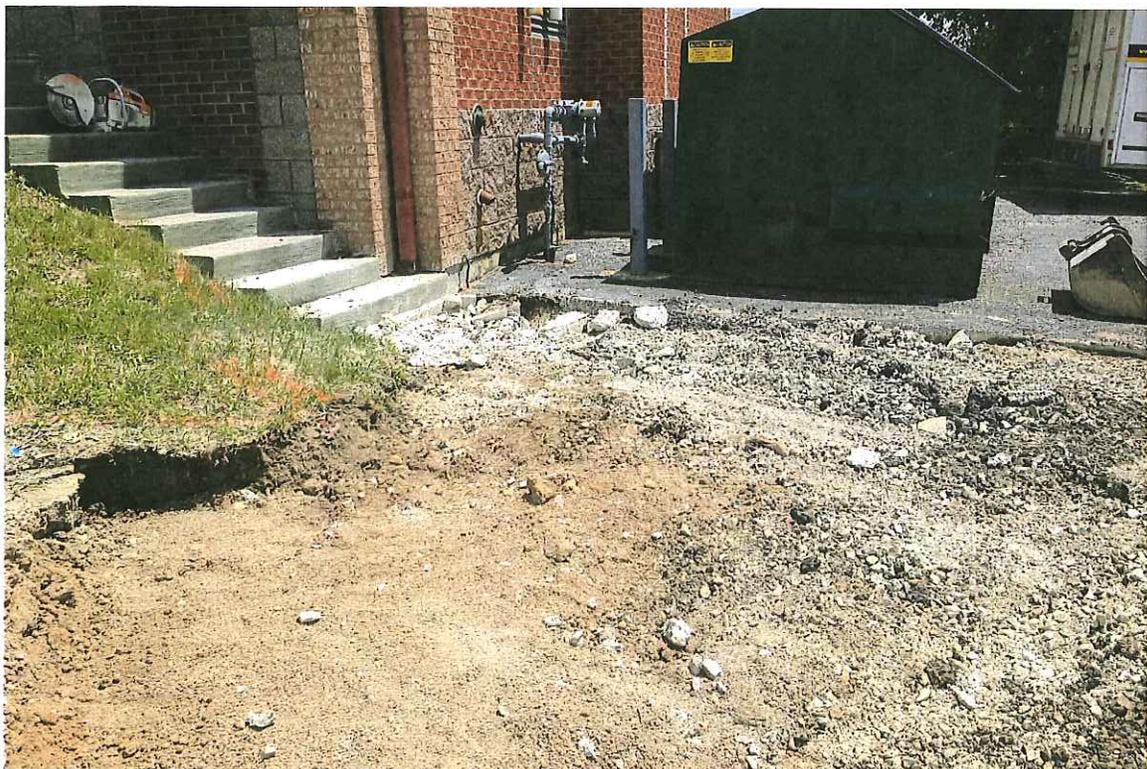
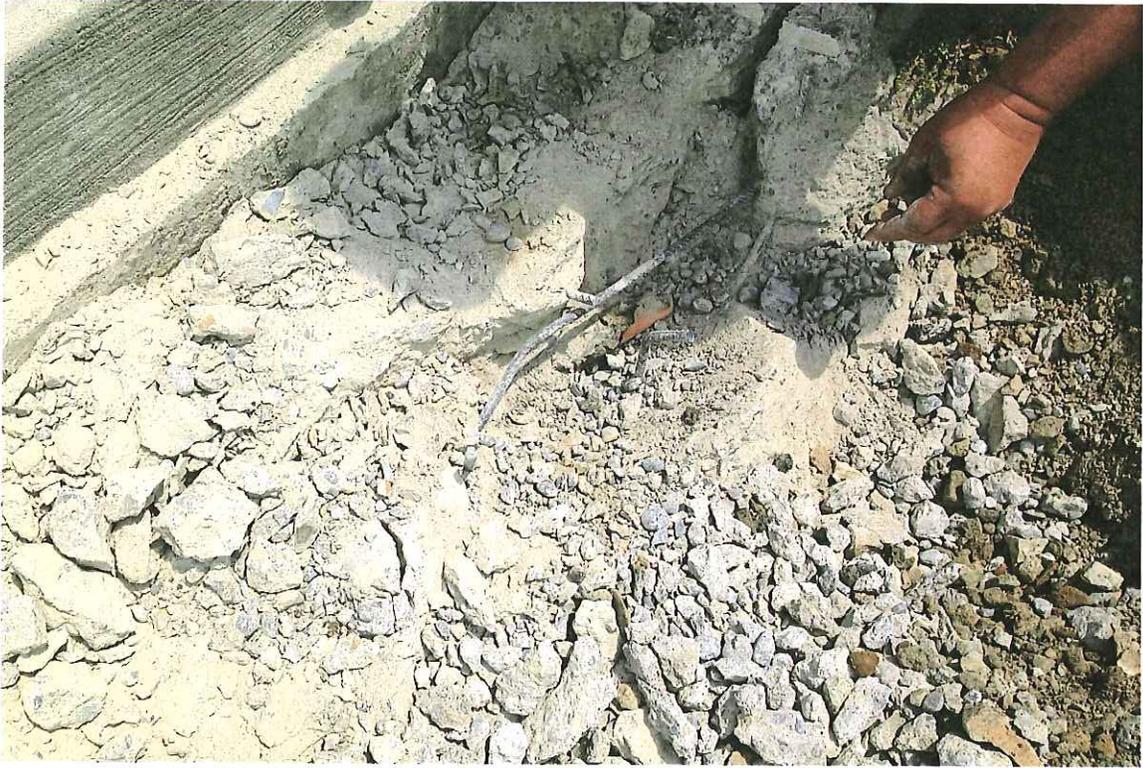
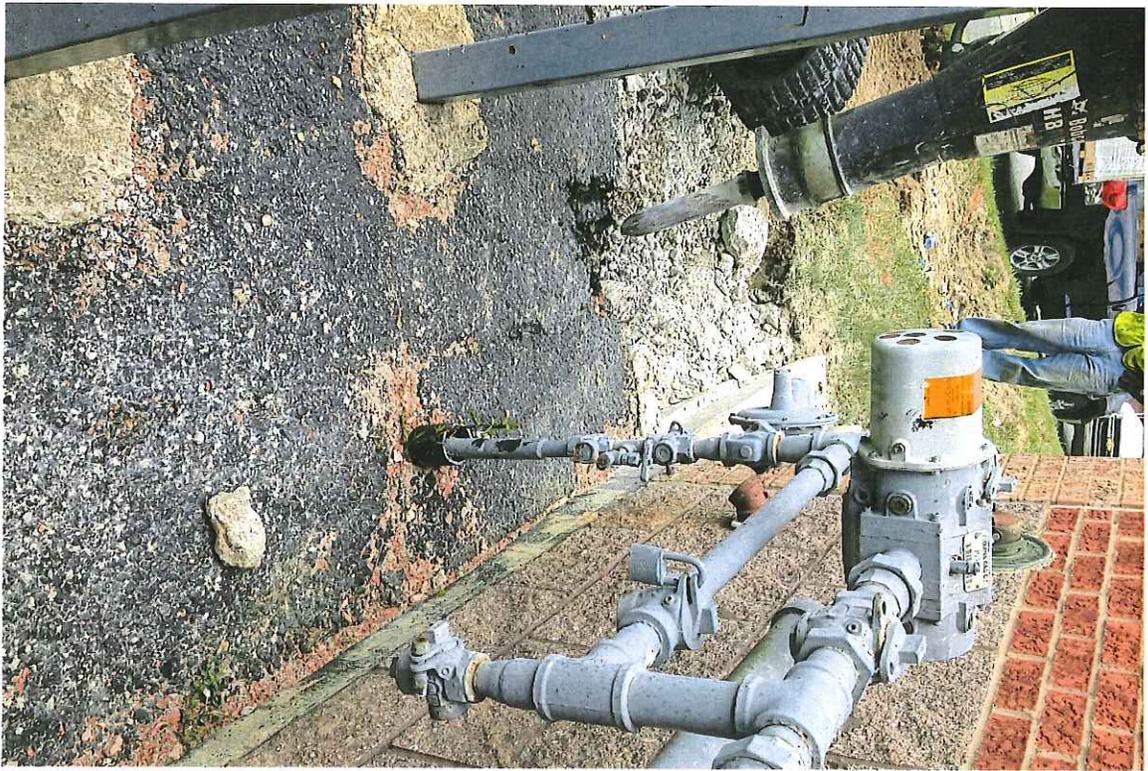
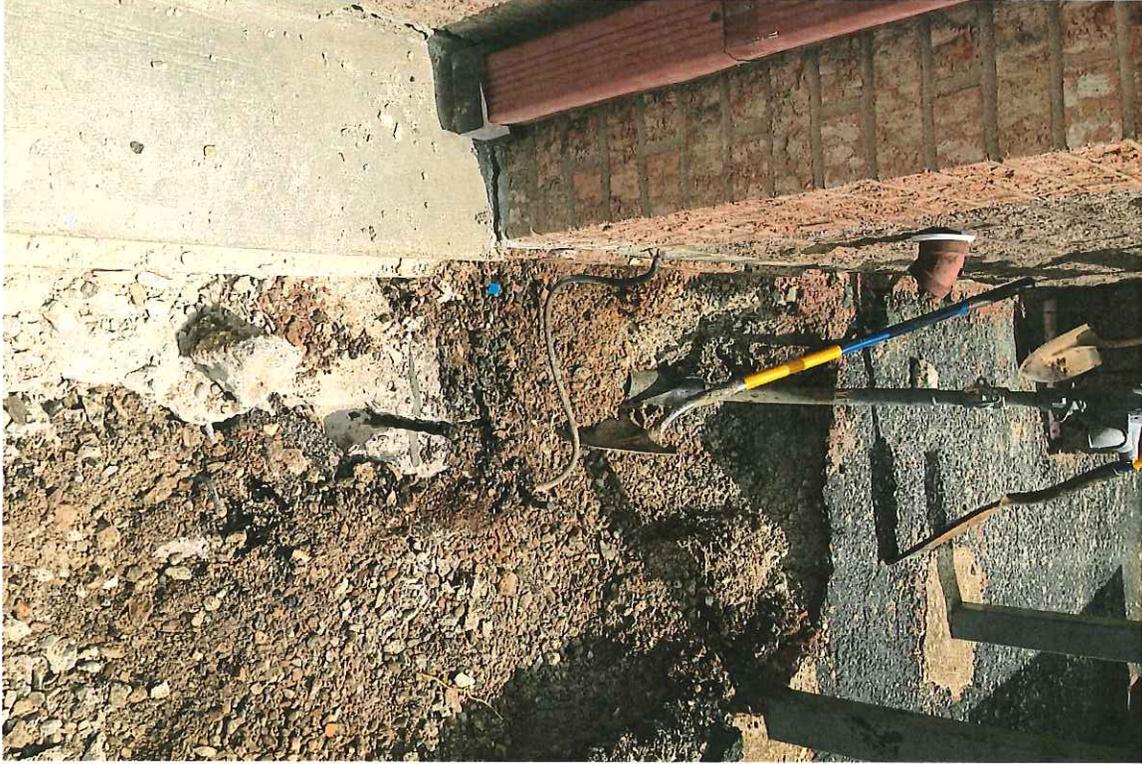
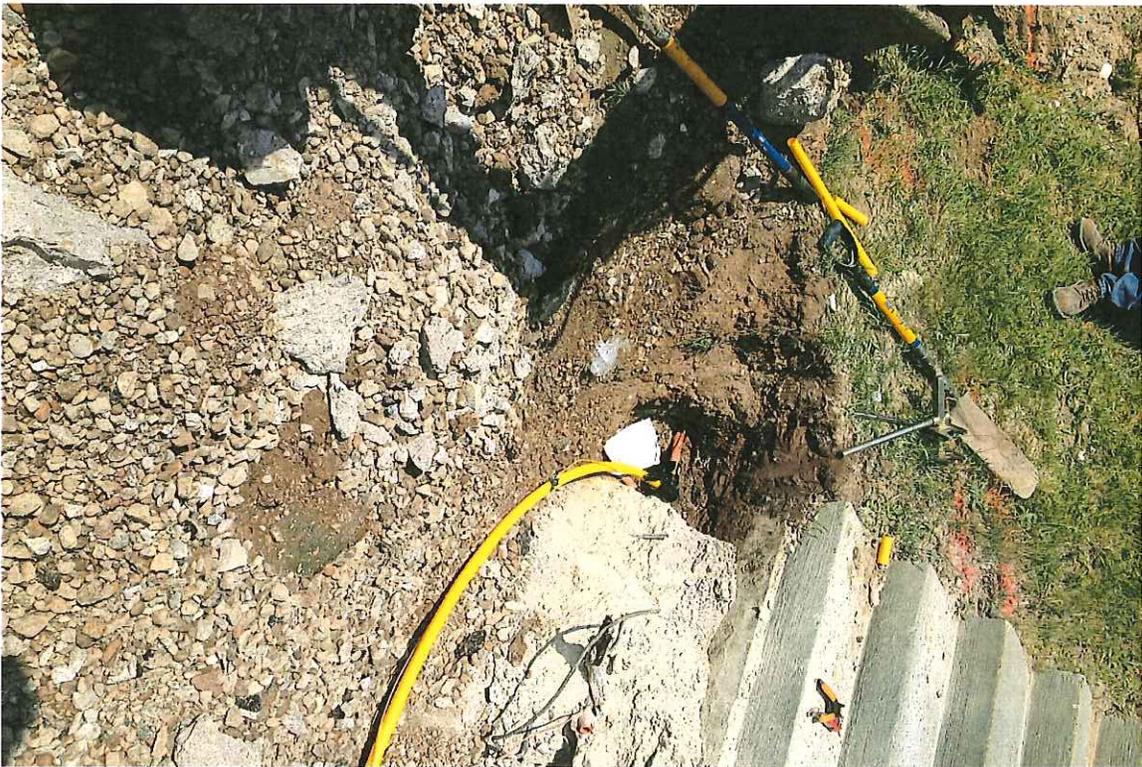
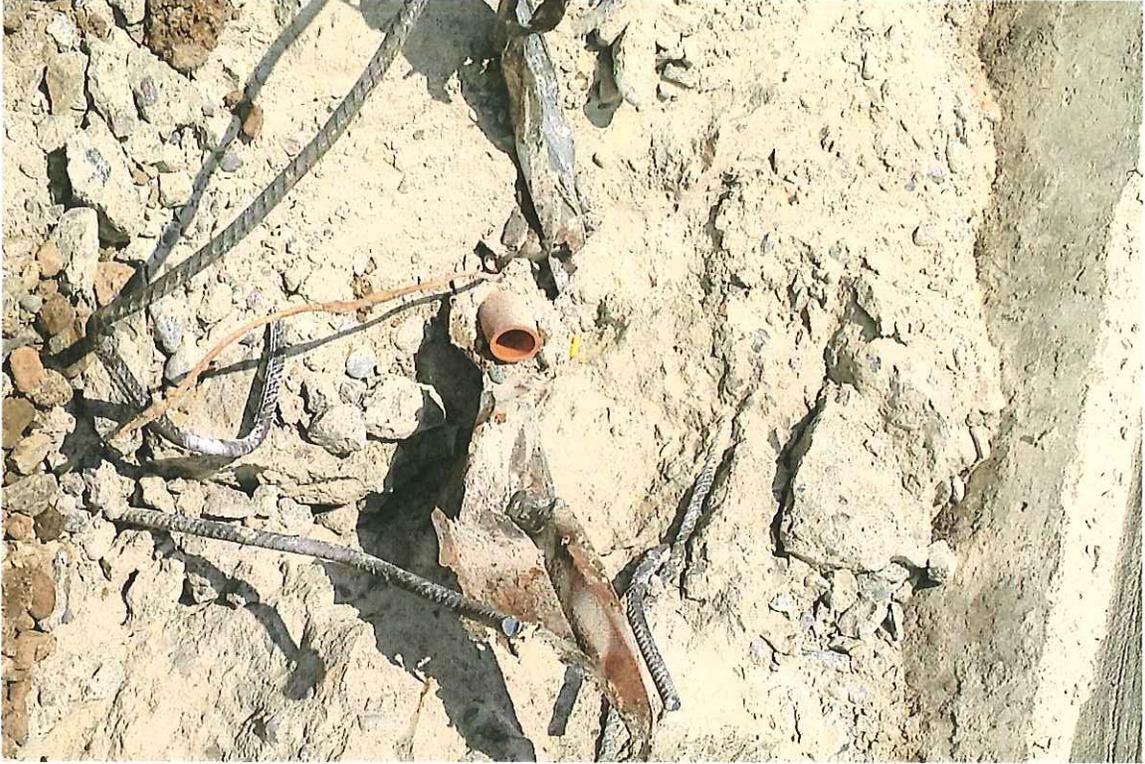
While demoing the bottom tread of the step, we hit the gas line with a jack hammer. It was only 6"-8" deep in the concrete as the pictures indicate.

Although I did not call in to get locates, the area had been located and marked. There was work being done on the lot next door and when they did locates on that lot they located lines on ours as well. You can see the locate lines in the pictures.

I knew the gas line was there. I suspected it was under the step, not in the step 6"-8" below the top of the concrete. The gas line should never have been run through the concrete. The gas line should have been a minimum of 2' below grade and not in the concrete. There was no way to avoid hitting the gas line where it was located. I always call 811 before doing excavation work. I did not call this time as I didn't think it was required in this instance to replace some asphalt because I was not lowering the grade or digging anywhere. I was simply removing a small area of asphalt in order to pour concrete.

* The existing service was ~~bar~~ buried under the steps to this house. Contractor was removing steps to install new ones. We relocated ~~the~~ the service around the steps.
