Pipeline Safety Division Investigation Report

Investigation regarding: TSI Paving

UPPAC Database Record ID: 5155

Synopsis: Excavator struck and damaged an underground natural gas service while performing curb/sidewalk work.

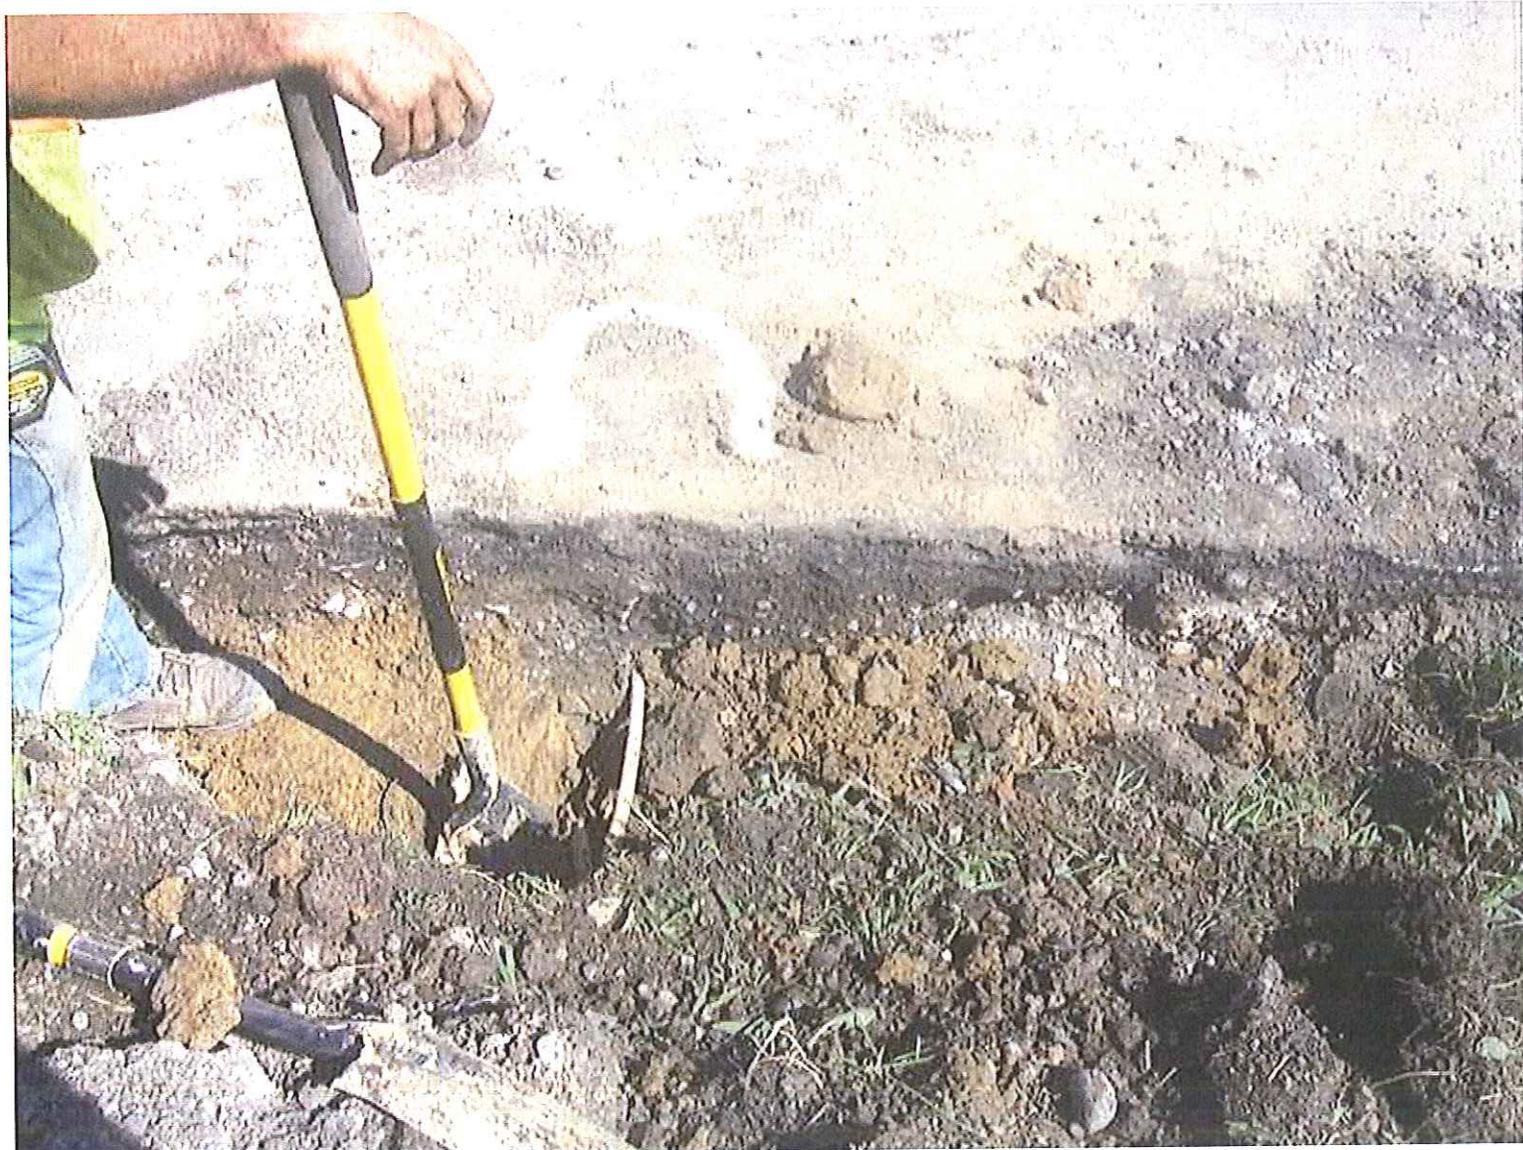
1/2" plastic service severed by hoe. Not hand exposed.

Property of United States Infrastructure Corporation
Photo taken on 7/12/2013 10:42:49 AM

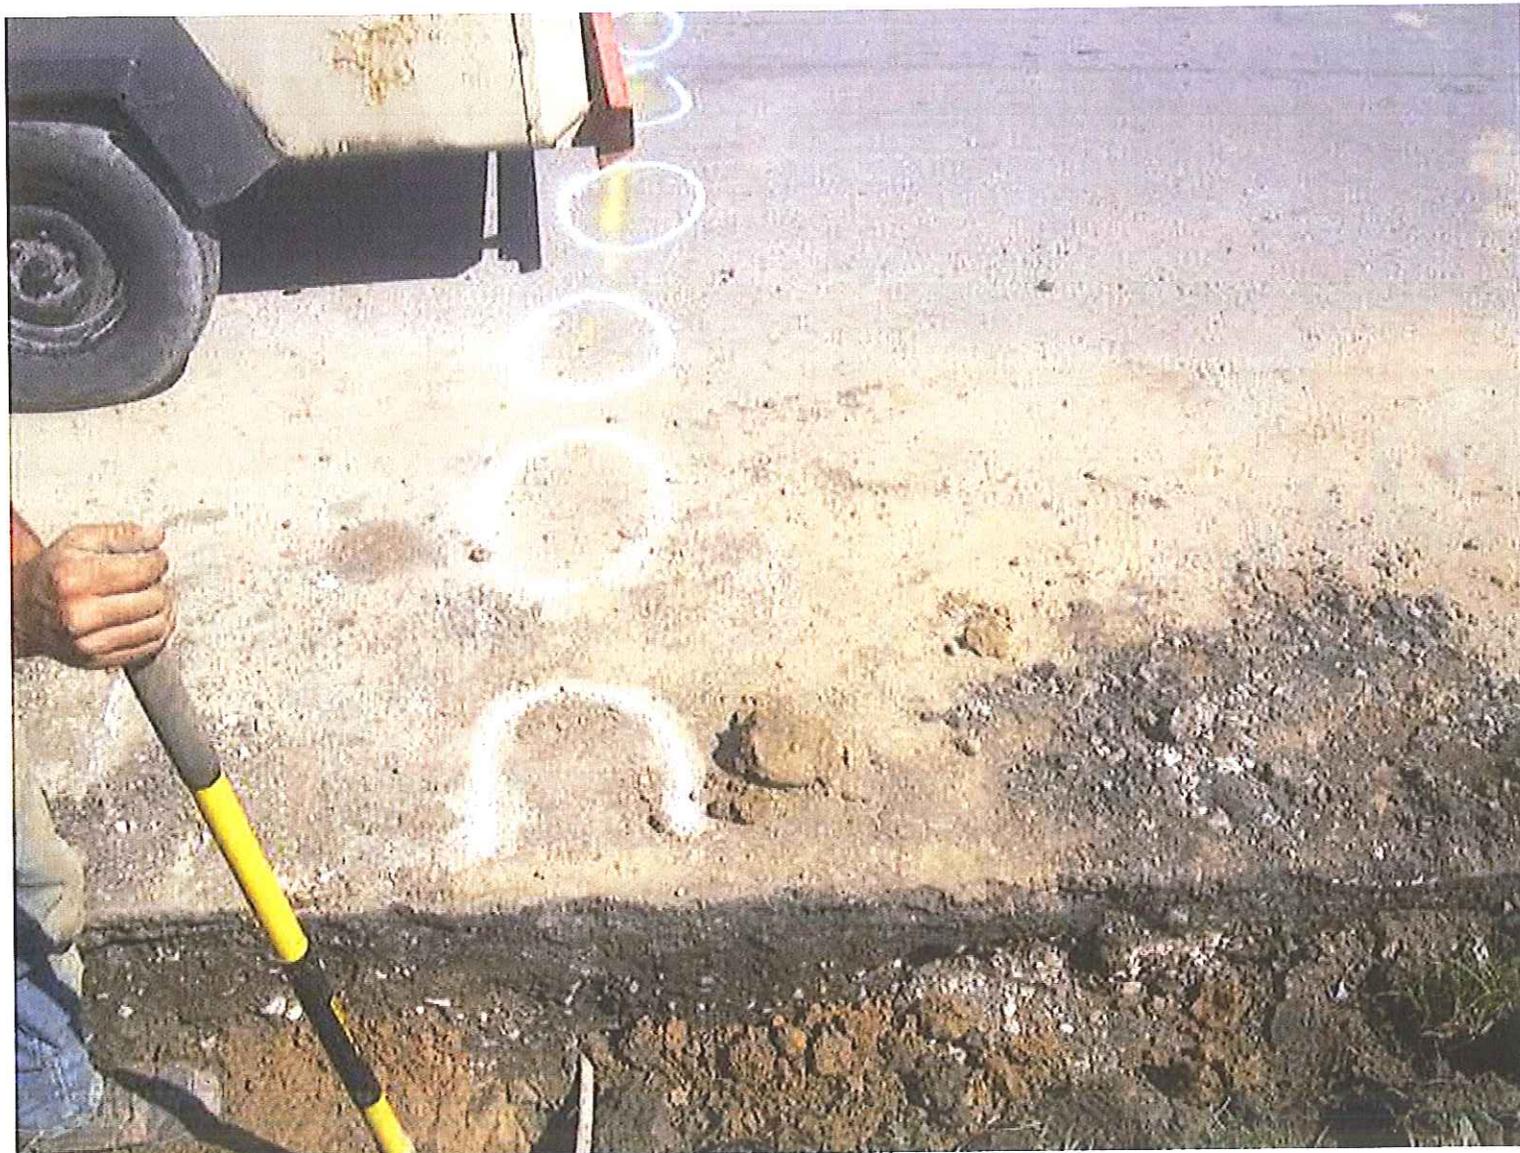
Property of United States Infrastructure Corporation
Photo taken on 7/12/2013 10:42:55 AM

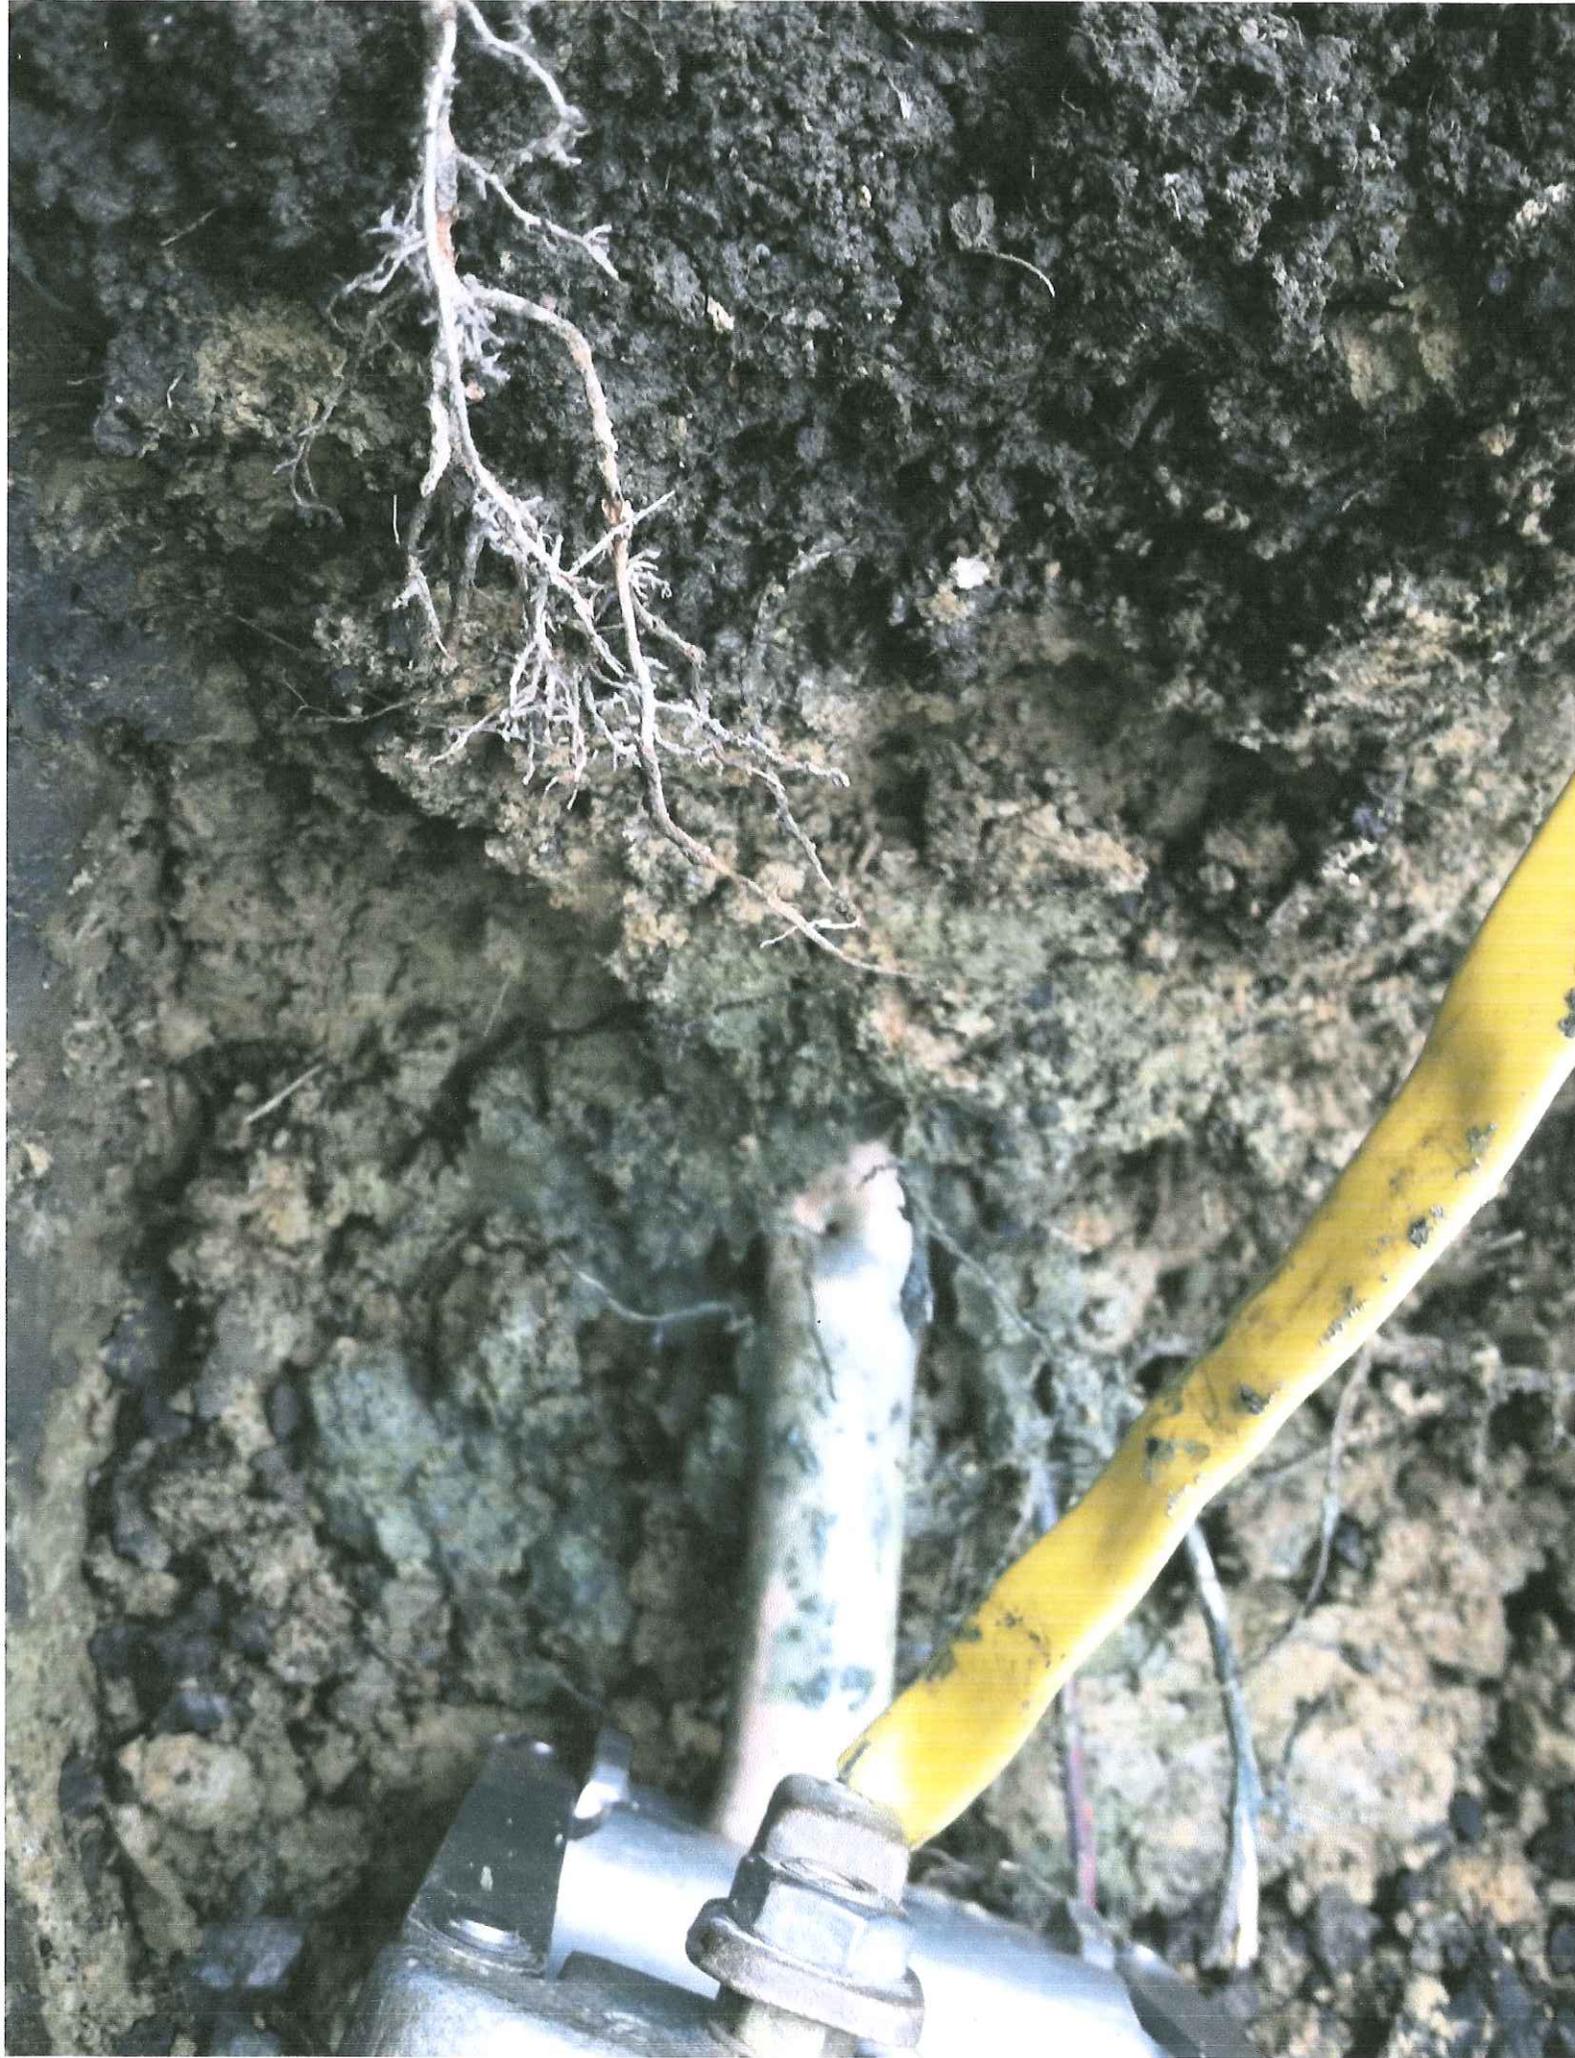
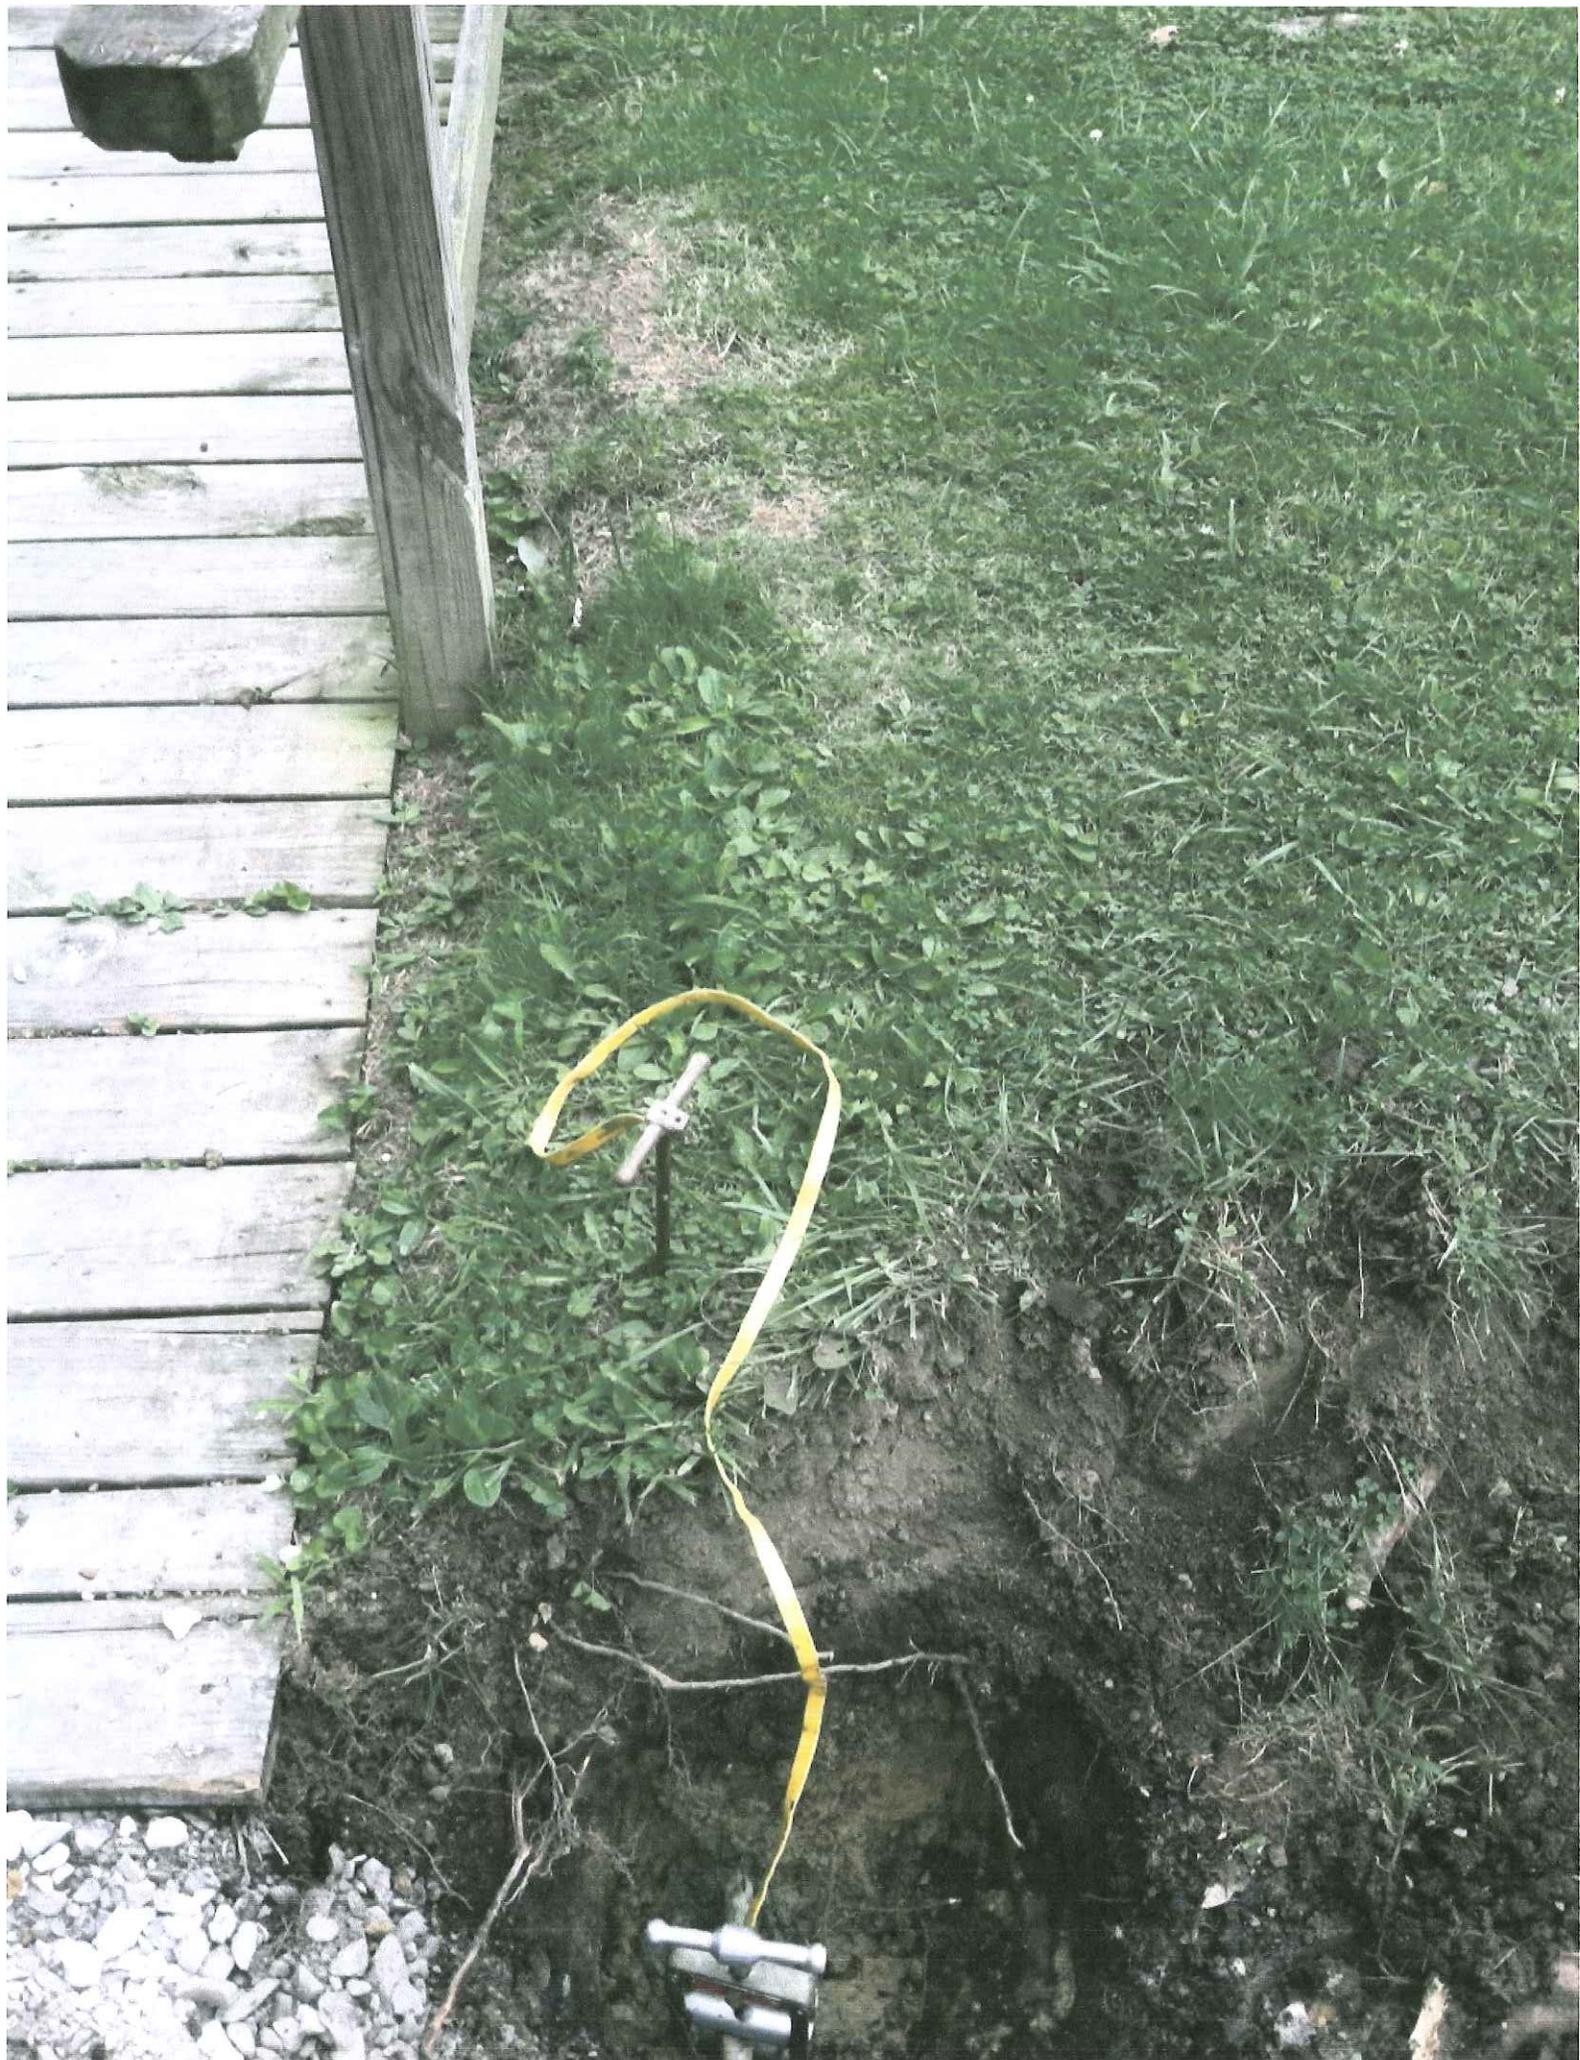
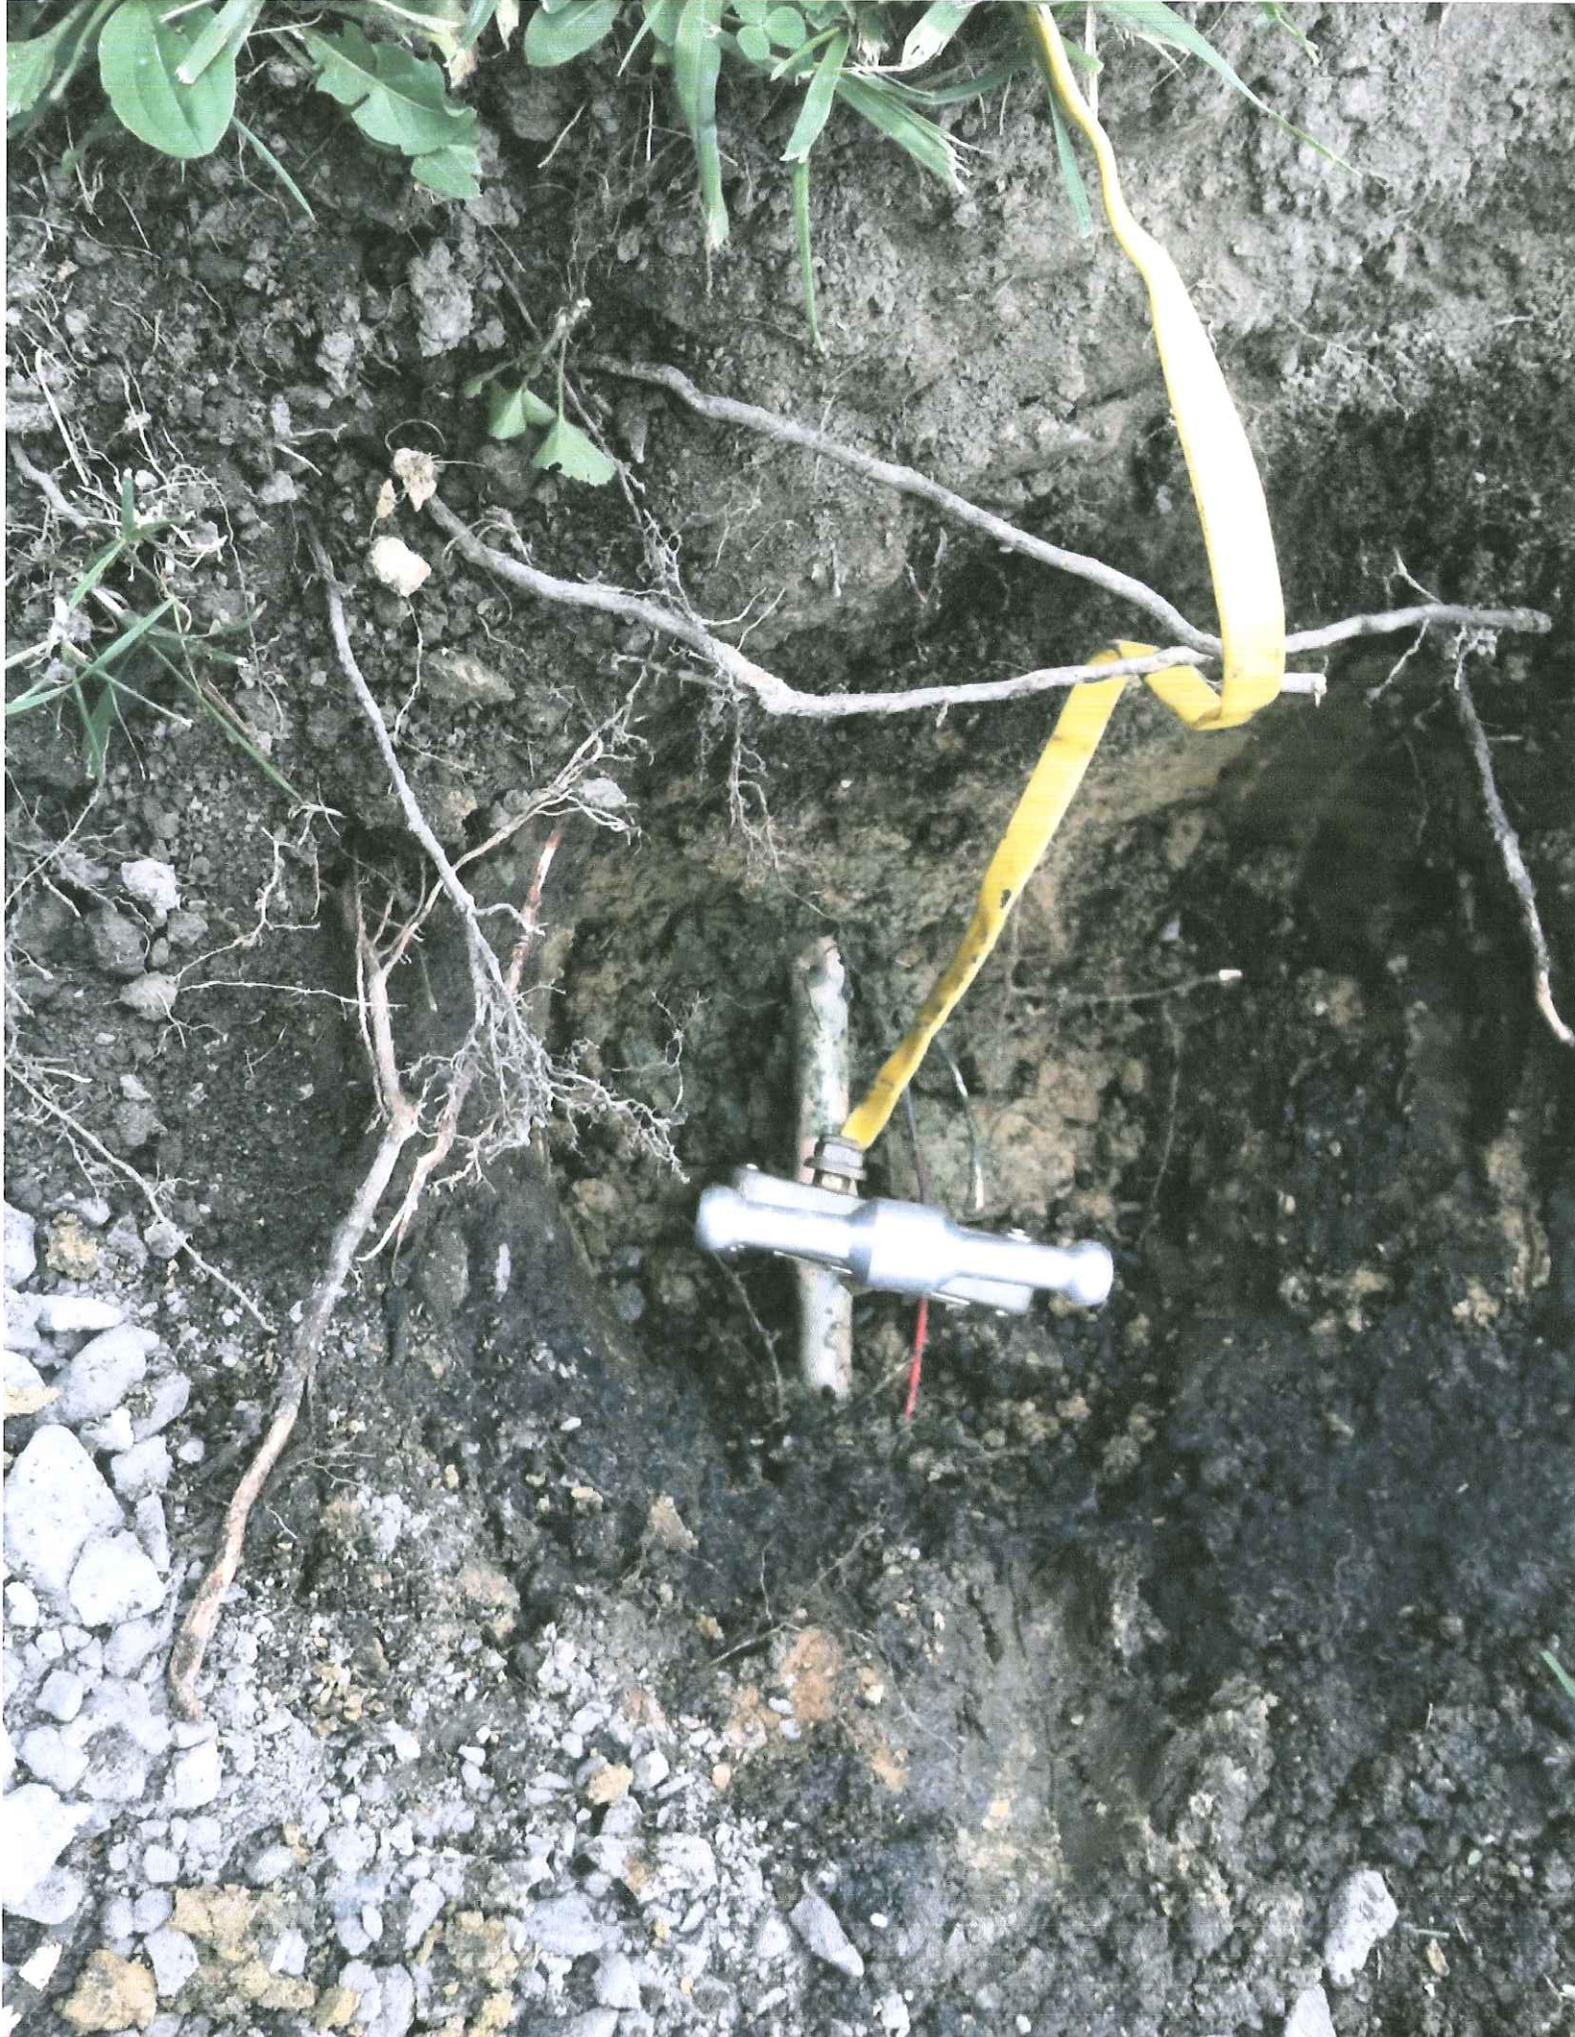
Photos attached.

While forming a sidewalk, employee was nailing a pin with a hammer and hit line.
