## Pipeline Safety Division Investigation Report

### Investigation regarding: NIPSCO

UPPAC Database Record ID: 5178

Damage Address: 13631 Empress Ln, Hanover, Lake

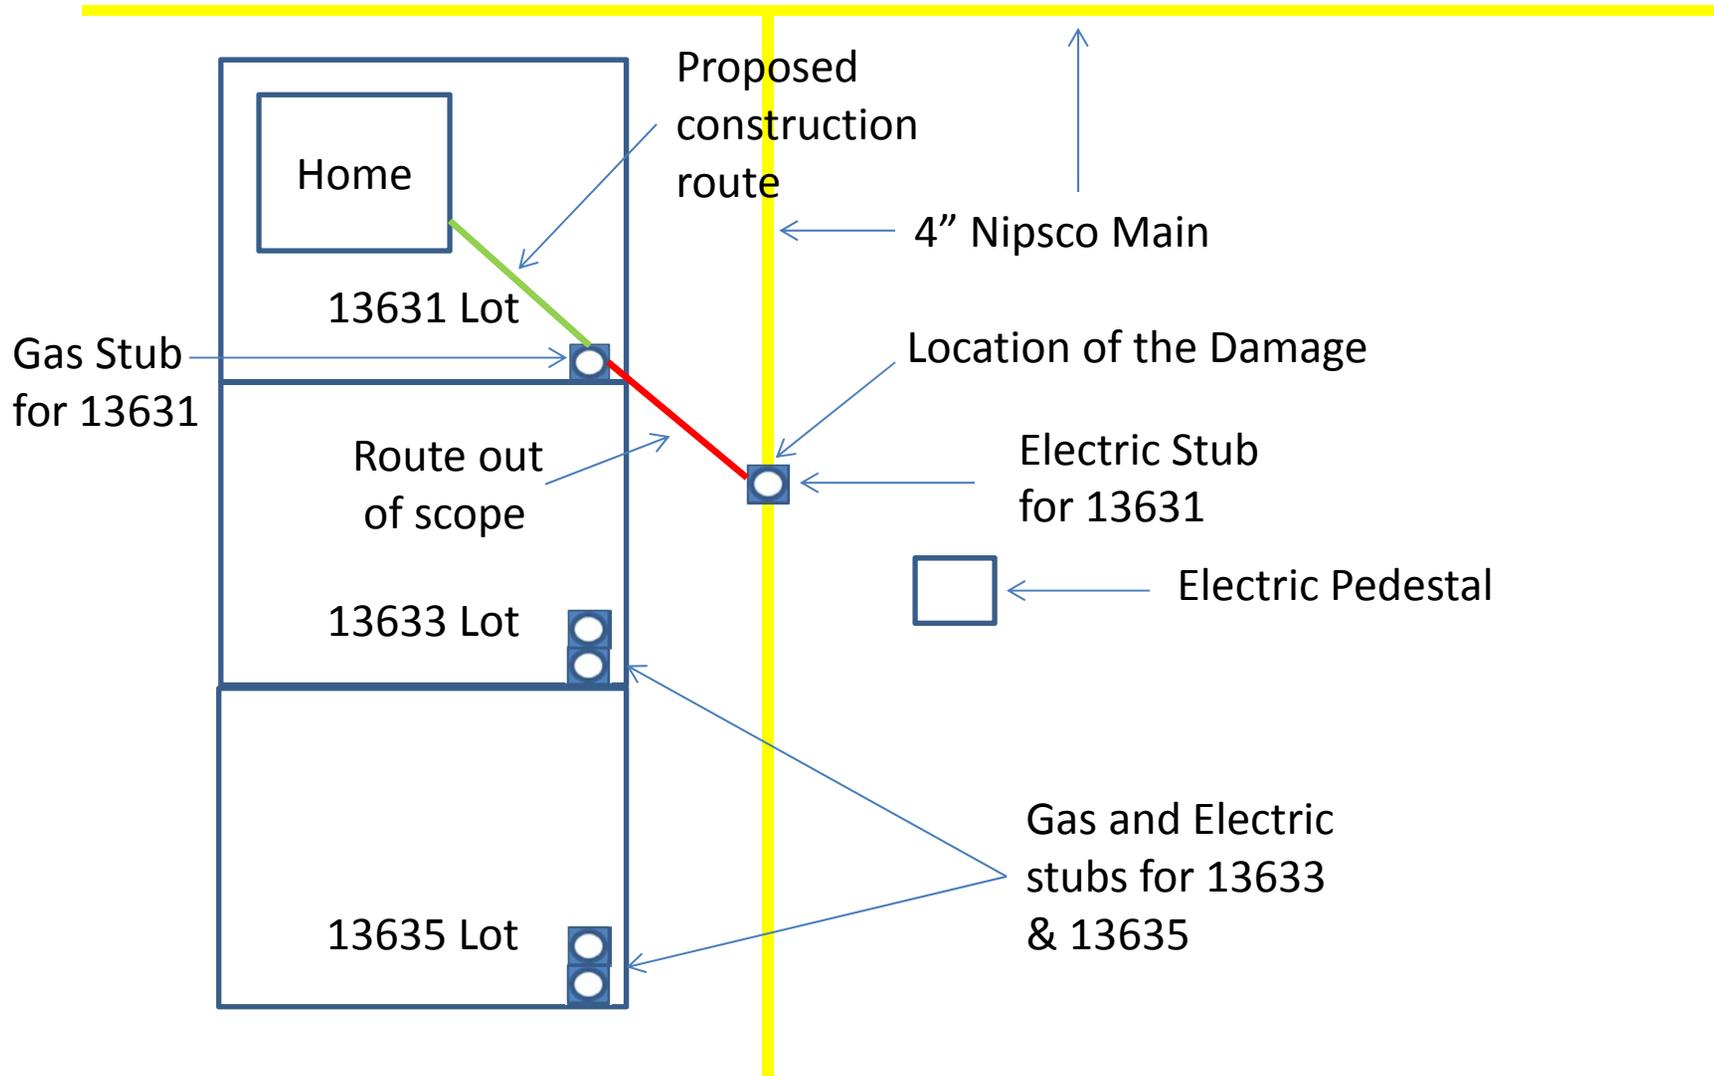
# Diagram Of Damage & Location

# Hit 4" Main 13631 Empress Lane.

- Original Locate # 1307171980
- Emergency Locate # 1307241749
- Tracking #01820130724007
- Damage # 1307241727
- Damage Date 7/24/2013
- Time Reported 10:54 AM
- Crew on Site 10:54 AM
- Gas Stopped
- 4" Plastic Main
- Gas Restored

**Description of Incident:** NIPSCO C&M Line Crew was installing buried electric and gas to address. Locates on site were for the 13631 Empress Lane address facilities and not the area the damage occurred at the main. Line crew struck the 4" main with an excavator approximately 20' from the located gas stub. No visible gas or electric locates were near damage location. While excavating the visible electric stub the crew hit the 4" gas main directly below the electric stub.

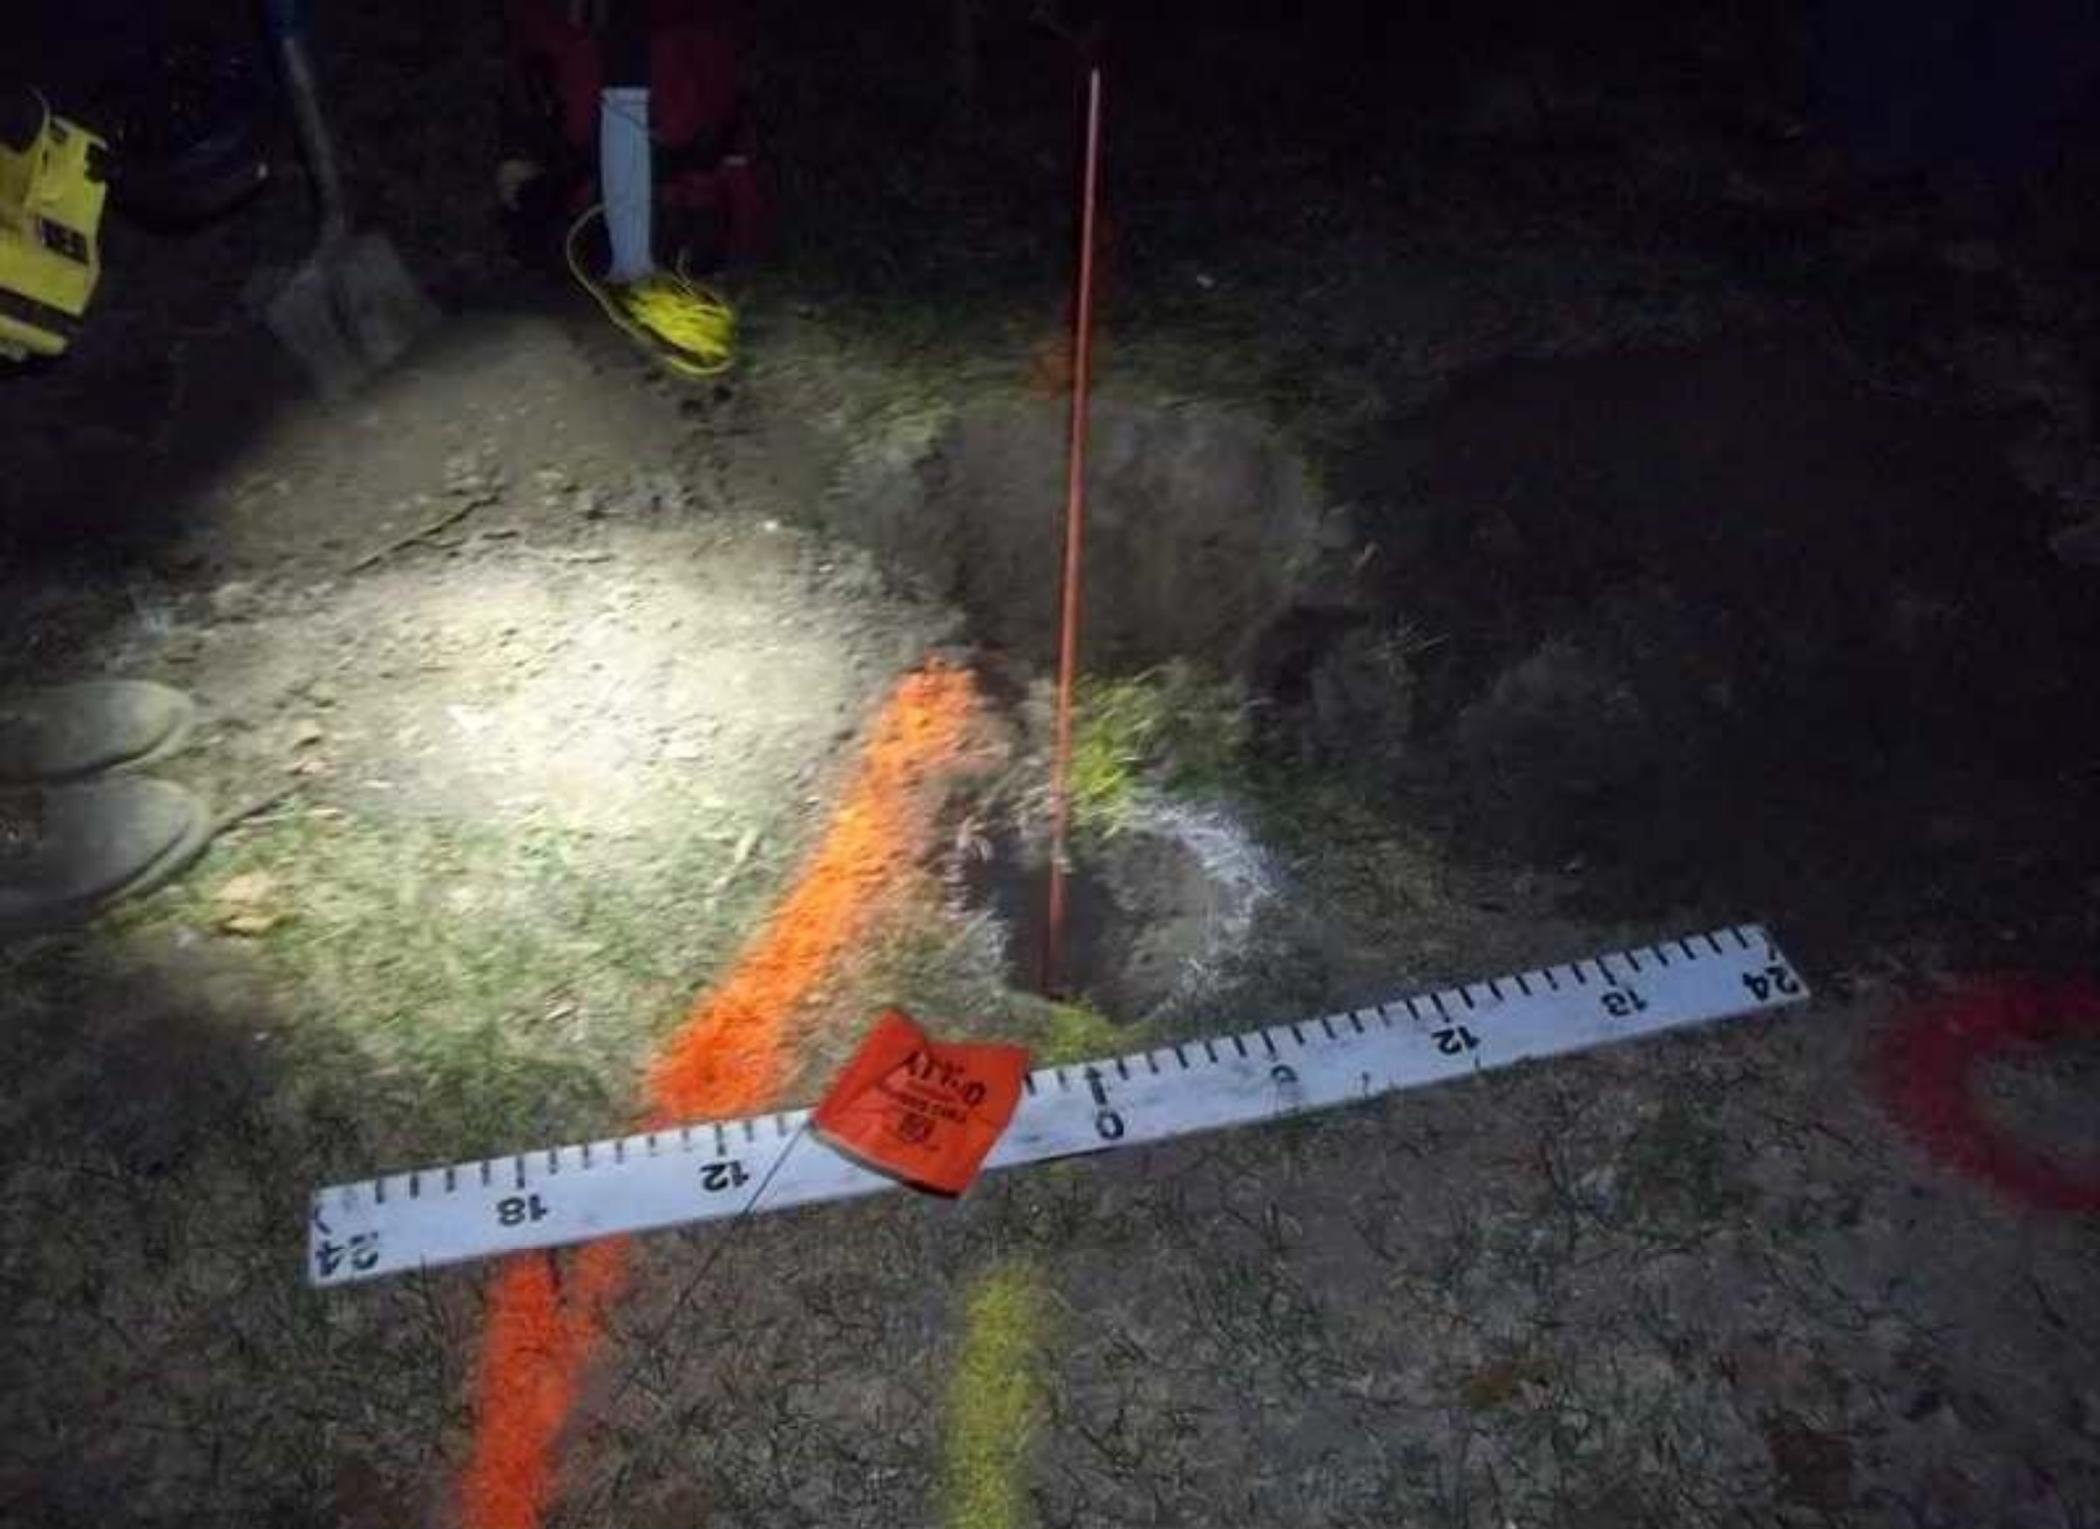
Photo taken on 7/24/2013 9:52:37 PM

NIPSCO damaged the 4" gas main while installing gas and electric services to the house. The stub for the electric was placed directly above the 4" gas main. The post locate show the main was marked where the damage occurred. Upon investigation there was only one mark left due to construction activity. The existing mark was within tolerance of the damaged line. When repaired the damaged main NIPSCO found the main further away from the damage using our original marks to squeeze the line and stop the gas from blowing.
