Pipeline Safety Division Investigation Report

Investigation regarding: **D and M Excavating Incorporated**

UPPAC Database Record ID: 5198

Damage Address: 210 Dunes Plaza, Coolspring, Laporte

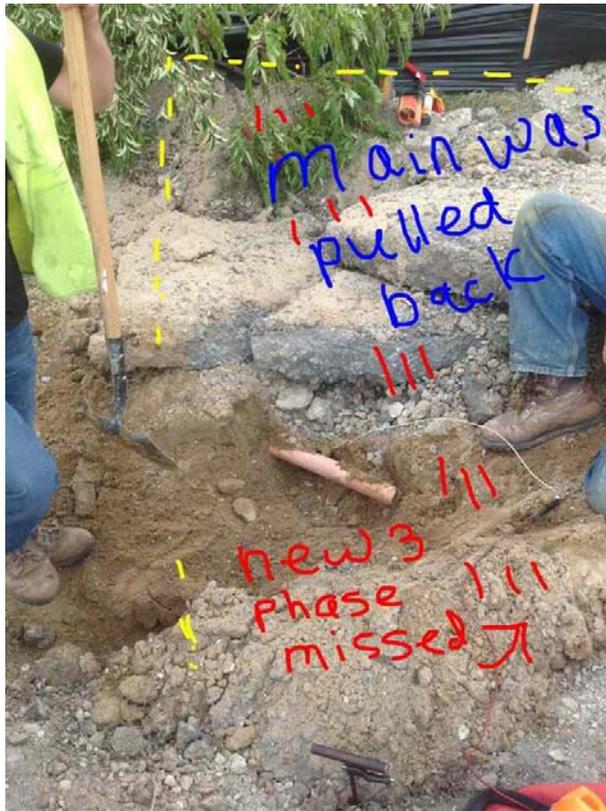
Photo 1

Contractor cut a 2" gas main. The locate called for the South and West sides of the building to be located also stated that the area would be marked with white paint. Contractor was digging approx 150' south west of the building on the south west corner of the property. There were no white lines or white paint any where near the location of the damage. Photos of the white lined areas are on ticket #1307120365.

Diameter of HOLE in the gas facility: 2 inches, ripped in half

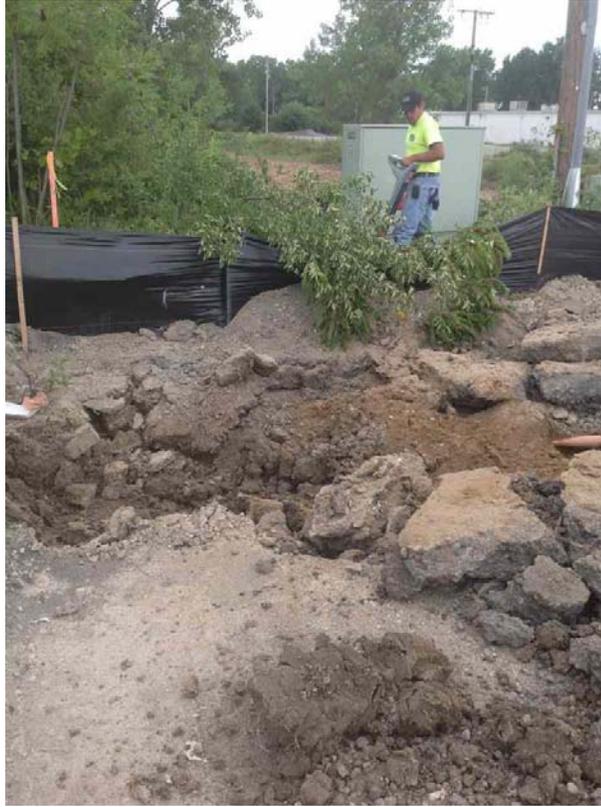
Photo 2

There is a new gas test stand, a large phone cabinet and a new riser with the BRAND NEW three phase electric that is feeding the new business they are there working for coming down the pole right next to the trachoe and all of the other facility indicators were all within 5' - 20' away in plan open site. This operator having those three indicators CLEARLY visible had no business putting a Trachoe bucket in the ground with NO marks on any of those facilities.

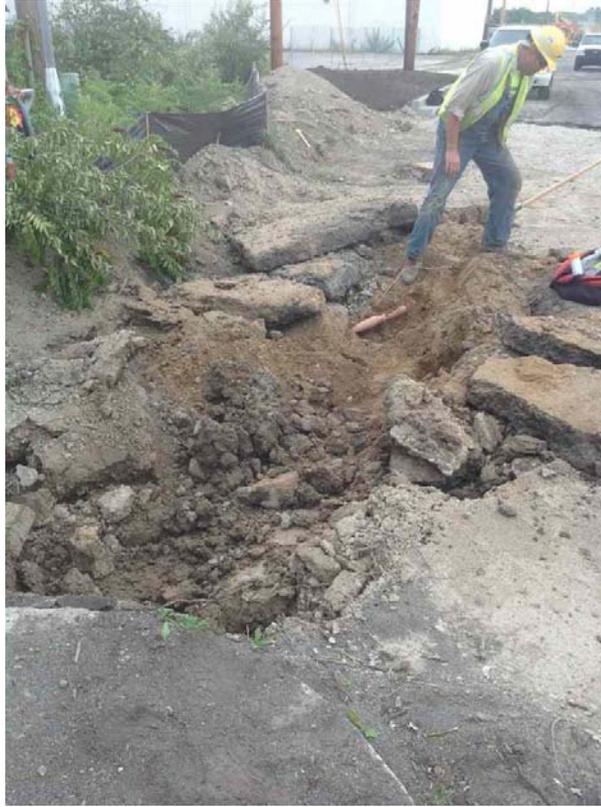
Photo 3

Contractor was outside of scope and had three CLEARLY visible indicators of three different utilities, gas, electric and phone that had NO marks on them and proceeded to dig blindly and just missed getting electrocuted by hitting the gas first and missing the new 3 phase electric by only 2ft.

Hand expose all facilities after having proper locate area called in and marked.

Make sure to use due dilligence when exposing buried facities.
