Pipeline Safety Division Investigation Report

Investigation regarding: South Bend Water Works

UPPAC Database Record ID: 5344

Synopsis: Excavator struck and damaged an underground natural gas main while performing water work.

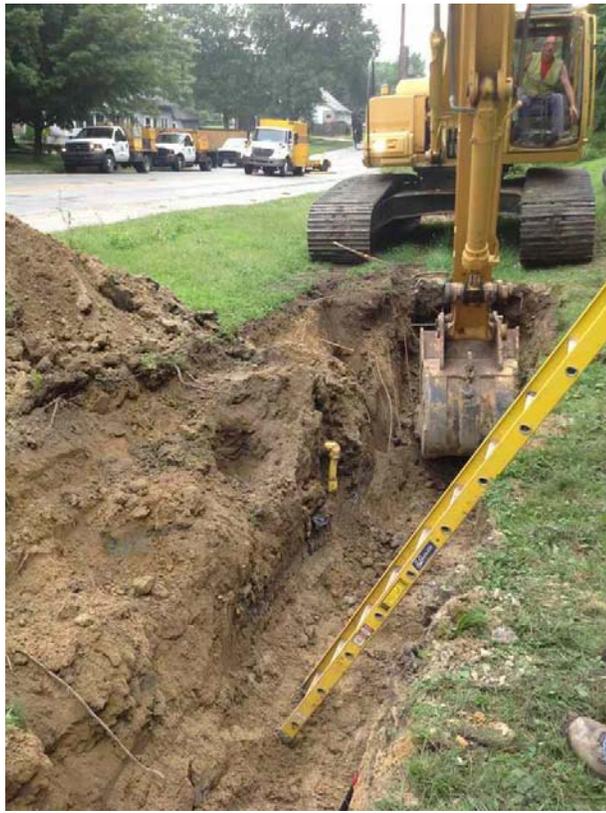
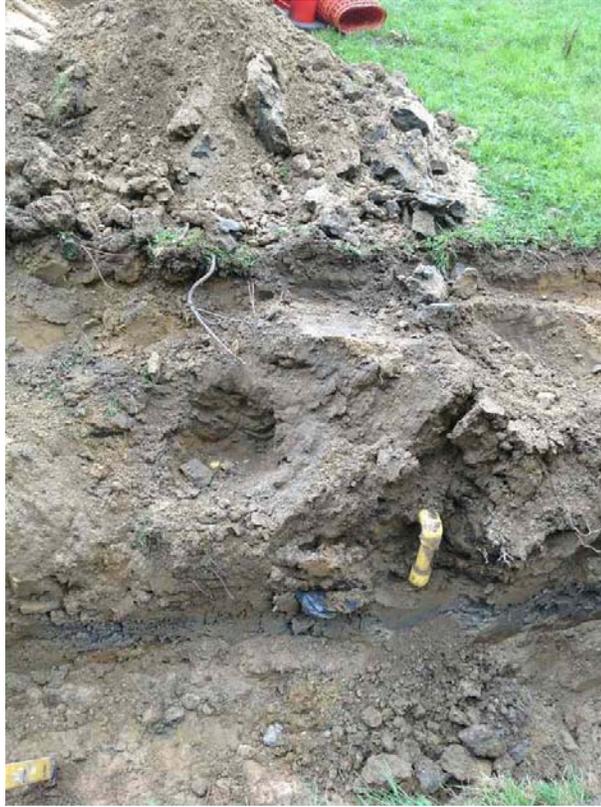
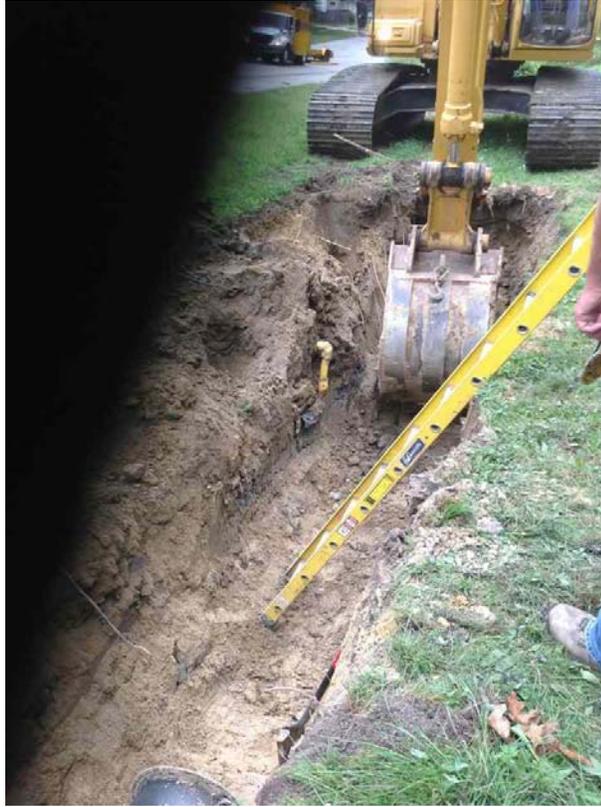
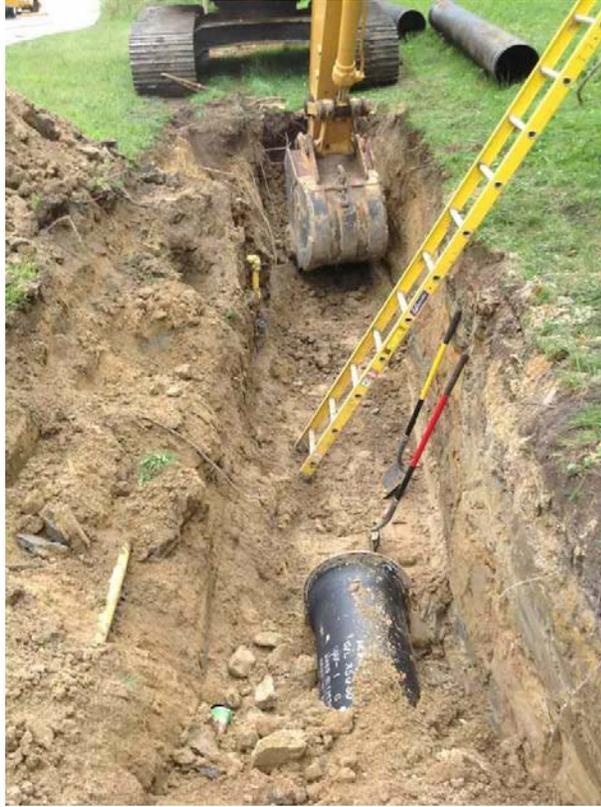
Contractor was using an excavator to dig alongside a 4" plastic main and hit the 2" plastic main where it attached to the 4" main. USIC had marked the facility accurately; marks were still on site and clearly visible. Contractor was using an excavator to dig within 2 feet of the mark and should have hand exposed the facility.

Contractor digging parallel alongside the gas main struck a 4 inch plastic gas main that

was a tie in (connecting main)

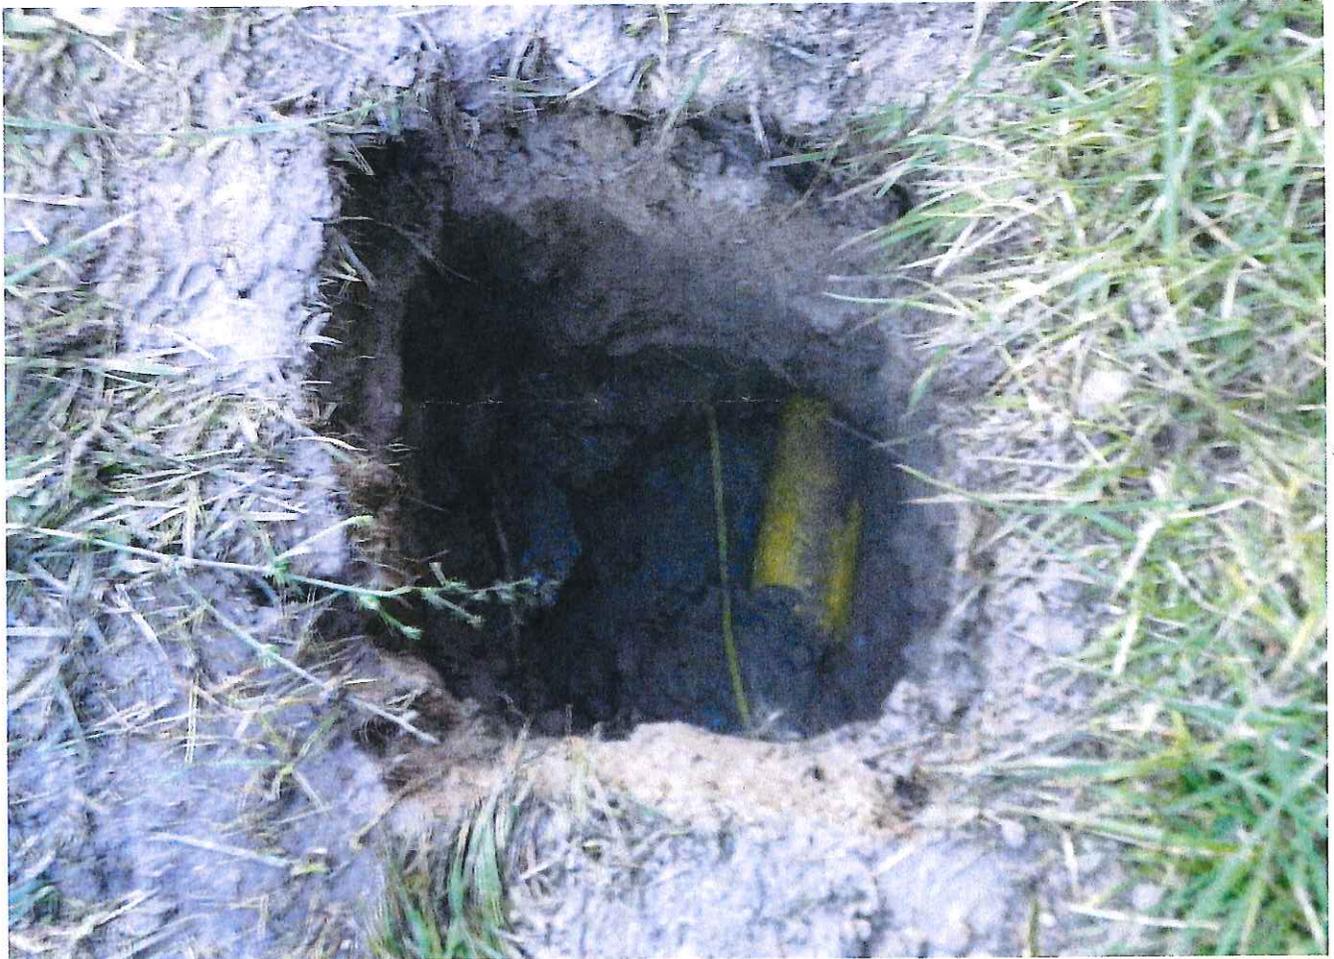
← 1

Picture 1: Shows where we pot holed to find gas to prevent damage. We pot holed every hundred feet to prevent damage.

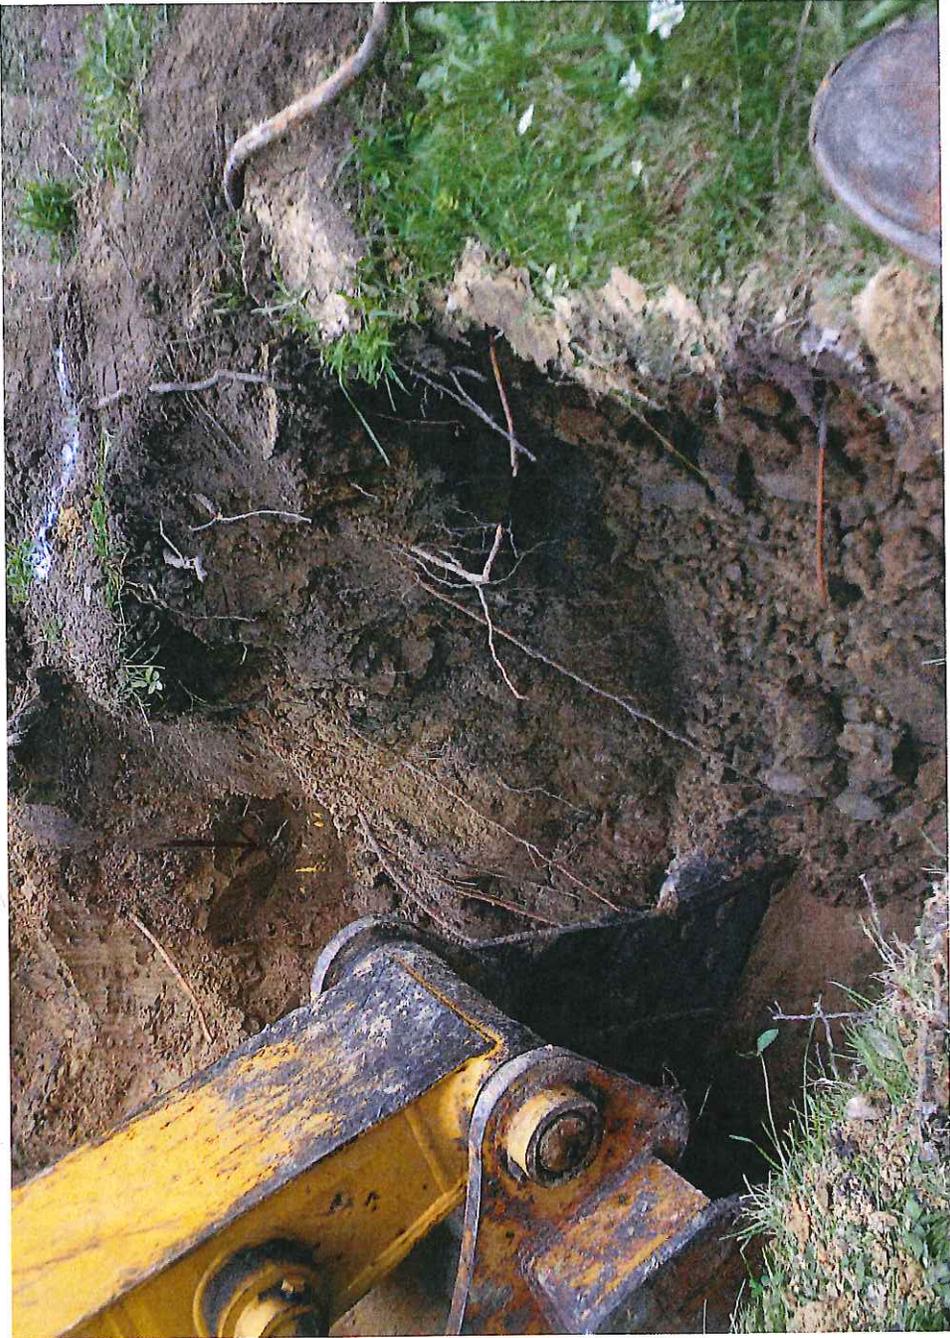
5 ←

Picture 5 shows where East / West 4" main was located. The 2" lateral line would not have been damaged if it was marked & not inside our 2 foot safe zone.
