Pipeline Safety Division Investigation Report

Investigation regarding: Tate Concrete

UPPAC Database Record ID: 1729

Synopsis: 1" plastic low pressure natural gas service damaged during the removal of a section of sidewalk.

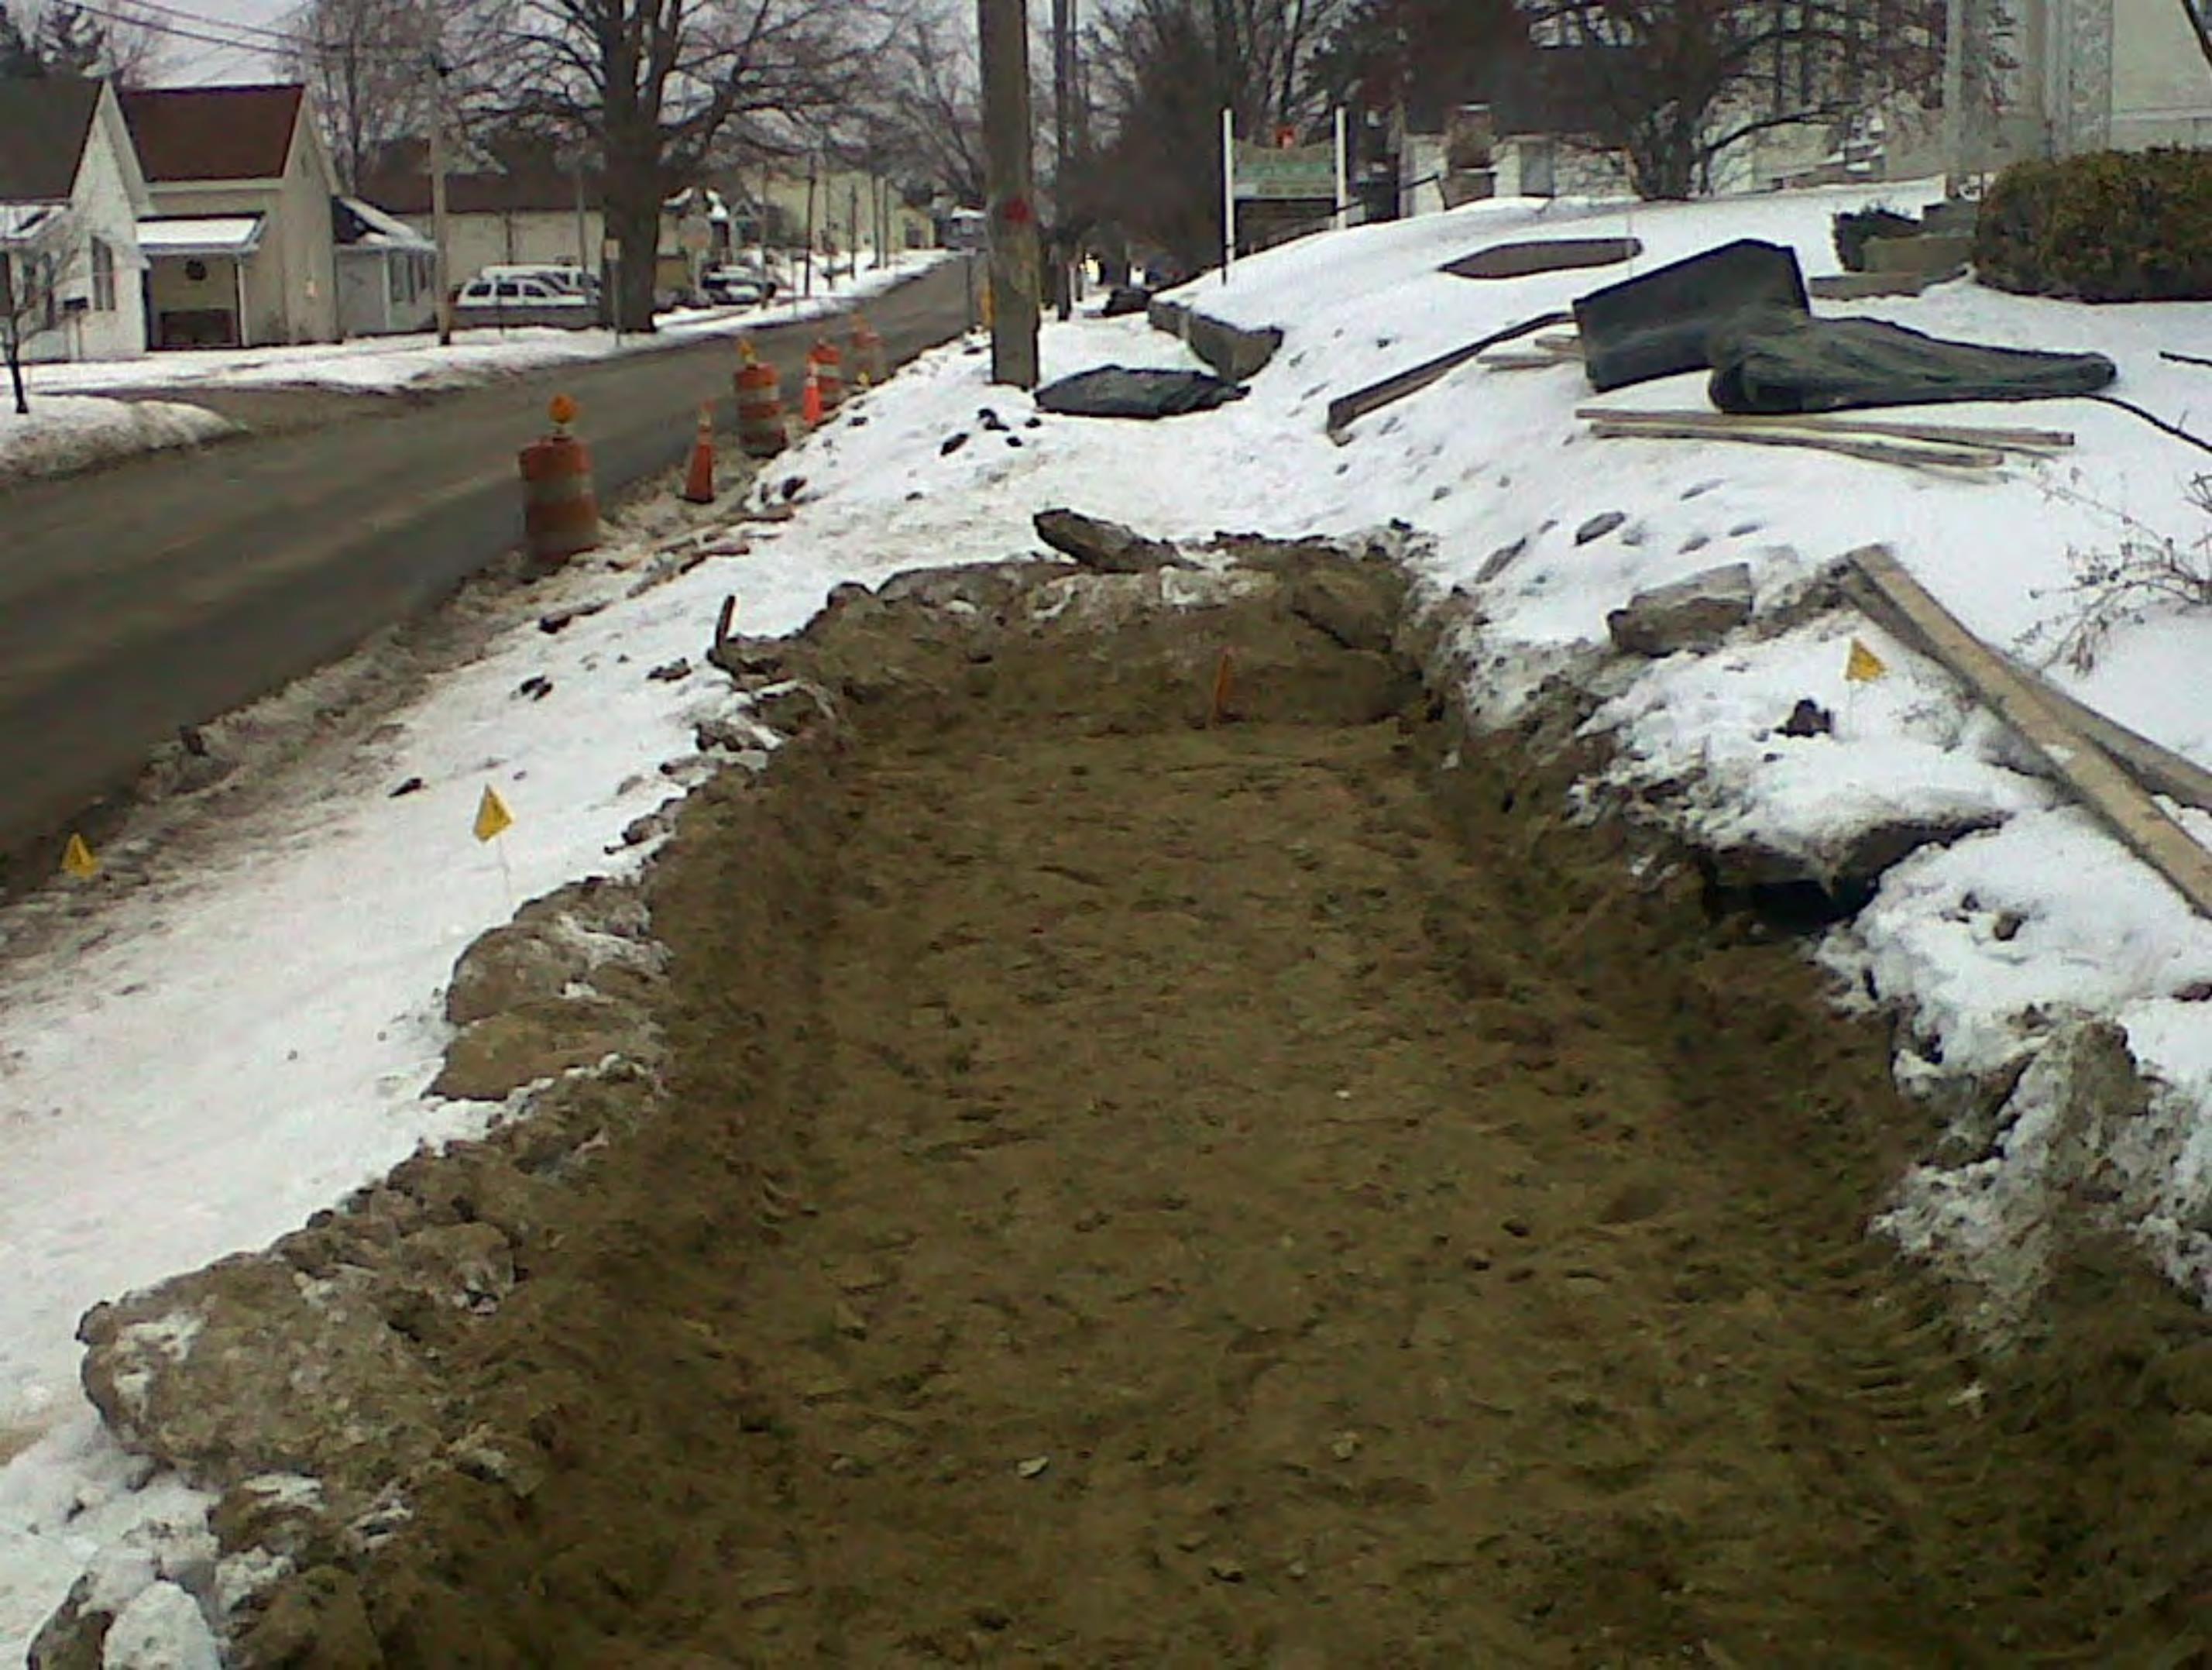
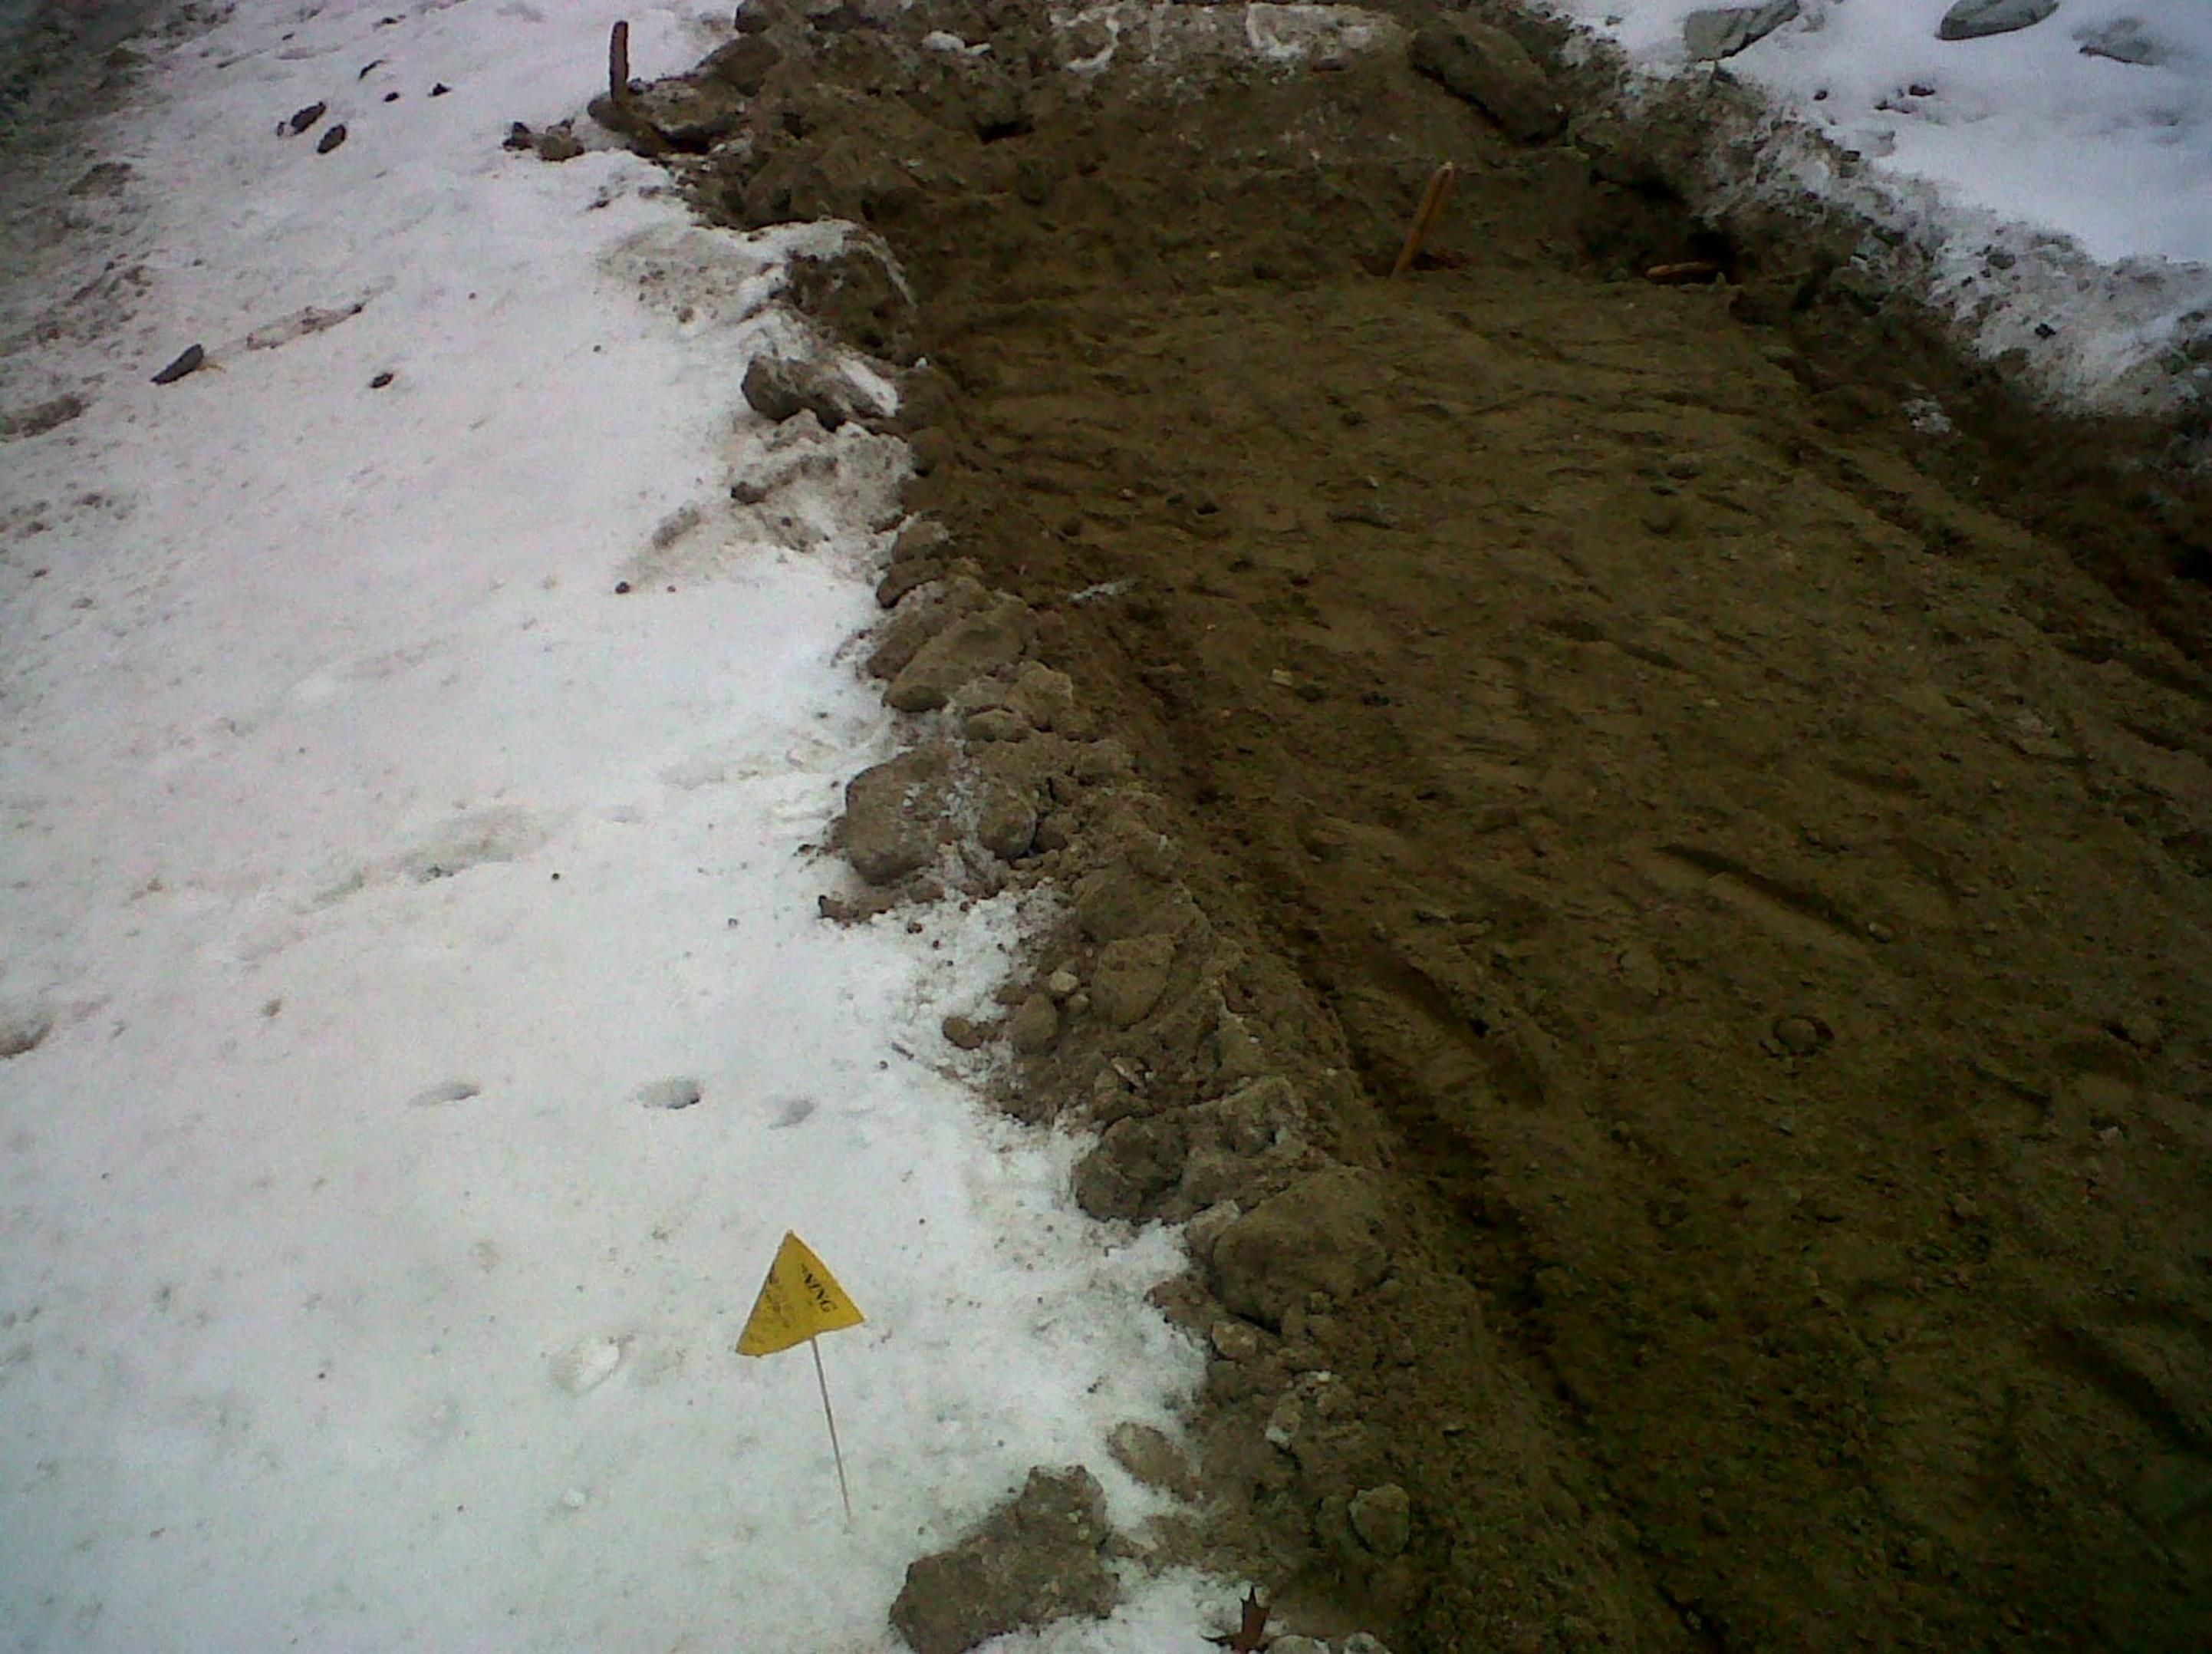
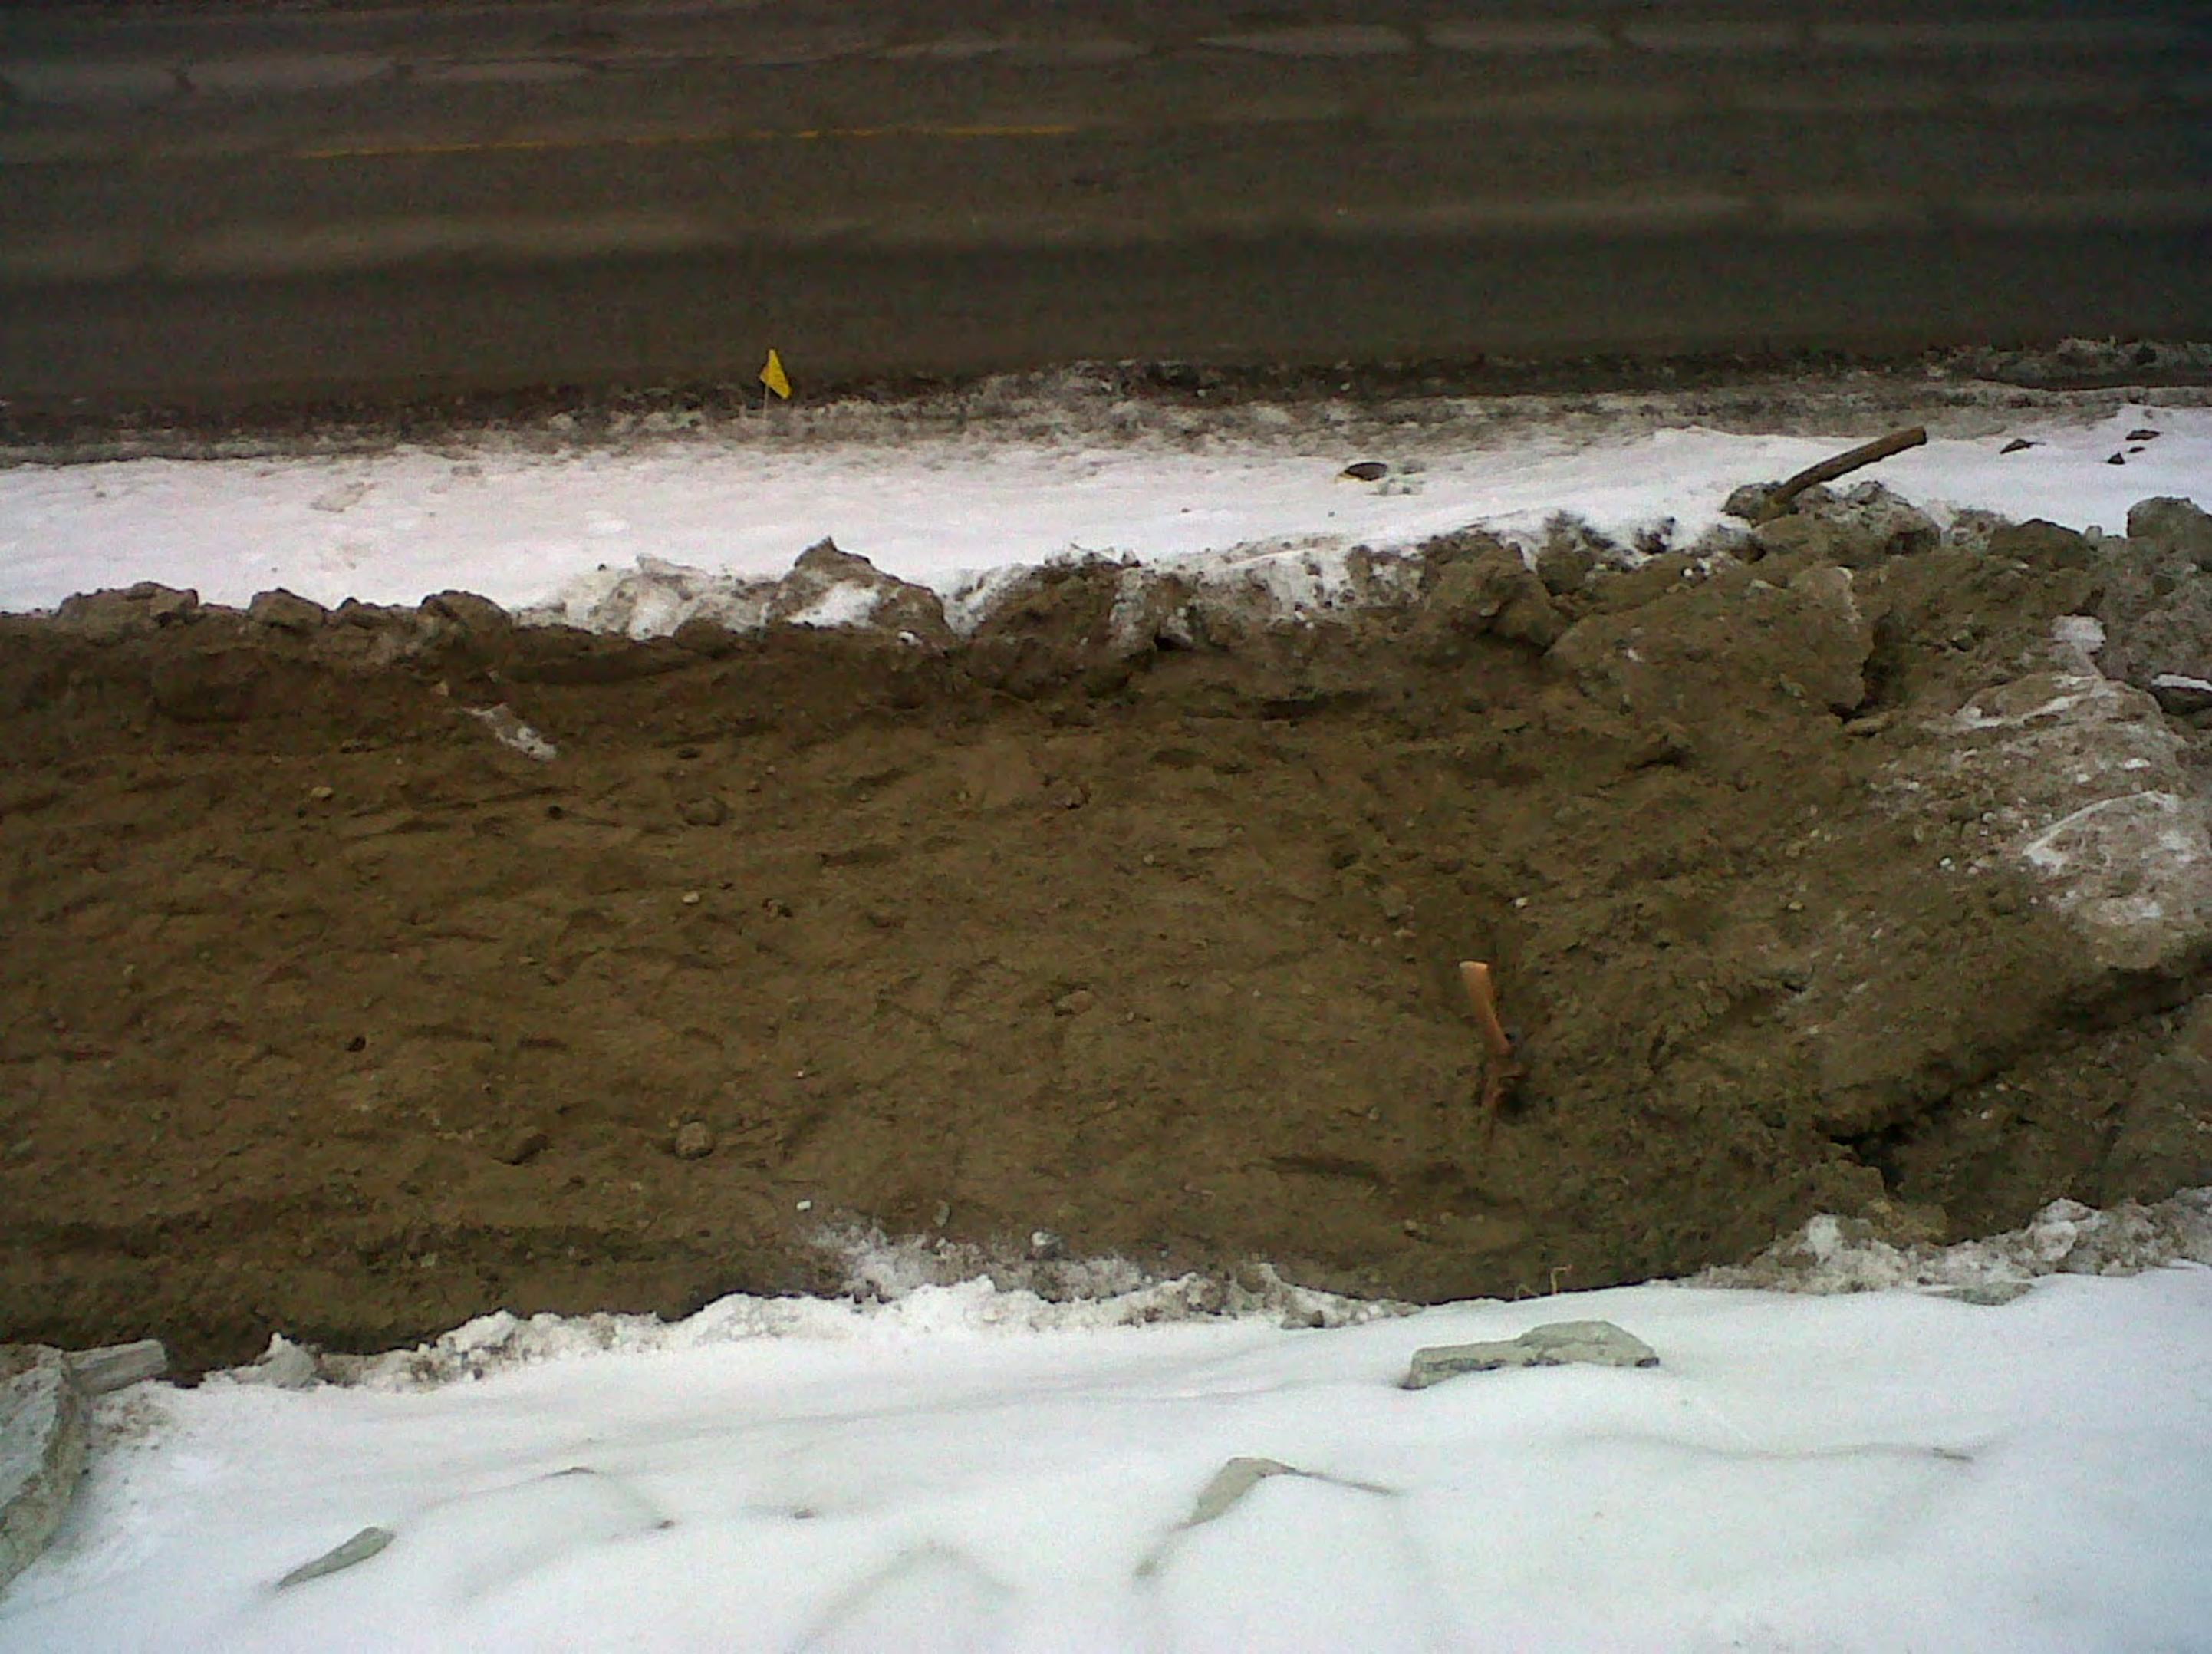
Additional Information/Comments: We were subcontracting for much larger job occurring on Mill/Elmore Streets. That contractor had locate request. Did not realize it should be done repetitively. Photo shows Gas line mark flags - marks on ground were not where we encountered the line. The line was very shallow - we don't dig more than 6"-8". Very surprised to encounter pipe at that depth - especially since locate flags were several feet south. Immediately reported and clamped pipe. All employees trained as firefighters to do that. On site utility came to repair. No negligence intended. We thought the markings there were sufficient since our contractor that we sub for was having marking done.
