Pipeline Safety Division Investigation Report

Investigation regarding: **Hrp Construction**

UPPAC Database Record ID: 3204

Synopsis: A natural gas main was damaged during excavation for a sewer line.

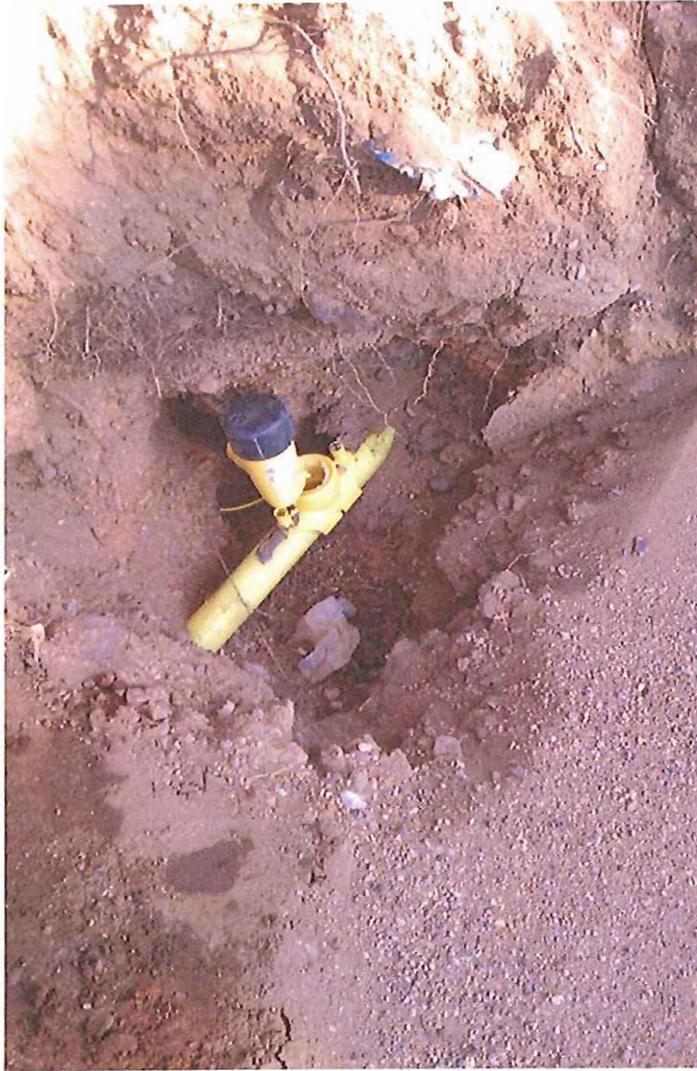
V6

Diamond Ave Trunk Storm Sewer
Hit 2" gas Main NW Corner of the Intersection of Portage Ave and Diamond Ave.

Picture of the 2" gas main broke at the tee.

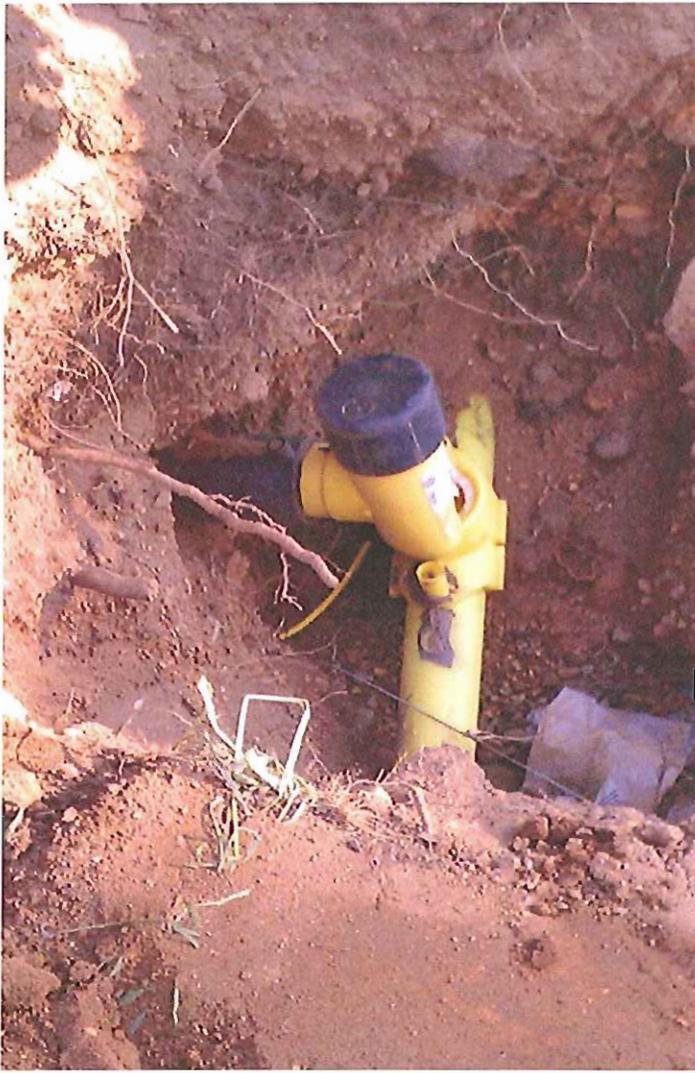
2/6

Hit 2" gas Main NW Corner of the Intersection of Portage Ave and Diamond Ave.

Up close picture of the broken 2" tee.

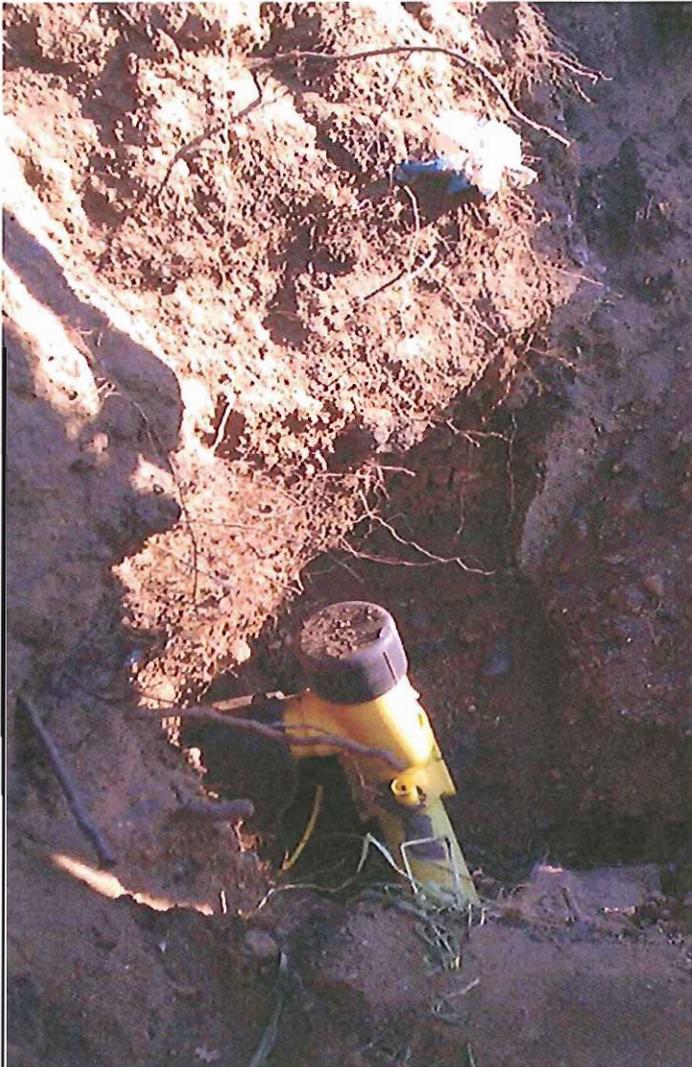
3/6

Hit 2" gas Main NW Corner of the Intersection of Portage Ave and Diamond Ave.

Another picture of the 2" tee.

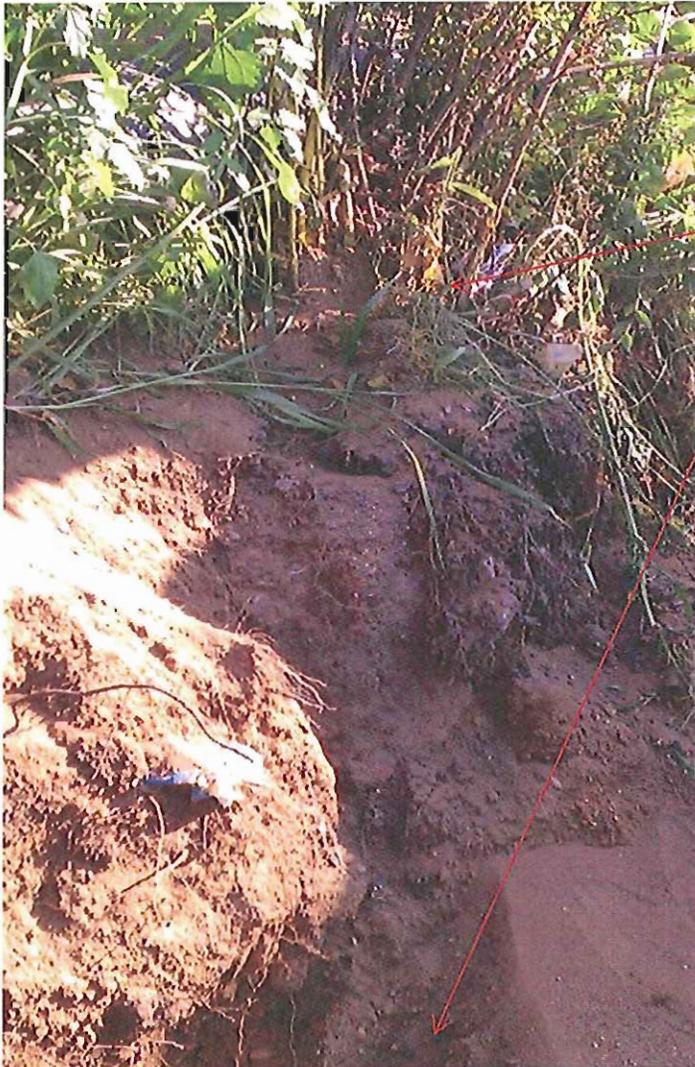
4/6

Hit 2" gas Main NW Corner of the Intersection of Portage Ave and Diamond Ave.

Locate mark in the bush and the tee at the bottom of the picture.

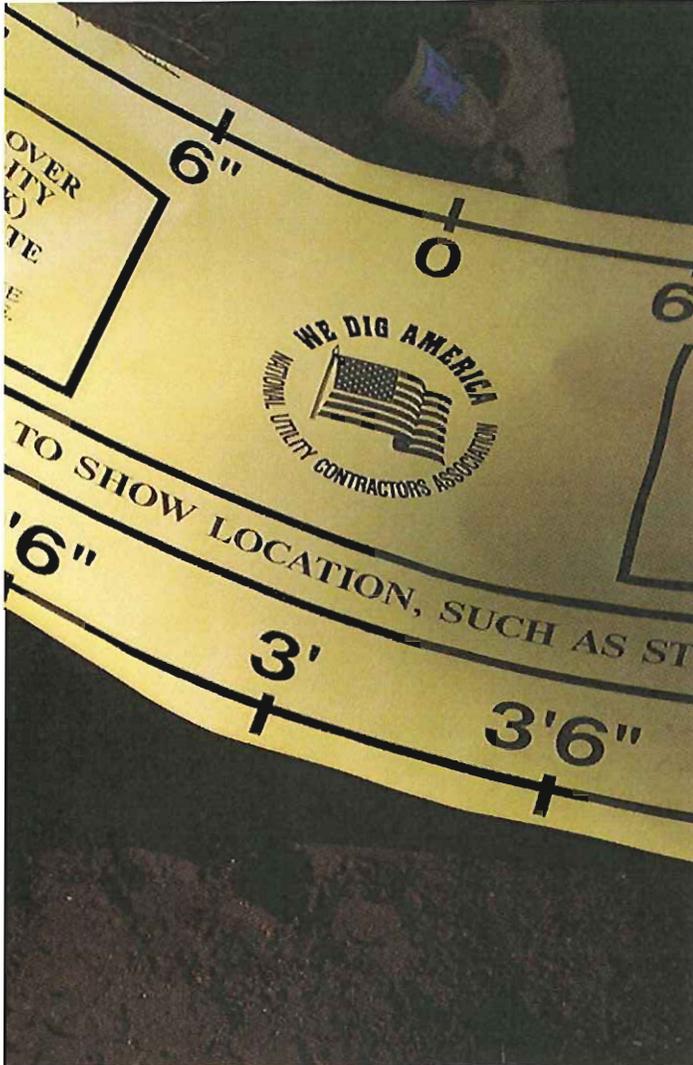
5/6

Enclosed / attached is a copy of our 3-page Utility Damage Report, filled out by our Field Supervisor, and six pages of six pictures total, which confirms this narrative. In fact our people measured almost a 3' difference from the tee to the locate mark.

Hit 2" gas Main NW Corner of the Intersection of Portage Ave and Diamond Ave.

Picture showing the tee 3' off the marks we had.

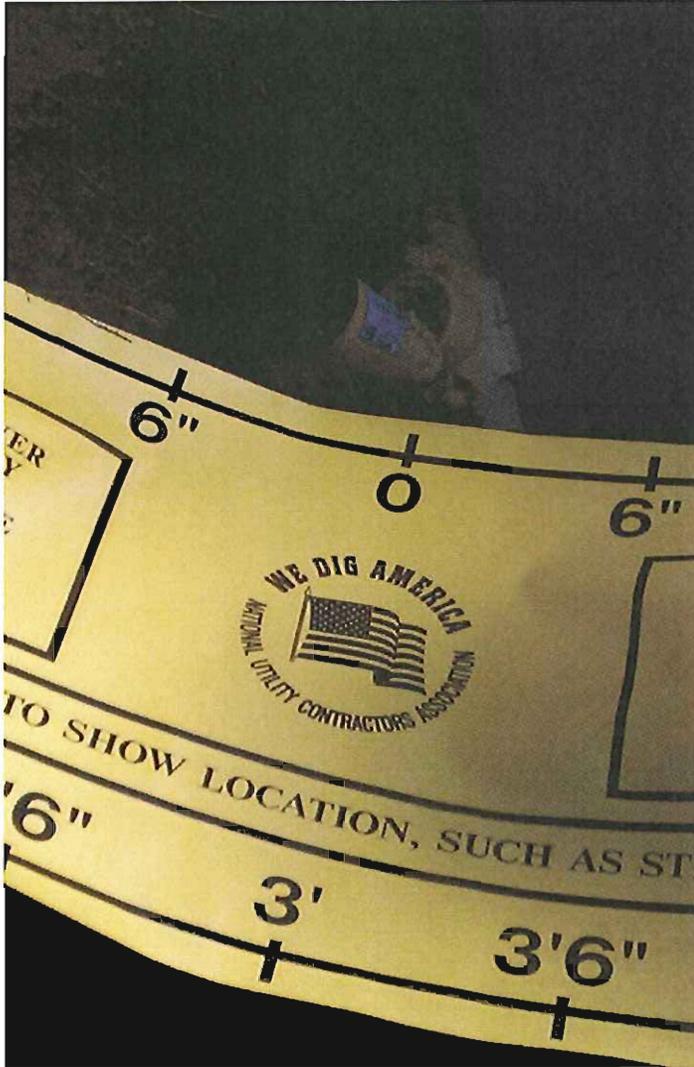
6/6

Hit 2" gas Main NW Corner of the Intersection of Portage Ave and Diamond Ave.

Another picture of the tee 3' off the marks.
