Pipeline Safety Division Investigation Report

Investigation regarding: Selge Construction Company, Inc.

UPPAC Database Record ID: 3243

Synopsis: A natural gas service was damaged during excavation for road work.

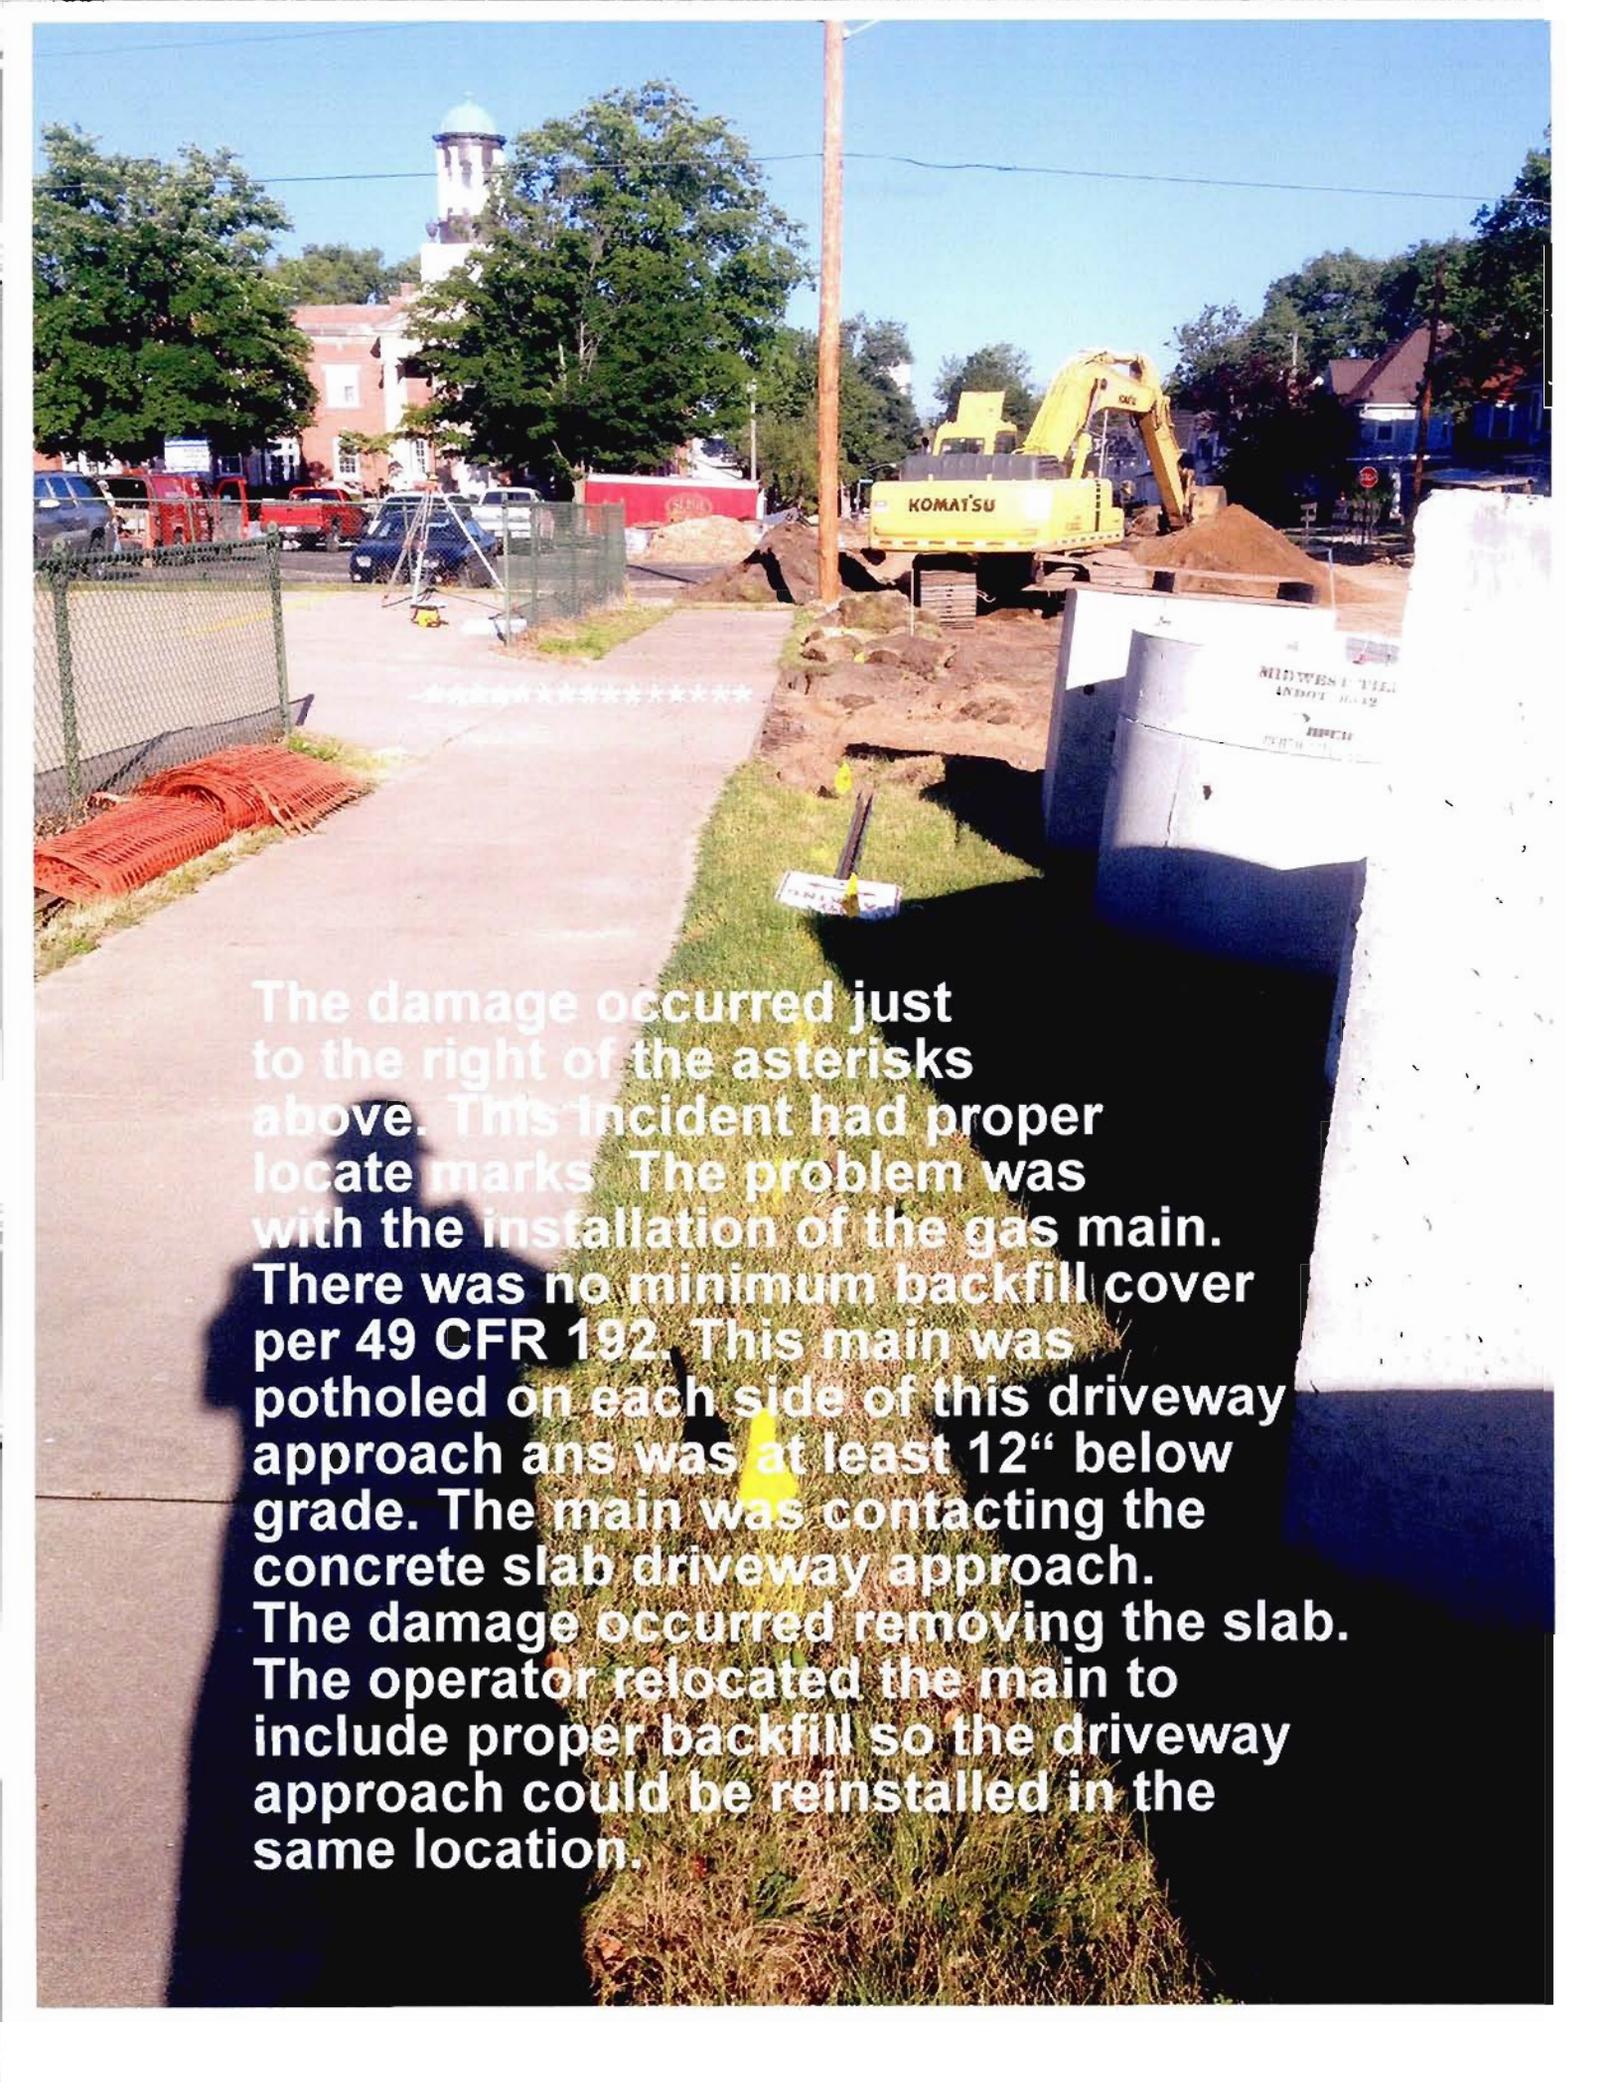
The damage occurred just to the right of the asterisks above. This incident had proper locate marks. The problem was with the installation of the gas main. There was no minimum backfill cover per 49 CFR 192. This main was potholed on each side of this driveway approach and was at least 12" below grade. The main was contacting the concrete slab driveway approach. The damage occurred removing the slab. The operator relocated the main to include proper backfill so the driveway approach could be reinstalled in the same location.

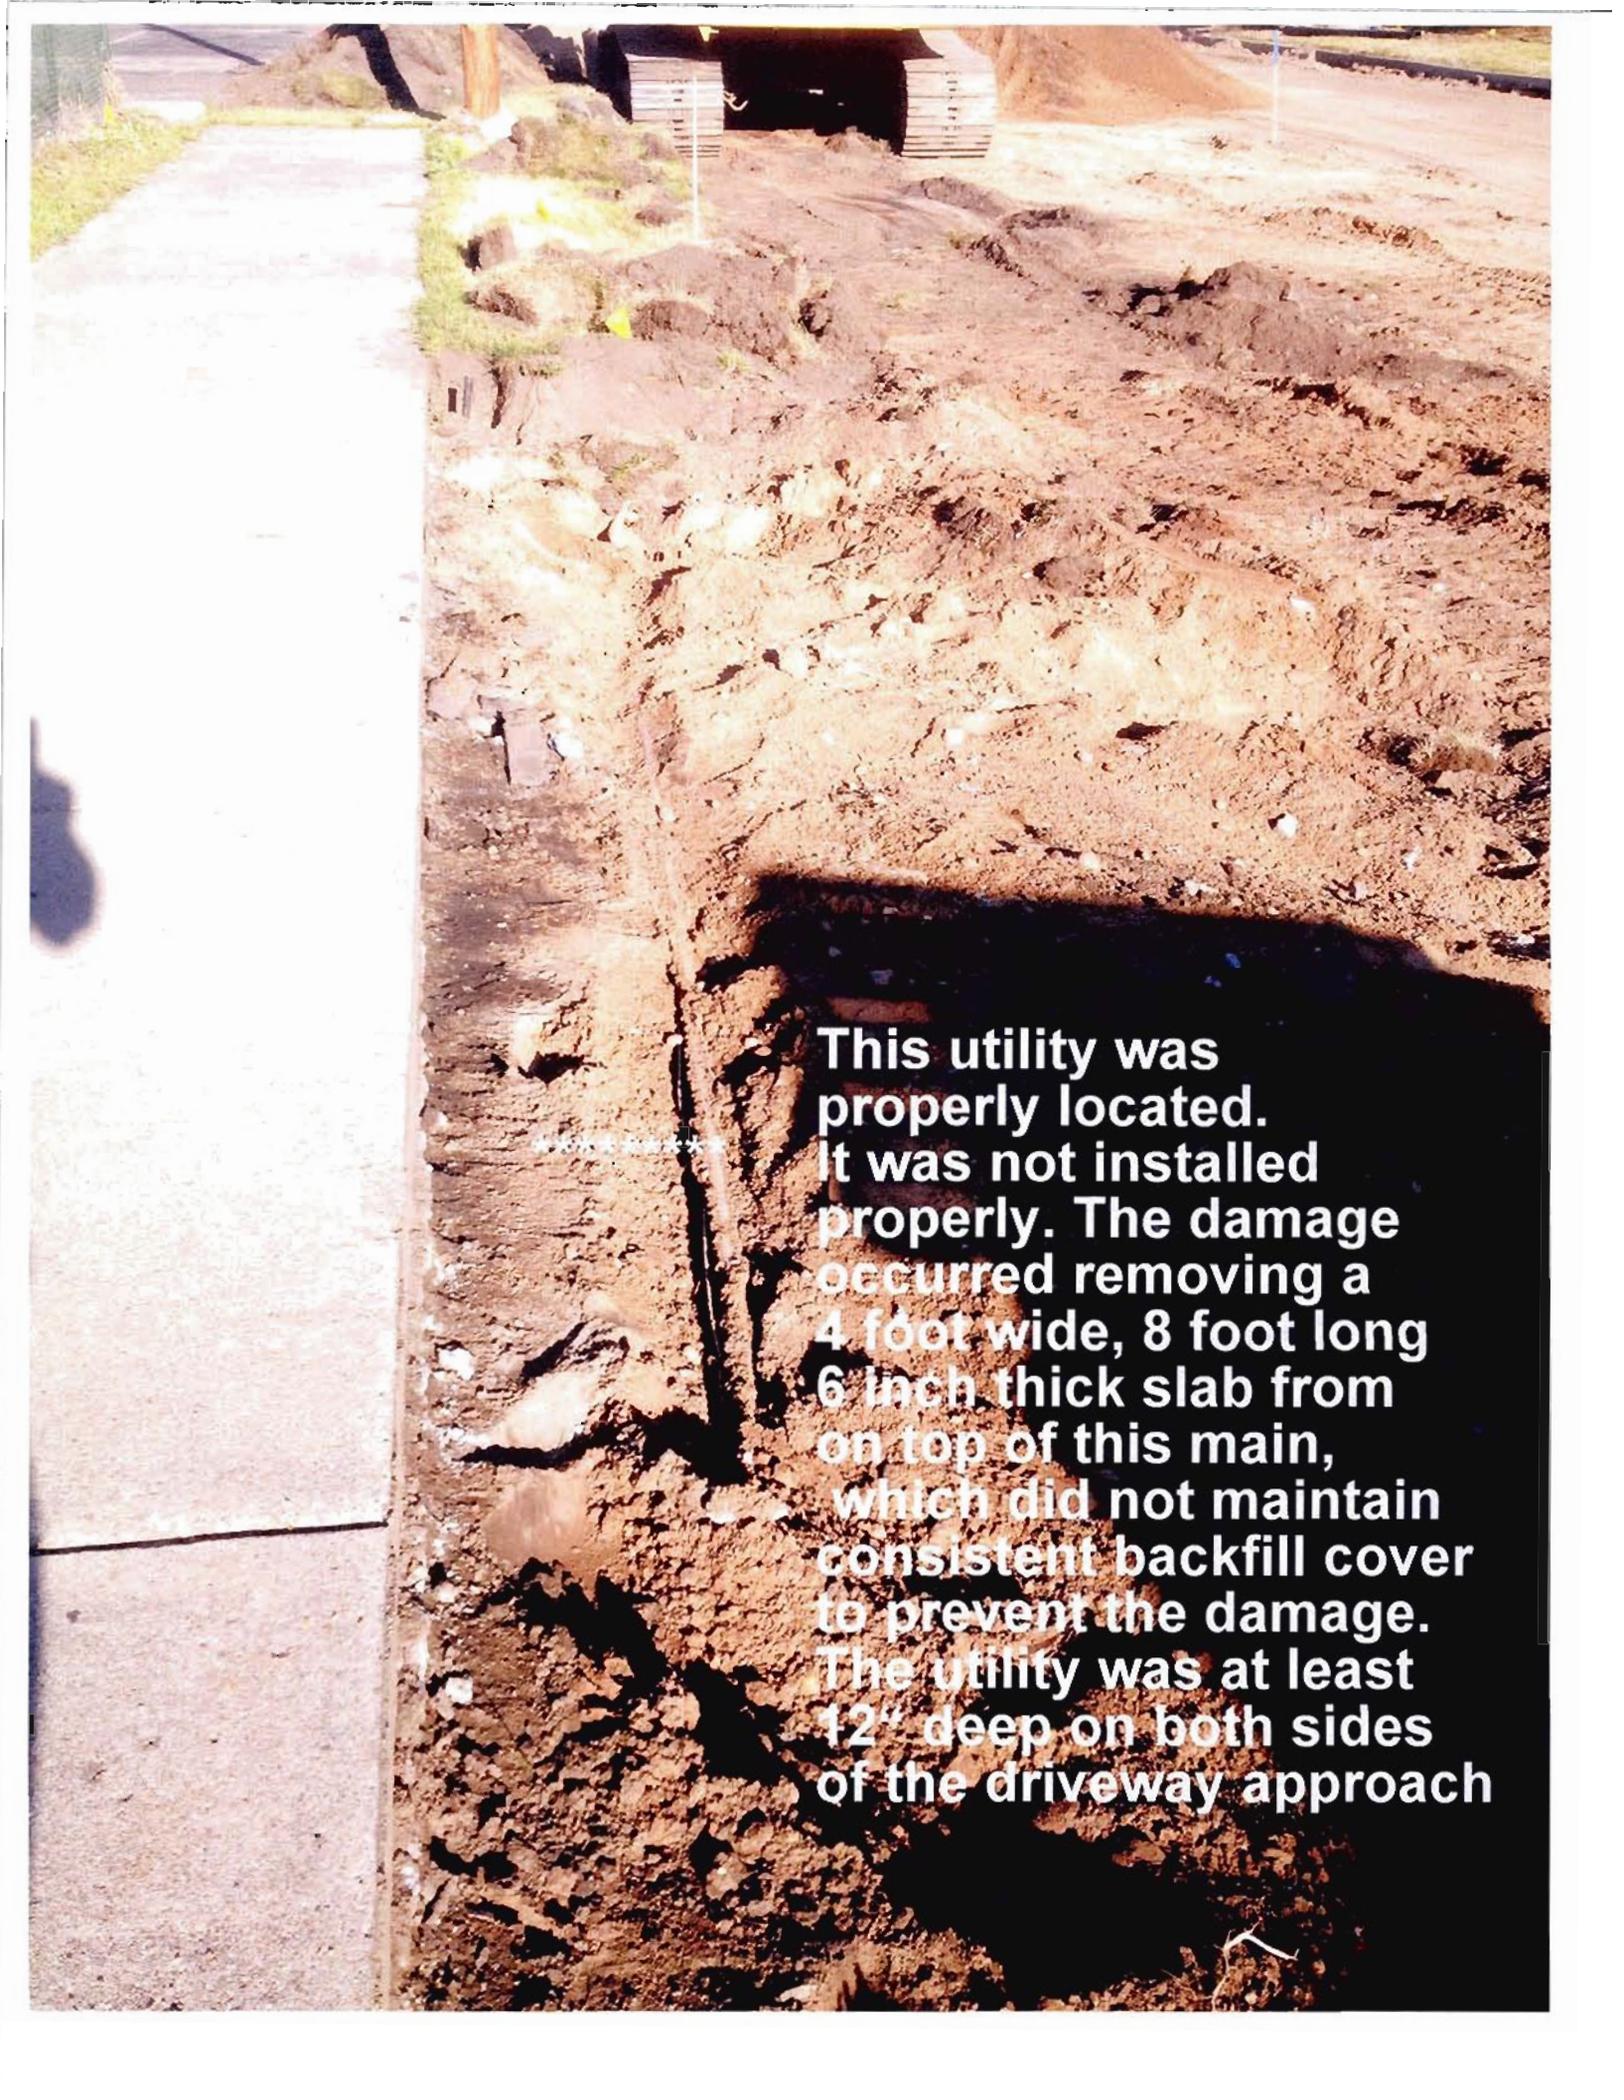
This utility was properly located. It was not installed properly. The damage occurred removing a 4 foot wide, 8 foot long 6 inch thick slab from on top of this main, which did not maintain consistent backfill cover to prevent the damage. The utility was at least 12" deep on both sides of the driveway approach
