## Pipeline Safety Division Investigation Report

### Investigation regarding: Dale Miller

UPPAC Database Record ID: 3297

## DAMAGE INFORMATION REPORT – PIPELINE SAFETY DIVISION

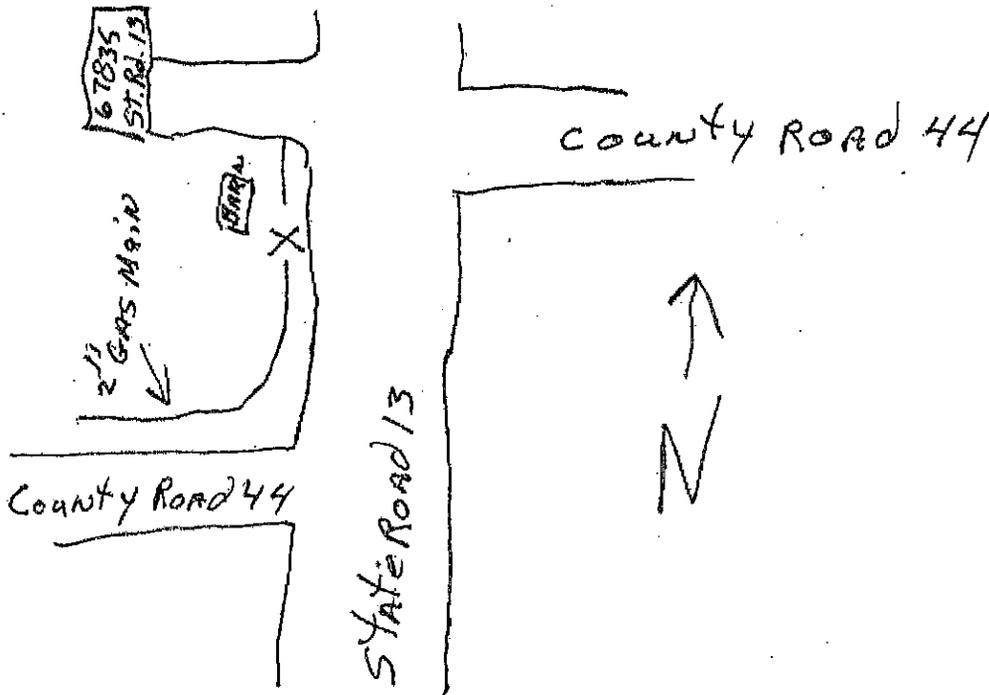
SKETCH: - Show position of all pertinent information

DEPTH OF FACILITY (Inches) 32" PRESSURE (PSI) 45 Lbs. Med

DIAMETER/MEASUREMENT OF HOLE IN GAS FACILITY: 8"

COMMENTS: Customer was Augering Post Holes  
For Fence with Bobcat, Drilled into 2"  
Plastic GAS Main with out locates
