Pipeline Safety Division Investigation Report

Investigation regarding: Castleman Septic Systems & Sewers

UPPAC Database Record ID: 3441

Report Date: 11/7/2012

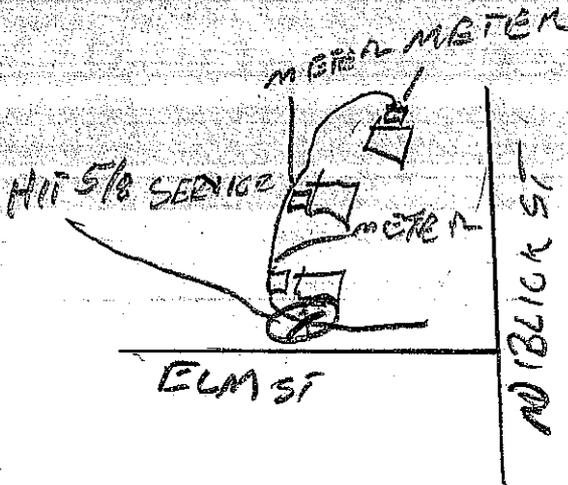
SKETCH: - Show position of all pertinent information

HIT 5/8 SERVICES

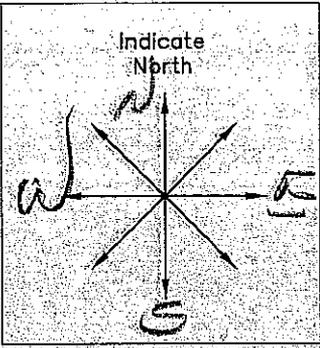
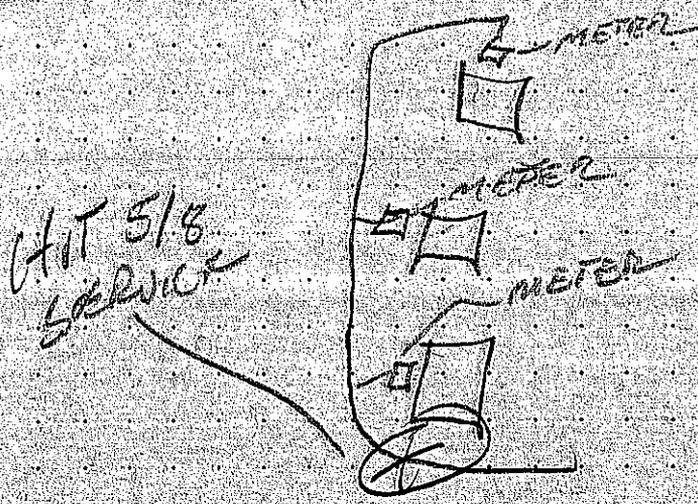
HIT 5/8 SERVICE

Comments: REPAIRED HIT 518 SERVICE
JO574367
