INDIANAPOLIS POWER & LIGHT COMPANY

REPORT IN RESPONSE TO

O'NEILL CONSULTING INDEPENDENT ASSESSMENT OF

DOWNTOWN UNDERGROUND NETWORK

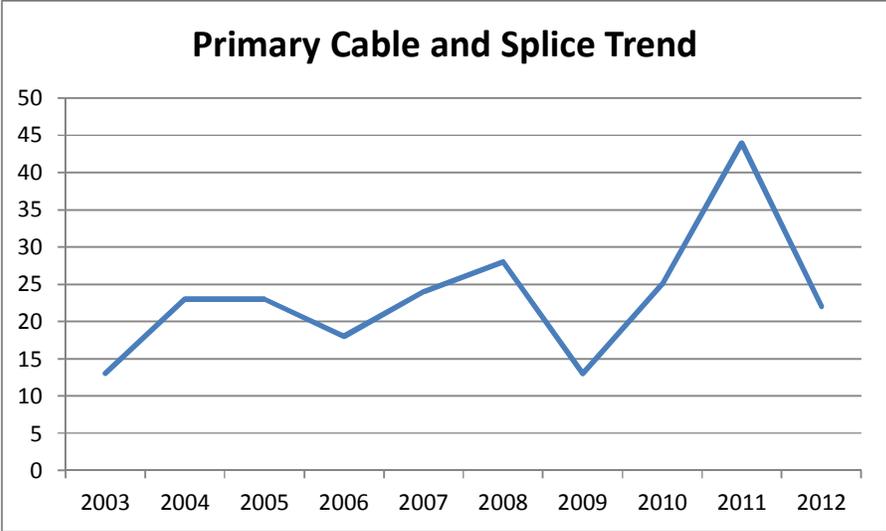
Figure 3-2 Primary cable and splice failure trend

Less cable and splice failures - The number of primary cable and splice failures dropped significantly in 2012 when compared to 2011. This improvement is especially noteworthy considering the greater stress from the 2012 heat wave. Figure 3-2 shows the ten year trend only for primary cable and splice failures.

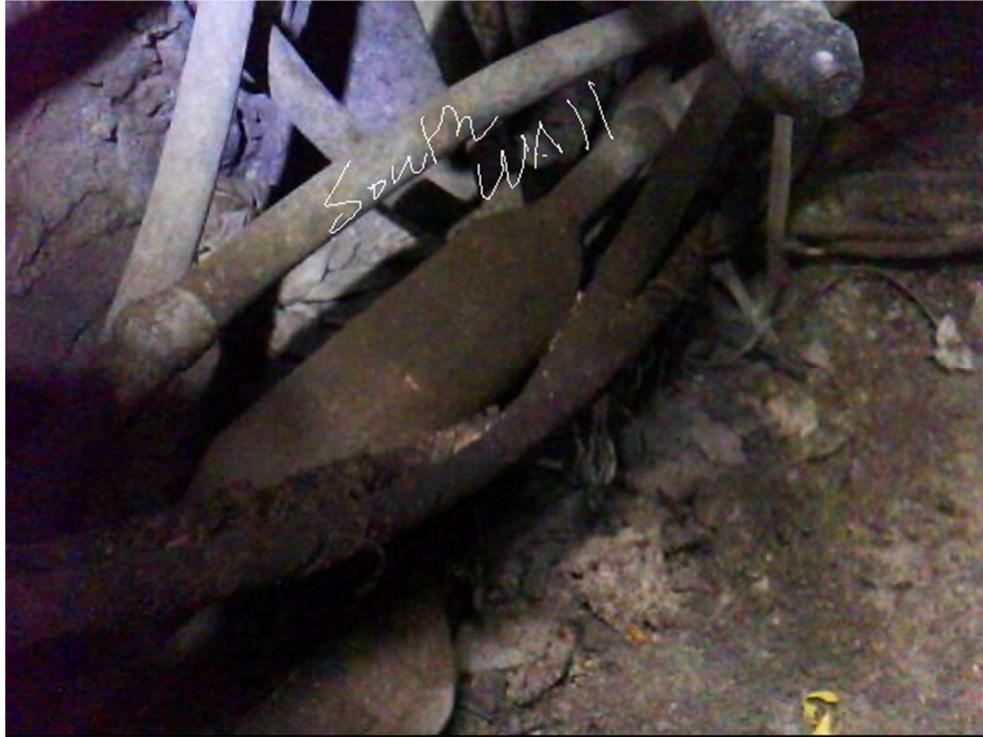
Figure 3-5 Handheld tablet picture with technician note on picture

The photograph of the problem is Figure 3-5. Also notice the technician wrote a small note on the figure adding information about the location of the problem. The technician wrote the note using the tablet computer.

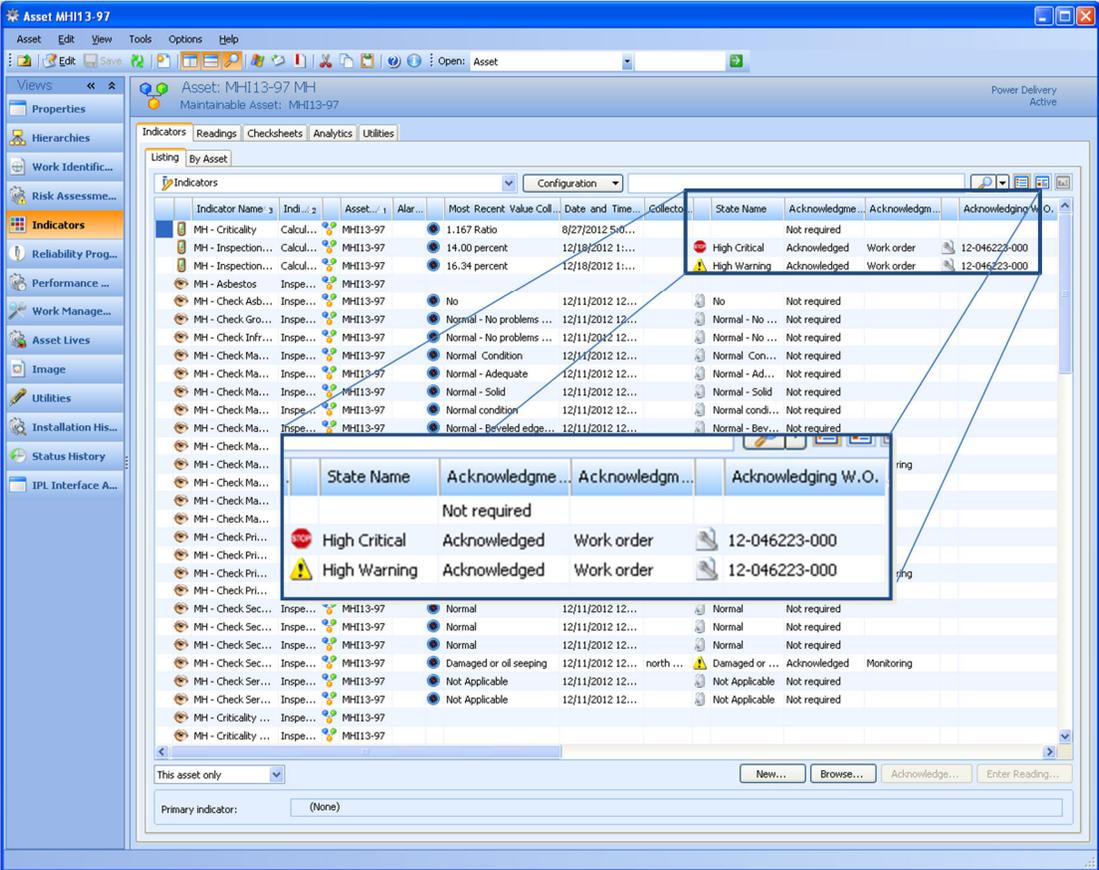
Figure 3-6 Acknowledged alarm and work order reference in Ivara

Tablet computer data uploads to Ivara. Ivara follows IPL business rules for condition and impact of the reported problem. Business rules in Ivara calculated a condition indicator and issued an alarm for manhole MNI13-97. Figure 3-6 shows the Ivara indicator screen with an important portion of the screen expanded for easier reading. An IPL employee acknowledged the alarm and issued EMPAC Work order 12-046223-000 to make repairs.

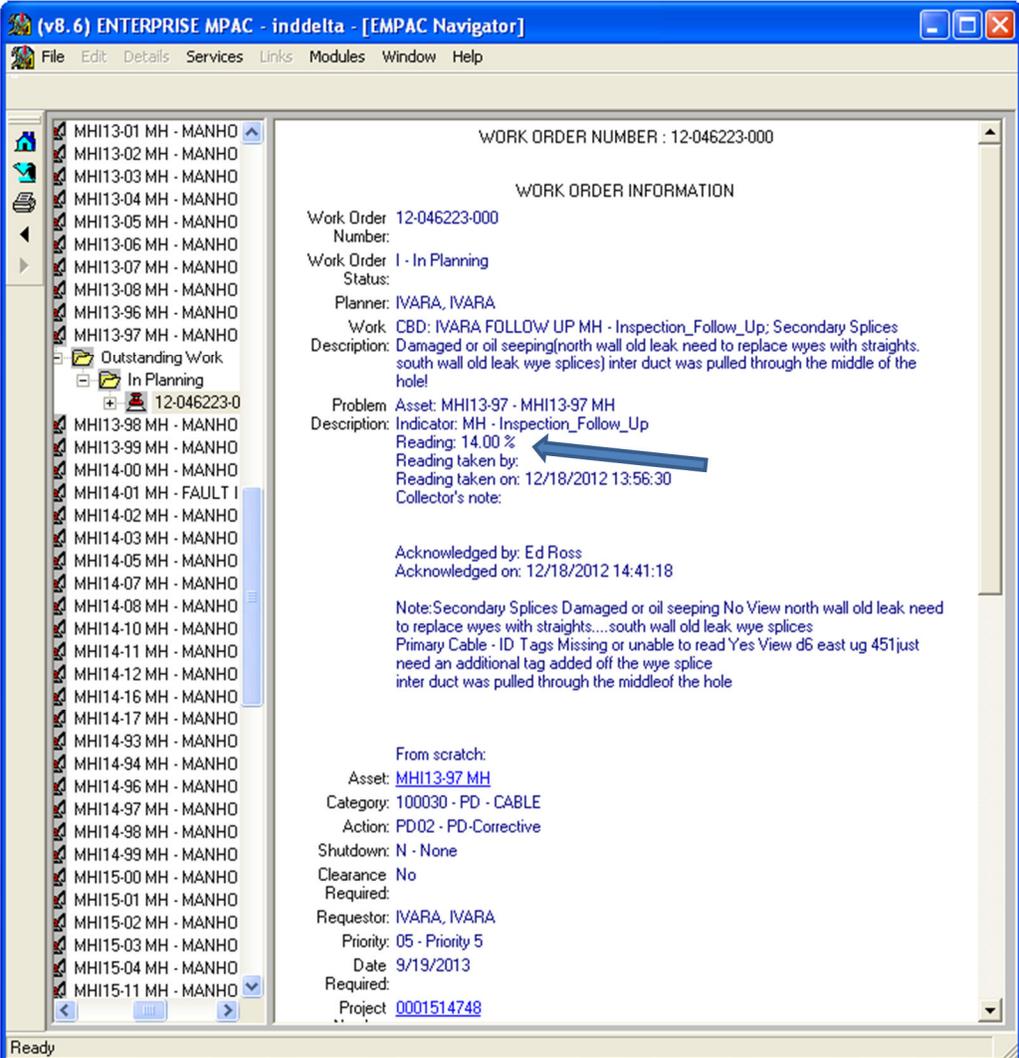
Figure 3-7 Work order as it appears in work management with indicator

Here is work order 10-046223-000 in the EMPAC asset and work management system. Note the arrow pointing to 14.00% importance reading from Ivara carried through to EMPAC. Additional details of the work needed carry through to the description. This gives the scheduler guidance on the priority of the work. The 14.00% reading generated a priority 5 rating based on IPL business practices.

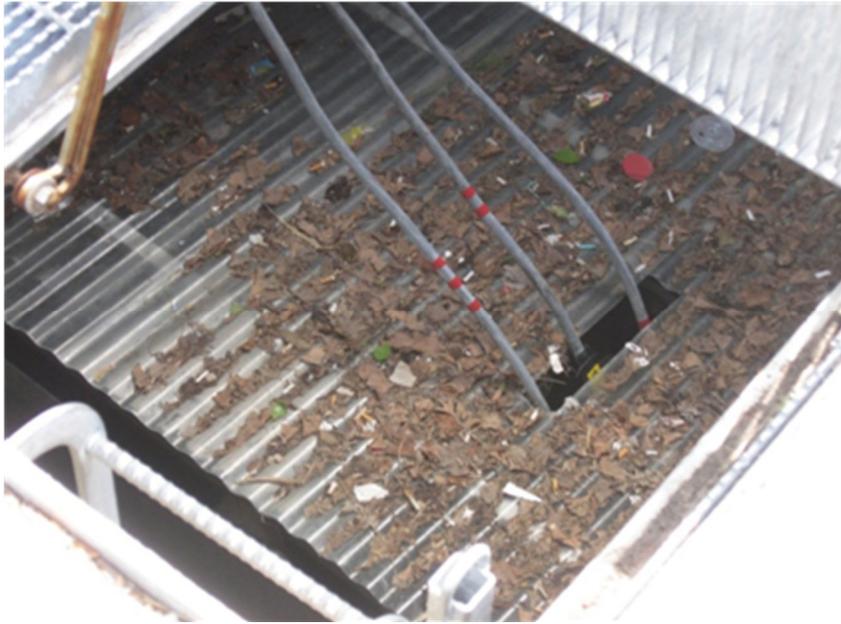
Figure 3-8 Debris captured by Deflector Shield

Alternate plan developed for pressurization - IPL has encountered a number of issues in trying to pressure test network protectors, with a focus on those identified as having aluminum bus. Even after replacing the door gasket material the network protectors still will not hold pressure. IPL has discussed this issue with O'Neill Consulting and the new course of action is to install deflector shields above these units. IPL is also investigating installing a moisture sensor either in the vault or in the network protector to detect a potential moisture problem and allow time for corrective action to be taken. Figure 3-8 shows an example of the deflector shield. A total of 25 shields were installed for this particular reason.

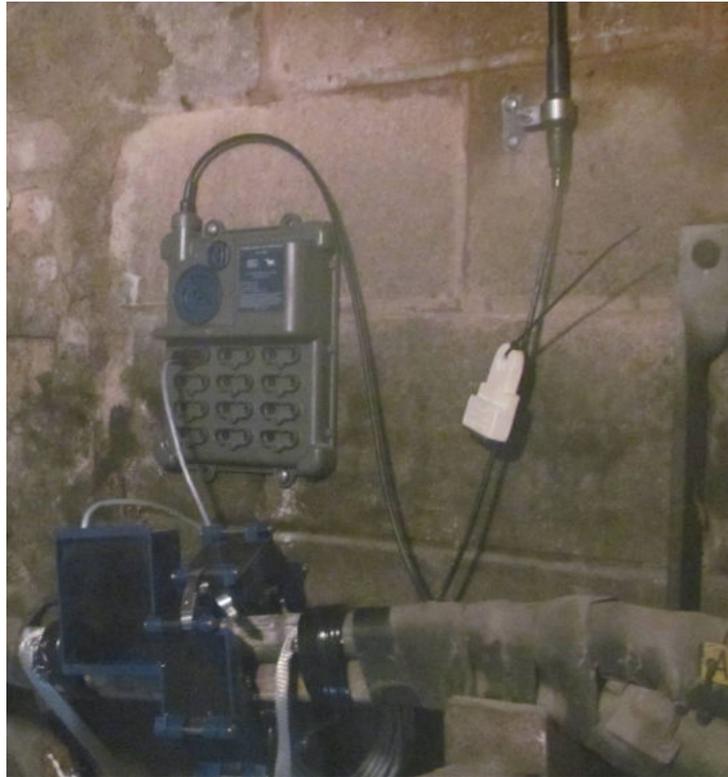
Figure 4-7 Cable fault indicator

Fault indicators - Installation of the fault indicators was not completed prior to the end of 2012. This work was rescheduled to coordinate with other Smart Grid work that will be completed by the end of April 2013. Scheduling the needed network primary circuit outages to install the fault indicators was also a factor in delaying the final installations. Fault indicators are now installed on 43 of 44 circuits. Fault indicators will be installed on the 44th circuit when the cable is replaced. Cable replacement on this 44th circuit is part of IPL's practice cable replacement program and is already in progress. Figure 4-7 shows a fault indicator installed in a vault.

IPL has seen benefits from the primary cable fault indicator. The indicators have been used to quickly narrow down the section of the circuit the fault is located in, greatly reducing the amount of time test voltage is applied to the circuit to find the fault. In one instance the fault was located in less than 45 minutes, where without the fault indicator information it could take upwards of 6-8 hours to find a fault. In another case the circuit faulted and did not yet have fault indicators installed. The crew could not locate the fault. The fault indicators were installed and the substation breaker was closed. It immediately tripped out but the fault indicators tripped narrowing down the section of the circuit where the fault was located. This helped the crew to find the fault much faster than they otherwise would have.

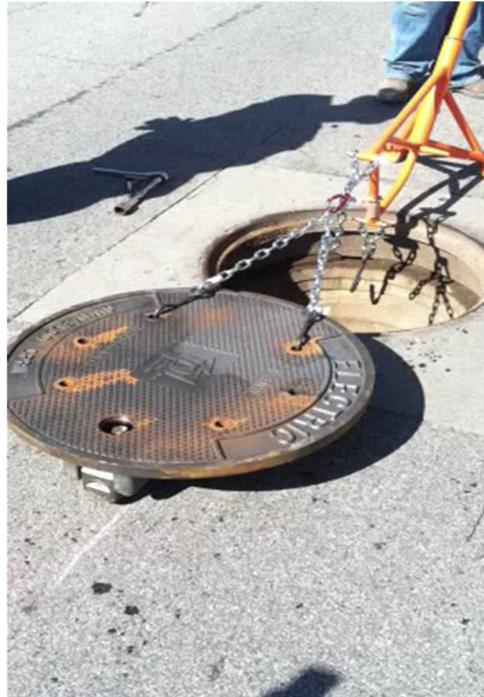
Figure 4-8 SWIVELOC™ manhole cover installation

Swiveloc™ locking manhole covers - IPL installed 152 of the Swiveloc™ locking manhole covers prior to the Super Bowl in February 2012. Another 50 Swiveloc™ manhole covers were installed in the fall of 2012 in high pedestrian traffic areas in the downtown area. Figure 4-8 shows a picture of a Swiveloc™ installation. To date IPL is not aware of a cable fault in a manhole with a Swiveloc™ cover. In the spring of 2013, a sampling of Swiveloc™ covers will be inspected for signs of corrosion from road salts. Assuming no corrosion issues or other problems are encountered in removing the covers after they have been exposed to the elements for a year, installation of additional Swiveloc™ covers in selected locations is planned.
