DEPARTMENT OF NATURAL RESOURCES

SMALL STRUCTURE MAINTENANCE AND REPAIR

PROJECT NO. ENG2502861255

PROJECT DESCRIPTION
Small Structure Repair in Steuben CountyPROJECT LOCATION
Fawn River Fish Hatchery-Culvert on Park/Service Rd. over Fawn River Bypass Creek

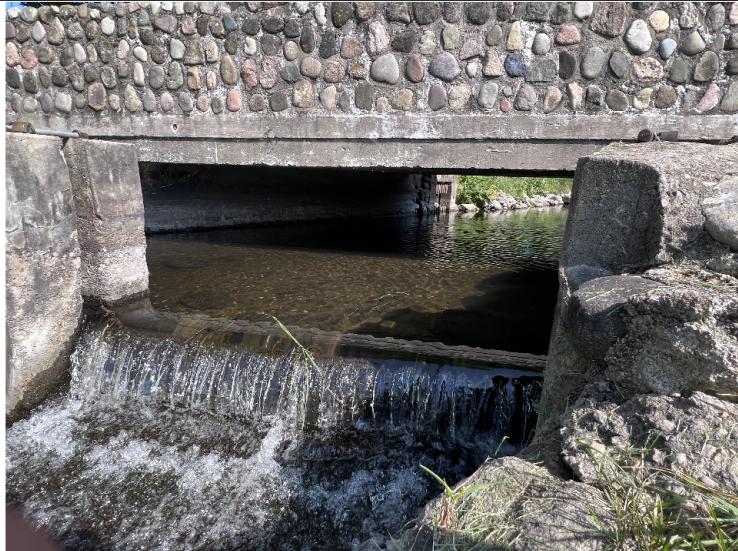
1. Side elevation Looking North. Some minor efflorescence visible along coping.

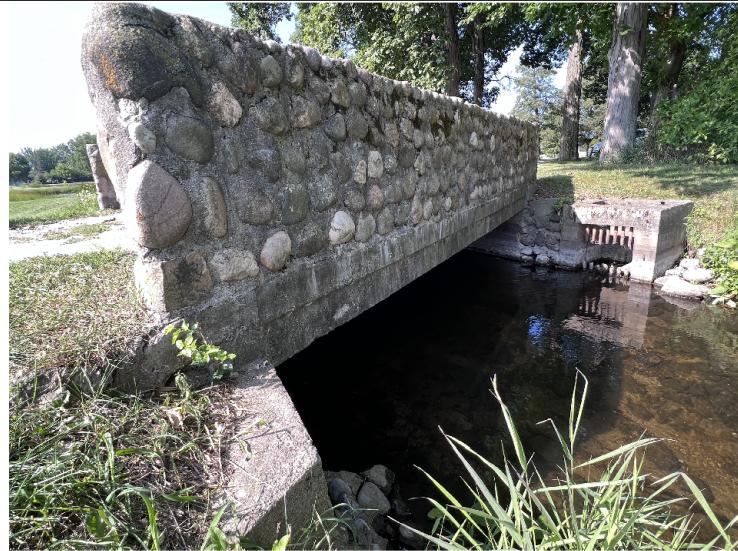
2. Looking West, efflorescence visible along deck coping. Some deteriorated mortar visible along end of abutment wall. Outside face of barrier wall visible, both barriers to be repaired by repointing.

- 4 Perform repointing on barriers. Work to be performed without the use of mechanical tools.
- 5 Patch spall at northeast corner of east abutment.
- 6 Provide temporary shoring for superstructure. Estimated unfactored dead load: 7 kips per beam end Excavate a minimum of 2 ft below channel bed and determine if the bottom of the abutment wall is visible. If the bottom of the abutment wall is deeper than 2 ft, and the condition of the wall is satisfactory, no need for underpinning. Contractor shall ensure the temporary shoring location is set away from any channel bed excavation.

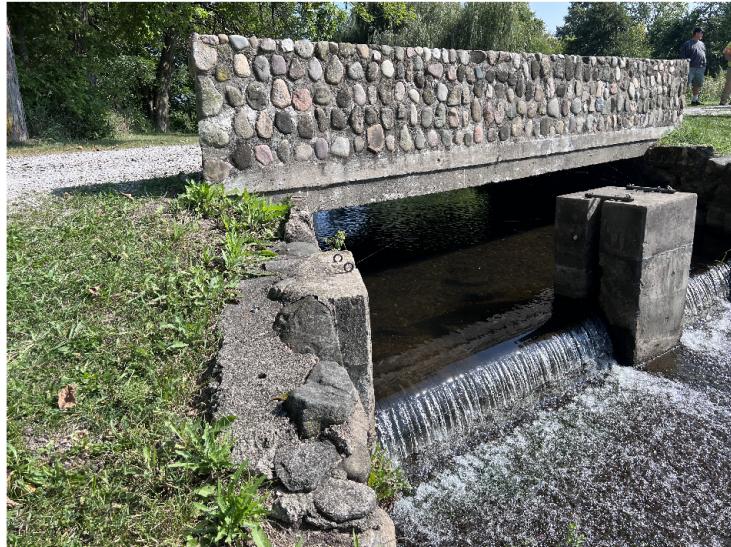
3. Side Elevation Looking North. Some minor efflorescence visible along deck coping. Outside face of barrier wall visible, both barriers to be repaired by repointing.

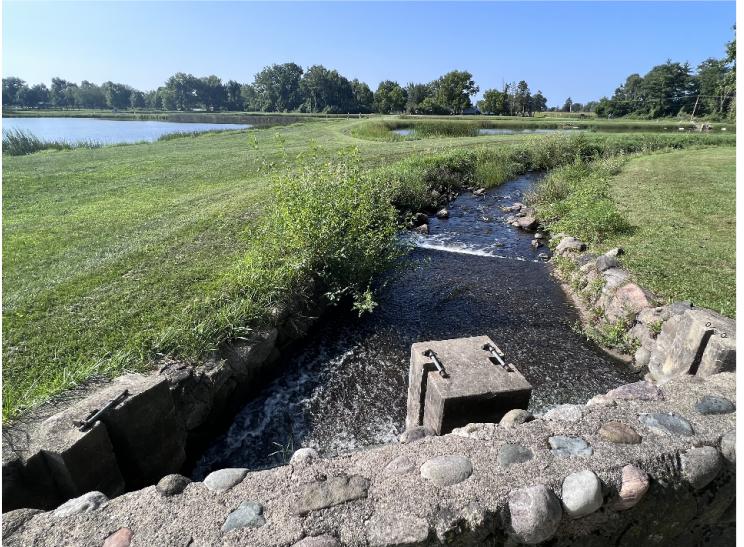
4. Looking South downstream, top of the barrier wall is visible.

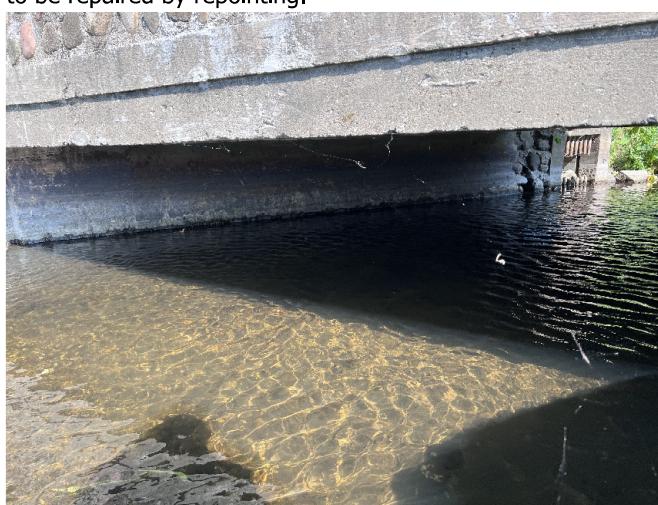
5. Looking west, afflorescence visible along deck coping. Some deteriorated mortar visible along length of abutment wall.
