# Indiana Classified Forest & Wildlands Forestry Best Management Practices Monitoring Results

# **Indiana Classified Forest & Wildlands Forestry Best Management Practices Monitoring Results**

By Jennifer Sobecki & Duane McCoy

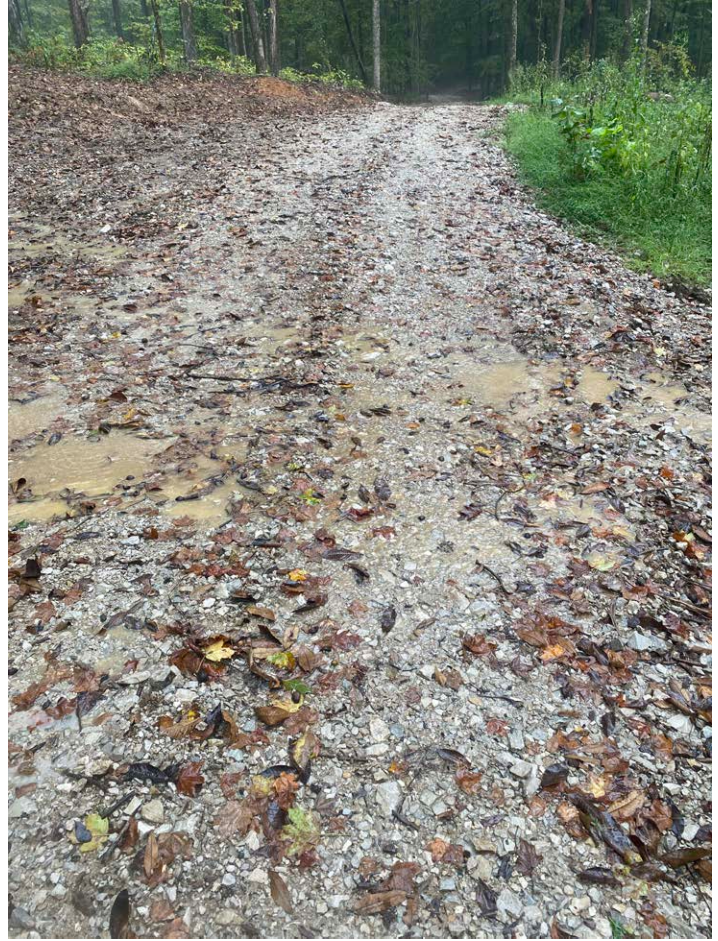
An outslope on this access road channels runoff to the forest floor. This prevents runoff from continuing down the access road, thus limiting erosion potential. Photo by Duane McCoy, DNR

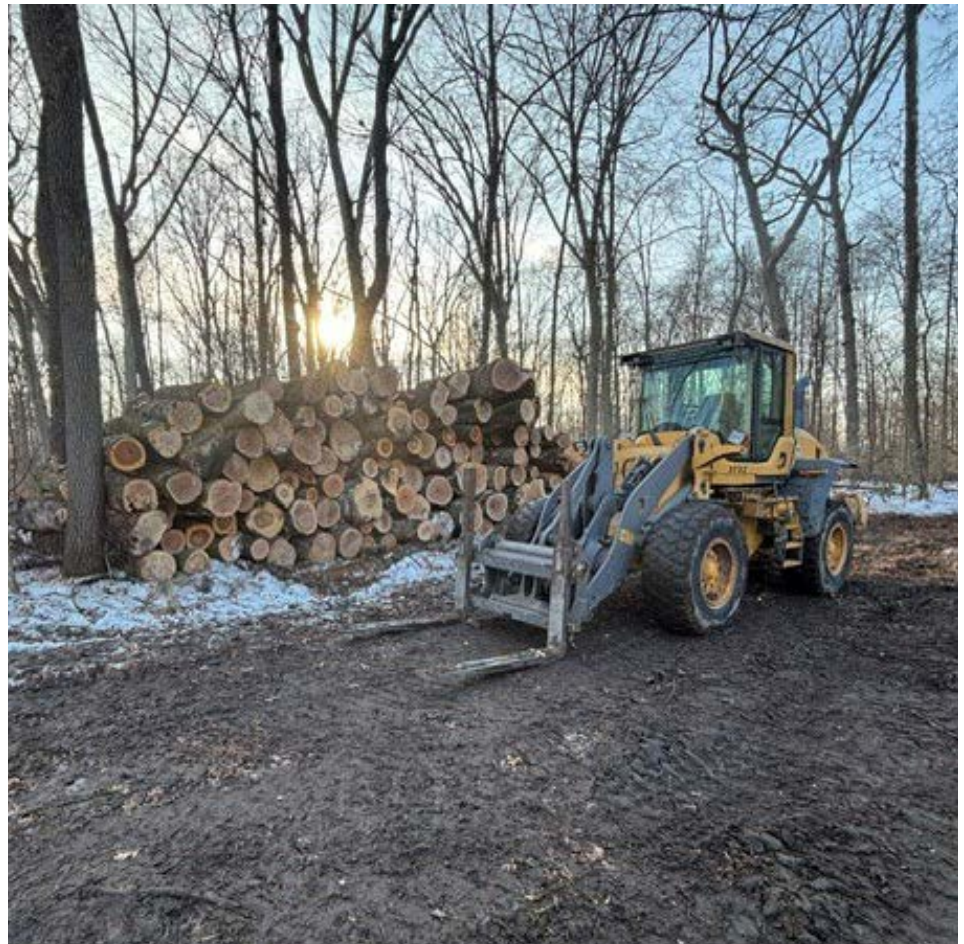
Logs stacked in a landing to be loaded after harvest has concluded. Ground was frozen, thus minimal damage to soil. Photo by Jennifer Sobecki, DNR

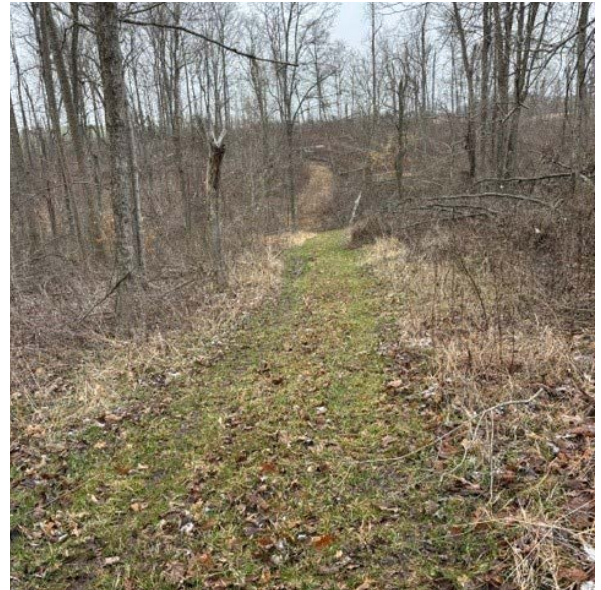
Short and mostly gentle slopes and heavy seeding have allowed this skid trail to heal and stabilize quickly after a tornado salvage harvest. Photo by Jennifer Sobecki, DNR

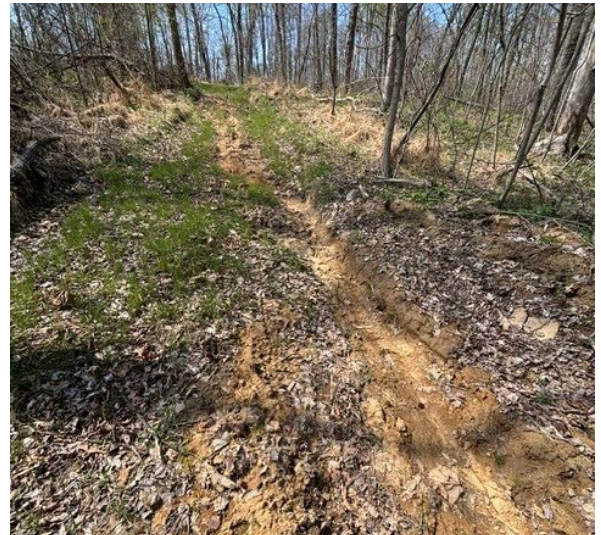
The main area of concern on CLFW skid trails was the installation of appropriate drainage and diversions (S7). The application rate of this BMP for CLFWs was 43.8%; however, this is a 15.6% increase from 28.2% in the 2011 report. The effectiveness rate for appropriate drainage and diversions installed was 60.9%. These numbers indicate that implementation departures in this area may be having some level of impact on water quality on CLFW harvest sites. However, trends are showing improvement in application of drainage and diversion installation. Other skid-trail BMPs in CLFWs that need further attention are S2, S8 and S9. These have application rates of 69.4%, 71.1%, and 67.0%, respectively. Effectiveness rates for S2 are 84.4%, 79.3% for S8, and 73.2% for S9. These departures in application seem to have a minimal total effect on water resources of the sites, with overall effectiveness at 85.1%.

Heavy seeding and good revegetation can only protect the soil so much on a steep and long slope. Lack of water diversions on this skid trail is causing erosion and destabilizing the trail after a harvest. Photo by Jennifer Sobecki, DNR

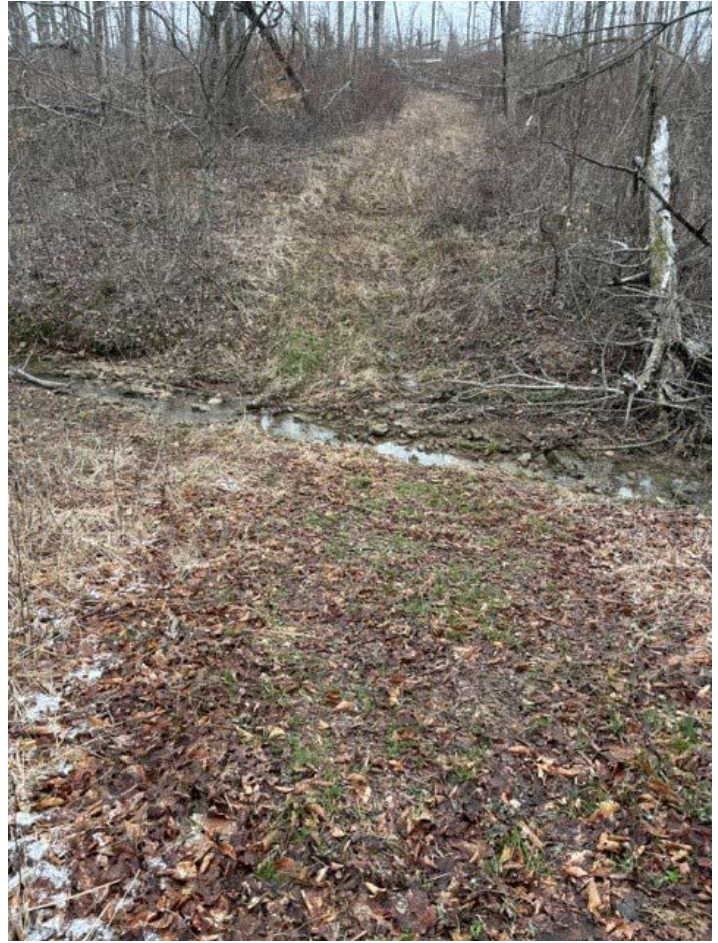
While water diversions on both sides of the stream prior to the crossing would have been ideal for the crossing, the heaving seeding and good revegetation are holding the soil and have stabilized the crossing. Photo by Jennifer Sobecki, DNR

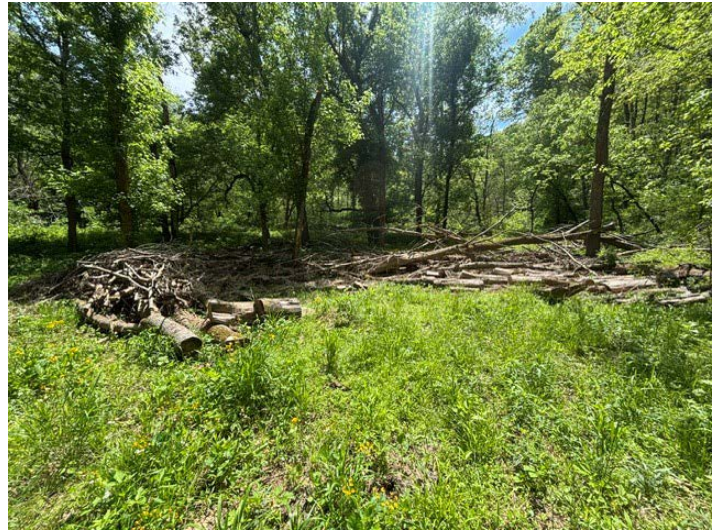
With many trees retained in the RMZ, the debris from floods are allowed to settle and prevents harvest debris from entering the stream. Photo by Jennifer Sobecki, DNR

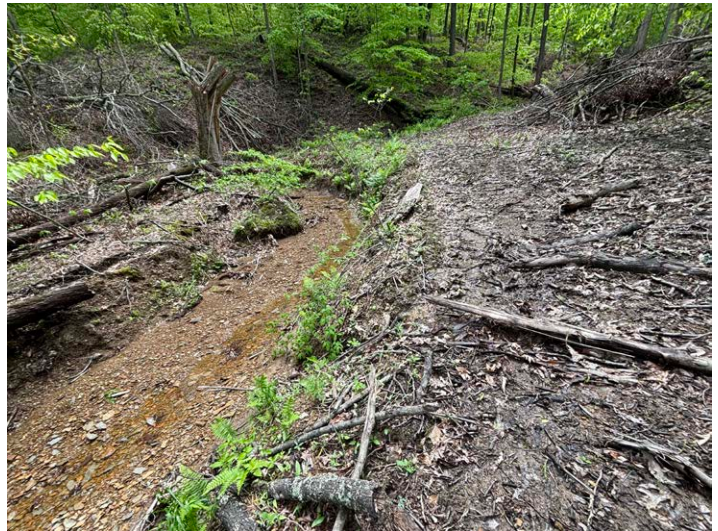
Skidding next to a stream is a violation of the Forestry BMP guidelines; however, it is sometimes necessary due to geographical constraints. In this instance the trail next to the stream was well closed out and stabilized and soil is not washing into the stream. Photo by Jennifer Sobecki, DNR
